# APPLICATION OF GPR DURING INVESTIGATION CONCERNING CAUSES OF FAILURE OF RAILWAY STATION PLATFORM IN JILEŠOVICE

## VYUŽITÍ GPR PŘI ZJIŠŤOVÁNÍ PŘÍČIN PORUŠENÍ NÁSTUPIŠTĚ NÁDRAŽÍ V JILEŠOVICÍCH

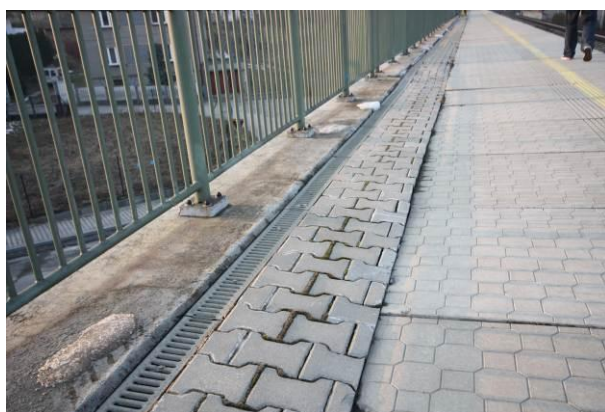
The composition of material of the historical embankment of the railway track in Jilešovice is not known. The embankment was naturally sloped. Within the reconstruction a bridge was newly built over a local road and the embankment was secured by supporting walls (Figs. 5 and 8). After the reconstruction was completed a deformation of the platform surface occurred (Figs. 6 and 7).

**Fig. 6** View in the longitudinal axis of the platform with visible deformations. Photo A. Poláček.

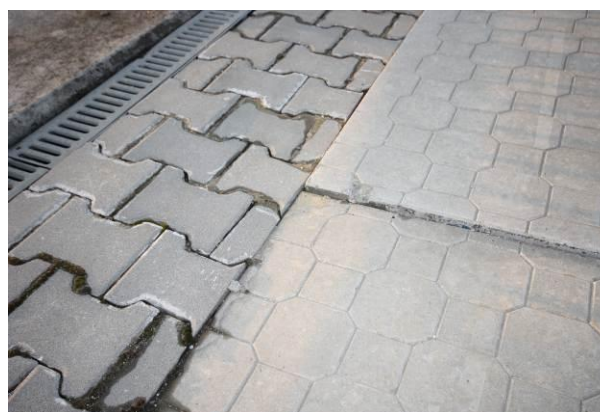
**Fig. 7** Detail of the platform surface deformation at the interface between interlocking pavers and concrete panels. Photo A. Poláček.
