A study of the low-cycle fatigue failure of a galvanised steel lighting column

Louise A. Alexander^a, James Wood^{b*}

ABSTRACT

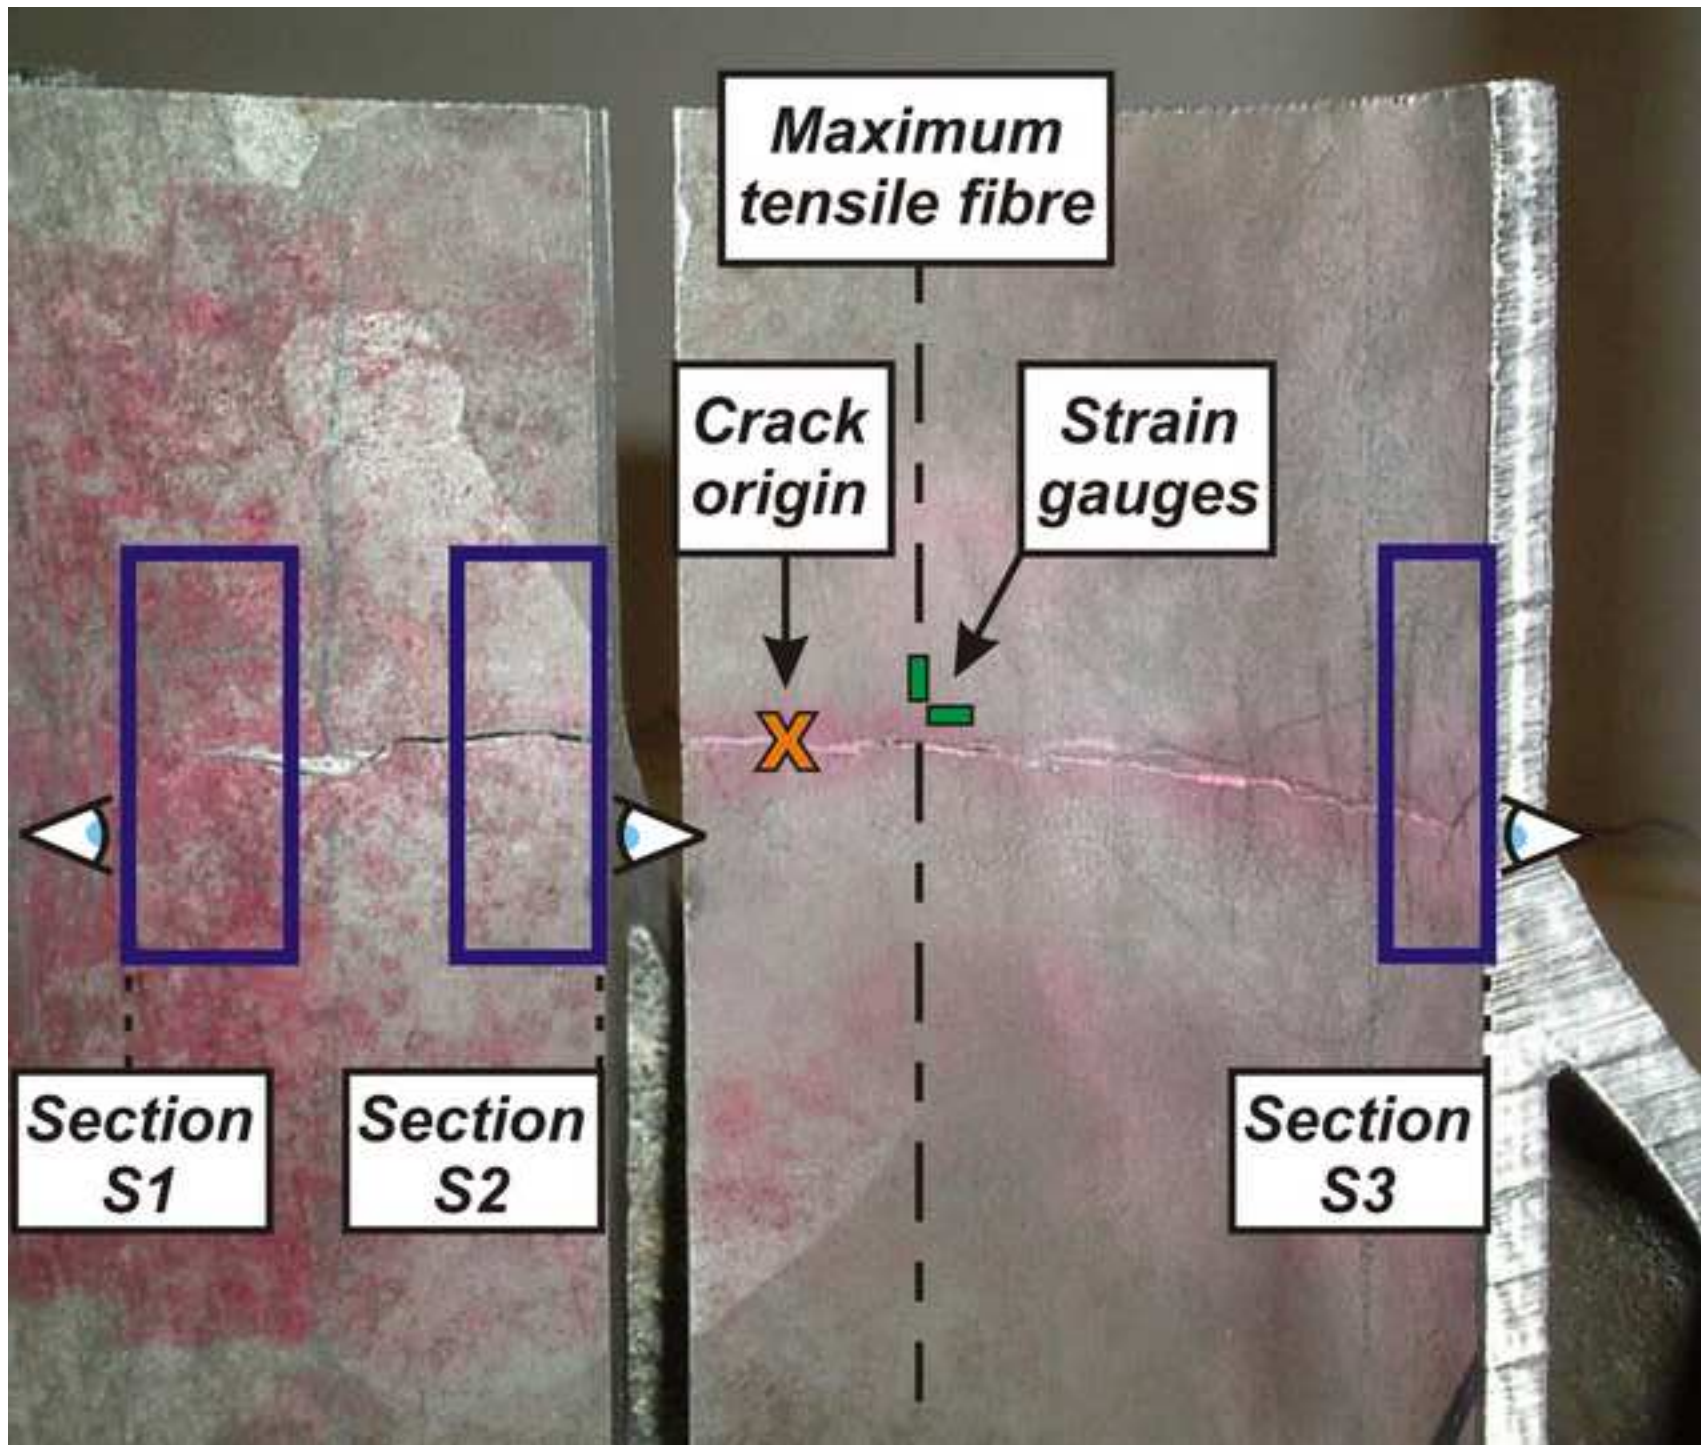
Figure 5

Shown in Fig. 5 is the location of the assumed crack initiation site on the outer surface of the column. Due to the nature of the low cycle fatigue test, the usual

beach marks, characteristic of high cycle fatigue, were not apparent in this case. This made identification of the initiation site difficult. It may also be noted that the cyclic strain range precluded ratcheting, which is another failure mechanism associated with cyclic plastic straining.

Also shown on the figure is the position of the maximum tensile stress, for reference purposes – on the outer surface at “bottom dead centre” in the test set-up.

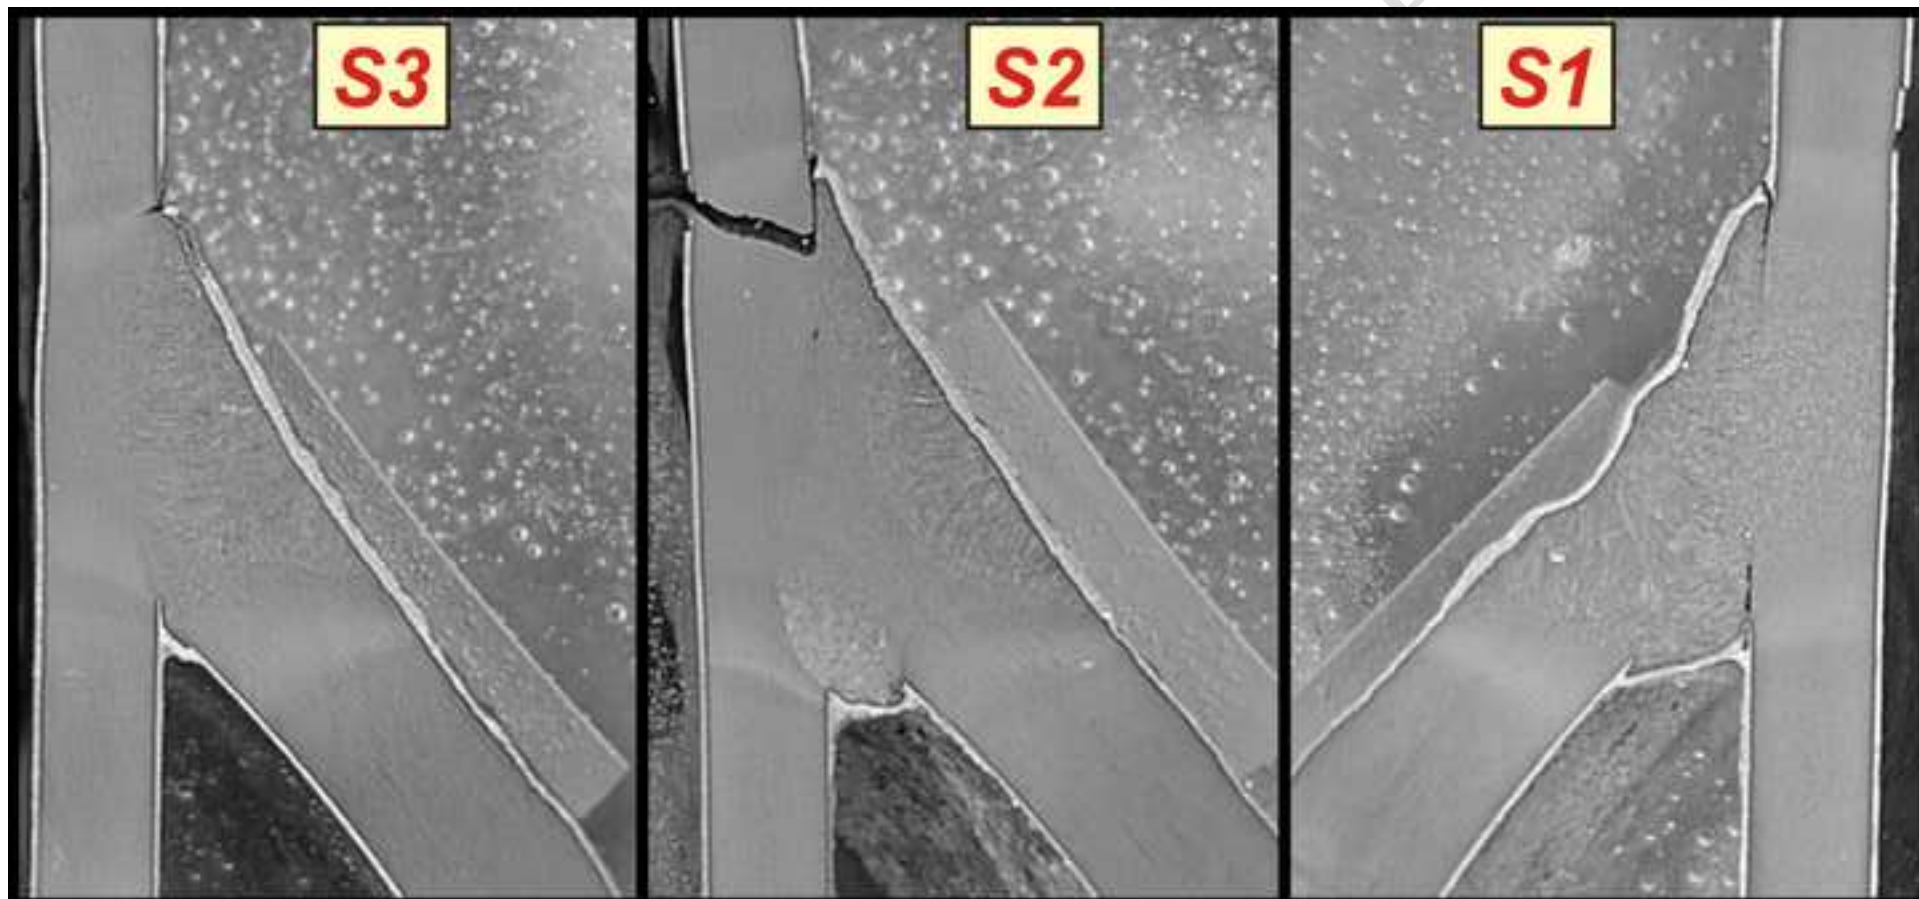
Figure6

First of all it may be observed in Fig. 6, that the quality of the weld is very poor. At section S1 there is lack of penetration, poor root formation, wall thinning and irregular weld profile. This un-fused weld metal is referred to as a “cold lap” and is a common problem in high deposition rate welds. They can inhibit the successful application of weld toe improvement techniques and have the practical disadvantage that the growing fatigue crack is under the weld and is therefore not visible and hence is less easy to detect. The root formation is variable across all three sections, as is the thickness of galvanised coating. Cracks are evident at the weld toe in all three sections.

The detailed micrographs for section S1 in Fig. 7 show that the toe crack, instead of propagating through the thickness, as would be expected, has joined with the “cold lap”. The fact that these “cracks” are probably due to lack of fusion is apparent in Fig. 6, as the cold lap at the root of S1 is still sealed with galvanizing.

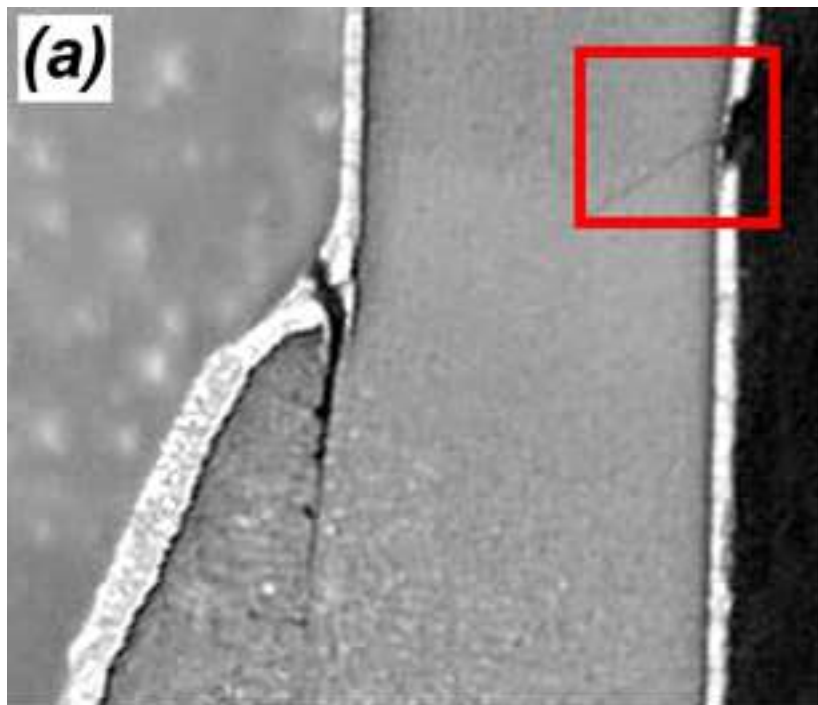
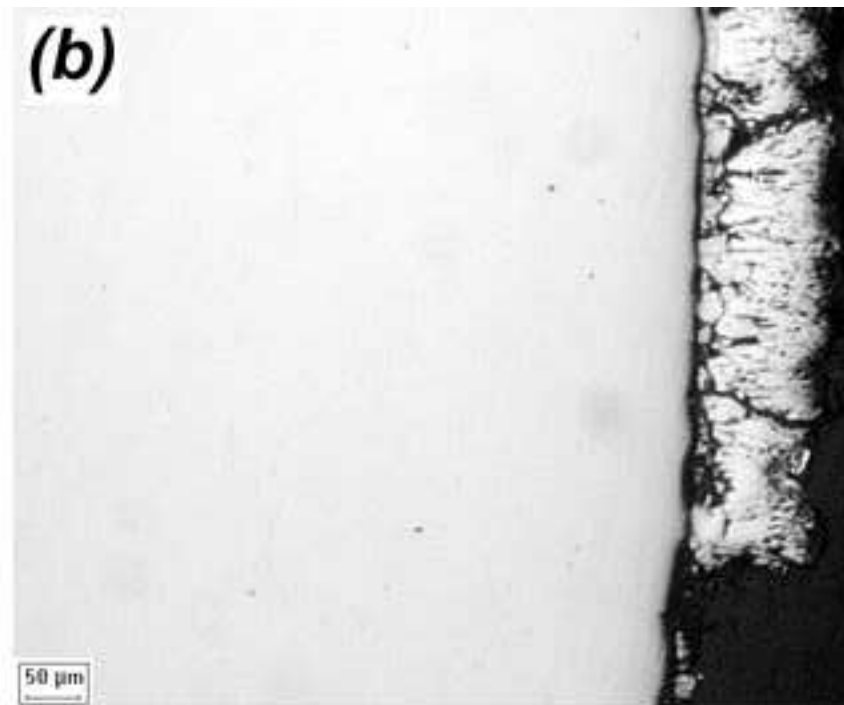
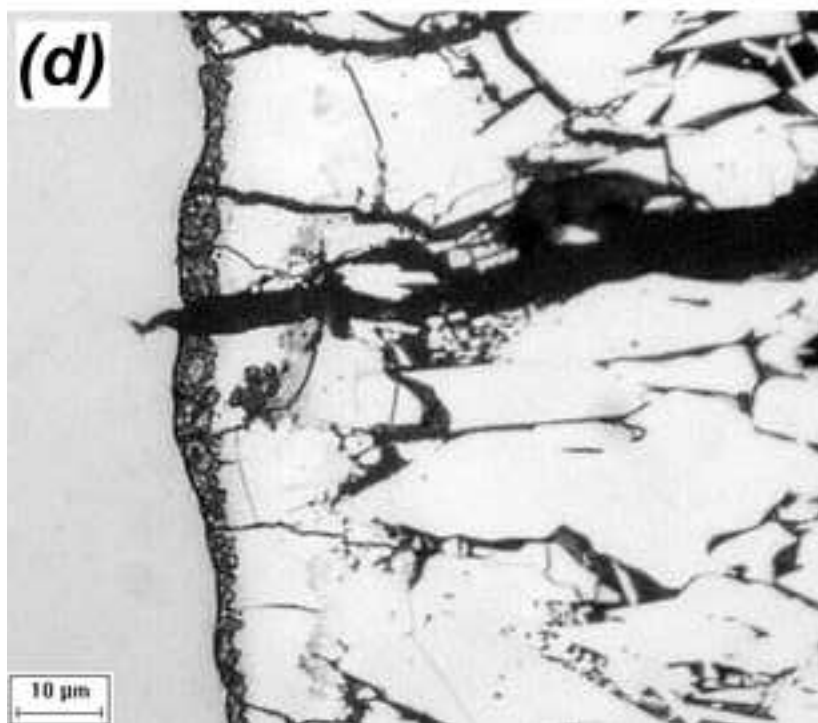
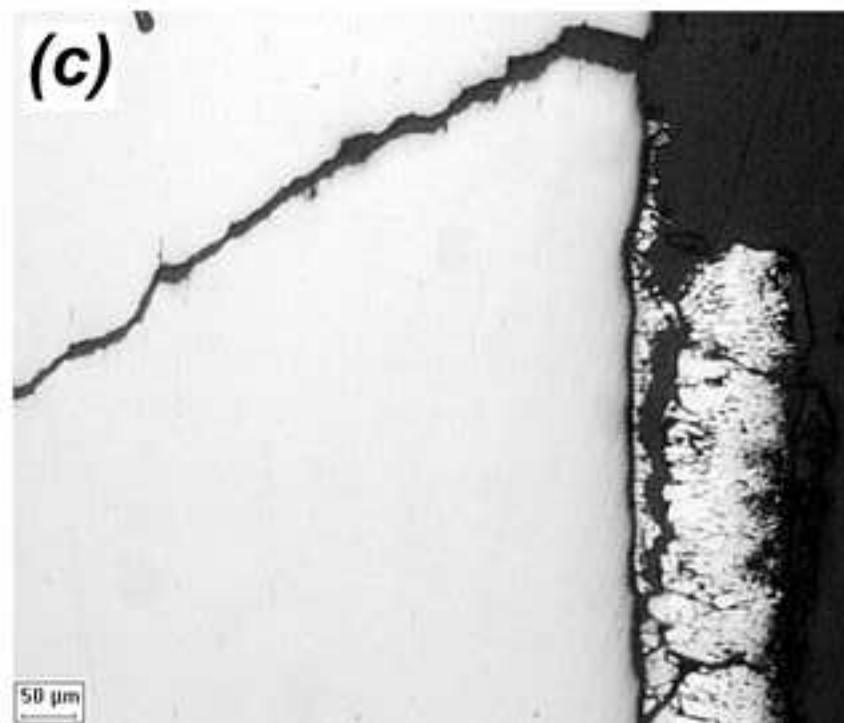
Figure 7

Interestingly however, Figs. 7(a) and (c) show fatigue cracks developing from the inside surface of the tube. This is somewhat unexpected, in that the inner surface is not welded and lacks the stress concentrating toe. In addition, the nominal bending stress is not as high on the inner surface as it is on the outer. All the more surprising therefore that there is a section of the galvanised coating missing on the inner surface. It is postulated that the coating has suffered damage and eventual de-bonding from the steel substrate due the perhaps unexpected local axial compressive stresses and strains in this vicinity as seen in Figs.12 and 13. This in turn may have acted as a severe stress concentration, leading to the development and propagation of the crack shown. The galvanised coating in this general area shows evidence of significant damage and cracking. Fig. 7(d) shows a crack just starting to run from the galvanizing into the steel. It would therefore appear that the coating de-bonding scenario is not always necessary either. These are significant observations and indicate that weld improvement may not in fact increase the fatigue life of galvanised steel lighting columns. There may also be residual stresses in this region that could affect damage initiation and development.

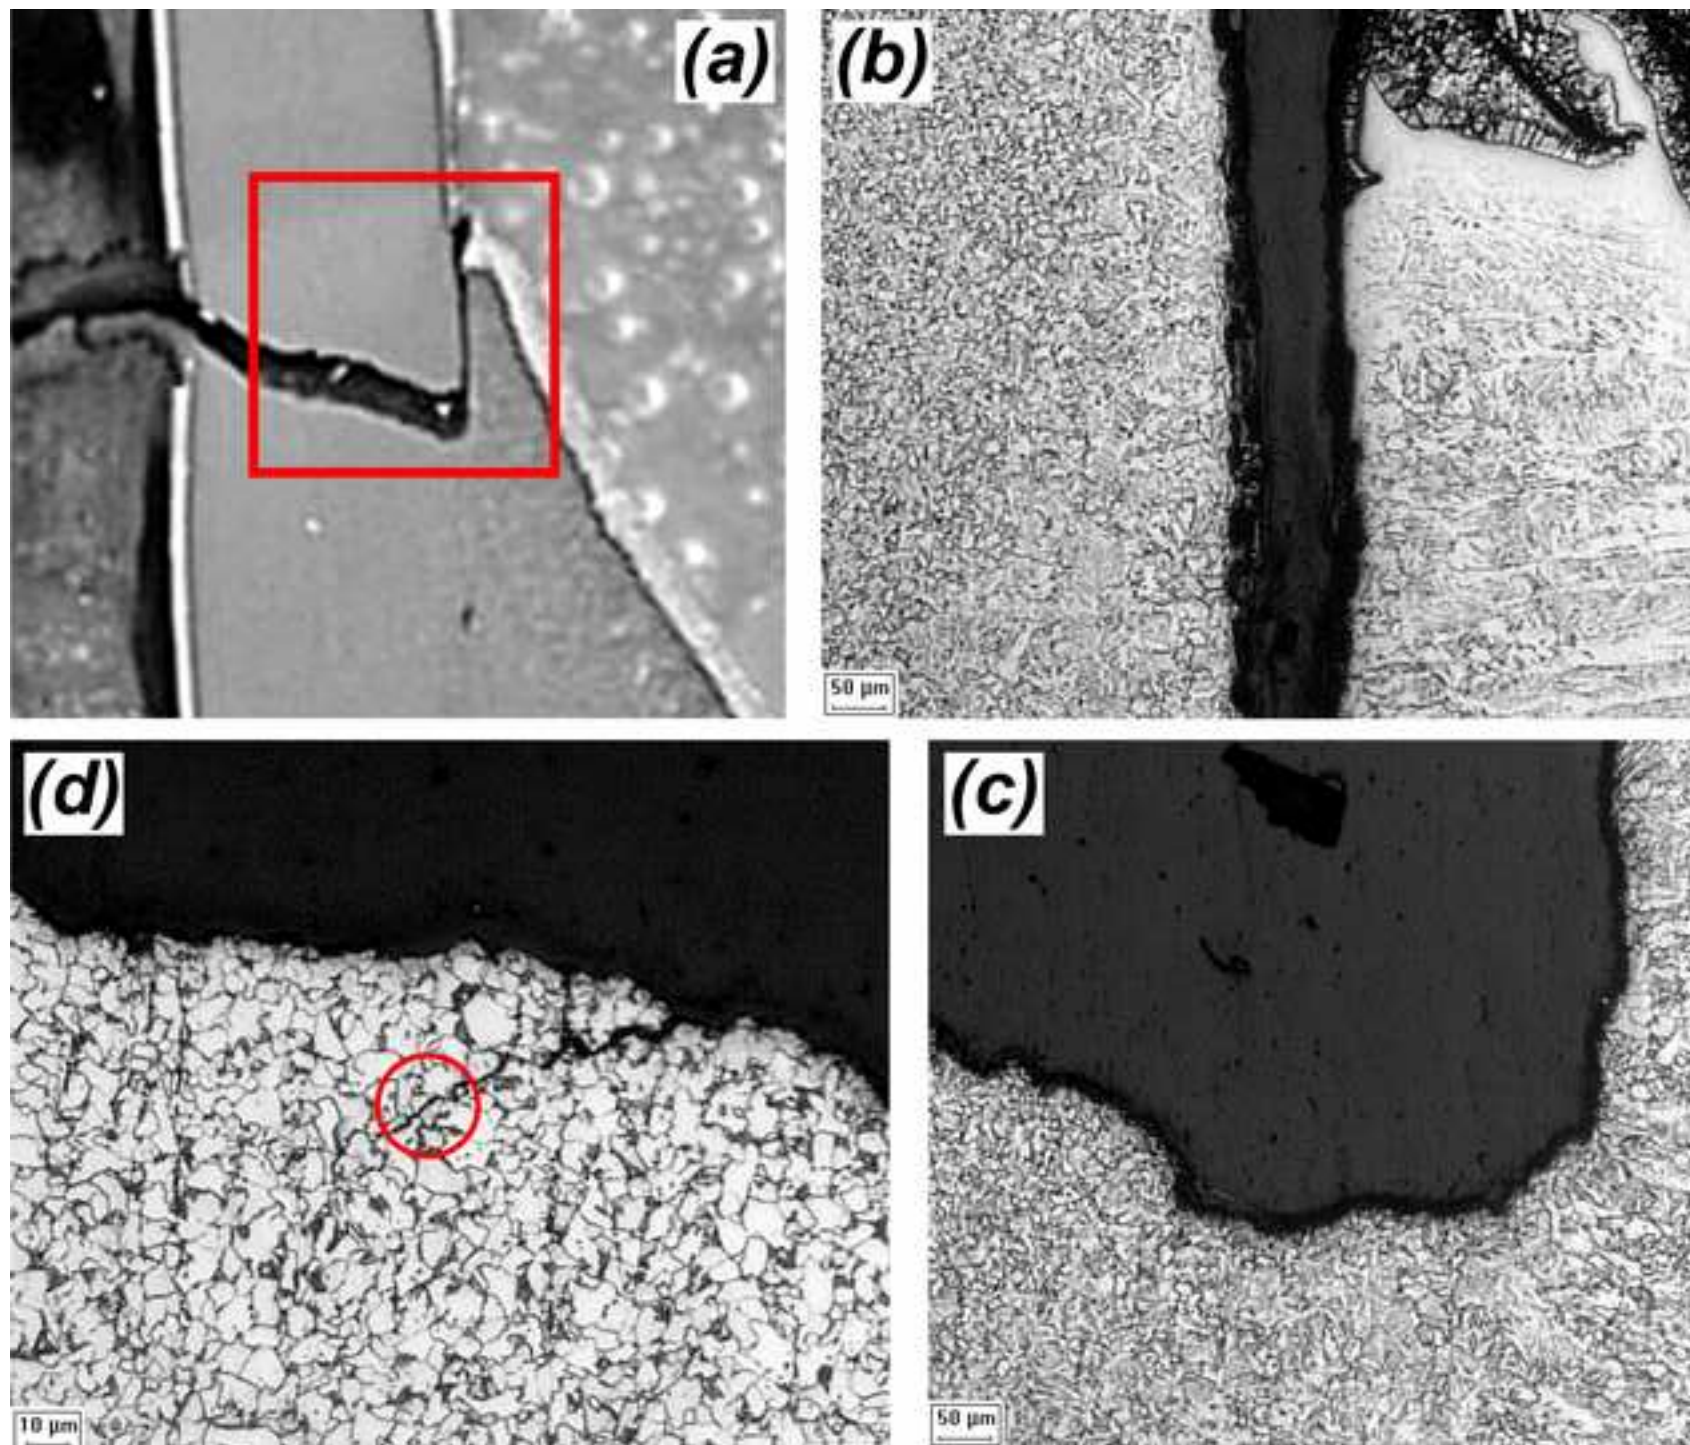
Figure 8

The micrographs for section S2 in Fig. 8 show the through-crack. The precise sequence of crack growth is unknown. However, from the cracks apparent in

section S1, it is possible that a similar scenario developed, with the crack from the inner surface galvanizing propagating until it met with the crack along the line of poor fusion. Fig. 8(d) shows evidence of trans-granular cracking in the steel, which is typical of fatigue.

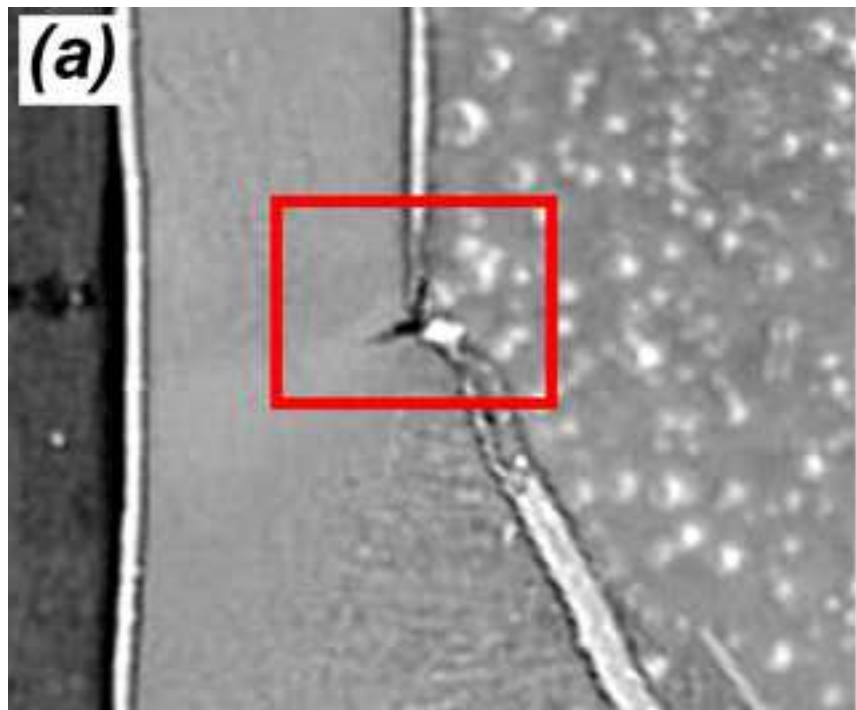
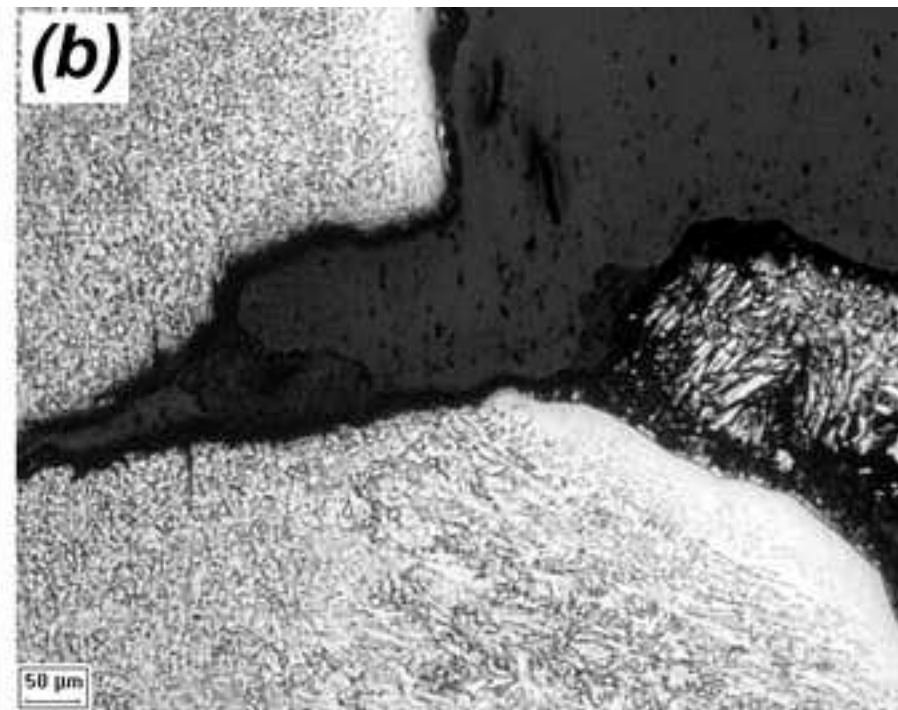
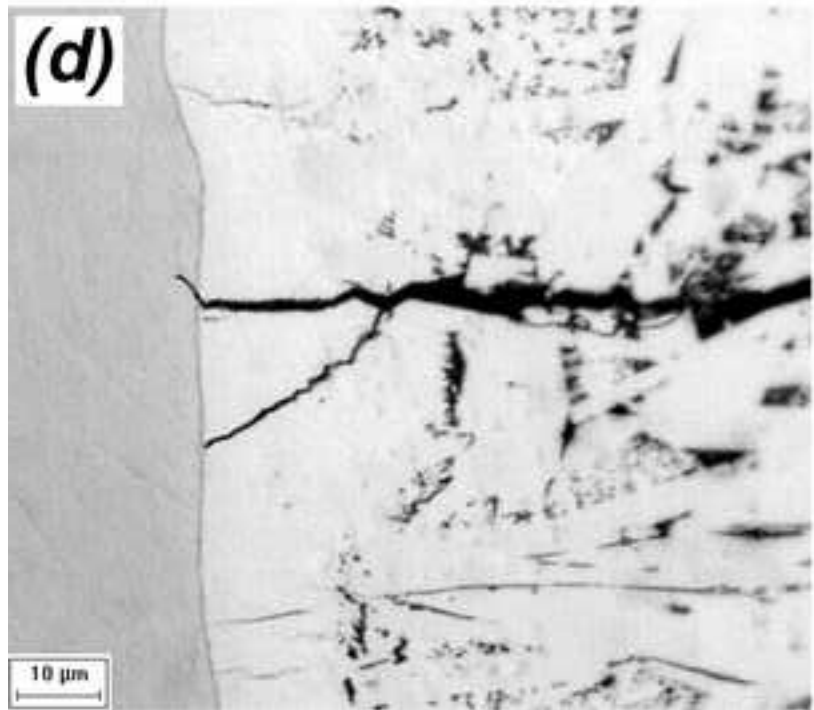
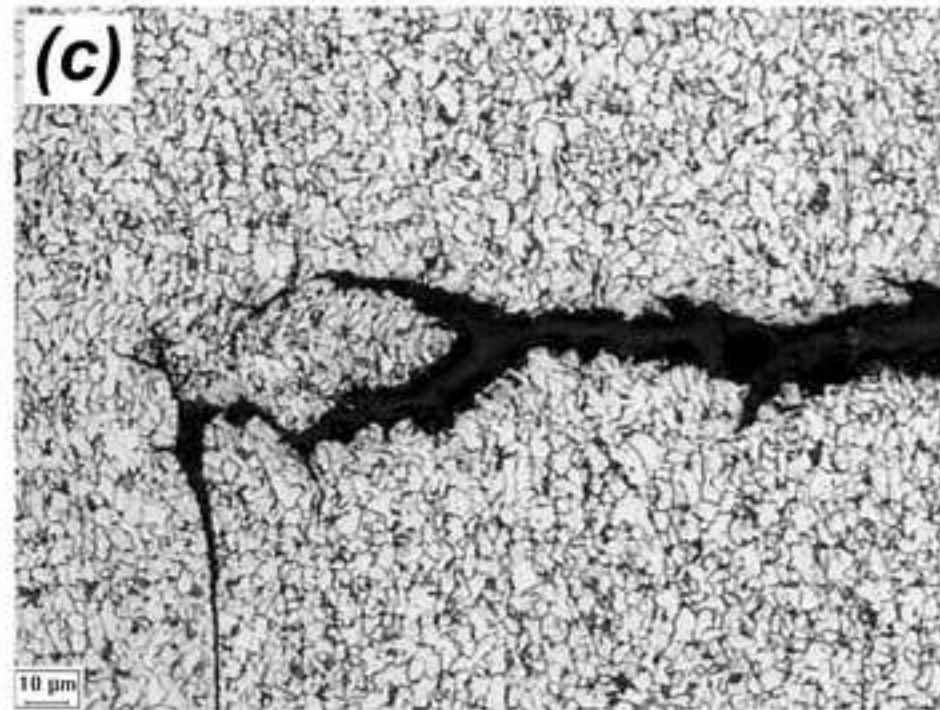
Figure9

Fig. 9 shows the normal expected fatigue crack development, initiating and running from the weld toe, through the thickness of the shell in a direction perpendicular to the maximum principal stress. Fig. 9(d) shows a fatigue crack running from the galvanizing on the outer surface into the steel. Fatigue cracking of the galvanised coating is clearly not limited to the inner surface of the tube.

The galvanising is seen to vary greatly in thickness. Thicker galvanising results in a slower cooling time, allowing more inter-metallic phase to form. Thick areas of inter-metallic phase can cause a loss of strength in the steel, owing to its embrittlement. Additionally, as shown in the micrographs, long needles are present in the zinc. These needles can act as stress raisers and may have arisen from a long emersion time or excessive temperature during the galvanising process. These factors reduce the ductility of the coating and increase the ease with which the zinc can crack and chip.
