**AN EXPERIMENTAL AND FINITE ELEMENT STUDY OF
THE LOW-CYCLE FATIGUE FAILURE OF A
GALVANIZED STEEL LIGHTING COLUMN**

James Wood^a, Louise A. Alexander^b and Ian Taylor^b

SUMMARY

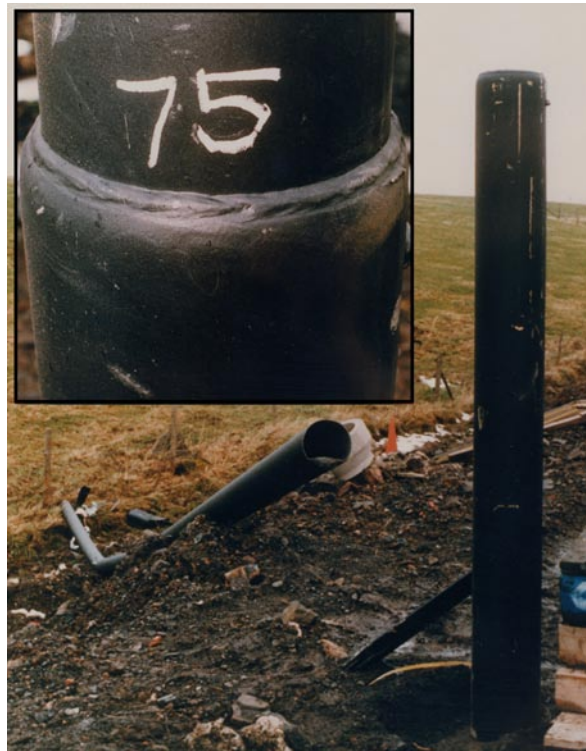
Figure 1: Low-cycle fatigue failure of 18m lighting column.

It may be observed that the columns failed at the fillet weld adjacent to the swage section above the door. The swage joint is the focus for the present investigation. The period of vibration, amplitude of vibration and time to failure for these newly installed columns, observable from the video footage associated with these failures, would indicate low-cycle fatigue as the failure mechanism. This type of failure proved to be a significant problem with particular designs of column throughout the UK.

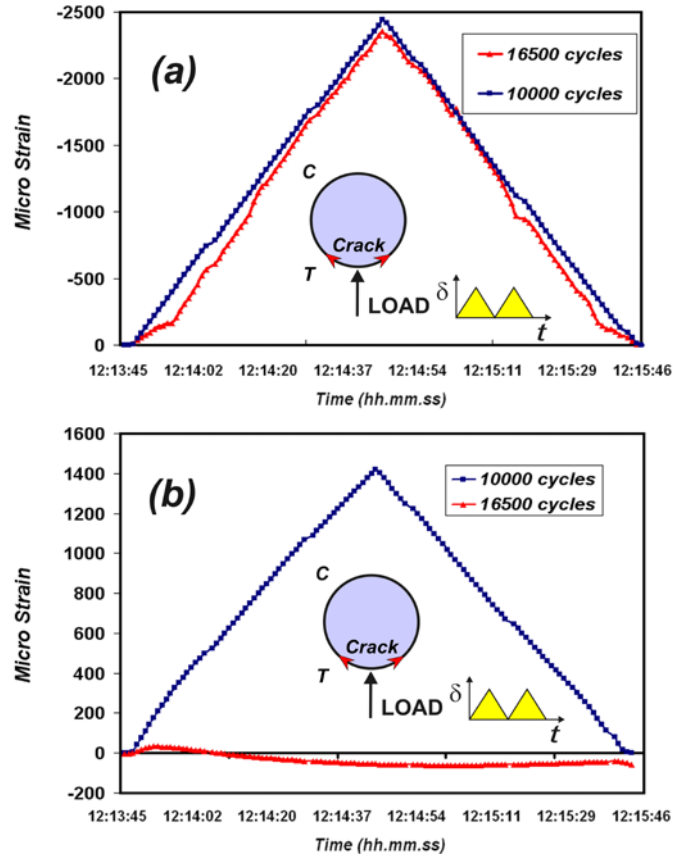
approximately 10 hours. The crack was found to be approximately 102mm long in the hoop direction along the weld toe, as illustrated in Figure 5.

Figure 5: Strain-time variation for 10000 and 16500 cycles.

Figure 5 shows the strain-time variation for the 10000 and 16500 cycles, for the longitudinal gauges closest to the swage joint on both the compression (a) and tensile (b) surfaces. Figure 5(b) shows the strain drop-off on the gauge on the tensile side as the crack develops around the circumference of the tube. There is clearly no such drop-off on the compression side.

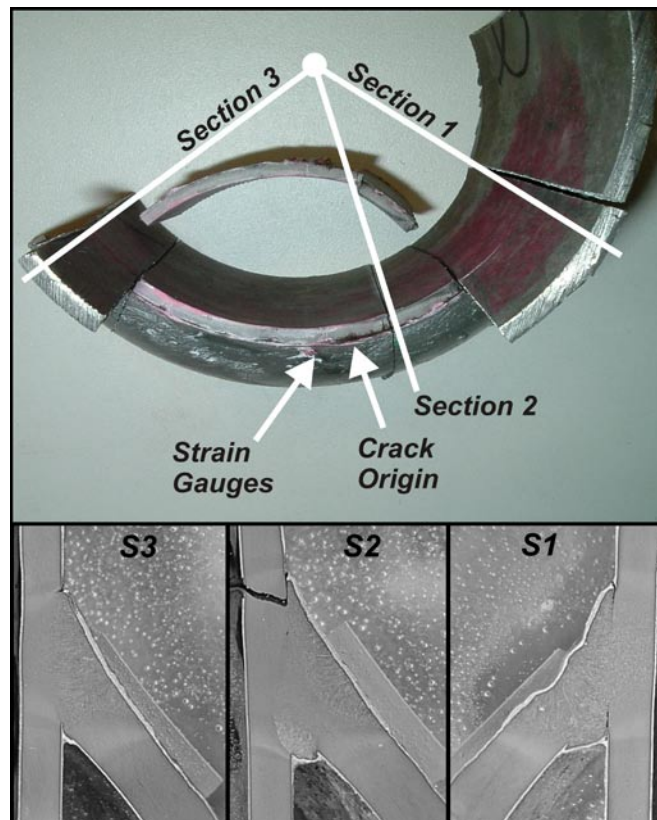
Figure 7: Micrograph specimen location.

First of all it may be observed in Figure 7, that the quality of the weld is very poor. At section S1 there is lack of penetration, poor root formation, wall thinning and irregular weld profile. This un-fused weld metal is referred to as a “cold lap” and can be a problem with high deposition rate welding. They can inhibit the successful application of weld toe improvement techniques such as toe grinding and also have the additional problem that the growing fatigue crack is not visible and hence is less easy to detect. Figure 7 also shows that the root formation is variable across all three sections, as is the thickness of galvanised coating. Cracks are evident at the weld toe in all three sections.

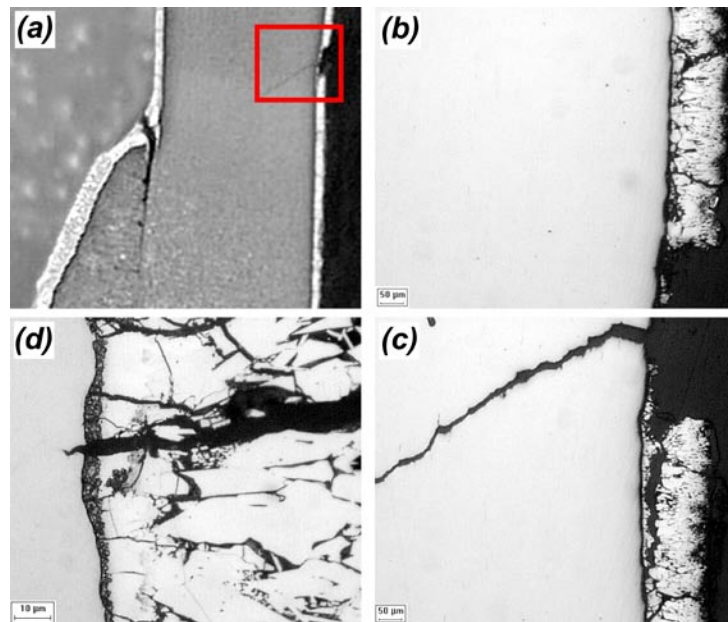
The micrographs for section S1 in Figure 8 show that the toe crack, instead of propagating through the thickness, as would be expected, has joined with the “crack” formed by the “cold lap”. The fact that these cracks are due to lack of fusion is apparent in Figure 7, as the root is still sealed with galvanizing.

Figure 8: Micrographs for specimen 1.

Interestingly however, Figures 8(a) and (c) show a fatigue crack developing from the inside surface of the tube. This is somewhat unexpected, in that the inner surface is not welded and lacks the stress concentrating toe. In addition, the nominal bending stress is not as high on the inner surface as it is on the outer. However, it may be observed that there is a section of the galvanised coating missing. It is postulated that the coating has de-bonded from the steel substrate due the axial compressive stresses in this vicinity. This in turn has acted as a severe stress concentration, leading to the development and propagation of the crack shown. The galvanised coating shows evidence of significant damage and cracking. Figure 8(d) shows a crack just starting to run from the galvanizing into the steel. It would therefore appear that the de-

bonding scenario is not necessary for crack initiation and propagation. These are significant observations and indicate that weld improvement may not in fact increase the fatigue life of galvanized steel lighting columns.

Given that the most severe corrosion will be on the outside of columns and the detrimental effect of galvanizing on fatigue performance, then columns may benefit if the inner surface was not galvanized in regions of stress / strain concentration.

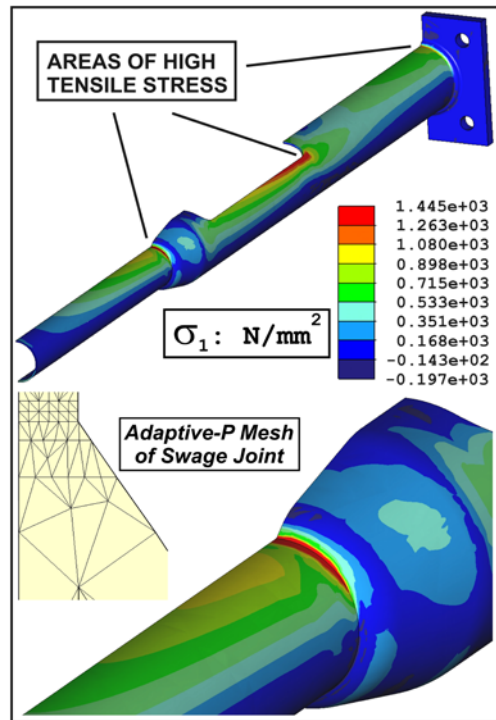
Figure 9 shows 3 areas of high stress – the base weld, the lower corner of the door opening and the swage joint. As has been previously indicated, it is the swage joint which is the focus of attention in this study.

Figure 9: Adaptive P-method Finite Element Model.

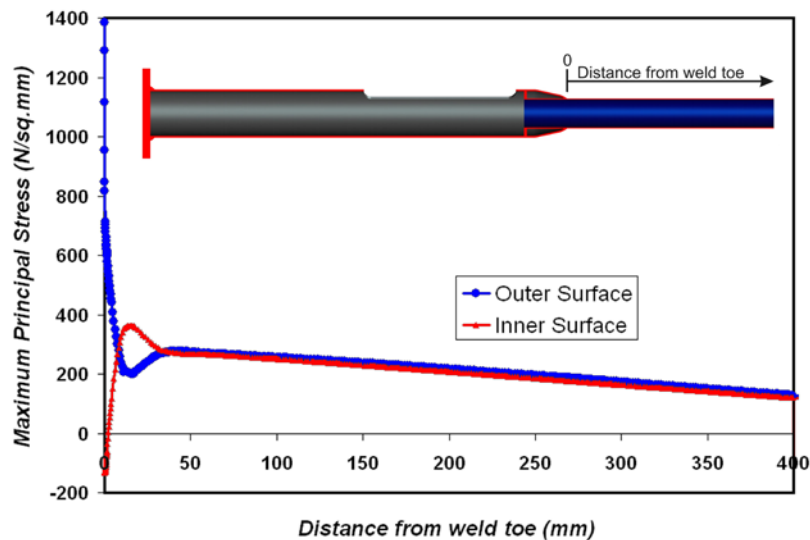
The localized nature of the stress concentration at the swage joint is illustrated in Figure 10. The stress distribution on the toe side tends to infinity with mesh refinement due to the singularity at the weld toe. The extremely localised effect due to the weld (within a quarter of the tube thickness of the weld toe) is superimposed on the gross geometric stress concentration due to the swage. It is the localized component due to the weld that has to be removed for fatigue assessment. This is necessary because the fatigue allowables in the Codes of Practice already include the effect of the weld.

The stress distribution on the inner surface is continuous however. This distribution is terminated opposite the toe for comparative purposes. The very steep gradient on the inner surface is also apparent and the axial bending stress becomes compressive within a distance of one wall thickness of the weld toe position. The compressive strains associated with this stress field could be the source of possible damage of the relatively low-ductility galvanised coating in this region. This in turn will result in fatigue cracks developing from the inner surface as observed in the experiment.

Figure 10: Maximum Principal Stress Decay at Swage Joint.
