Fault Location and Diagnosis in a Medium Voltage EPR Power Cable

ABSTRACT

This paper presents a case study on fault location, characterisation and diagnosis in a length of shielded 11 kV medium voltage ethylene-propylene rubber (EPR) power cable. The defect was identified on-site as a low resistance fault occurring between the sheath and the core. A 43 m section was removed for further analysis. The fault resistance was characterised and the location of the defect pinpointed to within a few cm using a combination of time-difference-of-arrival location and infra-red imaging. A combination of X-ray computed tomography, scanning electron microscopy and energy dispersive X-ray spectroscopy were then applied to characterise any abnormalities in the dielectric surrounding the breakdown region. A significant number of high density contaminants were found to be embedded in the dielectric layer, having an average diameter of the order of 100 μm , a maximum diameter of 310 μm and an average density of 1 particle per 2.28 mm^3 . Scanning electron microscopy and energy-dispersive X-ray spectroscopy were used to determine the geometry and elemental composition of some initial contaminant samp

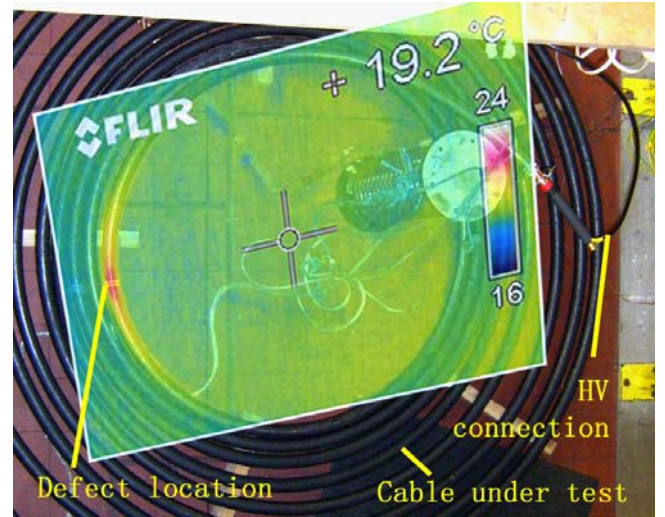
Figure 4. Fault location using infra red imaging. The location is 1.8 m from the cable datum end. For clarity, this composite image consists of the thermal image superimposed on a photograph of the experimental setup.

The cable had been placed in a spiral arrangement so that the entire cable length was within the field of view. The site of the fault was apparent on the inner coil of the spiral arrangement as evidenced by increased temperature in the region. Once thermal equilibrium was reached the peak cable temperature was found to be 21.7°C (2.5°C above the ambient level).

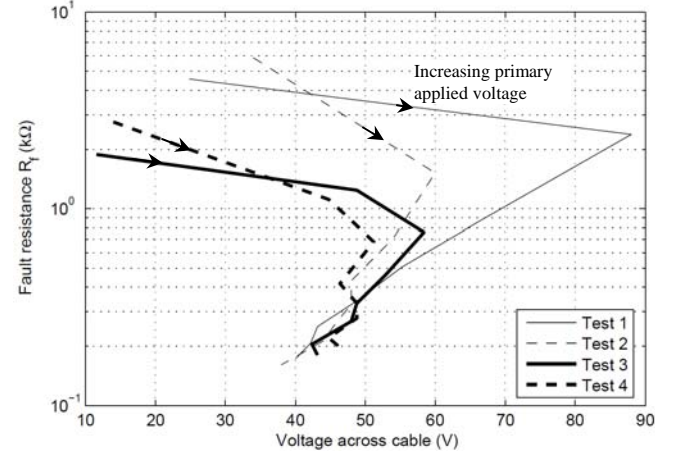
Figure 7. Variation of fault resistance with the voltage across the cable.

Arrows shown in the figure indicate an increasing supply voltage (and current) applied at the primary winding. In each of the four tests, a corresponding increase occurs in the voltage across the cable, until the fault reaches a transition point where its resistance decreases significantly. In each of the test cases, the defect resistance approaches a minimum of around 200 Ω at the maximum applied primary voltage. This minimum value was consistent with that initially obtained by the site engineer, leading to decommissioning of the cable.

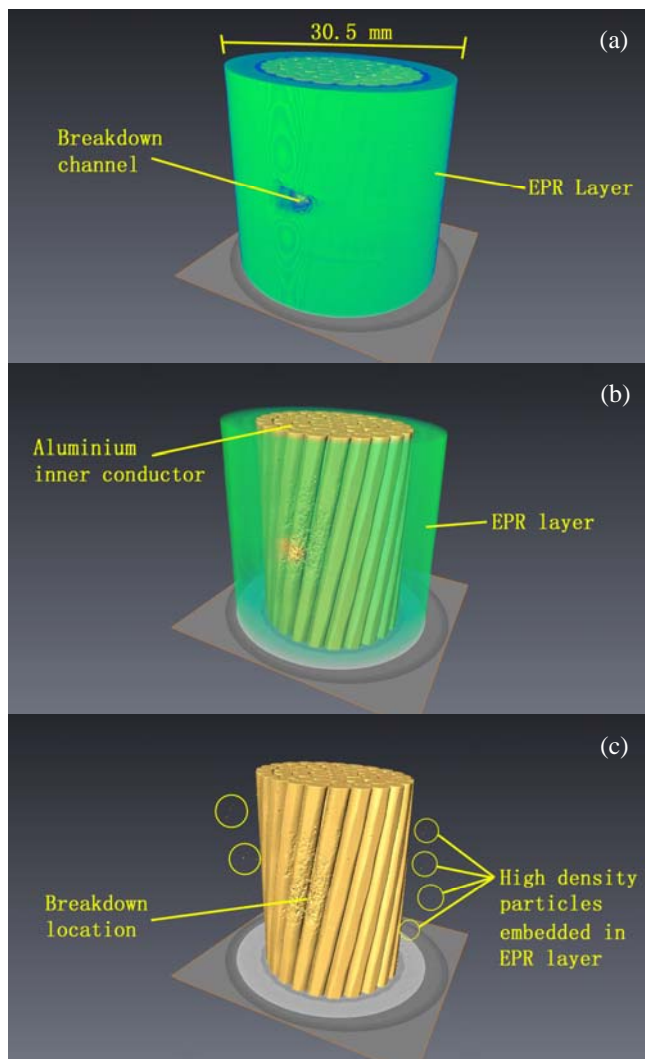
Fig. 9 shows the results of volume rendering of the reconstructed data. Rendering the high-density region as an isosurface, while separately rendering the volume of the EPR and semiconducting layers, allowed the effect of artificially removing the insulation layer. This revealed the presence of multiple high-density contaminants. Several contaminants have been highlighted in Fig. 9 (c) for illustration purposes. Damage to the inner core is evident around the breakdown region as is an increased contaminant density. Due to sustained stressing, the fault has largely disintegrated the EPR region surrounding it. Particle diameters are of the order of 100 μm.

Figure 9. Reconstructed cable geometry from X-ray scans. (a) EPR layer is fully visible, (b) EPR layer set to semi-transparent, (c) EPR layer hidden to show particle contamination and damage to inner conductor.

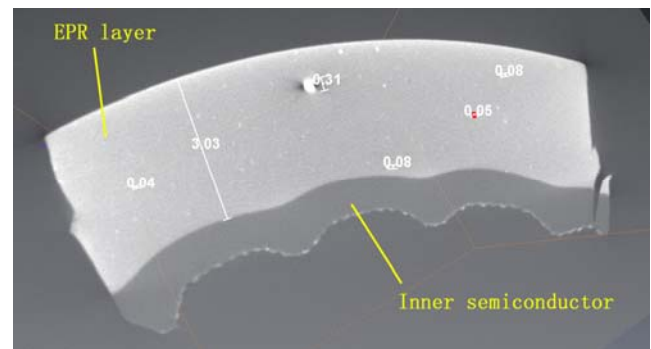
Figure 10. Reconstructed 2D orthographic slice of a thin sample of insulator near the defect region. Embedded high density particles appear as light regions. Dimensions are in mm.

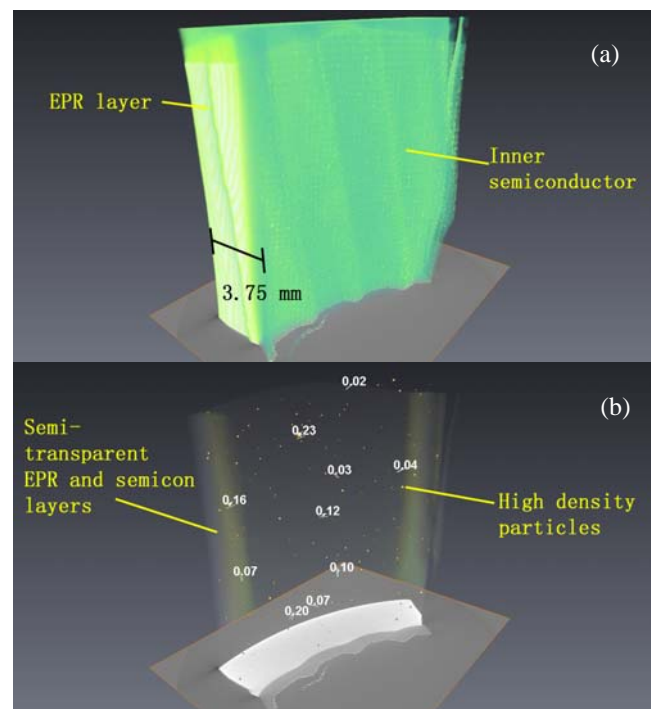
Fig. 11 shows the reconstructed volume of the small dielectric sample. Setting the low-density insulation region as a semitransparent layer reveals the embedded contaminants. The average particle density in this region is 1 particle per 2.28 mm^3 .

Figure 11. Reconstructed 3D geometry of a thin sample of insulator and semiconductor removed from near the defect region. (a) Semiconducting and EPR layers fully visible, (b) EPR and semiconducting layers set semitransparent to reveal embedded high density particles. Dimensions in mm.
