ULTRASONIC TOMOGRAPHY FOR DETECTING AND LOCATING DEFECTS IN  
CONCRETE STRUCTURES

A Thesis

JOSHUA BENJAMIN WHITE

Submitted to the Office of Graduate Studies of  
Texas A&M University  
in partial fulfillment of the requirements for the degree of  
MASTER OF SCIENCE

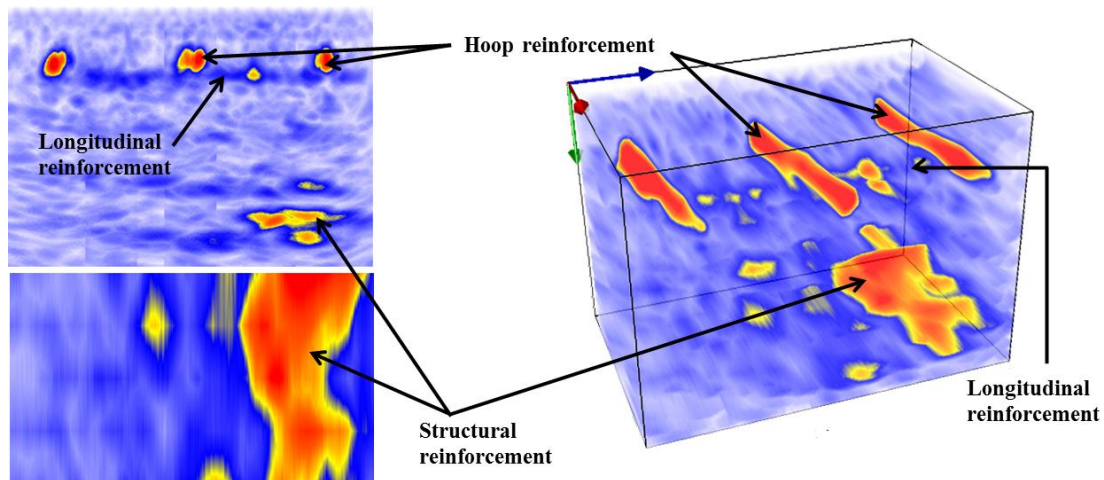
As would be expected, the “sound” concrete area (Map ET 10.4-1, 2 in Appendix B) showed no signs of significant delamination, but a clear interface was observed approximately 411 mm (16.2 in.) below the surface (~239 mm, or 9.4 in. wide).

This interface was consistently seen at every testing location between Segments 8-10 within the Eisenhower Tunnel lining and is surmised to be part of the structural reinforcement that was in place prior to the placing of the tunnel lining. Detailed tunnel blueprints for verification at this location were not available for confirmation. Fig. 27 (a, b, and c) correspond to typical B-, C-, and Volume-scans, respectively, at this location. In the B-scan, the hoop (or circumferential) reinforcement is clearly observable at approximately 107 mm (4.2 in.) in depth and at 251 mm (9.9 in.) o.c. A single rebar as part of the longitudinal reinforcement is seen in the B-scan and Volume-scan as well.

**Fig. 27. UST images of “sound” area: B-scan (top left), C-scan (bottom left), and Volume-scan (right)**

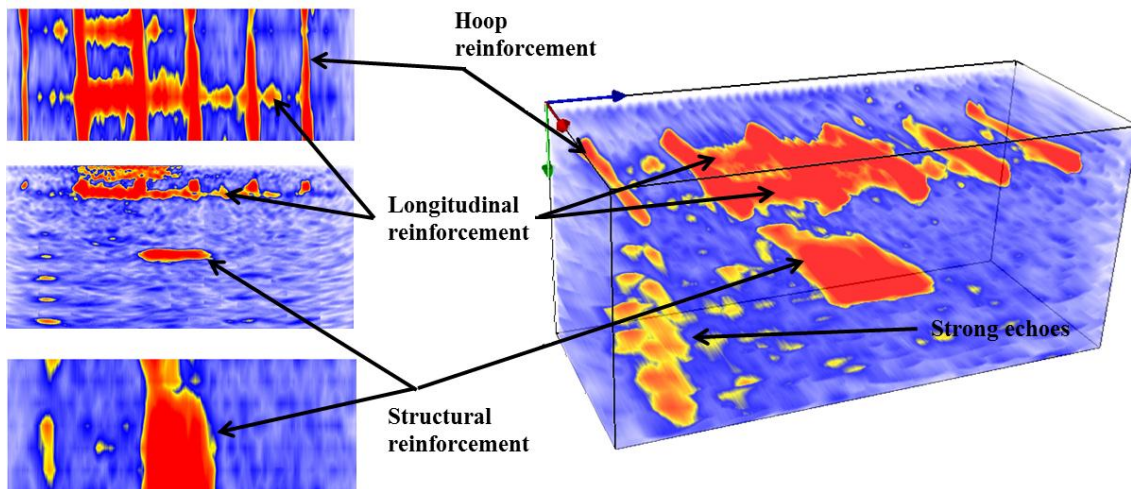
In the second area that displayed significant surface cracking and crazing near a joint (Map ET 10.4-3 in Appendix B), a severe crack running vertically down the tunnel

**Fig. 28. UST images of surface cracking/crazing area: B-scan (center left), C-scans (top and bottom left), and Volume-scan (right)**

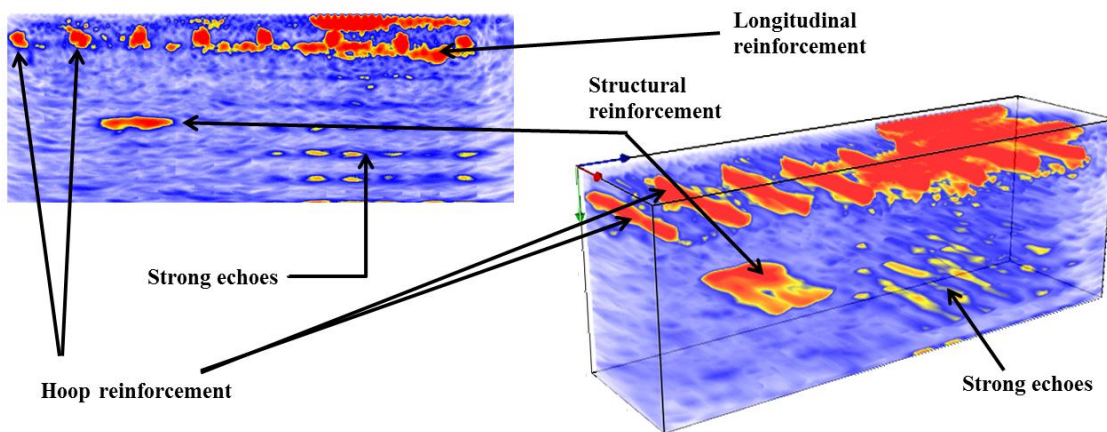
**Fig. 29. UST images of surface cracking/crazing area near stalactite formation: B-scan (left) and Volume-scan (right)**

possible debonding of the hoop and longitudinal reinforcement. The last areas tested at the Eisenhower Tunnel were on the interior precast divider wall (particularly surrounding joints) even though significant distress was not visible. Fig. 30 shows the typical B-scan, with the region surrounding the crack completely lacking in any

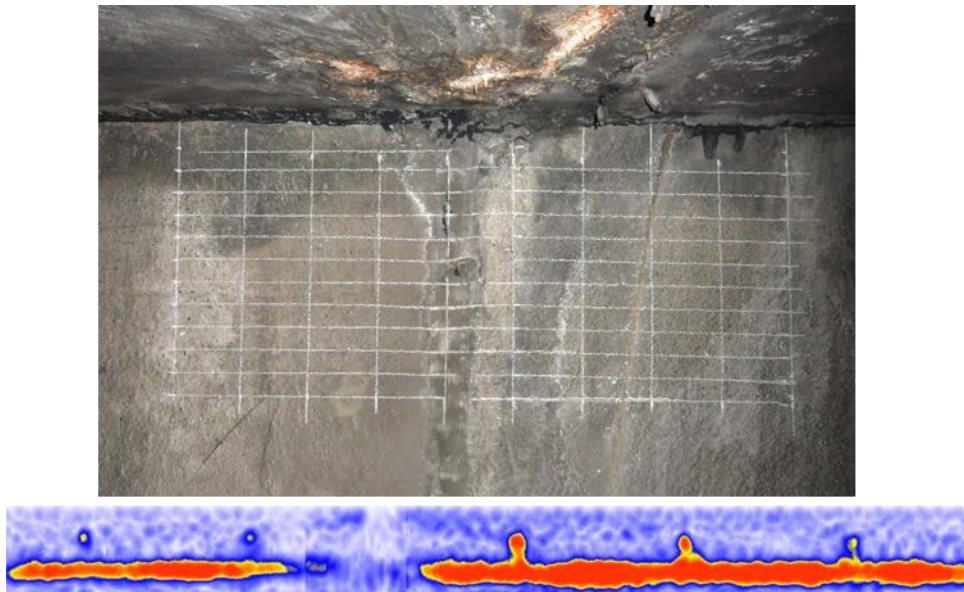
**Fig. 30. B-scan of precast divider panel showing backwall reflection and reinforcement**

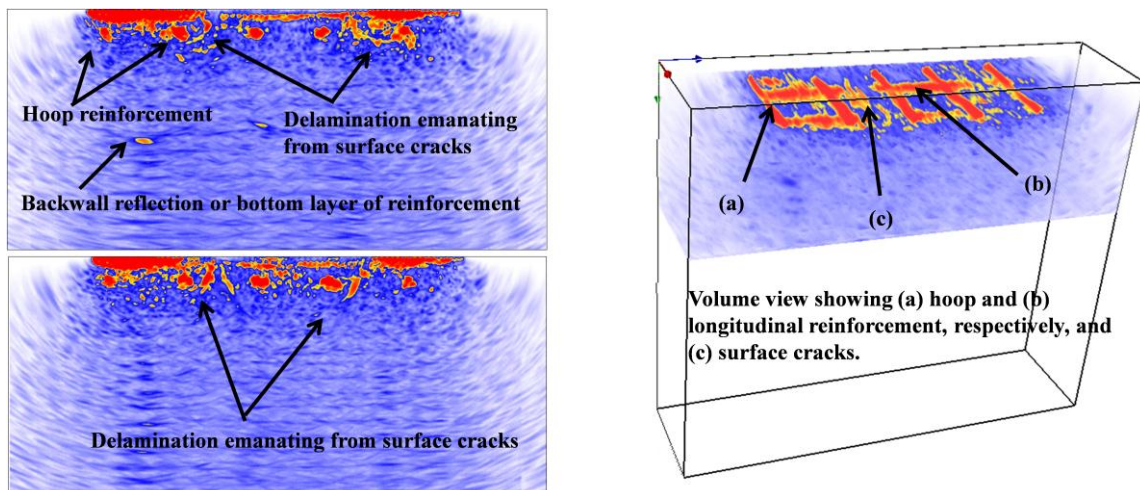
**Fig. 35. UST images showing surface cracks and delamination: B-scans (left) and Volume-scan (right)**

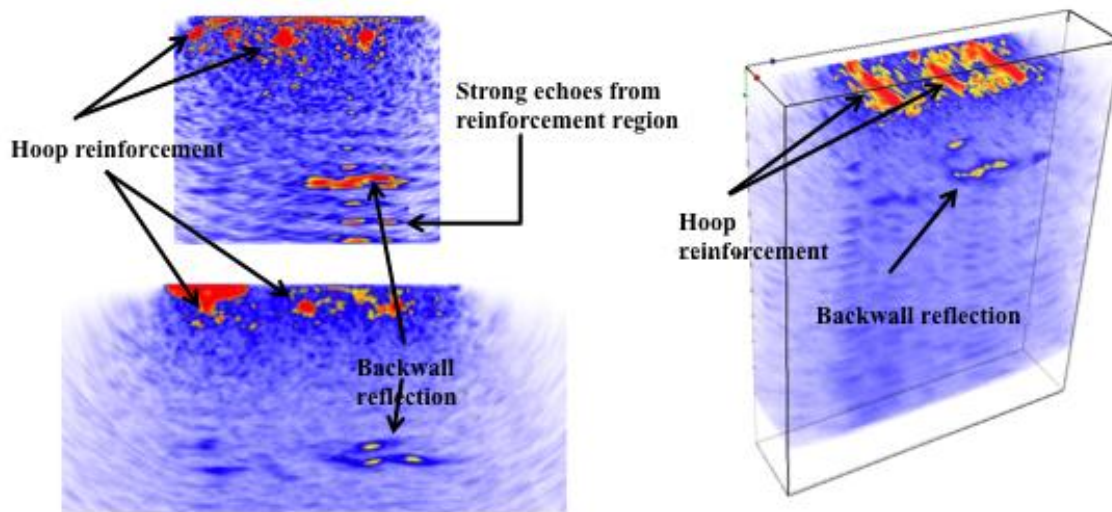
Another area with significant cracking (Map HLT 10.5-8, 9 in Appendix B) did not show any sign of delamination; the surface crack appeared only to follow a single hoop reinforcing rebar. The backwall, however, was clearly distinguished at approximately 752 mm (29.6 in.) in depth (Fig. 36). Above this backwall reflection is

**Fig. 36. UST images showing possible deep delamination: B-scans (left) and Volume-scan (right)**

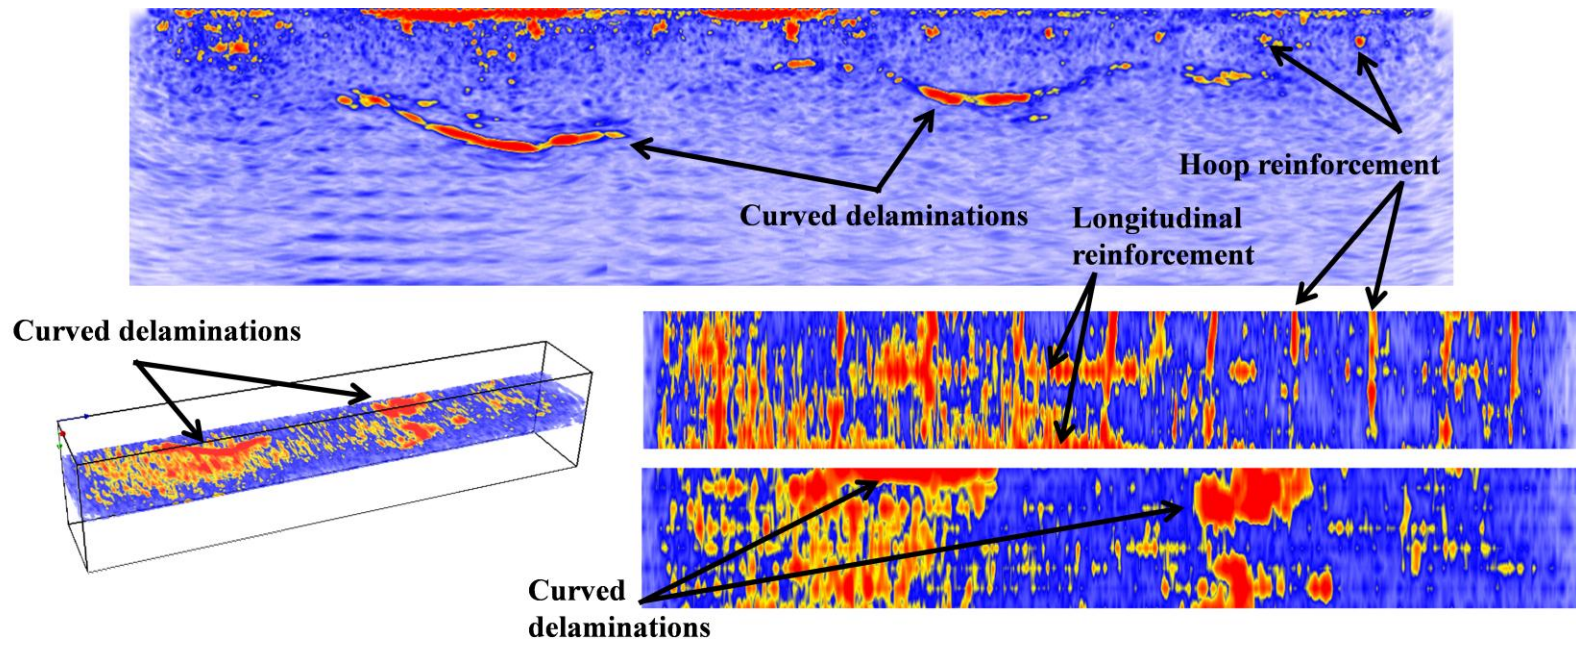
Fig. 37. UST images showing significant deep delamination: Volume-scan (bottom left), B-scan (top), and C-scans (bottom right)

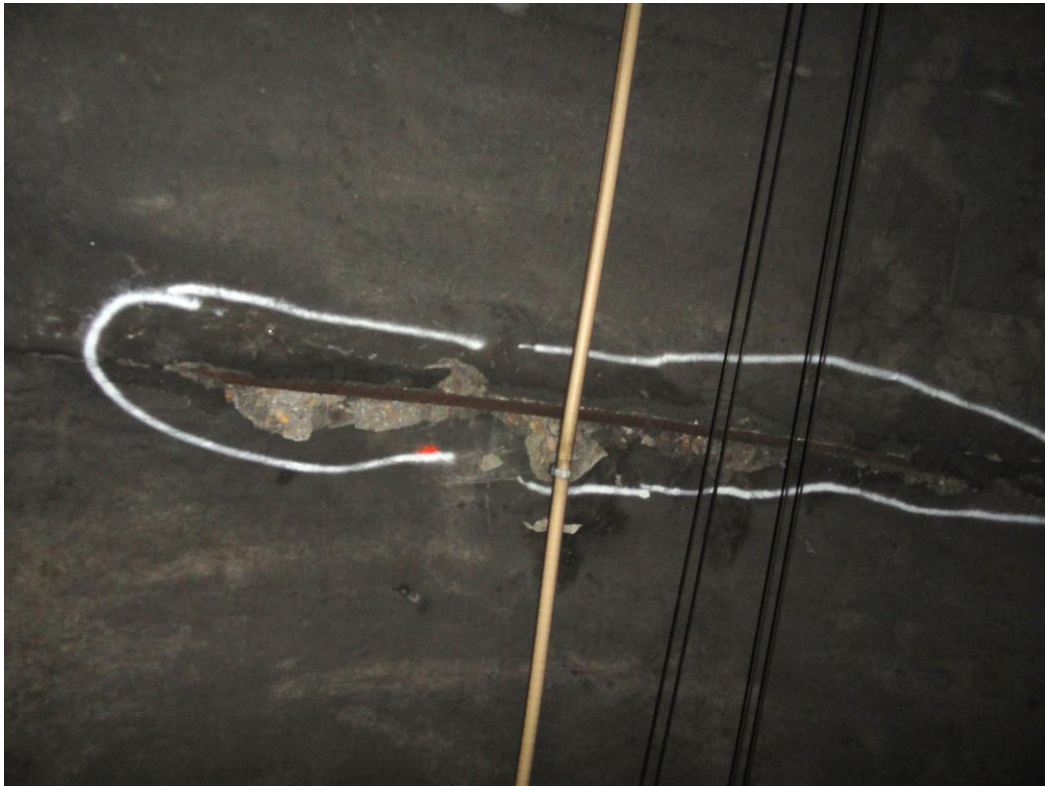
Fig. 42. Typical spalling and corrosion

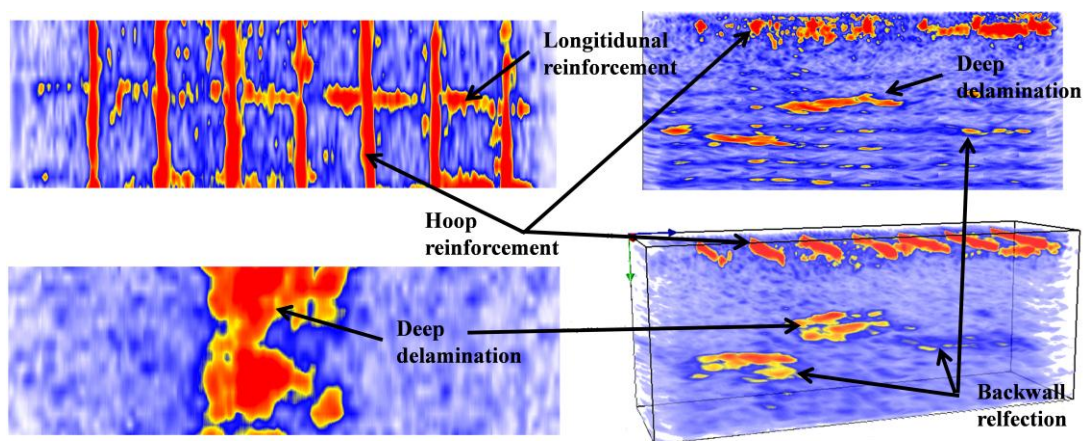
**Fig. 44. UST images at STA. 481+76 showing deep delamination**

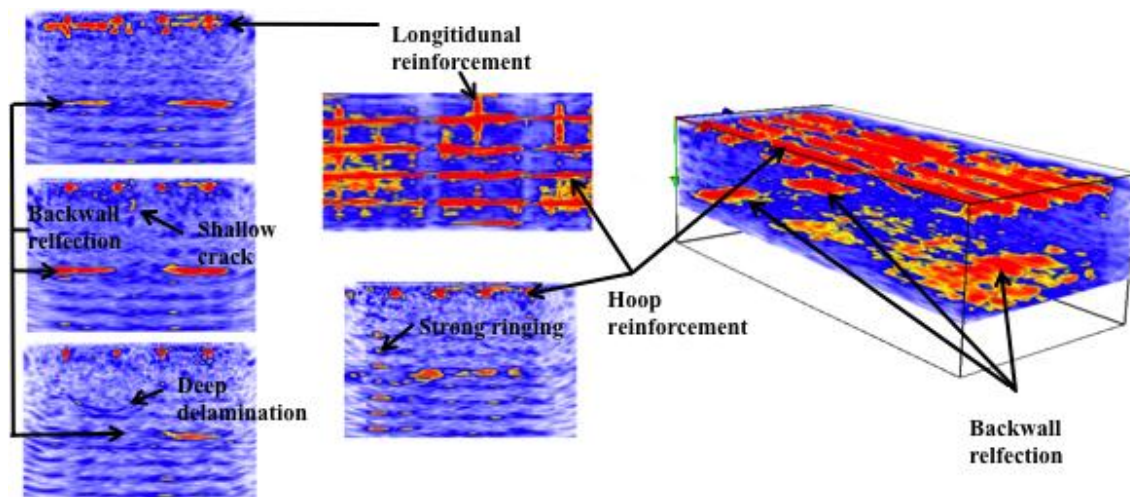
The "gap" in the backwall reflection (Fig. 45, B-scans on left) and the omission of some of the hoop reinforcement (Fig. 45, Volume-scan on right and C-scan top

**Fig. 45. UST images surrounding circumferential crack**

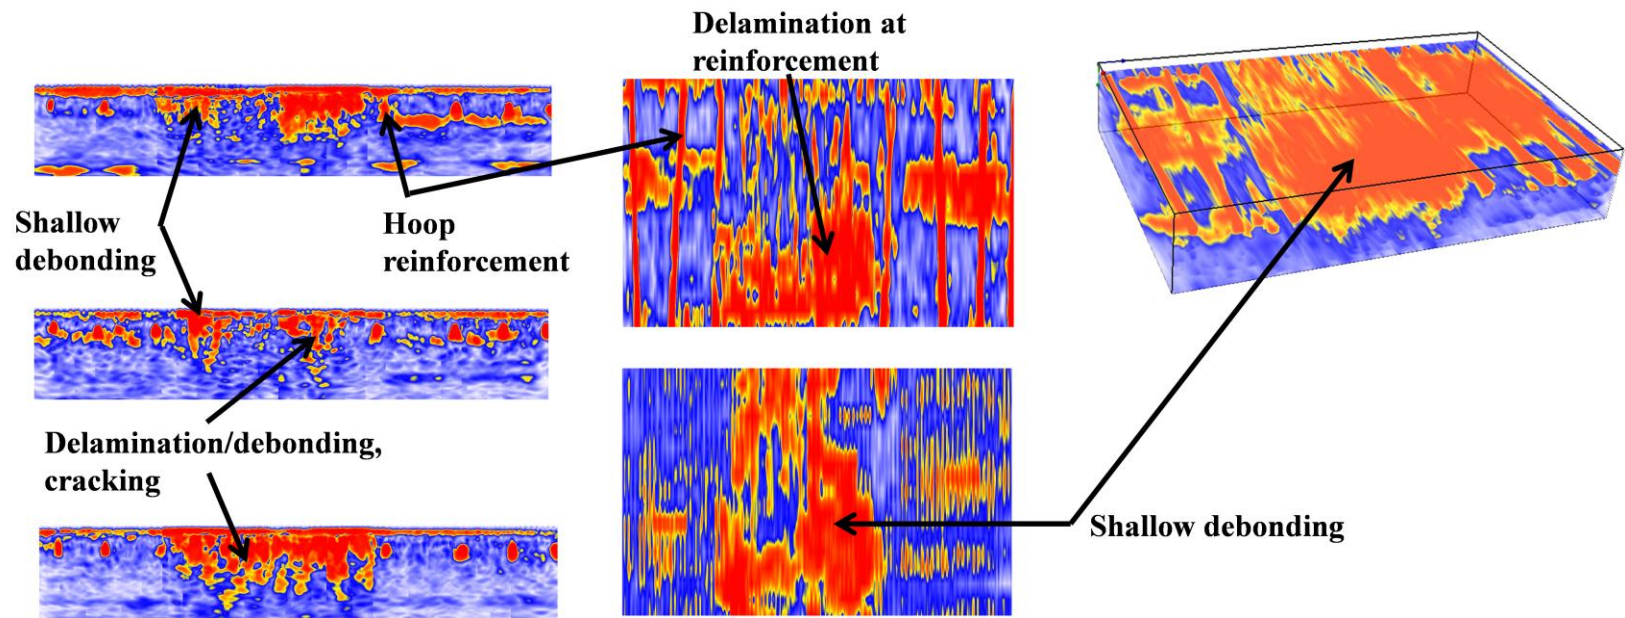
Fig. 54. Area tested surrounding debonded tiled: B-scans (left), C-scans (center), and Volume-scans (right)

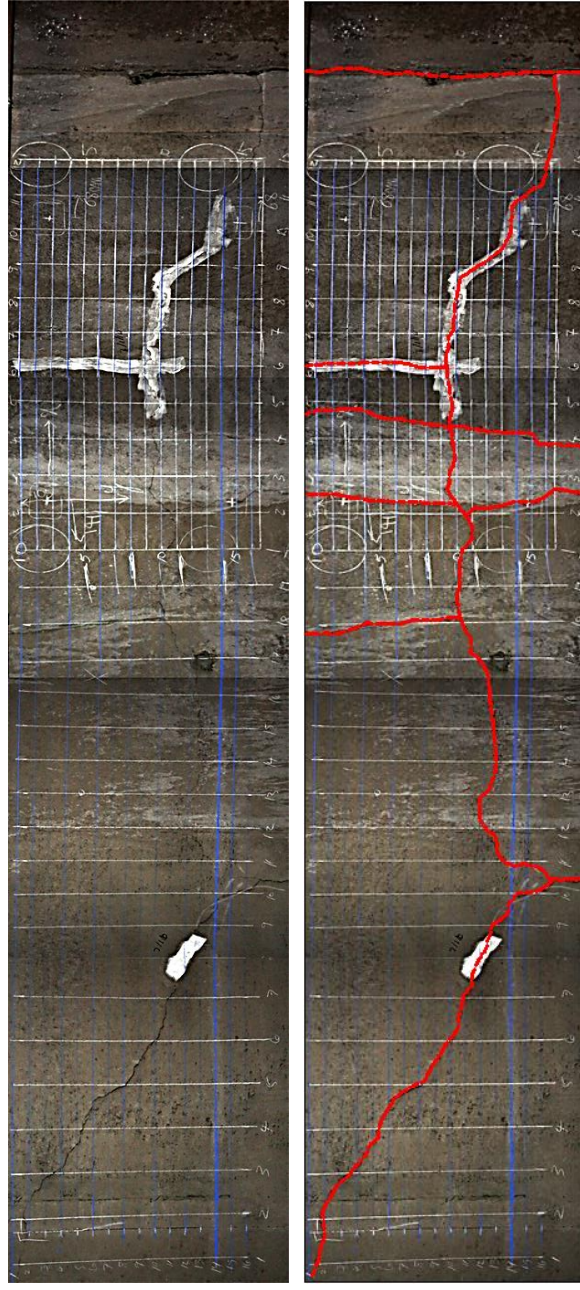
Defects	Notes	Backsurface	Reinf. Detail	Test Parameters
Significant delaminations discovered which stretched over 11', ranging from 8"-20" below the surface.	Area tested because of severe cracking. The B-scan below shows variance in depth and the C-scans show the planar nature of the delaminations.	Not discernible due to high presence of delaminations.	Hoop Reinf: ~2.9"-5.1" deep @ ~16.4" O.C. Longitudinal Reinf: On top	$V_{shear} = 2159 \text{ m/s}$ X-step: 150 mm Y-step: 50 mm Max Depth: 1000 mm Frequency: 50 kHz
Glenwood Springs, CO Hanging Lake Tunnel HLT 10.5-10, 11, 12 Segment 55 TAMU/TTI 10/2011
