Journal section: Operative Dentistry and Endodontics
Publication Types: Research

Analysis of Surface Characteristics of ProTaper Universal and ProTaper Next Instruments by Scanning Electron Microscopy

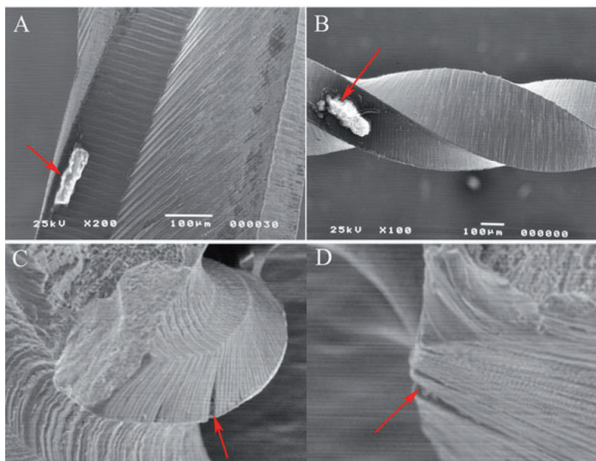
Fig. 2: SEM images of used and sterilized PTU and PTN rotary files. Debris was seen both file types PTU (A) and PTN (B). Figures 2C and 2D show crack formation and initiation of fractures in the PTU and PTN respectively.

Surface analysis of the files that were subjected to instrumentation and sterilization procedures, was performed by stereomicroscopy. The files appeared to have minimal morphological changes except the files that were bent, unwound, or fractured (data not shown). However, the SEM images showed a variety of differences in the files after they had been used in the extracted teeth. Figure 2 shows the SEM images demonstrating organic debris, metal flash, and crack formation and initiation of fractures for both PTU (Figures 2A & C) and PTN (Figures 2B & D). Crack origins were typically seen associated with manufacturing defects near the surface of the metal. Figures 2C and 2D are representative images of a crack initiation sites for both files.

An interesting finding was the frequency of the presence of remaining organic debris on the surface of the rotary files even after thorough ultrasonic cleaning and autoclaving (Fig. 2A,B). This finding was in accordance with previous studies where dentin debris was found adhering to the file surface after use and cleaning (18,20,30). It is suspected that the organic debris adheres to and remains on the file due to mechanical retention within irregularities both from manufacturing flaws and defects created during instrumentation. It can be assumed that these dental chips and other debris from root canal preparation *in vivo* will remain after extensive ultrasonic cleaning and autoclaving. This remaining debris has implications that should be studied further. Alapati *et al.* proposed that embedded dentin deposits cause a wedging action within machining cracks and may lead to their propagation resulting in instrument distortion and failure (18). Another concern is the potential exchange of organic debris between patients. This debris is assumed to be sterile after autoclaving, but its presence may be a source of antigens, infecting agents, or nonspecific irritants (31). Another study has demonstrated that prions can be present in human dental pulp tissue and there may be a risk of infection by contaminated files (32). However, research is lacking on the risk of infection and further studies should be pursued before a recommendation can be made.

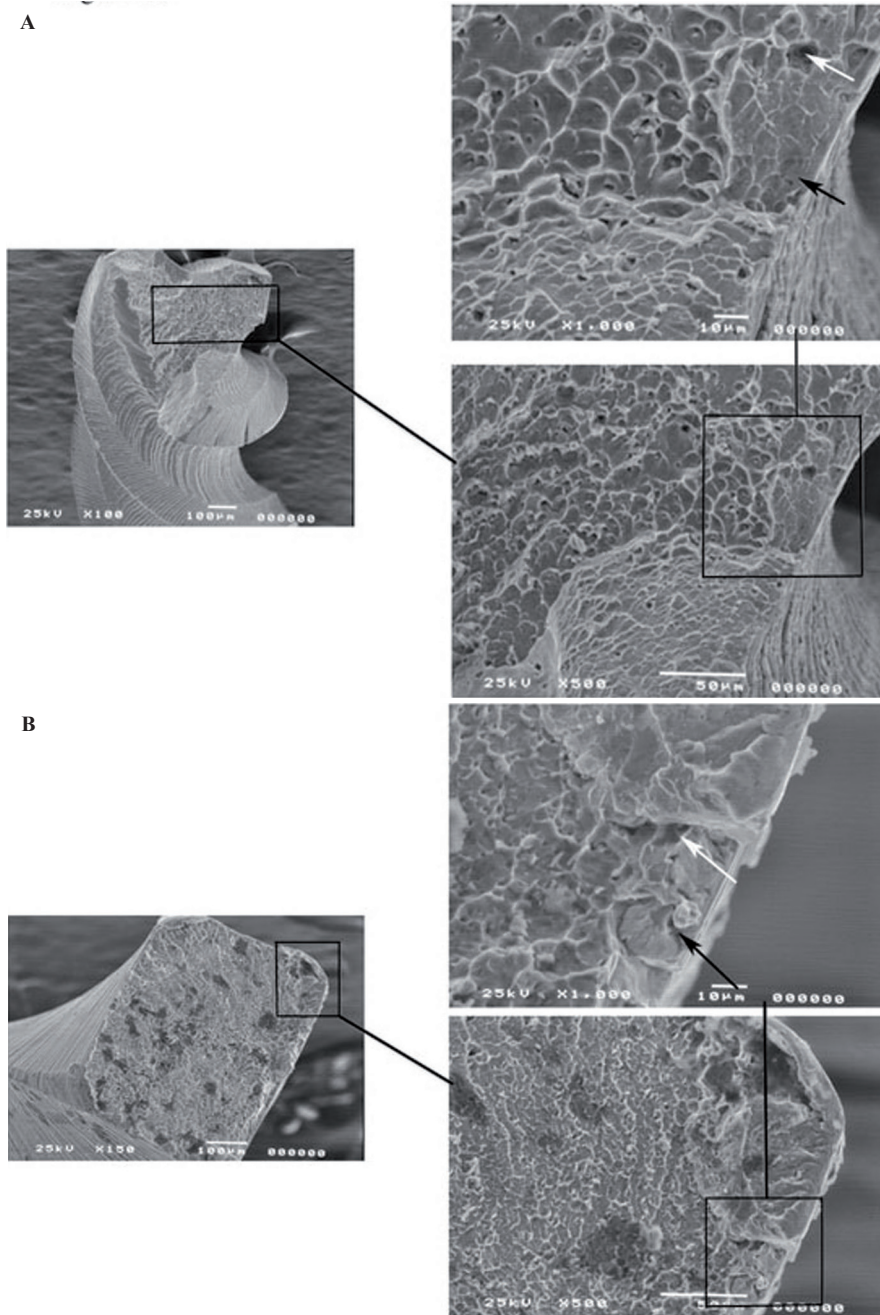
Files from both groups (F3 and X3 files) were subjected to fractures due to cyclic fatigue as described previously (13). The fractured files examined by stereomicroscopy showed signs of both torsional and flexural fracture, according to classification by Sattapan *et al.* (14). However, when these fractured surfaces were examined under the SEM, they demonstrated a ductile fracture associated with a defect within the file. Figures 3A and B are views of the fractured surfaces of an F3 PTU and an X3

Fig. 3: SEM images of files fractured by cyclic fatigue. Figure 3A is an SEM image of a PTU F3 file fractured and Figure 3B is an SEM image of a PTN X3 file fractured by cyclic fatigue. The sub-figures show a magnified image of one part of the fracture surface which demonstrates the beginning of the fracture at this inclusion (black arrows) where it progresses to voids within the body of the alloy (white arrows). Then past this point we can see a fast fracture under load, represented by the signs of ductile fracture.

PTN file respectively. The sub-figures show a magnified image of one part of the fracture surface. As seen from the figure both file types showed the beginning of the fracture at the inclusions (black arrows) from where it progressed to voids (white arrows) within the body of the alloy. The start of the ductile fracture was associated

The inclusions within NiTi alloy are assumed to be titanium carbonitrides and NiTi oxides formed during the vacuum melting and casting in graphite cubicles (22,27) (Fig. 4). This process causes slight carbon contamination in the melt, forming the oxide impurities that appear evenly distributed within the NiTi matrix (27). The concentration and distribution of the inclusions has been proposed as a method of assessing the metallurgical quality of the NiTi alloy produced by different manufacturers of rotary instruments (28). However, there was no apparent difference in the distribution of inclusions between PTU and PTN rotary files. The voids and inclusions were distributed evenly within dimples associated with ductile fracture in all samples (Fig. 3). This is an

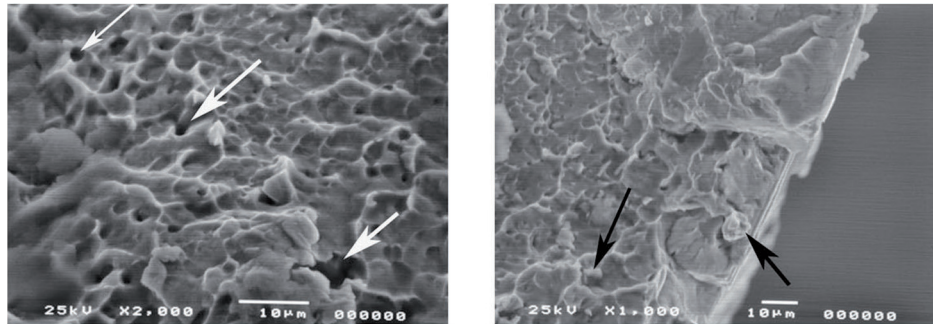
with larger voids or fractures within the metal. Figure 4 is another representative image of the fractured surface of a file PTN X3 demonstrating inclusions and microvoids of varying sizes that were also seen distributed throughout the fractured surfaces of the files. Similar voids and inclusions were seen in the PTU F3 file group.

Fig. 4: A representative image of the fractured surface of a file PTN X3. The figure demonstrates microvoids (white arrows) and inclusions (black arrow) of varying sizes that were also seen distributed throughout the fracture surfaces of the files.
