Olukanni et al USEP: Journal of Research Information in Civil Engineering, Vol.14, No.2, 2017

Assessment of Selected Dams in Kwara State, Nigeria

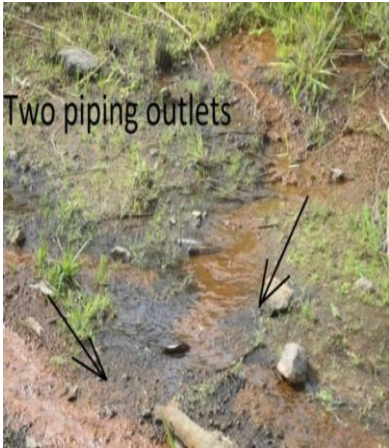
Dam	Unilorin dam	Okuta-Oja dam (Isapa)	Maleté dam	Asa dam (Ilorin)
Age	10 years	5 years	37 years	38 years
Deterioration	i. Seepage (2 piping outlets), Broken and eroded drain & retaining wall, ii. Broken and eroded drain & retaining wall, iii. Plant growth and coloration on spillway iv. Damaged and eroded baffle blocks v. reduced riprap boulders at dam toe vi. Plant and tree growth	i. Seepage from the concrete/rock interface ii. Seepage from the body of the concrete dam. iii. Seepage from the foundation of the dam. iv. Erosion of topsoil/earth at toe of dam from spillway water thus exposing foundation	Heavy seepage from an outlet	small trees and plant growth at embankment side
Deterioration Location	i. At left side downstream of dam. ii. Right side downstream wing wall iii. spillway of dam iv. stilling basin v. dam toe vi. Left and Right side upstream	i. right hand downstream of dam. ii right hand downstream of dam. right hand downstream of dam. iii. right hand downstream of dam iv. Dam toe	right hand downstream of dam	right hand upstream of dam

Possible Causes	i. piping outlet leading to seepage, ii. Weathering and erosion from drain water iii. large water algae loads, allowing growth of thick algae layer iv. force impact/erosion from spillway waters v. washing away by spillway run-off waters vi. Poor weed control	i. openings in between rock-concrete interface ii. Openings in between concrete -concrete interface due to different casting period. iii. openings in between rock-concrete interface/poor foundation preparation iii. inadequate or no riprap provision at toe	Uncontrolled piping outlet developed overtime into a heavy seepage source	Poor weeding practice

Figure1 Piping outlets leading to seepage

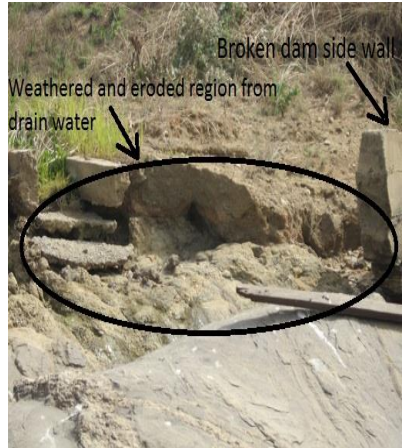
Figure 2 Broken and Eroded part of drainage at right-side retaining wall

Owing to the structural requirements of dams (elevation and slope), abrasion-erosion and cavitation damage of appurtenant structures and earth around flanges and retaining walls do occur. To minimize damage from cavitation, the designer should consider the cavitation index. This should however be attended to by construction and proper channeling of drainages, refilling and repairing of affected areas regularly. This can also be reduced by using high-strength concrete during construction and/or repairs. Ripraps at dam toe help

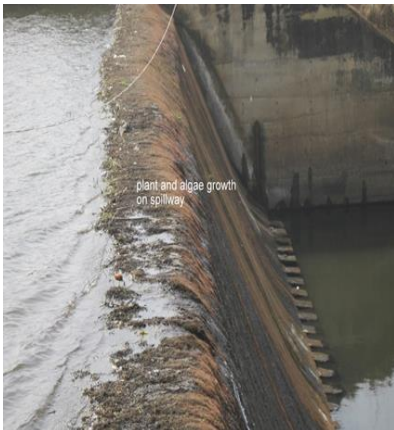
Figure 3. Plant/algae growth and blocks

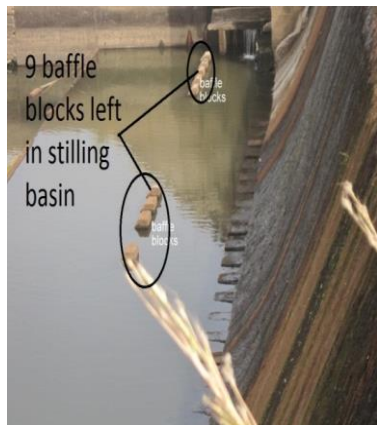
Figure 4 Damaged and eroded baffle decoloration of concrete spillway

Baffle blocks in dam stilling basin are installed to help cut/reduce the force impact of spillway water runoff such that the resulting force impact can be accommodated by the End Sill to allow gentle flow of water after spilling off the spillway towards the downstream. They help in energy dissipation which is to protect the downstream riverbed and banks from erosion and to ensure that the high velocity, turbulent flow from the outlet works does not undermine the dam and adjoining structures (FEMA, 2010). Once the baffle blocks are damaged or reduced in number (significantly, like that of the Unilorin earth dam), water spills from the spillway at a high velocity which will cause damage at downstream areas through erosion and washing away of banks and downstream areas. The distance between the chute blocks and baffle blocks, as well as the baffle blocks and end sill, is important for improved efficiency. Placing the baffle blocks too far upstream leaves them susceptible to cavitation and can cause waves downstream (FEMA, 2010). The design and construction of baffle blocks should also be supervised by a qualified Structural Engineer as weaving and knitting of the reinforcements should be done to design specifications. Damaged baffle blocks and areas in stilling basins should be repaired with shotcrete, a polymer improved cementitious mortar with aggregate that has a 28-day compressive strength over 48.3 MPa. It should be used to repair grout patches that had been damaged by erosion. Shotcrete is recommended for these repairs because it is fast setting, has exceptional bonding properties, and has an abrasion resistance six times greater than that of conventional concrete. This was used for similar repairs (baffle blocks and eroded spots) at the Old River Control Project located on the Mississippi River about 80 km (50 miles) northwest of Baton Rouge LA in 1988 (Curtis and McDonald, 1999).

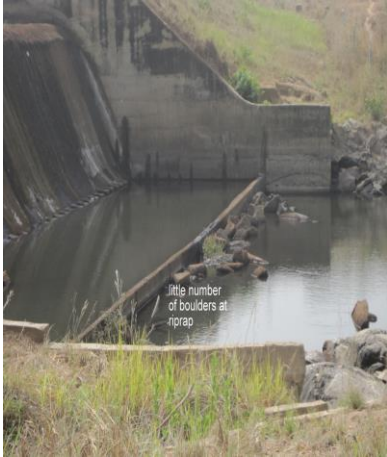
Figure 5 Washed-off riprap boulders at dam toe

to reduce erosion of earth at the toe (Okuta-Oja and Unilorin dams). Checking of Riprap at toe of dam should be done seasonally so as to know the rate/extent of erosion of boulders and when to replace washed off quantity. Crack/seepage repair in Okuta-Oja dam; following the evaluation of the crack, a suitable repair procedure can be selected. The opening in the concrete in Okuta-Oja dam falls within the range of fine external crack $0.1062 < 0.2032$ mm ($0.004 < CW$ 0.008 inch).

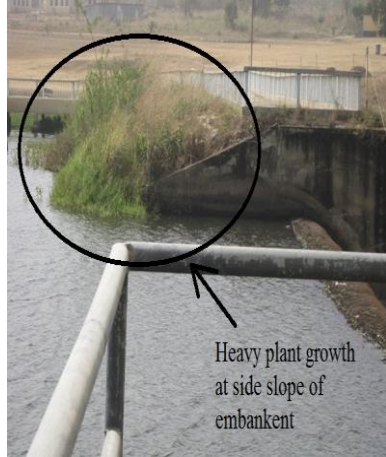
Figure 6 Plants and small trees on upstream sides

The commonest form of poor maintenance in dams can be observed as trees and plant growth at the side of embankments, most dam stations have been found guilty of this act (poor weed control). Small trees/tree crops are usually left to grow at embankment sides. The older the tree crop becomes, the stronger and bigger its roots becomes, the greater the penetration through the

compacted earth, which in turn creates seepage path for dam water to pass through. These plants should be uprooted regularly. Cultivation of Shallow rooted grasses will be advised as they will not only beautify the dam, but also help reduce washing away of earth from the side slopes through rain water.

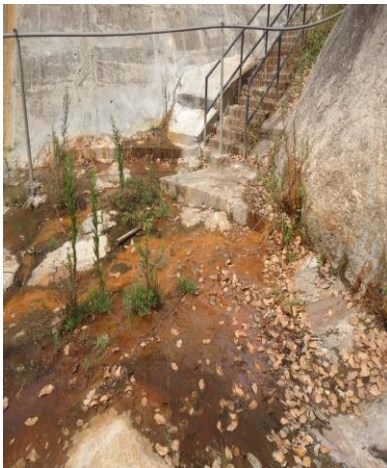
Figure 7 Seepage from the concrete/rock interface

Curtain grouting is performed to reduce deep underground seepage through the foundation and abutments. Pressure grouting using a mixture of cement and water or other materials is probably the most frequently used method to remedy serious foundation or abutment seepage problems in rock. However, it should not be used indiscriminately. Before any grouting effort, an investigation to determine the seepage conditions and locations should be conducted.

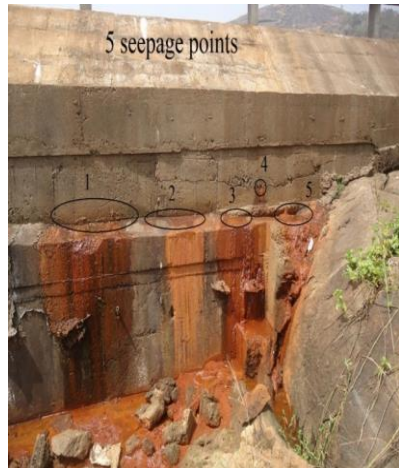
Figure 8 Concrete body seepage

Repair of large cavities in concrete & masonry dams by Hybrid Polyurethane Injection Resin like TamPur 115,116 which is an example of a non-Foaming PU Resin which is used for cavity filling in concrete in both under water and above water. It's a silicate modified PU resin and two component system. TamPur 115 & 116 can be used for any big cavity filling in Masonry or Concrete dam in underwater by using a twin piston PU pump from top. However, trained diver is needed for such repair under supervision from an experienced Engineer who has knowledge of such materials and its application (Mukhopadhyay, 2014).

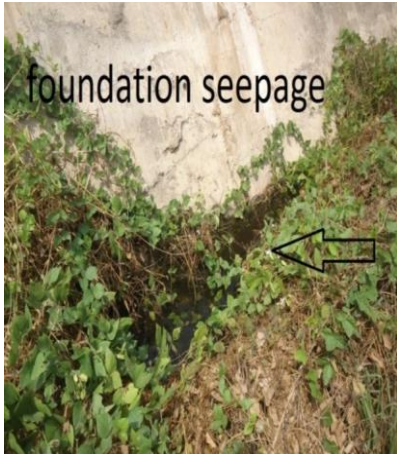
Figure 9 Foundation seepage

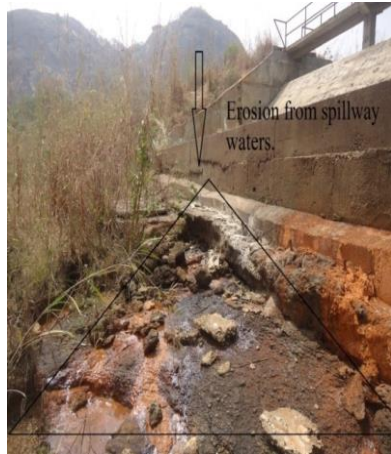
Figure10 Scouring at dam toe

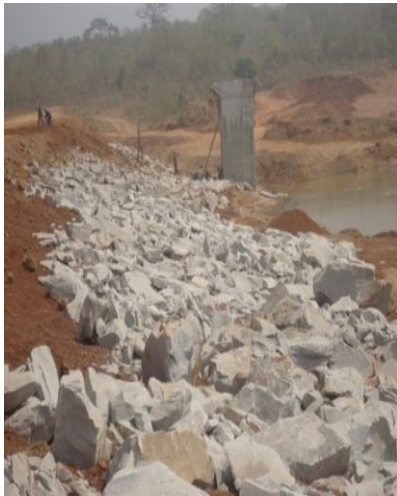
Figure 11 Re-construction in process

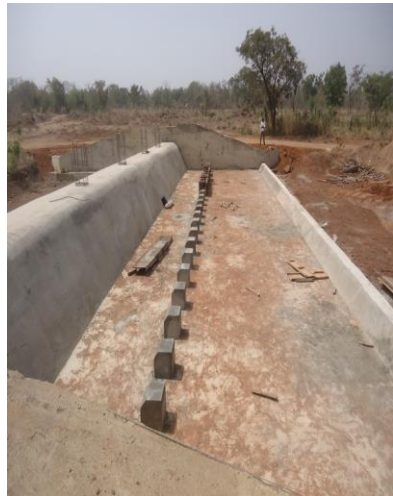
Figure12 Spillway under construction

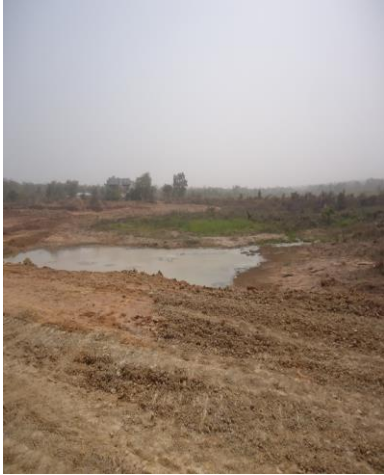
Figure 13 Seepage from original dam

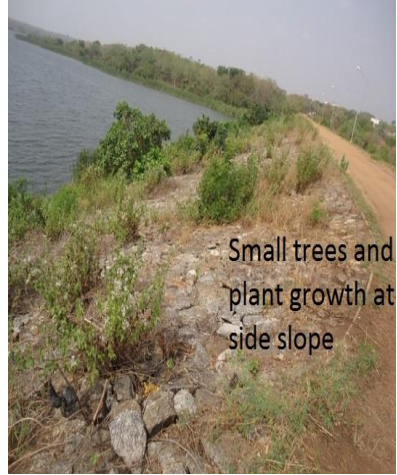
Figure 15. Small trees and plant growth on right side upstream of embankment

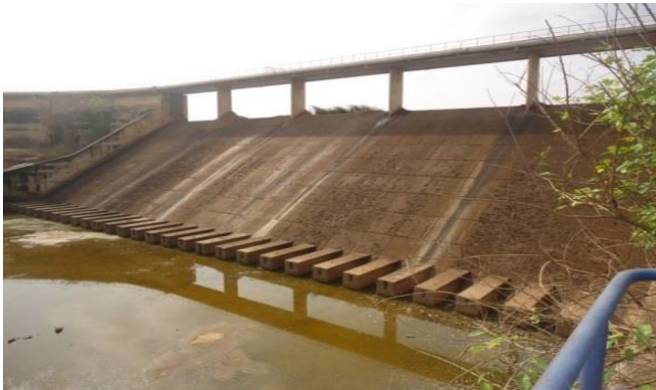
Figure 16 Spillway showing freeboard
