**Assessing the quality of retrofits in solid wall dwellings**

Journal:	<i>International Journal of Building Pathology and Adaptation</i>
Manuscript ID	IJBPA-05-2017-0022.R1
Manuscript Type:	Original Article
Keywords:	Domestic energy efficiency, Moisture, Policy, Retrofit, Survey, Unintended consequences

The purpose of the paper is to provide a detailed appraisal of the quality of domestic retrofits.

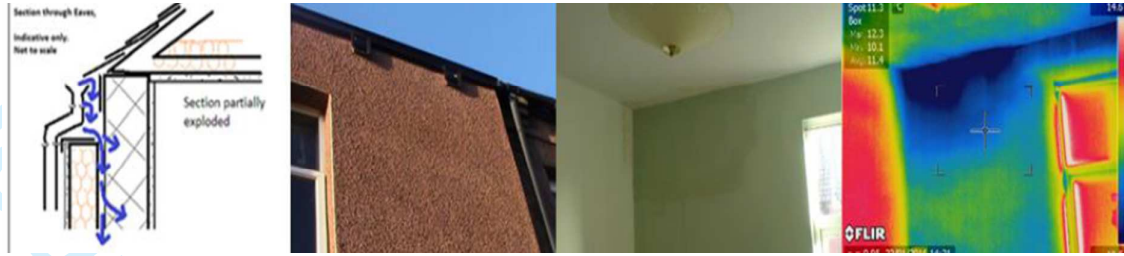
In addition, product or process failure can cause moisture problems (e.g. leaks). This was identified in one of the post retrofit surveys; rain water ingress occurred due to inadequate sealing between the EWI top capping and the wall causing damp patches, as shown in Figure 3.

Figure 3 Photographic and thermographic observation of damp and schematic to show route of water ingress behind EWI

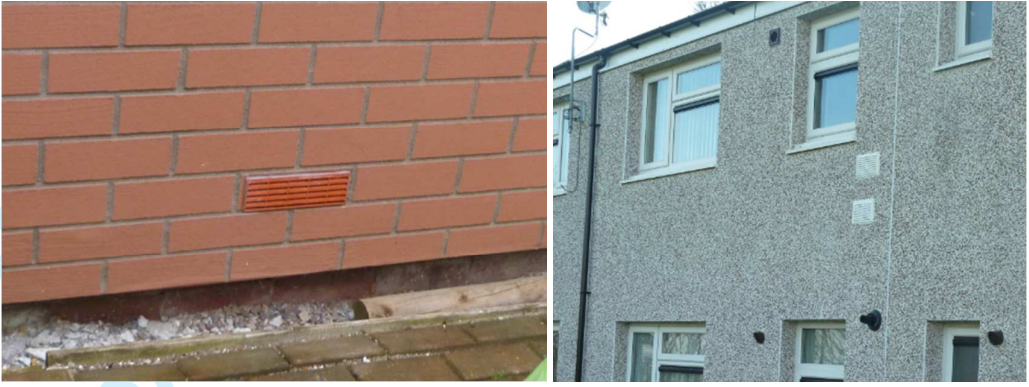
Figure 4 Maintenance and addition of ventilation post EWI retrofit

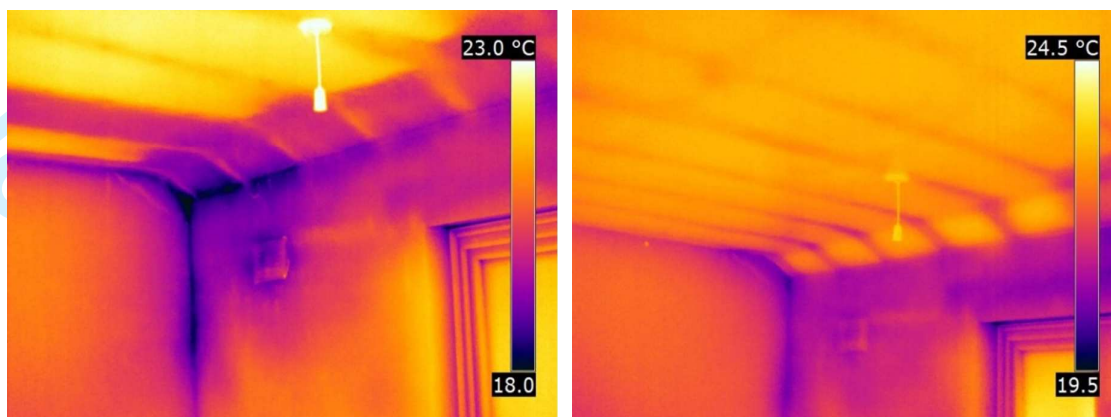
Another example of a lack of consideration of adjacent elements is shown in Figure 7 illustrating raked eaves (sloping roof detail at the external wall junction) where a significant thermal bridge only emerged once the wall and loft were insulated, as prior to retrofit the raked eaves and external wall displayed similar surface temperatures. A solution to this one particular installation was recommended by the research team and a standard mineral wool cavity wall batt was inserted from inside the loft between the rafters to insulate this 'forgotten' area while still allowing airflow over the top to ensure the loft space remained adequately ventilated. As can be seen in Figure 7, this appeared to resolve the problem and the final solution was separately as part of this research project eventually calculated to no longer pose a condensation risk according to BR 497 (Ward and Sanders, 2007).

Figure 7 Raked eaves without (left) and with (right) mineral wool cavity batt inserted

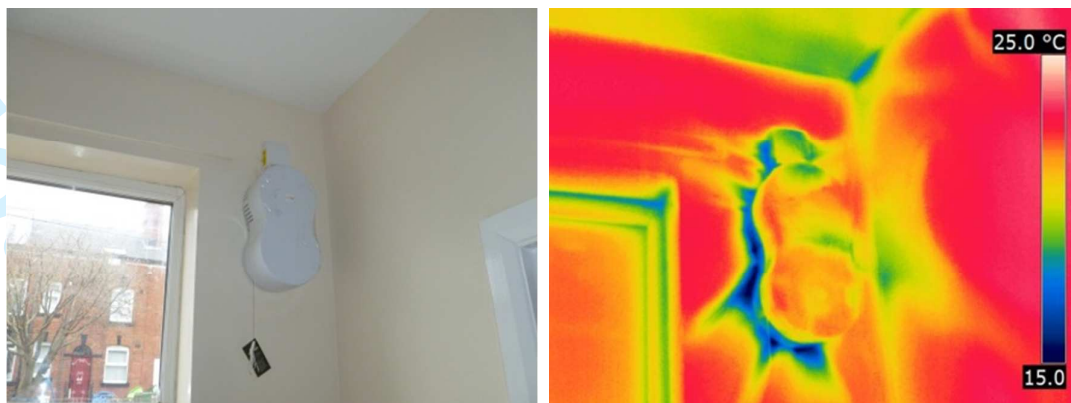
One common observation was a lack of sealing around breaches in the air barrier, in particular around service penetrations as shown in Figure 8. Another issue shown in Figure 9 was inadequate and inconsistent contact between EWI and the external wall surface, which could allow air to circulate behind the insulation, reducing the EWI's effectiveness, as had previously been observed on other projects (Siddall, 2009).

Figure 8 Inadequate sealing of penetrations (extract fan) through IWI seen during depressurisation

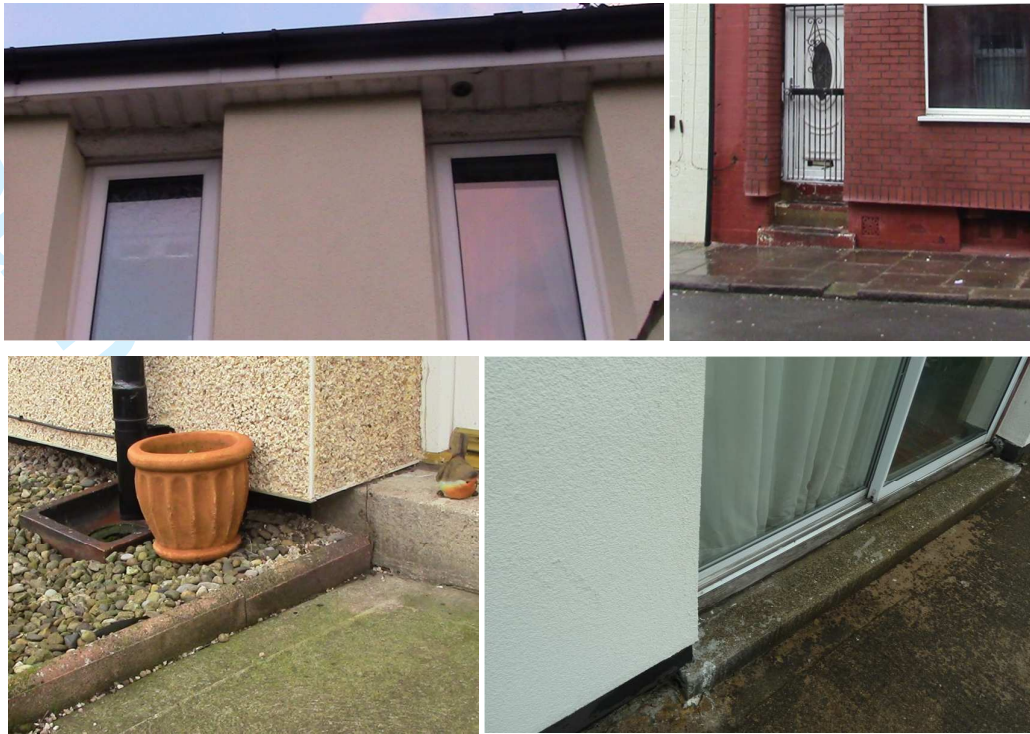
Figure 12 Common EWI details causing thermal bridging
