Integrated Approach for Post-fire Reinforced Concrete Structures Assessment

RESEARCH ARTICLE

Abstract

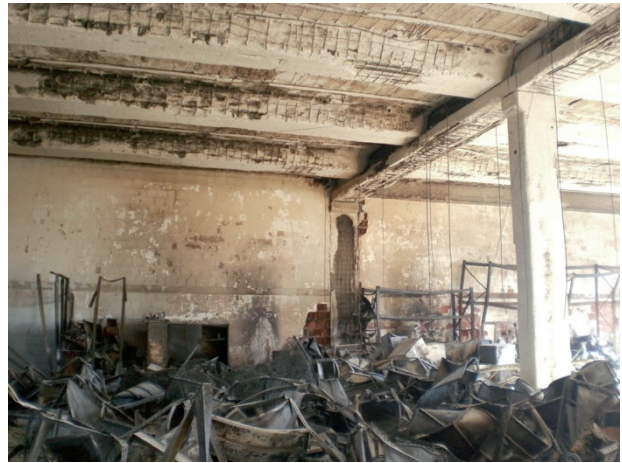
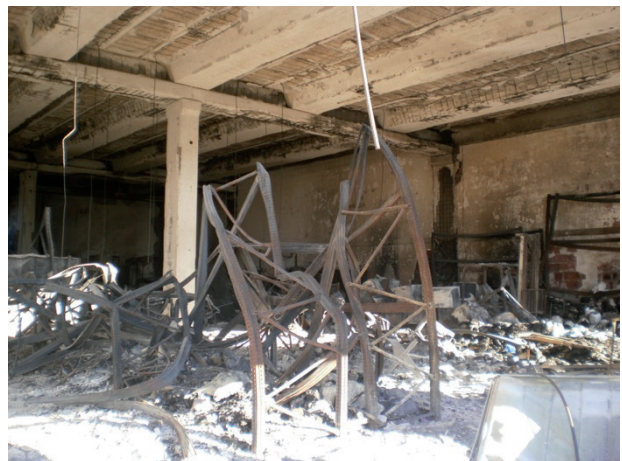
Visual examination is the simplest and cheapest technique. A trained eye can record very interesting data regarding both the residual structural safety and mechanical characteristics after a fire. In this work, initial visual examination provided a rapid survey of the damage: the central area of the ground floor was damaged by the fire, as shown in Figure 7.

Lateral columns labelled 4–6–7–9 present the most evident damage: it seems that they have been hollowed out from the fire-exposed side towards the core, probably due to convective motion generated during the fire. Concrete belonging to these columns was expelled, leaving a visible void, while reinforcements are still present although damaged. The contrast with the neighbouring fire-resistant wall is patent as well, and is depicted in both Figure 7 and Figure 9, where it is easy to note that column 6 is severely hollowed-out. On the contrary, perimeter columns 1–2–3–10–11–12 were less exposed to the fire, and negligible visible damage was recorded.

Central columns 8–5 present a completely different situation: the superficially-burned plaster exhibits great characteristic roughness, and its colour tends towards greyish white. Spalling of concrete occurs infrequently in these elements.

Fig. 7 Overview of the fire-damaged area.

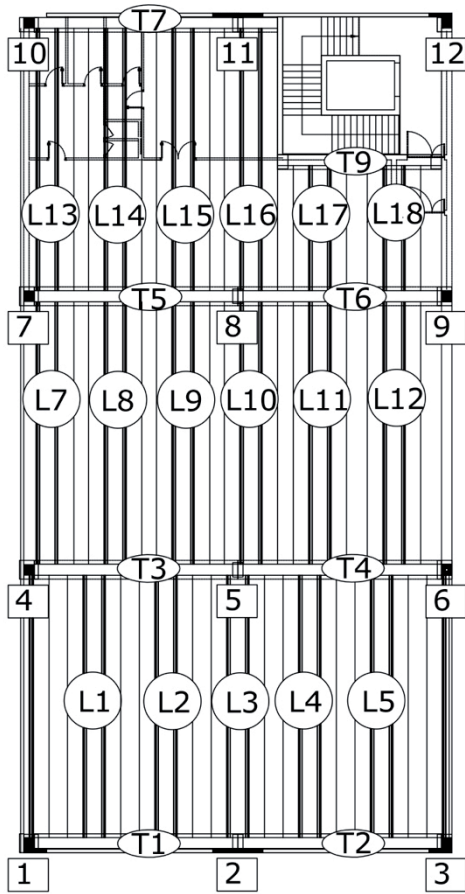
The bottom part of the T-shaped beams (labelled with T in Figure 8) was exposed to the fire; indeed, the upper part was protected by the slab and by the omega-shaped beams. In particular, beams T3–T4–T5–T6 seem to have suffered the most important damage, with concrete spalling and desolidarisation of prestressing tendons.

Fig. 8 Plant view of the fire area on the ground floor.

A different situation can be deduced from analysis of the longitudinal omega-shaped beams (corresponding to label L, see Figure 8). In the lower part of the plant, deflection values corresponding to beams labelled L1 and L4 are quite important, with a peak of 74.23 mm, corresponding to 6/1000 of the span of the L4 element. This value proves that the effect of the fire, in addition to the dead load of the structure, removed initial negative deflection (equal to 25–30 mm, see the undamaged beams labelled La and Lb located outside the fire zone) present in all L-beams, in only a few damaged elements. In most other cases, the deflection value is still negative, proving that prestressing action is still active in several beams and girders.

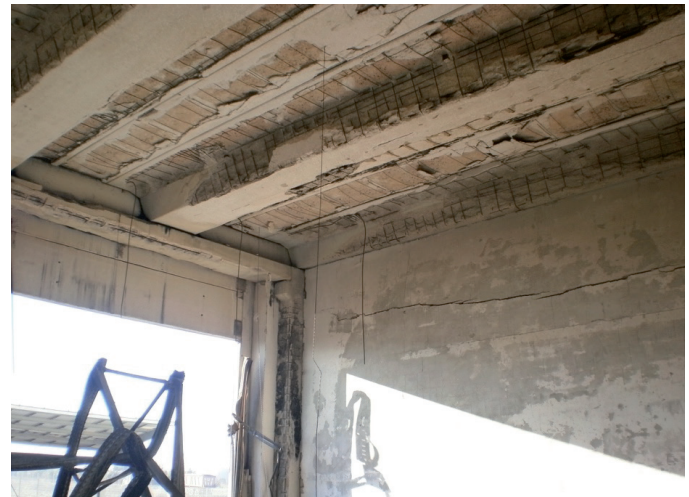
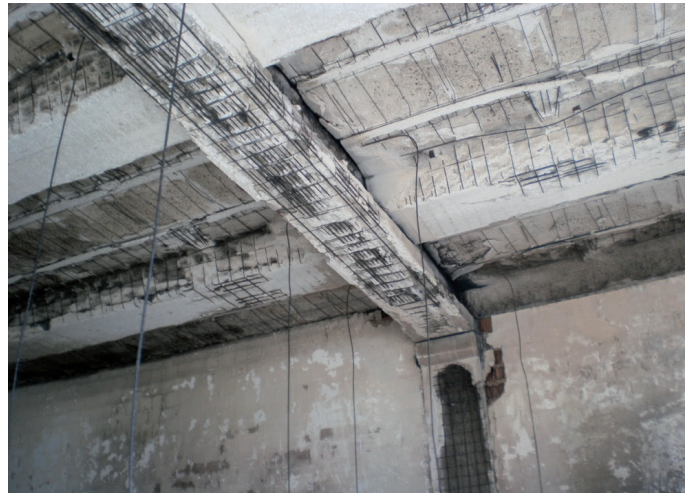
In Figure 9b, the situation of beam T6 and corresponding longitudinal beams is reported. The latter are visibly damaged as well: in most of these omega-shaped beams, concrete spalling is present in broad areas. Thus, in this case as well, there are areas in which prestressing tendons have lost their principal effect, becoming ordinary reinforcements. The other heavily-damaged longitudinal beams are labelled L4–L5–L8–L9 in Figure 8. As reported in the previous paragraph, the fire-resistant lateral partition wall guarantees a fire protection class equal to REI 120.

Actually, it separates the fire area from other areas, providing sufficient thermal insulation. The left wall (referring to Figure 8) was heavily damaged, with many cracks and incumbent collapse, as shown in Figure 9a. The right wall, shown in Figure 7 and Figure 9b, has lost part of its plaster, but there are no visible cracks.

Fig. 9 Lateral cladding cracks (a), T-shaped beams, girders and lateral column damage (b).

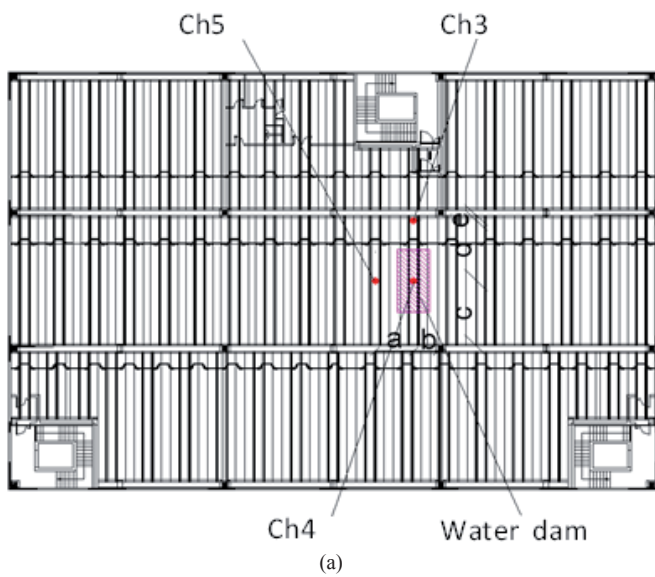
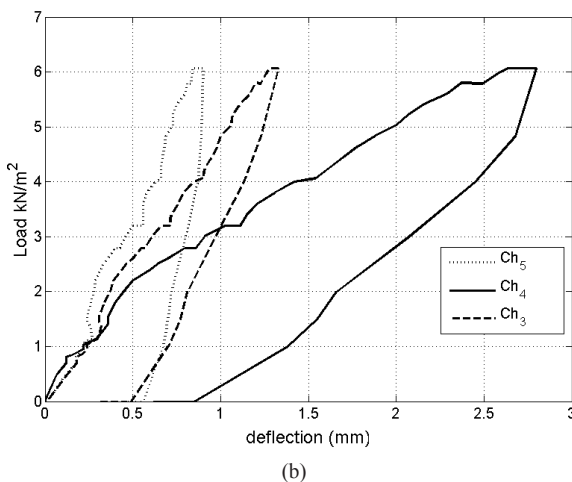
Three displacement transducers, characterized by an accuracy of 0.01 mm (Ch3–Ch4–Ch5), were positioned at the intrados of beam L12 according to the scheme reported in Figure 10a. In this way, it was possible to record deflection at mid-span (Ch4), at the end of the beam (Ch3) and mid-span deflection of the neighbouring beam labelled L11 (Ch5). The load was applied in subsequent steps, varying the amount of water contained in the dam. Displacements at the above-mentioned three points were continuously recorded and are represented in Figure 10b.

The RC slab supported by the beam tested plays a structural role which is not negligible; this is proven by the deflection recorded by Ch5. Stress distribution due to this effect also reduced beam deformation during the fire.

Fig. 10 (a) Positions of displacement transducers and the water dam during the loading test, $a = 3.55$ m, $b = 2.27$ m, $c = 6.30$ m, $d = 5.80$, $e = 0.50$ m. (b) Load-displacement diagrams for the three transducer recordings.

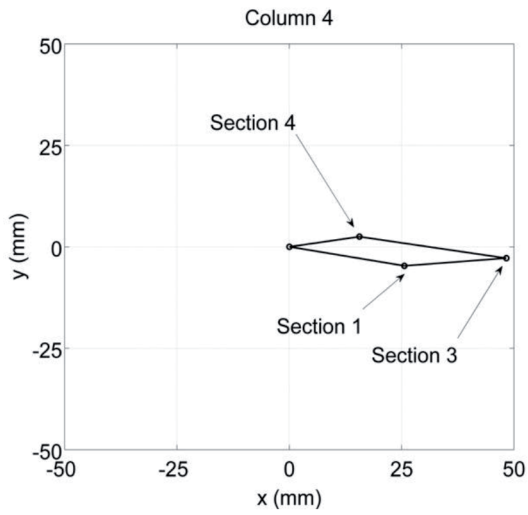
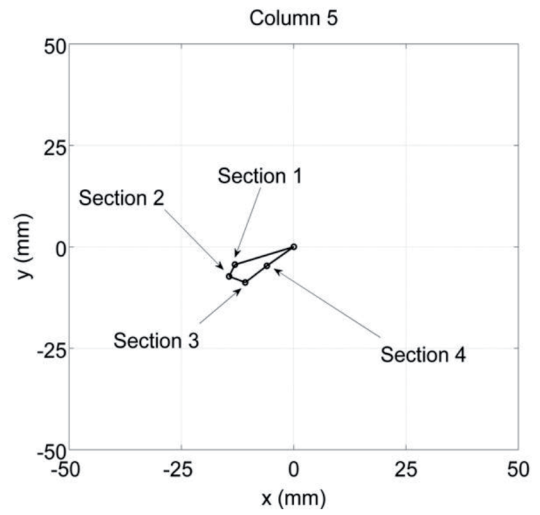
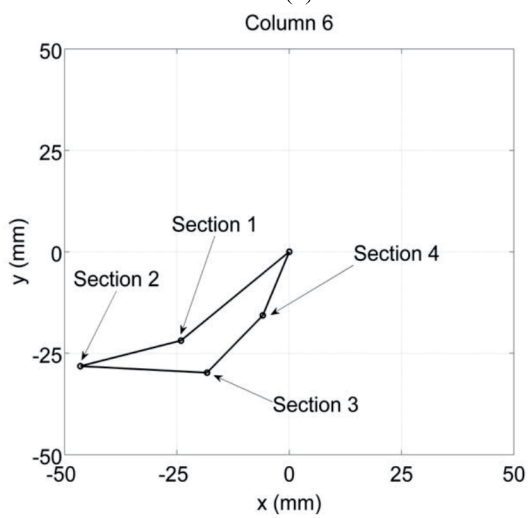
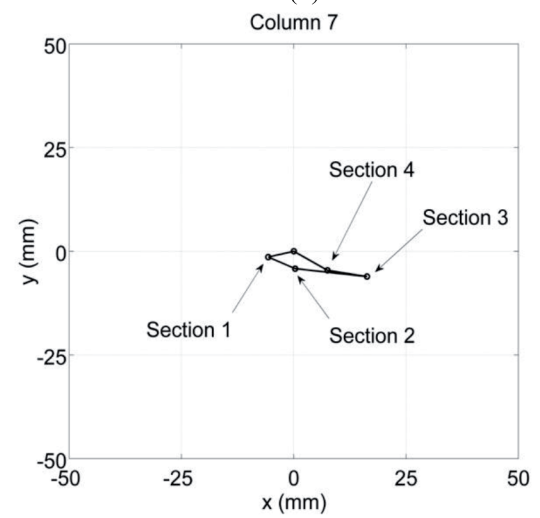
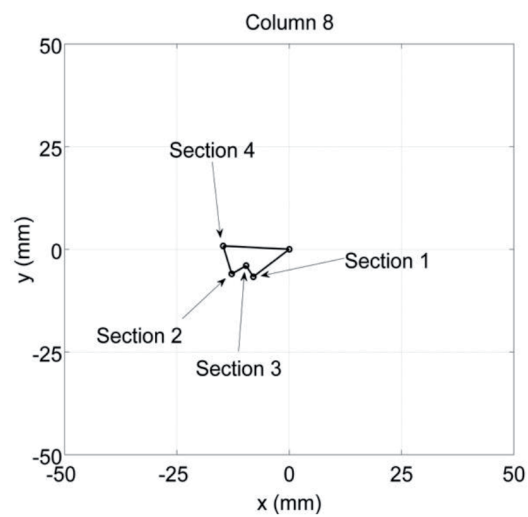
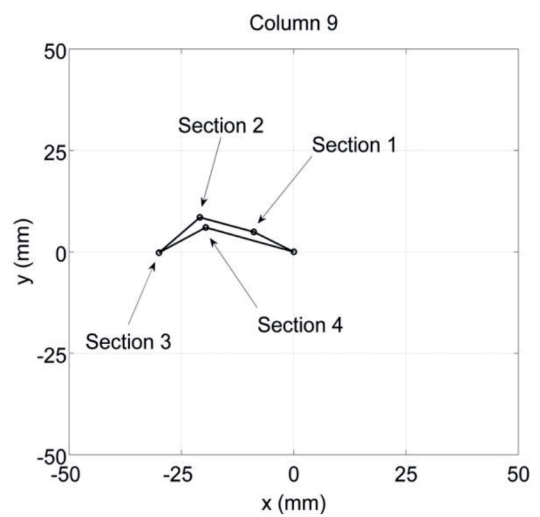
Only columns 4 and 6 show a SD x higher than 10 mm, while in all other cases, it is unlikely to find values greater than 5 mm. These centre-of-gravity position variations represent a small fraction of column height, in addition, as stated previously, they are probably due to local damage of the cross-section and not to real displacement of the column, see Figure 13. Furthermore, after a complete section restoration with new concrete, variations will be reduced to completely negligible values.

Fig. 12 Centre-of-gravity position of column cross-sections at different heights.

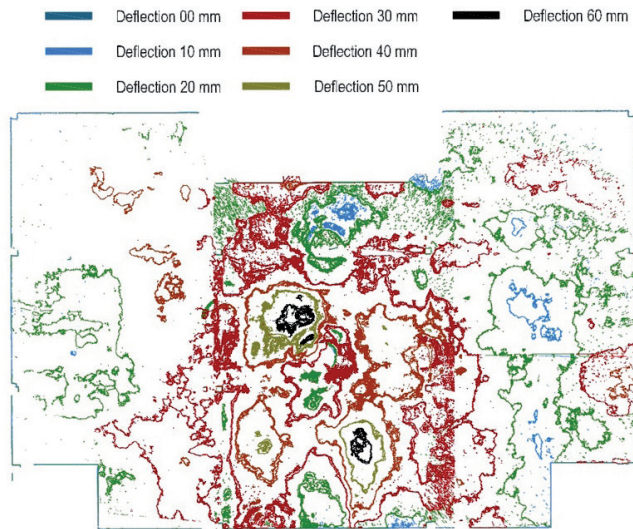
First-floor slab deflection was also investigated by means of a Laser Scanner, and results are reported in Figure 15. The maximum deflection of 60 mm is indicated by the black lines located on the left side and in the bottom part of the fire area. Both of them correspond to a midspan beam point.

Despite the high value of maximum deflection (60 mm), there are no visible cracks in the extrados, and the only other sign of the fire is the floor discolouration.

It is interesting to point out that Figure 15 can also represent a synthetic map of structural fire damage; indeed, it highlights the most deformed area, corresponding to beams T5, L4 and L5.

Fig. 15 First-floor slab deflection.

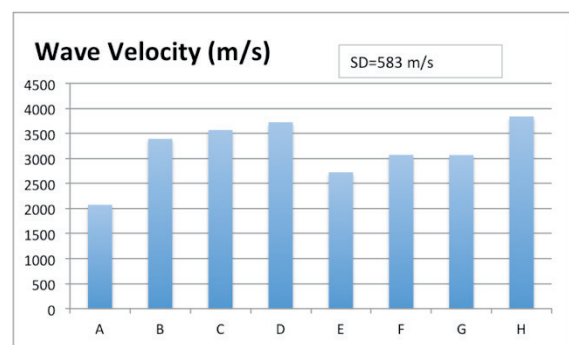
From the data reported in Figure 17, it is clear that the most highly damaged area corresponds to left points A and E, which present the lowest speed (2000–2400 m/s). Indeed, it is well known (see [21]) that damage significantly reduces the speed of sonic pulses. On the other hand, points H and D present the highest speed value (3800 m/s) and are located in a corner of the slab, near the stairwell. The latter points were probably less exposed to the fire and consequently reached lower temperatures than the ones (points A and E) located in the centre of the slab.

Fig. 17 First-floor slab Sonic Test chart results.

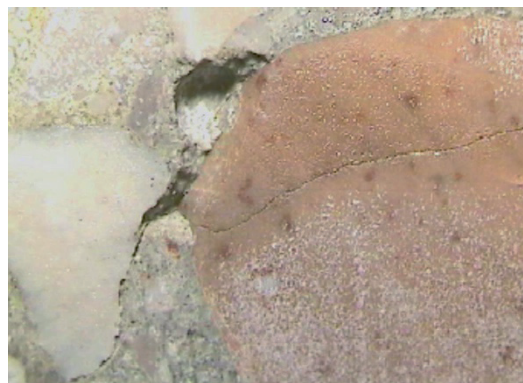
Fig. 18 Cracks around the perimeter of aggregates and inside the reddish aggregate (sample label: Beam 3).

On the contrary, the fire-damaged concrete (e.g. COL 4, COL 5, COL 9, BEAMS 8-9 and BEAM 3, see Table 9), is characterized by surface pulverisation, intense whitening, selective erosion and deformation. Microfracturing is widespread: fractures cut the aggregates or develop inside the transition zone (see Figure 18).

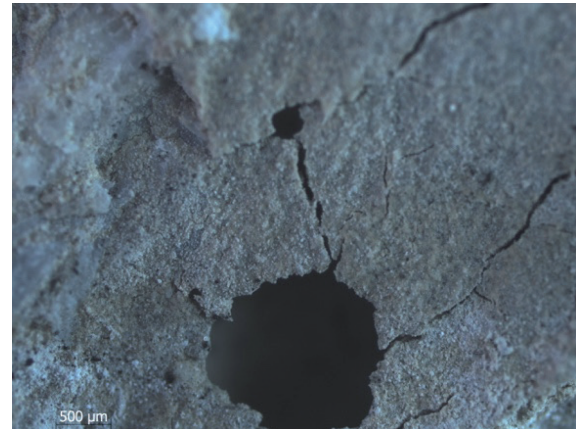
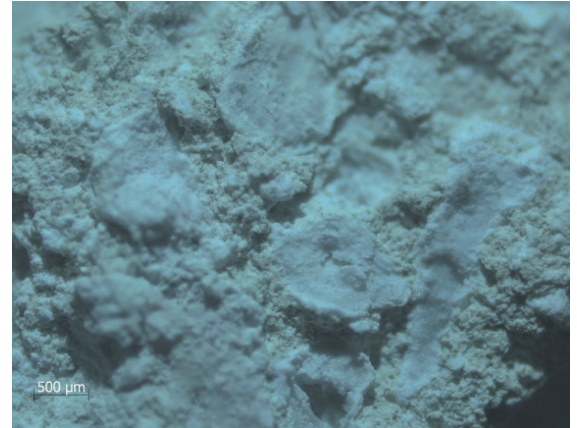
Fig. 20 Microphotos of damaged concrete surface in RL mode: (a) micro-cracks radiating from a macro-pore, cement matrix altered in colour, COL 4a Sp a; (d) pulverization and whitening (Beams 8-9 a133), see Table 9.

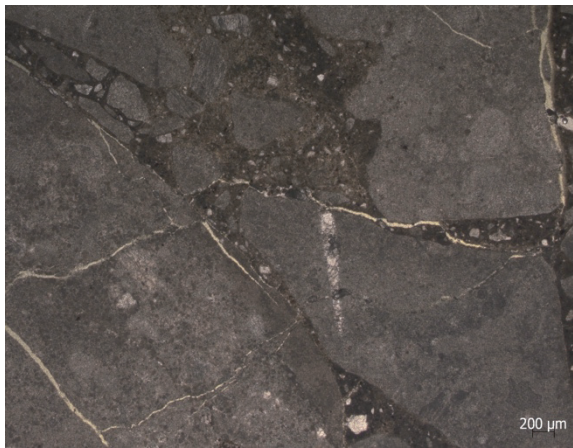
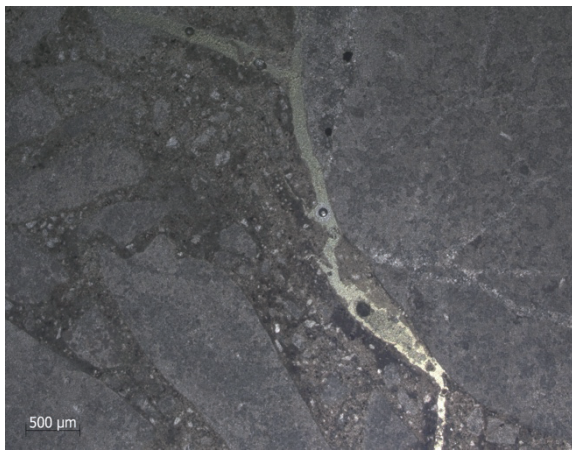
Fig. 21 Microphotos of damaged concrete surface in PPTL mode: microcracks involving the transition zone and cutting the aggregates, sample COL 5B(a); interfacial cracks, sample COL 4A(b), see Table 9.

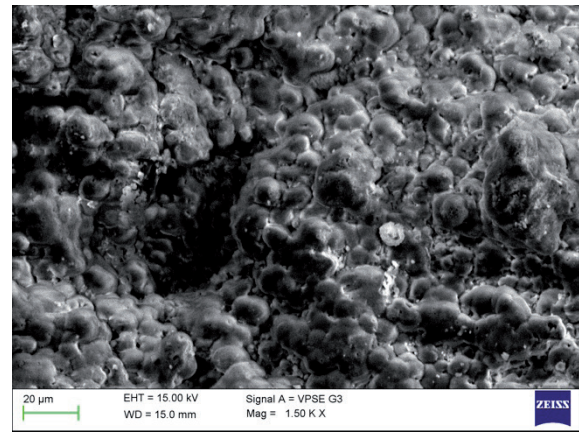
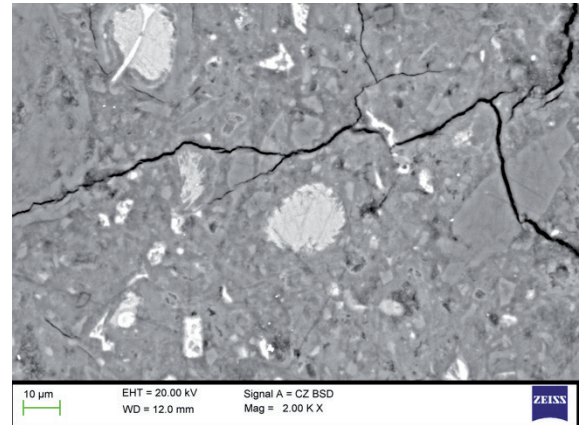
Fig. 23 SEM image of the top of high-damage sample: (a) micrometric globular formations, COL 4A; (b) microfracturing affecting cement matrix, transition zone and aggregates, COL 5B, see Table 9.
