Gonzalez-Longo, Cristina (2008) *Conserving, Reinstating and Converting Queensberry House*. In: Proceedings 8th International Seminar on Structural Masonry (ISSM 08). UNSPECIFIED. ISBN 978-975-561-342-0

# **Conserving, Reinstating and Converting Queensberry House**

## Cristina GONZÁLEZ-LONGO<sup>1</sup>

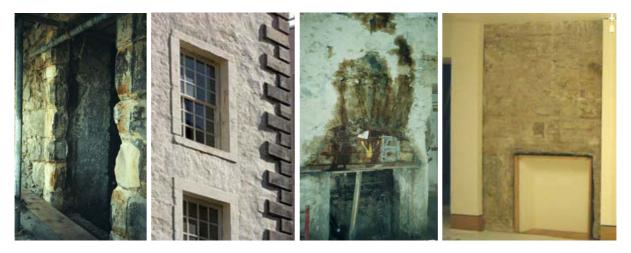
The walls of Queensberry House are of rubble-filled stone masonry, mainly sandstone, with wall thickness between 300mm and 700mm. Dressed stonework is present at raised quoins and window margins, doors surrounds and in the channelled rusticated V-jointed ashlar of the vestibule. The poor condition of windows stone lintels, sills and jambs (Fig. 5a), required initially an extensive and time-consuming campaign of careful survey and drawing, leading to stone indenting and in some instances replacement. The inspection of the stone windows' margins was hampered by the existence of paint covering the fabric, as all stonework has been painted at various times with differing materials. Such paint finishes had to be carefully removed from the stonework, which was a long and time-consuming task.

Figure 5. Before and after the works [a] External masonry and window margin [b] Internal wall and fireplace

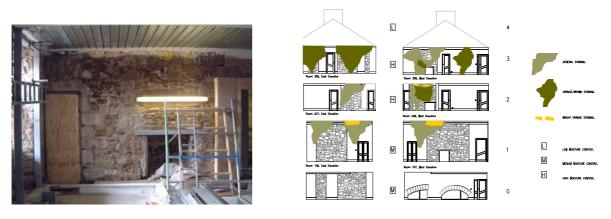
Superficial deterioration of the stonewalls, including a significant discolouration to a brown/yellow and bright orange, depending on the background support, was consistently evident at the upper part of the masonry walls (Fig. 8a). In order to understand the extent of the problem, a detailed mapping showing the internal staining zones was carried out (Fig. 8b). A consistent pattern emerged, closely related with the presence of existing filled chimney flues, but opinions on its origin were contradictory so Dr John Dixon from the University of Edinburgh produced a specialist and independent report [Dixon 2002]. Residual flue products, from the prolonged use of coal-burning fires for 300 years, were identified as the most likely cause of the staining. There was a clear association of the most intense discolouration with the most porous sandstone blocks. The main conclusion by Dr Dixon was that a water solution very rich in dissolved inorganic salt ions and with a very minor content of compounds derived from coal tar deposits in the stonework of the flues, has percolated through the stonework. The evaporative extraction of moisture has concentrated the salt solution on the outer layer of the stone along with its organic components that are water-soluble.

Figure 8. [a] Internal wall and fireplace showing staining- Stone discolouration [b] Mapping of staining

A small trial of removing the staining from the walls using a paper fibre poultice was successfully carried out, but due to cost and time implications it was decided not to proceed with it, concentrating instead into drying out the building. Once it was watertight, a drying out strategy using dehumidifiers was put in place to reduce slowly the relative humidity down to 70%. The BRE criteria were adopted, i.e., masonry walls with a moisture content above 5% would be classified as damp. Weekly readings were carried out. Heating was increasingly incorporated, replacing dehumidifiers, bringing the building fabric to adequate equilibrium conditions. Once the surfaces of the walls were dry, the areas of friable or delaminating stonework were brushed back with a stiff bristle brush to a sound finish. There was also need to rake out loose mortar from the joints and to repoint with matching lime mortar.

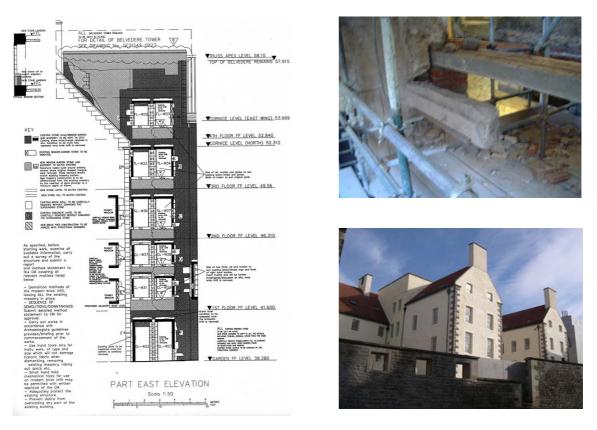
The Belvedere Tower was found to be in very poor condition as the lift of the hospital was located abutting it and in order to provide access the external wall was extensively demolished. The challenge was to conserve in situ all the remains of the original masonry and dressed stone window margins of the paired windows, mainly lintels. This was a difficult operation as the wall had been recently patched with brick, but the presence of almost all the original stone lintels gave enough evidence for the reinstatement of the paired windows. The reconstruction of the area was carried following the traditional technique 'repair by building', reconstructing carefully the missing area, in small sections at the time, without dismantling nor disturbing the existing openings, and keeping lintels in their original position during the works (Fig. 9).

Figure 9. Belvedere Tower [a] Design of intervention

[b] Existing lintels [c] A:

[c] After the intervention
