USING THE SCANNING ELECTRON MICROSCOPE ON THE PRODUCTION LINE TO ASSURE QUALITY SEMICONDUCTORS

**John W. Adolphsen
and
Robert J. Anstead**

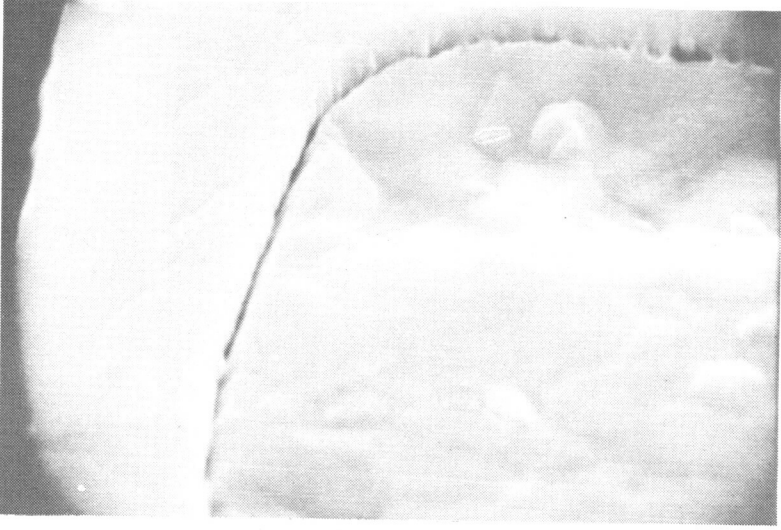
Metallization defects introduced during batch processing of semiconductor devices have been a major problem in several GSFC flight projects in recent years. Partial discontinuities in metallization at the step in the oxide at contact windows (Figure 1) have resulted in latent failures in systems already fabricated and tested. This condition cannot be detected with an optical microscope (Figure 2). The line at the oxide step is typical of that normally seen for a good device, but here the metallization is almost completely discontinuous. By contrast, Figure 1, which is a scanning electron microscope (SEM) picture, shows that the line is not a shadowing effect and clearly describes the actual condition of the metallization.

Figure 1—SEM picture of edge of contact window. Magnification is 5000X.

Although the SEM is capable of detecting this metallization anomaly, its use heretofore has been confined to the laboratory. A method of determining metallization integrity has been developed that culminates in a procurement specification, which uses the SEM on the production line as a quality control tool. Batch process control of the metallization operation is monitored early in the manufacturing cycle. When bad metallization is detected, lost time is reduced to about five weeks from the 30 weeks necessary for complete manufacturing and screening tests. A paramount requirement of the method was that the disturbance to vendors' normal process flows be minimal.

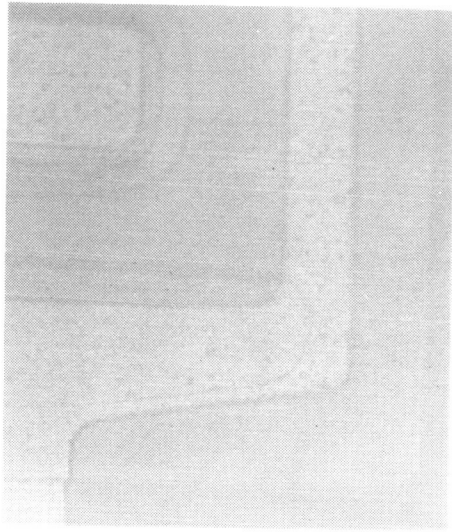
Figure 2—Optical microscope picture of transistor contact window. Metallization at S_1O_2 step appears good but is discontinuous. Magnification is 400X.

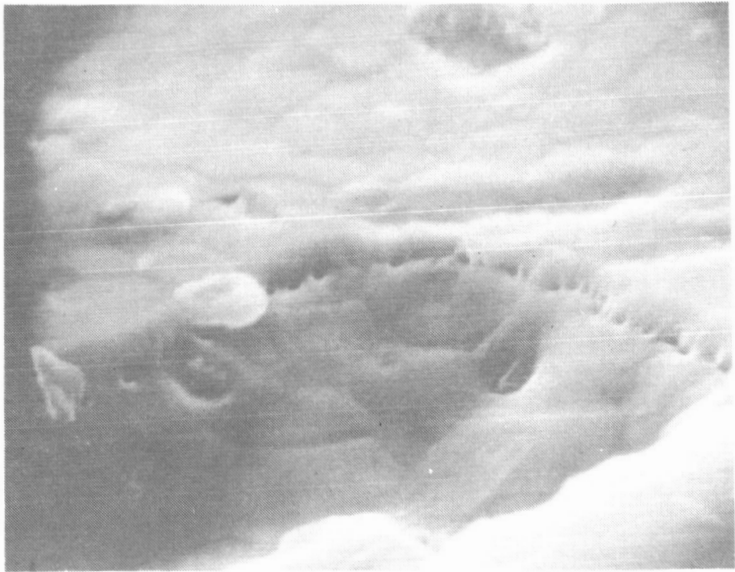
Figure 4—SEM picture of marginal metallization. A borderline case because of the number of discontinuities in aluminum at oxide step. Magnification is 5500X.
