# FATIGUE EXPERIENCE FROM TESTS CARRIED OUT WITH FORGED BEAM AND FRAME STRUCTURES IN THE DEVELOPMENT OF THE SAAB AIRCRAFT VIGGEN

By S. E. Larsson  
Saab-Scania Aktiebolag  
Linköping, Sweden

## SUMMARY

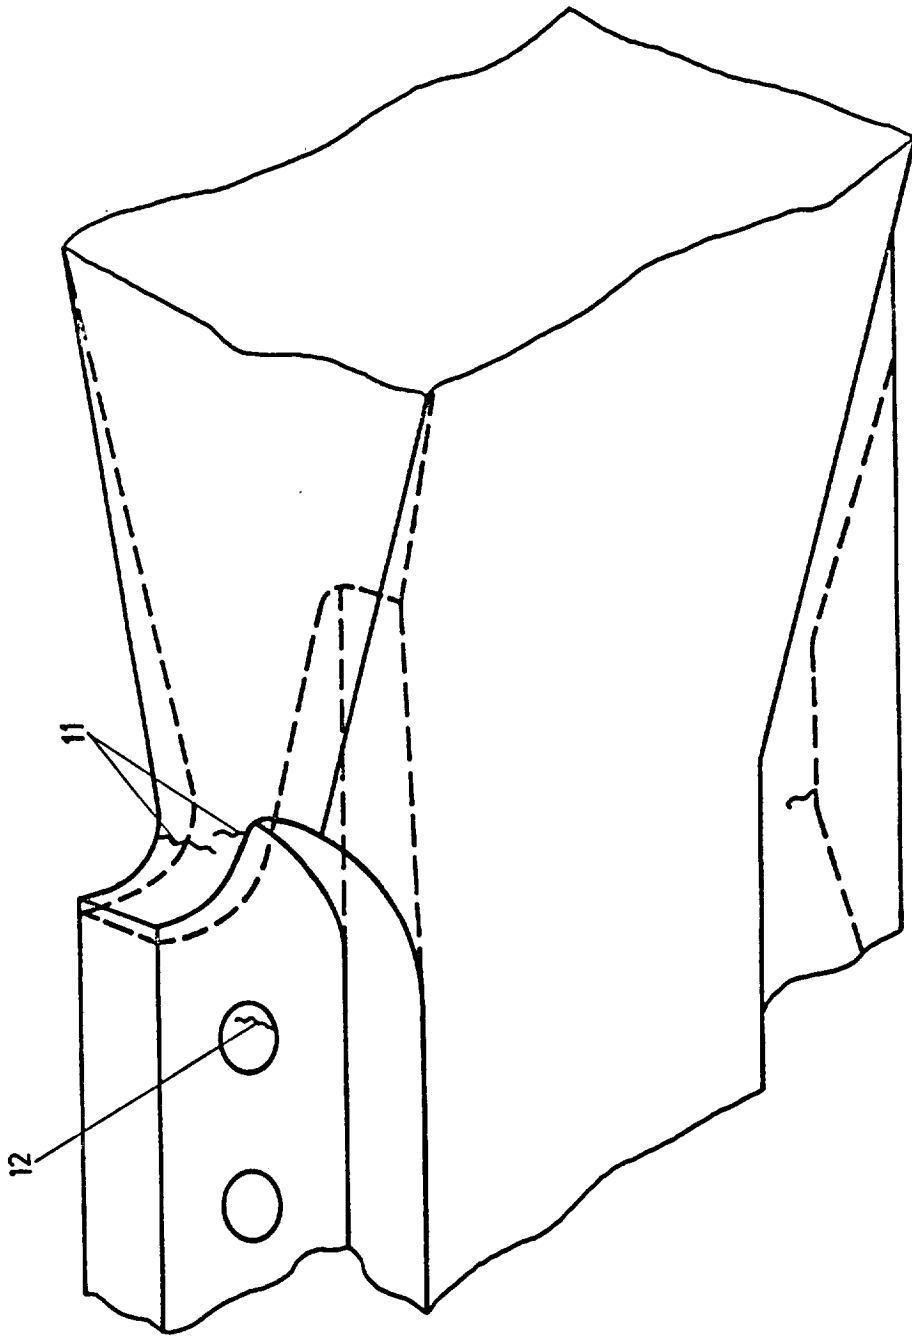
It can be seen in table I(b) that cracks appeared in specimen A<sub>1</sub> after only 3400 h. These cracks, no. 11, are shown in figure 9. One crack started where a radius  $r = 3$  mm interacted with the principal notch radius  $r = 10$  mm. Another crack started from the opposite side in a rough edge of the notch. Many very small cracks were also found in the anodized surface of the flange notch area.

Figure no.	Crack no.	Equivalent flying hours for specimen -			Comments
		A1	A2	A3	
9	11	(3400)			Geometry and surface finish not representative. Cracks occurred at flange (principal notch radius $r = 10$ mm). Cracks were removed and shape of specimen was modified.
10 and 11	21		8 400 15 200		Modified shape and polishing. Small crack found, $l \approx 1$ mm. Crack increased to $l = t = 12$ mm, $\delta = 6.0$ to $11.5$ mm.
12 and 13	31			7 700 10 500 11 600	Modified shape and polishing. Small crack found, $l \approx 5$ mm. Several cracks joined in one, $l = t = 12$ mm, $\delta = 3$ to $4$ mm. Crack propagated to $\approx 45^\circ$ , $l = t$ , $\delta = 14$ to $16$ mm.
9	12				Crack in flange in edge of bolt hole 1, $\delta = 2$ mm max., fretting.
10	22		15 200		Two cracks $\pm 45^\circ$ in flange at bolt hole 1, $l \approx 2$ mm $\approx 0.5t$ .
12 and 13	32			10 500 11 100	Crack out from flange at bolt hole 1, $\approx 10$ mm visible. Propagated $\approx 3.5$ mm, then nonpropagating.

Figure 9.- Test specimen A<sub>1</sub> with cracks found. Solid lines indicate original specimen in which cracks 11 occurred. The cracked material was milled off and the shape of the specimen modified as shown by dashed lines before occurrence of crack 12.

The specimen in this original shape was not quite representative of the aircraft structure, and it became less representative because the specimen was modified to remove the cracked material. However, the test was continued in order to study the area with bolt holes in the boom flange – that area which originally had been thought to be the most critical. For this case the cracked material was milled off, and the shape was modified to that marked with the dashed lines. Besides cracks in areas not considered significant, no new damage was found until crack 12 appeared in bolt hole 1 at about 21 000 h. The test was finished at 24 100 equivalent flight hours without a limiting failure.

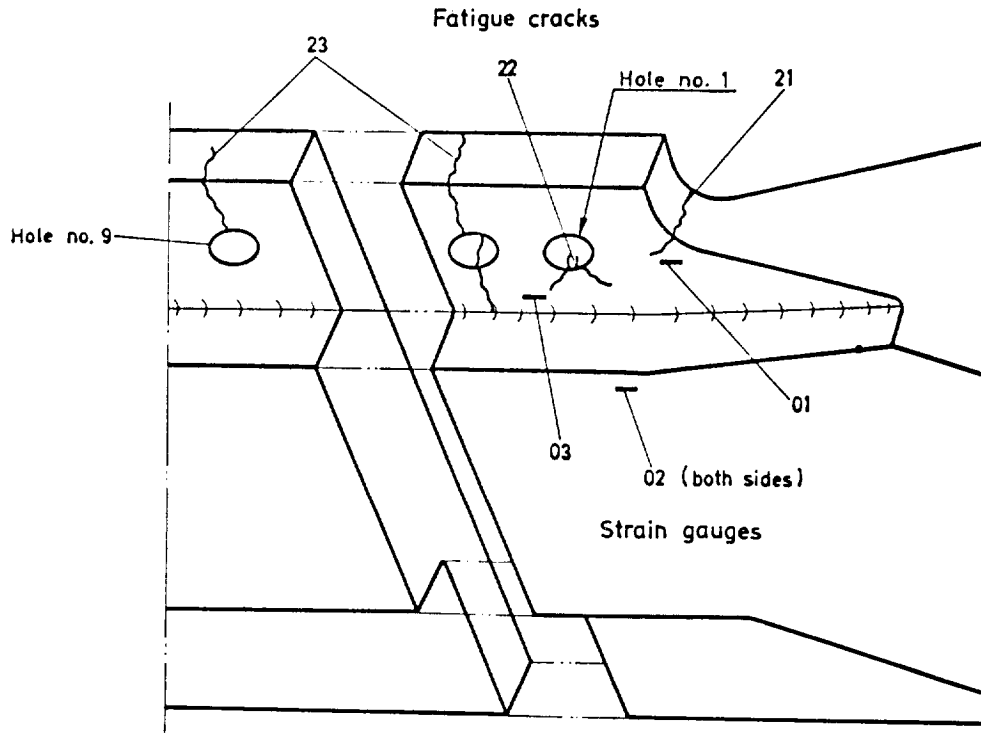
Figure 10 shows specimen A<sub>2</sub> in a late stage with the cracks fully developed. Crack 21 was found after 8400 h, when it had a length of  $l = 1$  mm. Its slow propagation was studied and it was under control until the test was ended as a result of bolt failure in hole 1 at 15 200 h. The crack propagation history can be followed in figure 20 (which includes sketches defining  $l$  and  $\delta$ ). Figure 11 shows details of the cracked specimen A<sub>2</sub>.

10 and 11	23		15 200		Crack through $t$ in flange at bolt hole 2; crack through $\approx 0.5t$ in flange at bolt hole 9.
-----	---	24 100	15 200	11 700	Testing ended. No failure or secondary-type failure.

Figure 10.- Test specimen A<sub>2</sub> with cracks found.

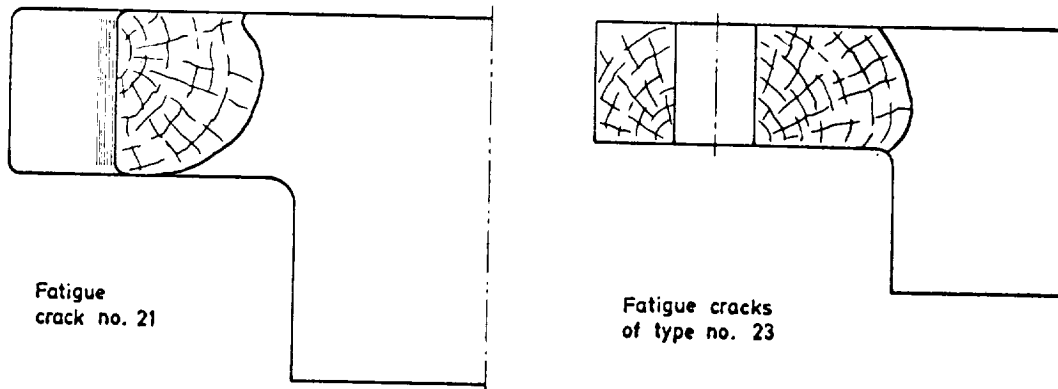
Figure 11.- Details of the cracked specimen A<sub>2</sub>.

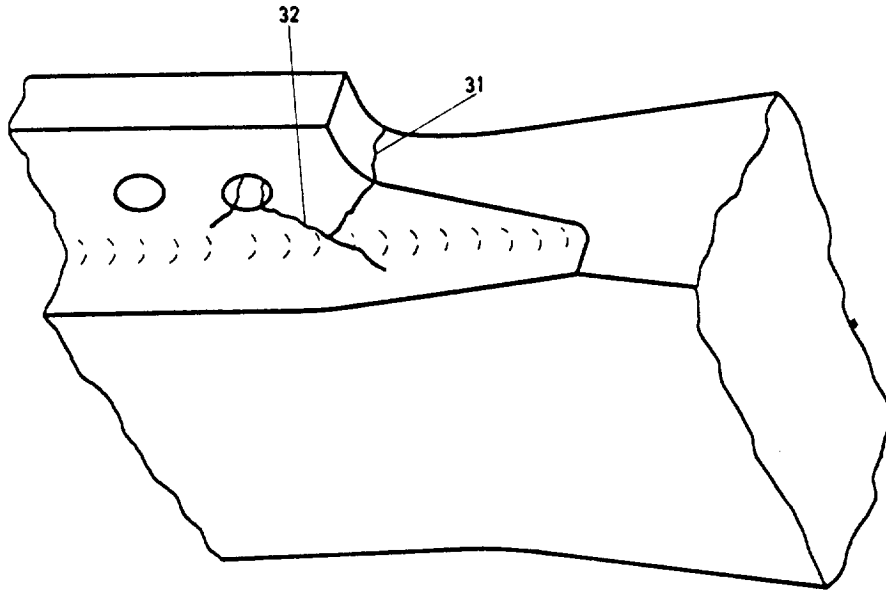
Figure 12 shows fully developed cracks in specimen A<sub>3</sub>. The nature of crack 31 was about the same as that of crack 21 in figure 10. Crack 31 was found at 7700 h, when it had a length of  $l \approx 5$  mm. It propagated somewhat more rapidly than crack 21.

The most interesting crack in specimen A<sub>3</sub> was the crack designated 32. This crack was seen for the first time at 10 500 h (not seen at crack search 600 h earlier). When discovered it had a visible length of about 10 mm (about 12 mm was hidden under the panel). From this stage it propagated rapidly (a rate of about 0.02 mm/h) and then more slowly. The same tendency toward crack development from bolt hole 1 can be seen in figure 10. The new results, however, are the rapid propagation of crack 32 and the complicated interaction with crack 31.

Figure 12.- Test specimen A<sub>3</sub> with cracks found.

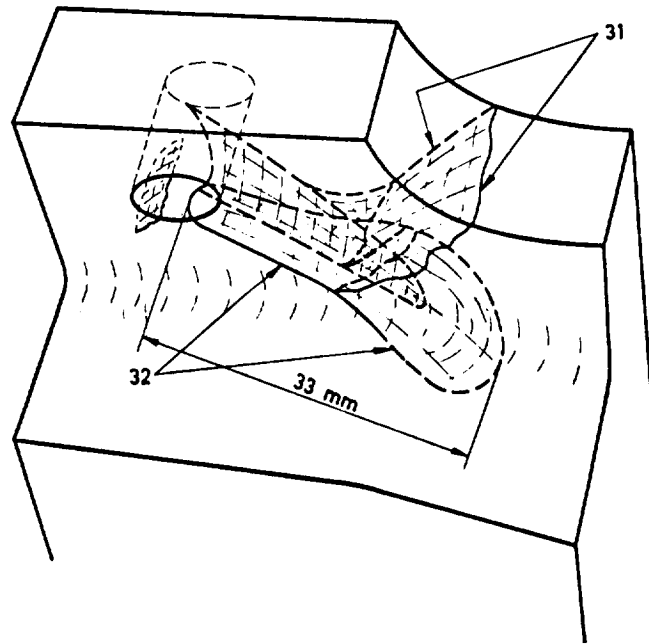
Figure 13 shows the features of the locally developed fatigue fracture surfaces of the cracked area in specimen A<sub>3</sub>. The slightly concave boom-side surface of crack 32 is thought to be the result of "Stage I" crack growth according to reference 2. The 45° direction is pronounced, and no unusual material properties or defects have been found. The surfaces were rubbed and could not give adequate information. At the stage of figure 13, crack 32 shows a tendency to change over to a 90° fatigue fracture. Figure 13 also shows that crack 32 must have been present when crack 31 passed through its area. The less interesting surfaces are not numbered.

Figure 13.- Details of the cracked specimen A<sub>3</sub>.

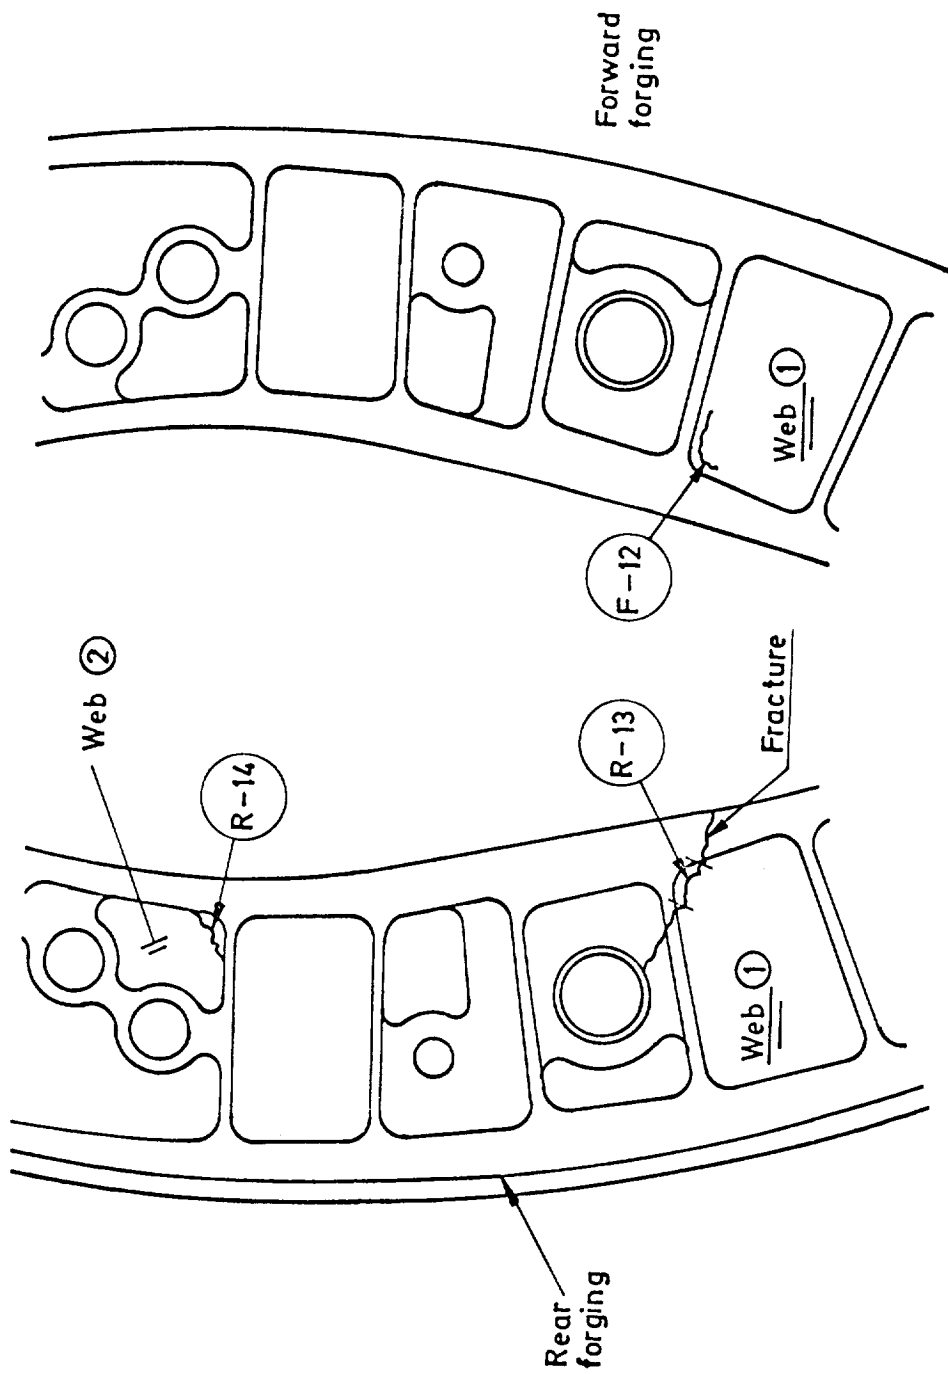
Ultimate failure of specimen B<sub>1</sub> occurred at 5300 h by fracture from an unexpected fatigue crack in web (1) of the rear forging, shown in figure 14. No crack search with fluorescent penetrant had been done in this area before failure. Afterward, however, four other cracks of about the same kind were indicated in three forgings of specimens B<sub>1</sub> and B<sub>2</sub>. The B<sub>2</sub> test was also ended. An inspection made clear that the surface finish of the web areas of the milled frame forgings was worse than specified.

Figure 14 shows test specimen B<sub>1</sub> with fatigue cracks and the location of failure indicated. Figure 15 shows the fractured area of specimen B<sub>1</sub> with a sketch of the fatigue fracture surface, which represented  $\approx 390$  mm<sup>2</sup>, or  $\approx 10$  percent of the whole area of the section. Figure 16 shows the surface shape of the fatigue crack that caused failure in B<sub>1</sub>. It is representative of a number of web areas in both B<sub>1</sub> and B<sub>2</sub>. The root radius  $\rho$  of the milling step marks was about 0.5 mm.

Figure 14.- Test specimen B1 with fatigue cracks and the location of failure indicated.

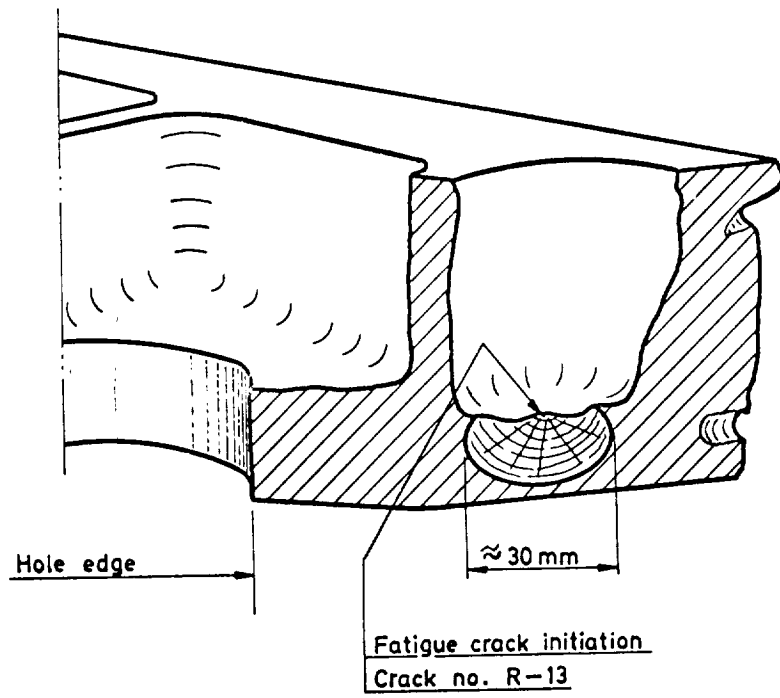
Figure 15.- Fractured area of specimen B<sub>1</sub>.

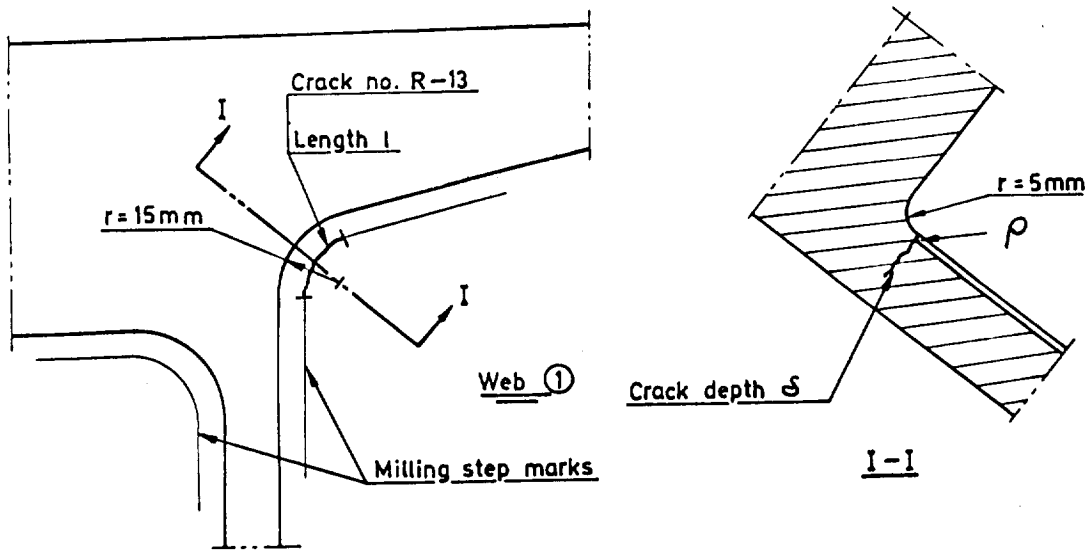
The main surface problem with the frame specimens B<sub>1</sub> and B<sub>2</sub> was the milling step marks shown in figure 16. In highly stressed areas, these milling marks and other surface imperfections on parts of the aircraft were eliminated by surface-improving procedures followed by adequate corrosion protection.

Figure 16.- The surface shape in a cracked area of specimen B<sub>1</sub>.

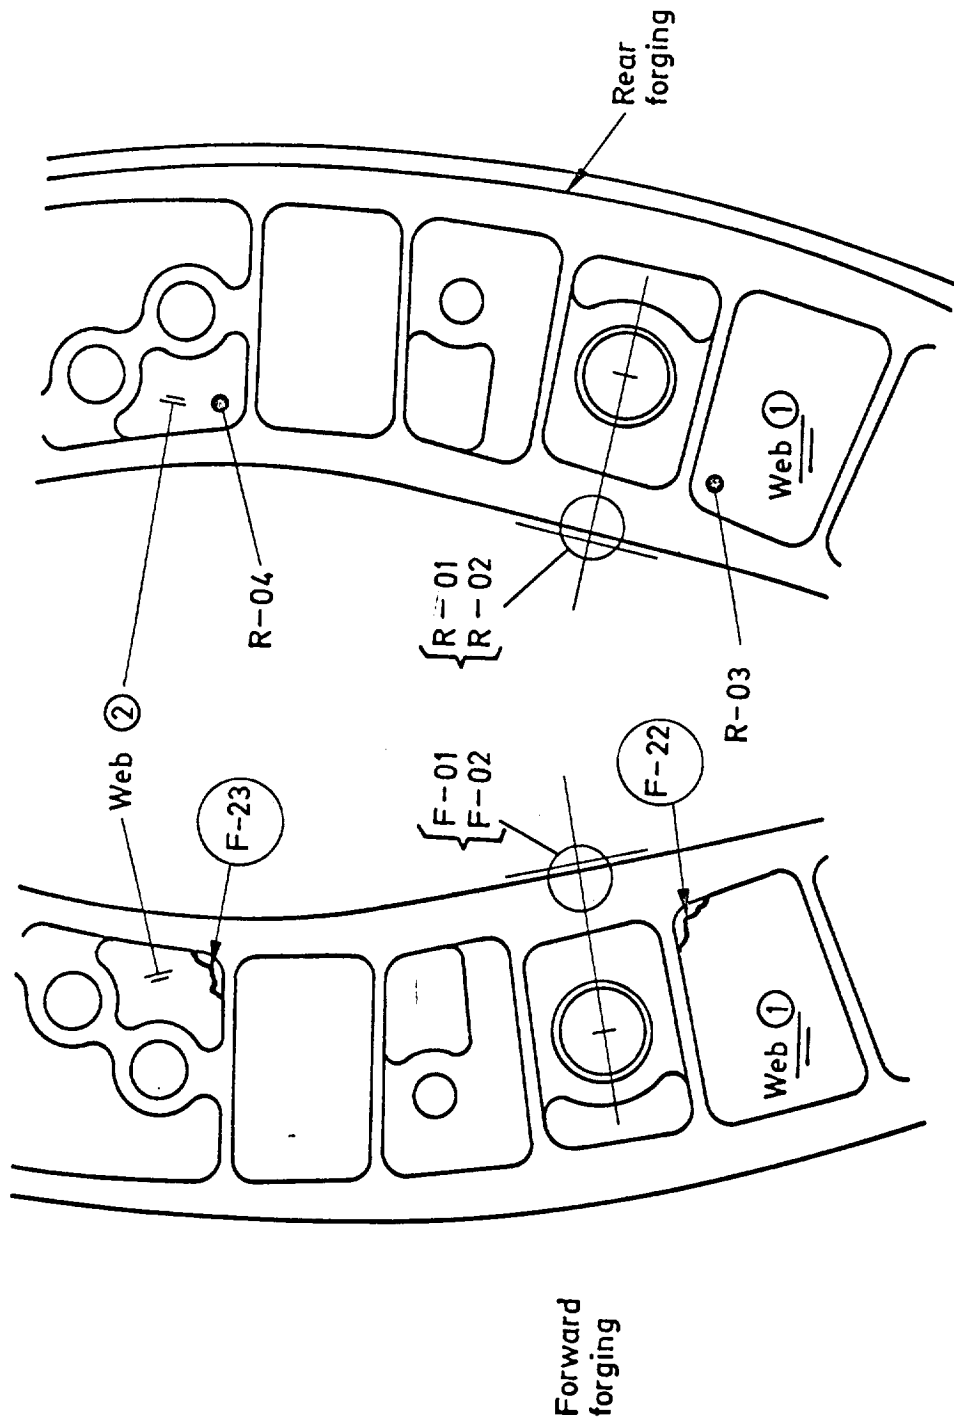
Figure 17 shows specimen B<sub>2</sub> with the location of cracks and strain gages indicated. Figure 18 shows the area with cracks in the inner sheet of the frame assembly. This area is not very representative of the aircraft because of the large unreinforced openings.

Figure 17.- Test specimen B2 with cracks and location of strain gages indicated.

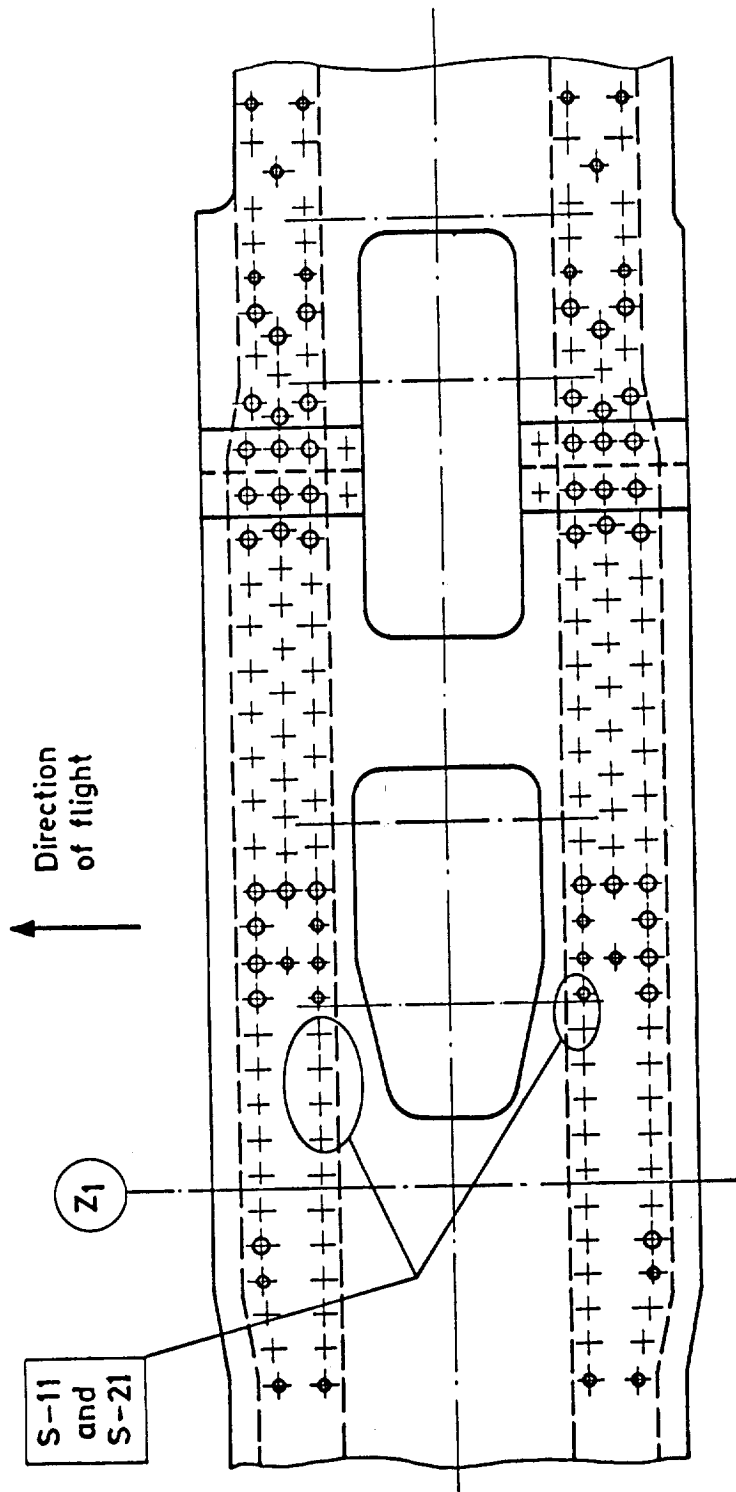
From table II(b) it can be seen that cracks appeared at screw holes in the inner sheet of the frame assembly after 4300 equivalent flying hours. Their propagation was observed, and in some cases they were stopped by the use of a blind rivet with  $d = 4.8$  mm or plug with  $d = 5$  mm (sheet thickness  $t = 3$  mm).

Figure no.	Crack no.	Equivalent flying hours for specimen -		Comments
		B <sub>1</sub>	B <sub>2</sub>	
18	S-11	4300		Inner sheet of frame assembly; cracks from two screws, $l = 3$ to 5 mm visible. Cracks at three holes, $l = 4$ to 10 mm, stopped at two.
		4800		
18	S-21		4300 4800	Inner sheet of frame assembly; cracks from one screw, $l = 1$ to 3 mm visible. Cracks from three screws, $l = 2$ to 5 mm visible.
14	F-12	5300		Forward forging, web (1); corner crack from milling step mark, $l \approx 30$ mm.
17	F-22		5300	Forward forging, web (1); corner crack from milling step mark, $l \approx 15$ mm.
17	F-23		5300	Forward forging, web (2); corner crack from milling step mark, $l \approx 10$ mm.
14 to 16	R-13	5300		Rear forging, web (1); failure due to crack, $l \approx 30$ mm, in corner.
14	R-14	5300		Rear forging, web (2); corner crack from milling step mark, $l = 19$ mm.

Figure 18.- Area with cracks in the inner sheet of the frame assembly. This figure represents both specimens B<sub>1</sub> and B<sub>2</sub>.

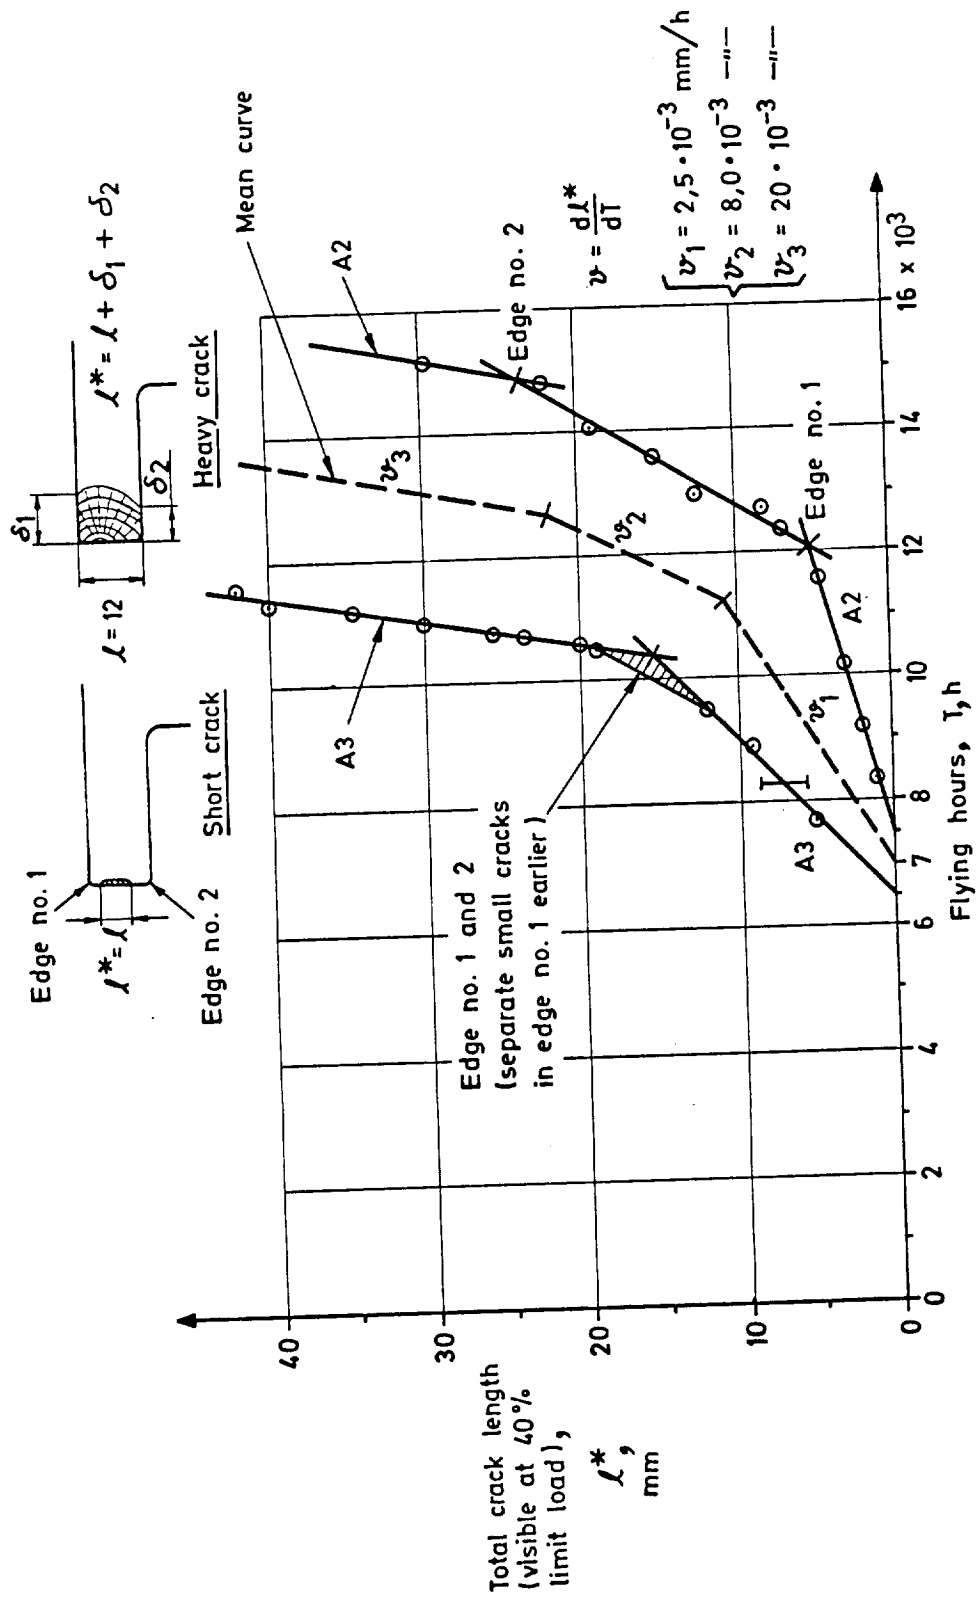
Propagation of the cracks in the AZ 74 boom flanges of specimens A<sub>2</sub> and A<sub>3</sub> (cracks 21 and 31) is shown in figure 20. Values of  $l^*$  (total visible crack length) were plotted against the number of equivalent flying hours  $T$ . The dashed lines make up a mean curve, visually estimated. This curve indicates that crack propagation, on the average, might be slow between  $T = 7000$  h and  $T = 11\ 000$  h. The mean crack propagation rate is  $v_1 = 0.0025$  mm/h in this time interval. (Environmental conditions, not considered in the tests, must also be accounted for when estimating the probable damage tolerance of the aircraft structure.)

Figure 20.- Crack propagation at flange notch in specimens A2 and A3.
