APOLLO 15 MAIN-PARACHUTE FAILURE

By Donald D. Arabian and Joseph E. Mechelay*

ABSTRACT

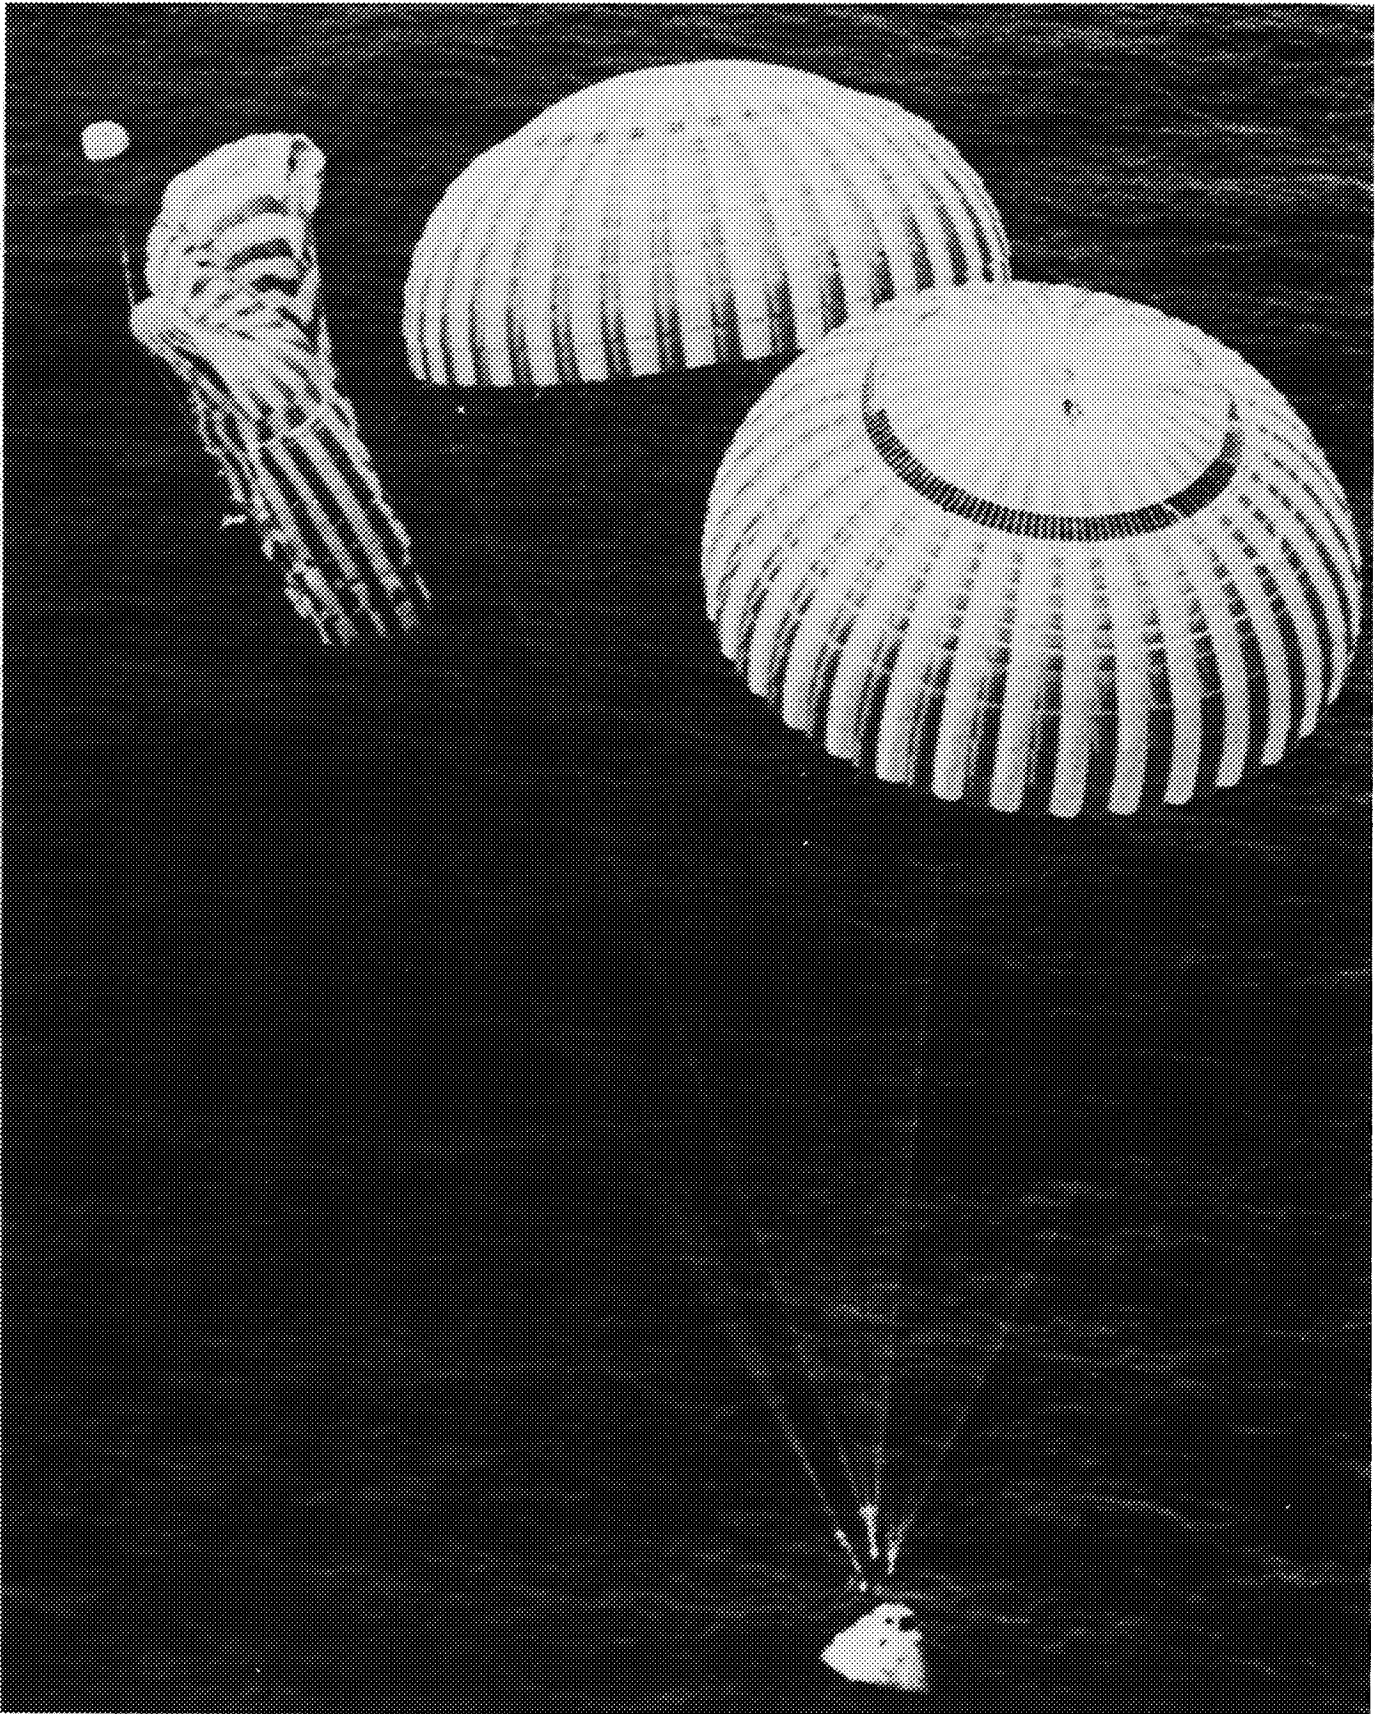
The three main parachutes of the Apollo 15 spacecraft deployed and inflated properly at approximately 3050 meters altitude. Films show that all three parachutes disreefed and opened fully in the proper sequence. The spacecraft and its parachutes were obscured by clouds at approximately 2135 meters altitude. On emerging from the clouds at approximately 1825 meters altitude, one of the three main parachutes was deflated,

as shown in figure 1. The spacecraft and parachute system descended in this configuration to water landing. The three parachutes were disconnected and one of the good main parachutes was recovered.

Figure 1. - Spacecraft descending with one main parachute failed.

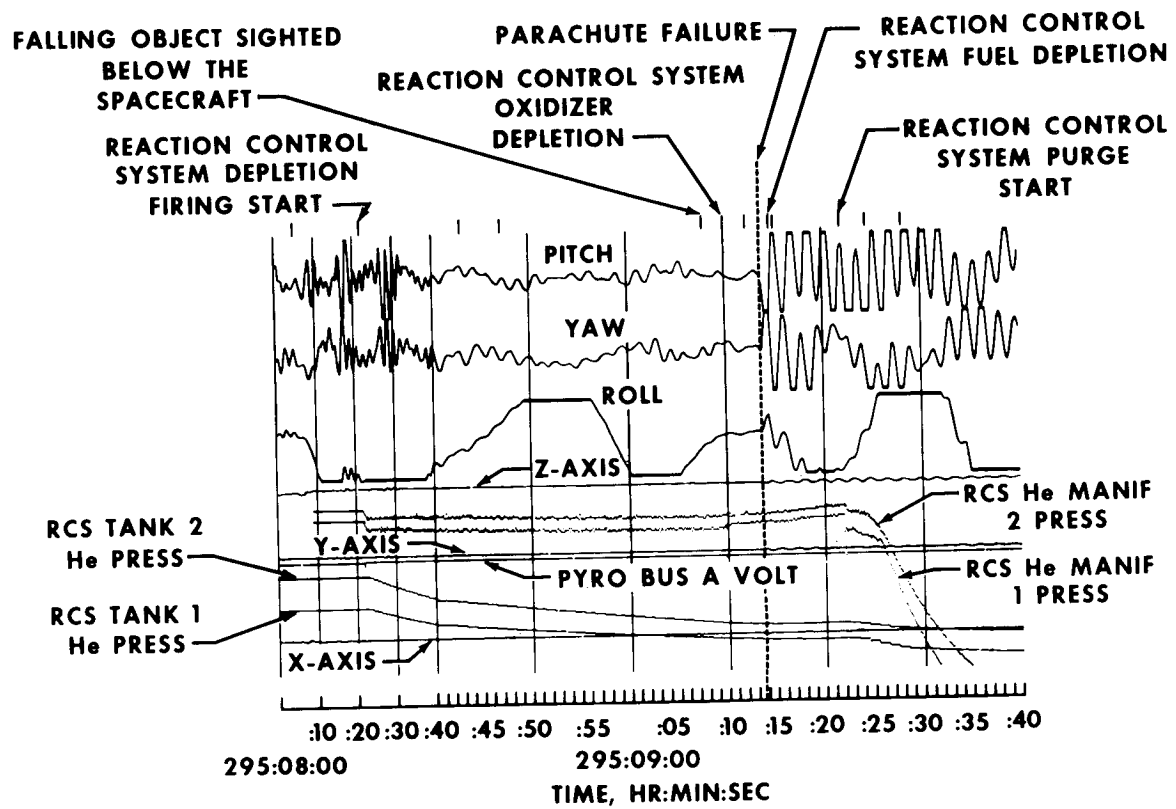
The initial efforts of the investigation team were concentrated on accumulating and assessing the spacecraft data, evaluating the photographic and television coverage, and inspecting the recovered parachute and the forward heat shield. The spacecraft data and the associated events are shown in figure 2. The time of the anomaly was determined from the X, Y, and Z accelerometer data and the associated rapid rate changes. The data show that the command module reaction control system depletion firing was completed approximately 3.5 seconds before the anomaly, as determined from an abrupt rise in the reaction control system manifold pressure. This change occurs when the pressure regulators abruptly close, as a result of the reaction control system tank bladders being collapsed. The completion time of the fuel (monomethyl hydrazine) dump that follows the depletion firing was determined by calculating the amount of fuel remaining at the end of the depletion firing (approximately 2.72 kilograms, using the known flow rate of the fuel through the engines). The 4.7-second duration of the fuel dump overlaps the time of the anomaly occurrence. The start of the reaction control system purge occurred 8.3 seconds after the anomaly, as determined from the spike in the pyrotechnic bus voltage and the immediate decreases in the reaction control system pressures.

According to these results, two connector links must fail simultaneously to satisfy the abrupt load change calculated from the data of figure 2. It is highly unlikely that this situation occurred because of the low-load condition at the time of failure (35 percent of the opening shock load). Assuming that the collapsed parachute did have two failed links, load still would have been carried by the fractured links. This fact was demonstrated by testing of the recovered failed link in which the link withstood two complete mission load cycles.

Figure 2. - Sequence of events during descent on the main parachutes.

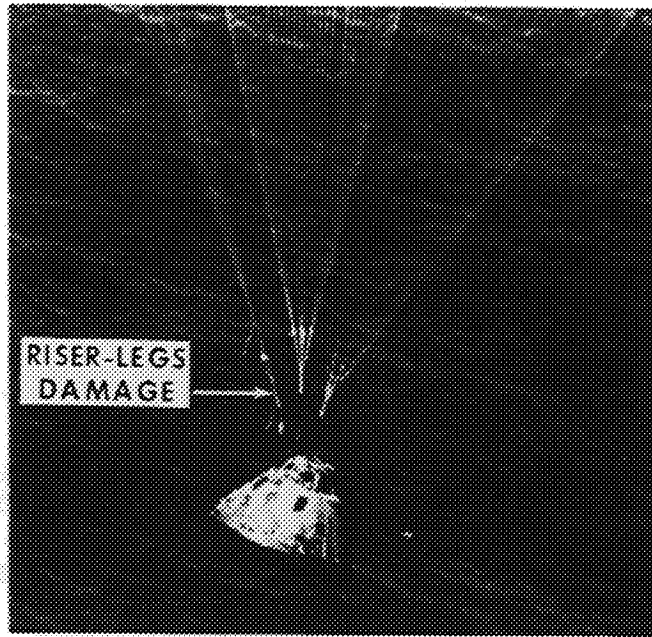
The two most significant items of photographic data obtained were the television tape, which indicated that the forward heat shield was in the vicinity of the spacecraft at the time of the anomaly, and the photographs shown in figures 1 and 3, which show the spacecraft parachute system damage when the spacecraft was relatively close to landing. The photographs show that

1. Three of the risers are taking the load.
2. There is no evidence of flailing suspension lines.
3. Two of the damaged riser lines appear to be full length.
4. Approximately two-thirds of the suspension system appears to be missing.
5. No significant canopy damage is visible.

Figure 3. - Parachute-riser damage during final descent.

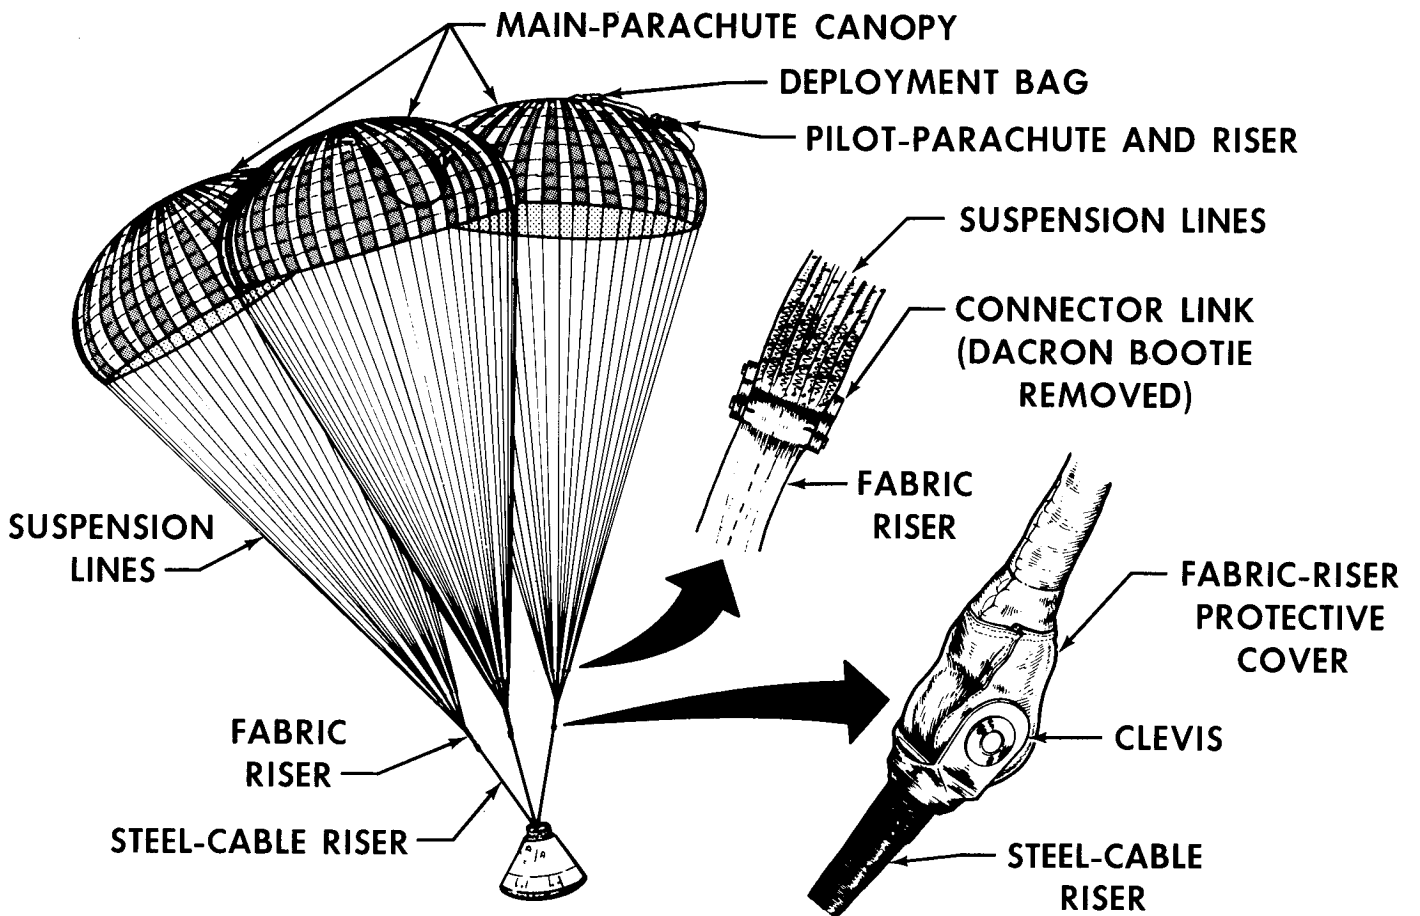
the recovered parachute showed only that it was not the one that had collapsed. Approximately 1 week after the first inspection, a second inspection was conducted, and a broken riser/suspension-line connector link was found after the Dacron bootie that protected it had been removed. Two to 3 weeks later, a closer examination of the Dacron riser protective cover (fig. 4) and the Dacron connector-link booties showed evidence of heat.

Later in the investigation, evidence of melting was found on the Dacron protective covering of the fabric riser and the connector link booties on the recovered parachute assembly. As a result, a closer examination was made of potential heat sources.

Figure 4. - Parachute system configuration.

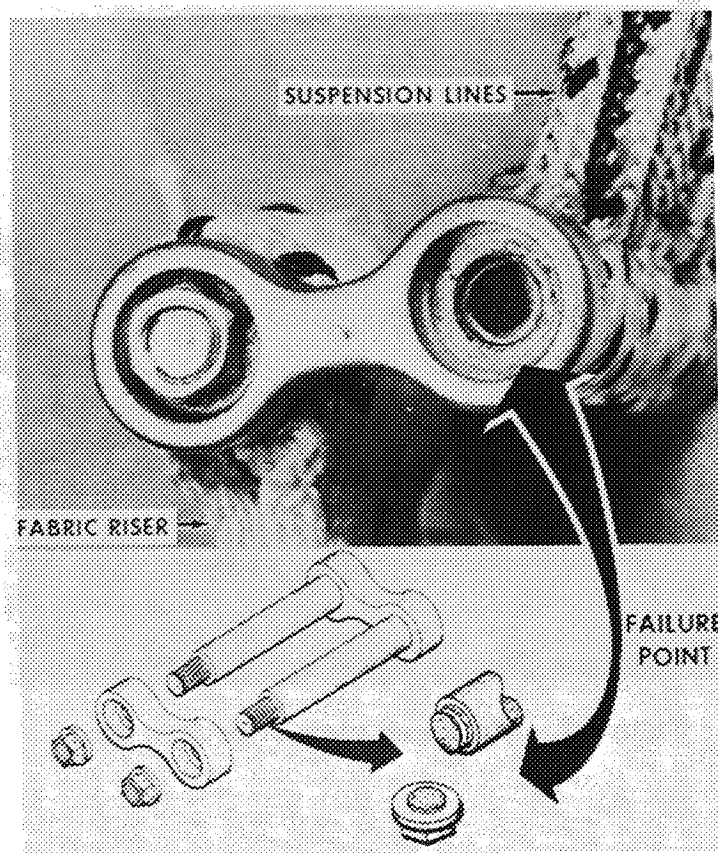
The discovery of the failed link on the recovered parachute (fig. 6) resulted in an extension of the investigation in order to identify the process that caused the connector link to fail and to determine if such a failure could have occurred and resulted in the parachute failure observed during the Apollo 15 landing. Microscopic inspection of the broken stud (fig. 7) indicated that stress corrosion or hydrogen embrittlement may have caused the link failure, or that it may have been caused by some other indeterminate means. The material used in the studs (4130 steel alloy) is susceptible to cracking when it is highly stressed and immersed in salt water. This process can cause stress corrosion. Hydrogen embrittlement can occur in the plating operation during the manufacturing process. The plating produces hydrogen that causes the embrittlement if the subsequent heat treating is improper.

Tests were performed on the connector links in an attempt to determine if either stress corrosion or hydrogen embrittlement was the process that caused the link failure. These tests included sustained-load tests to determine if hydrogen embrittlement was present; stress-corrosion tests to determine if salt-water corrosion could have induced the failure; over-torque tests of the studs to determine if tolerance buildup of stresses could have caused the problem; and hypergolic propellant exposure to determine if propellant exposure could have caused the observed flaws. The results of the tests and the metallurgical examinations performed were inconclusive in isolating the failure mechanism.

Figure 6. - Main-parachute connector-link failure.

Corrective actions for the reaction control system include landing with the propellants on board for a normal landing and biasing the propellant load to provide a slight excess of oxidizer. Thus, for the low-altitude abort land landing, burning the propellants when the parachutes are deployed will subject the parachutes to some acceptable oxidizer damage but will eliminate the dangerous burning-fuel conditions. The suspension-line connector-link material has been changed to Inconel 718 to eliminate the requirement for plating, and the link-stud threads are rolled rather than machined to improve the metallurgical properties of the material.

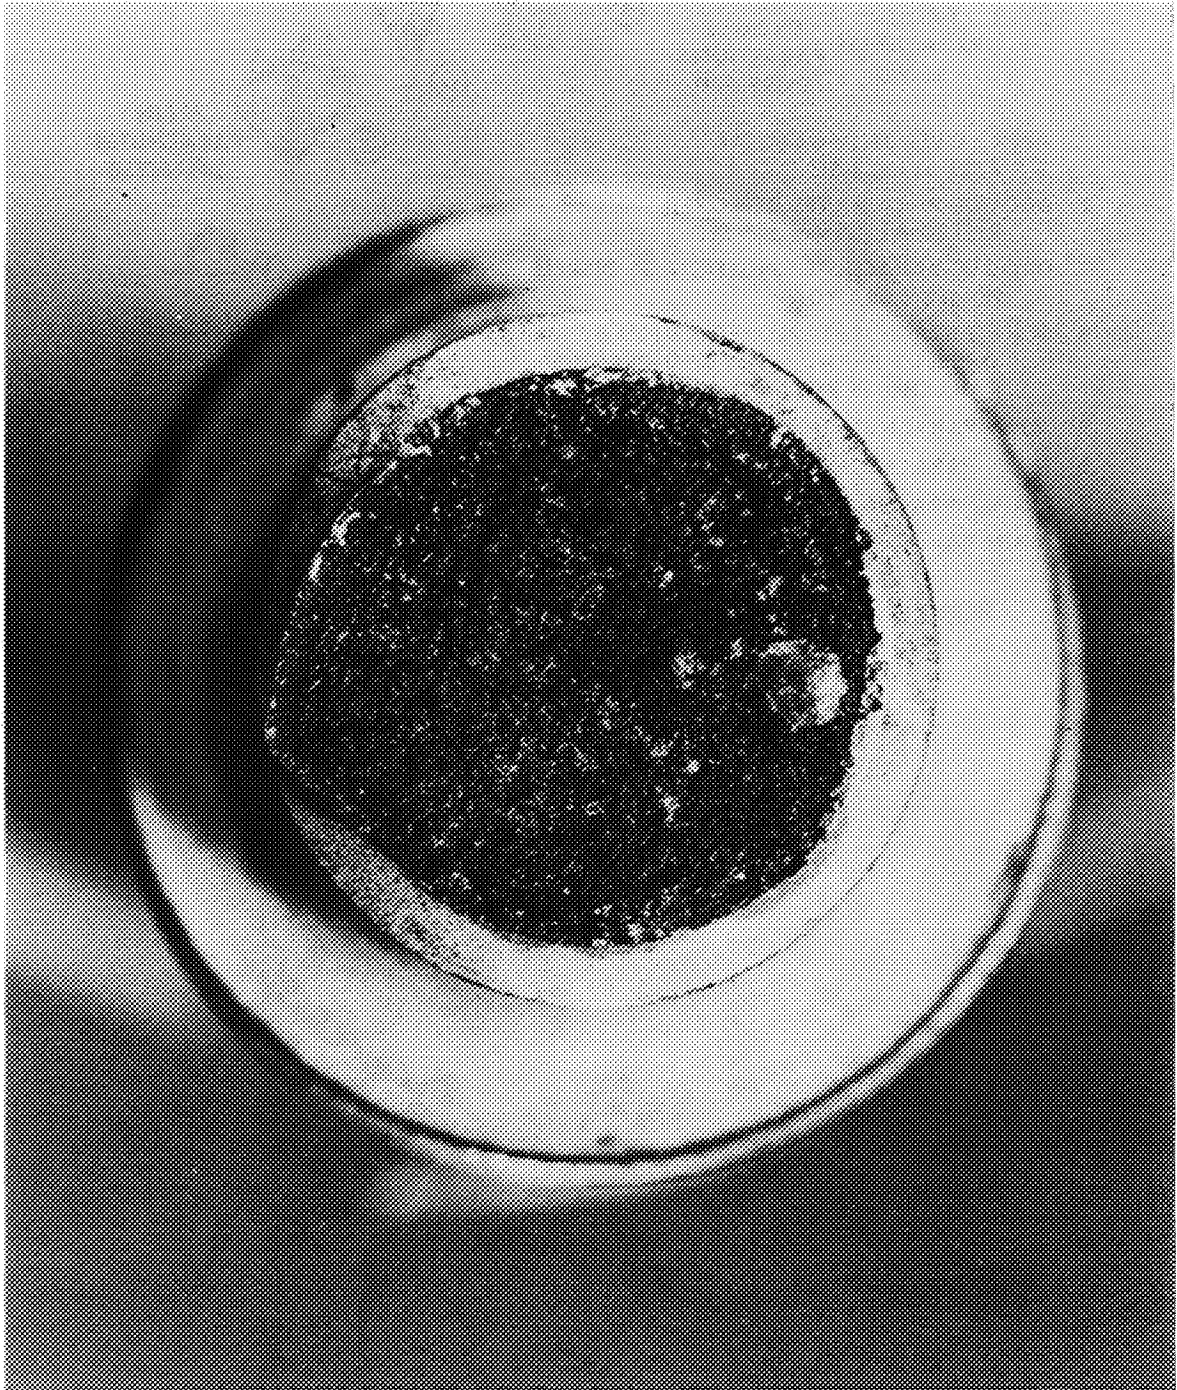
Figure 7. - Enlarged view of broken stud.
