THE HELIOS EXPERIMENT 5 ANTENNA MECHANISM

by E. J. W. Müller, Dipl.-Ing.

DFVLR-BPT, Germany

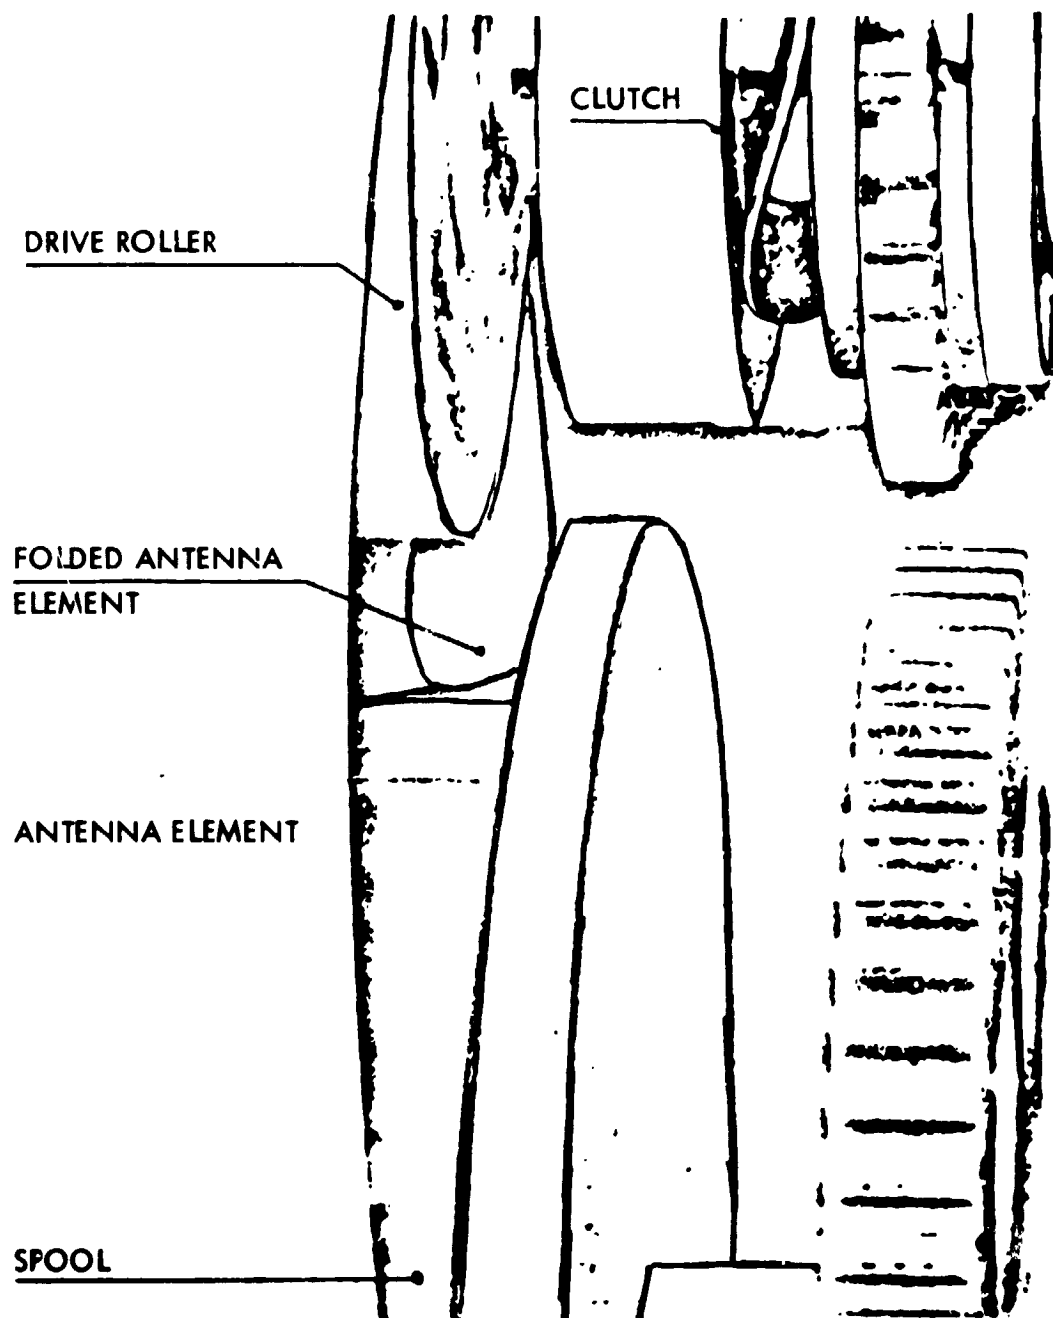
The most probable failure mode which could have caused the problem on HELIOS A was found in tests No. 1.2 and 1.3 when the effect of the ion guard on the antenna element was determined. When the ion guard and the antenna system are assembled for S/C integration, the ion guard is compressed to about 30 cm for storage. During storage, it is additionally twisted axially through two to four turns due to the normal rotation of the helical spring inside the ion guard. When the ion guard deploys (simultaneously with the antenna element), it imparts a torque to the antenna element transmitted by the friction between ion guard end flange and antenna tip mass. When the direction of the ion guard torque is such that the antenna cross section tends to open, the antenna element is caused to bind at the end of the ploy. As a result, a blooming or buckle occurs between the drive roller and the ploy. When this effect was detected at Fairchild, approximately 5 seconds had elapsed between stall of element and power switch-off. The 5-second delay was enough to damage the antenna element. A possible explanation was that one antenna worked properly and that it was impossible to overcome the failure on board HELIOS A by retracting and deploying maneuvers of the S/N 006 unit. Figure 3 shows a close-up view of the failed mechanism after test step 1.2.

Fig. 3 Close-up view of the failed mechanism after test step 1.2

Based on S/C noise data obtained by Experiment 5a on board HELIOS A, the experimenter requested the elimination of the foldable ion guard. It should be replaced by a rigid electrically conducting tube of 10-cm diameter and 0.8-m length to provide electrostatic shielding of the antenna base from noise originated by the spacecraft solar array. This modification completely eliminated the interaction between ion guard and antenna element. Together with the elimination of the foldable ion guard, the detent spring inside the mechanism could be removed. This spring was necessary to hold the antenna element in its stored position during vibration loads, because of the pulling force of the ion guard on the antenna element.
