BLADE DESIGN AND OPERATING EXPERIENCE
ON THE MOD-OA 200 KW WIND TURBINE
AT CLAYTON, NEW MEXICO

Bradford S. Linscott and Richard K. Shaltens
NASA Lewis Research Center
Cleveland, Ohio

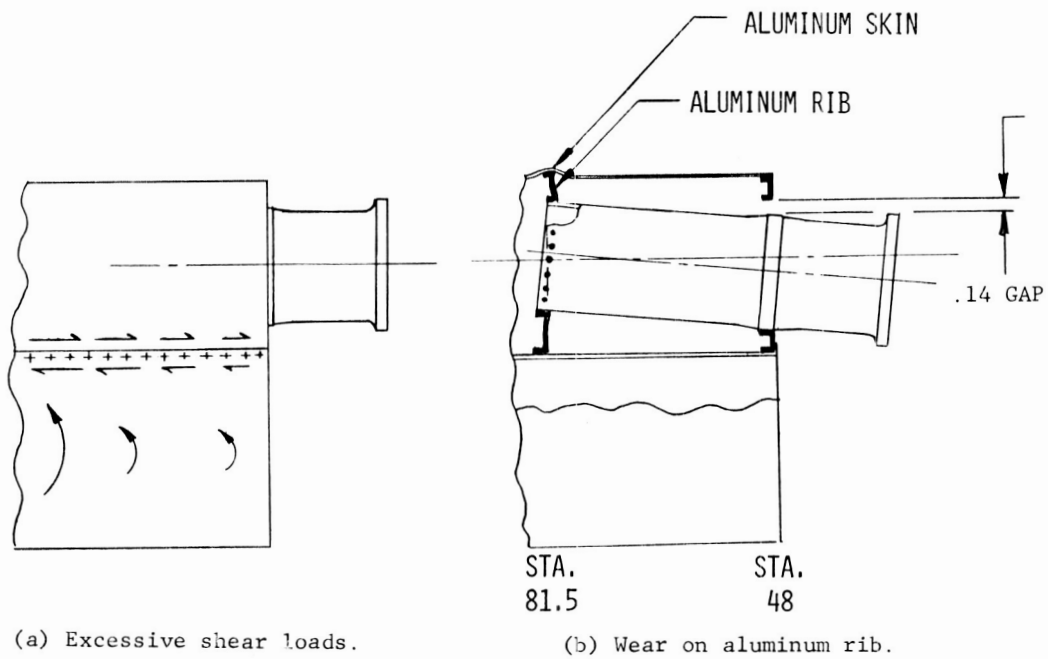
Figure 5. - MOD-0A detail design deficiencies.

One design deficiency was located along the line of fasteners joining the trailing edge skin to the D-spar, shown in figure 5a. It was determined that the joint, shown in figure 5a, could not carry the applied shear loads. The shear loads occur primarily due to the weight of the blade. As a result broken and loose fasteners were found, and cracks were found in several angle stringers located in the root end end of the D-spar. This design deficiency was corrected by adding doublers, on the exterior of the blade, between station 48 and 100, as shown in figure 6.

The second design deficiency was the bearing interface, located between the aluminum rib, at station 48, and the steel root end fitting, shown in figure 5b. It was observed, during the blade inspection at the Lewis Research Center, that the steel root end fitting had rubbed on the aluminum rib during operation. This rubbing action caused excessive wear of the aluminum rib. The wear resulted in a radial clearance of 0.14 inches between the root end fitting and the rib as shown in figure 5b. Because of the large radial clearance at sta 48, a bending moment, larger than the design allowable, was applied to the rib at station 81.5. The high bending moments applied to the station 81.5 rib caused the rib to crack and also caused the 0.25 thick D-spar skin to crack.

As a result, doublers were added to the blade exterior at station 81.5, as shown in figure 6. A special bearing was designed, as shown in figure 7, to reduce the wear of the aluminum rib at station 48.

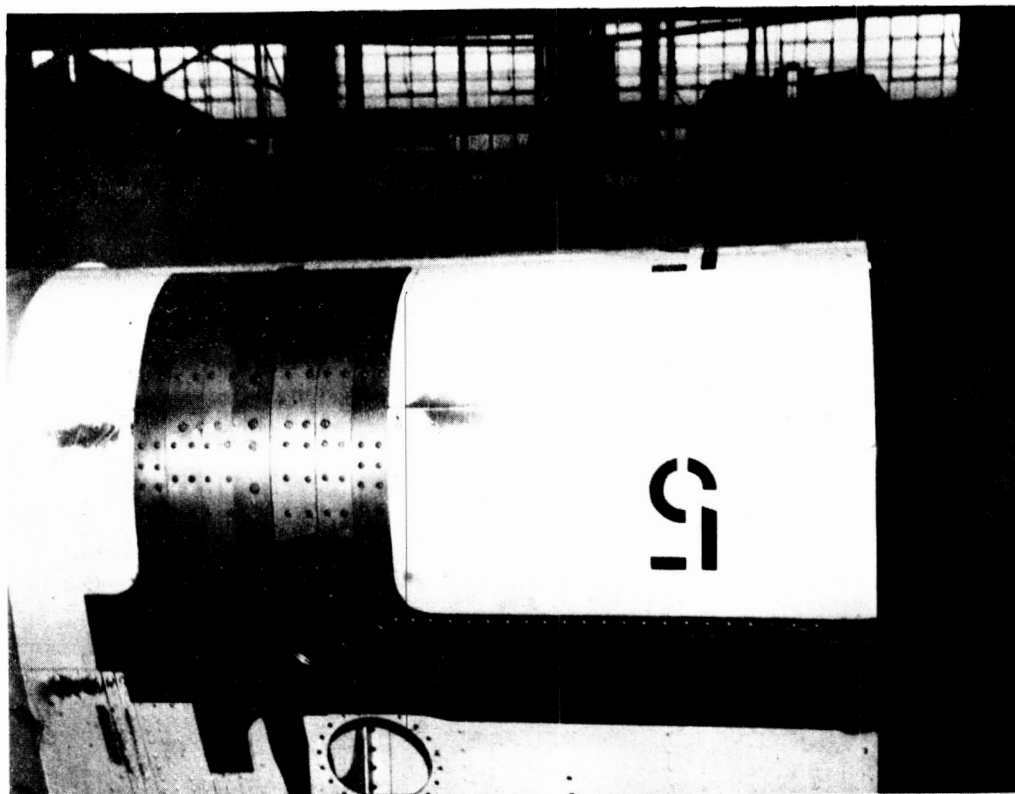
Figure 6. - Final installation of doublers on the low pressure side of blade SN-1005.

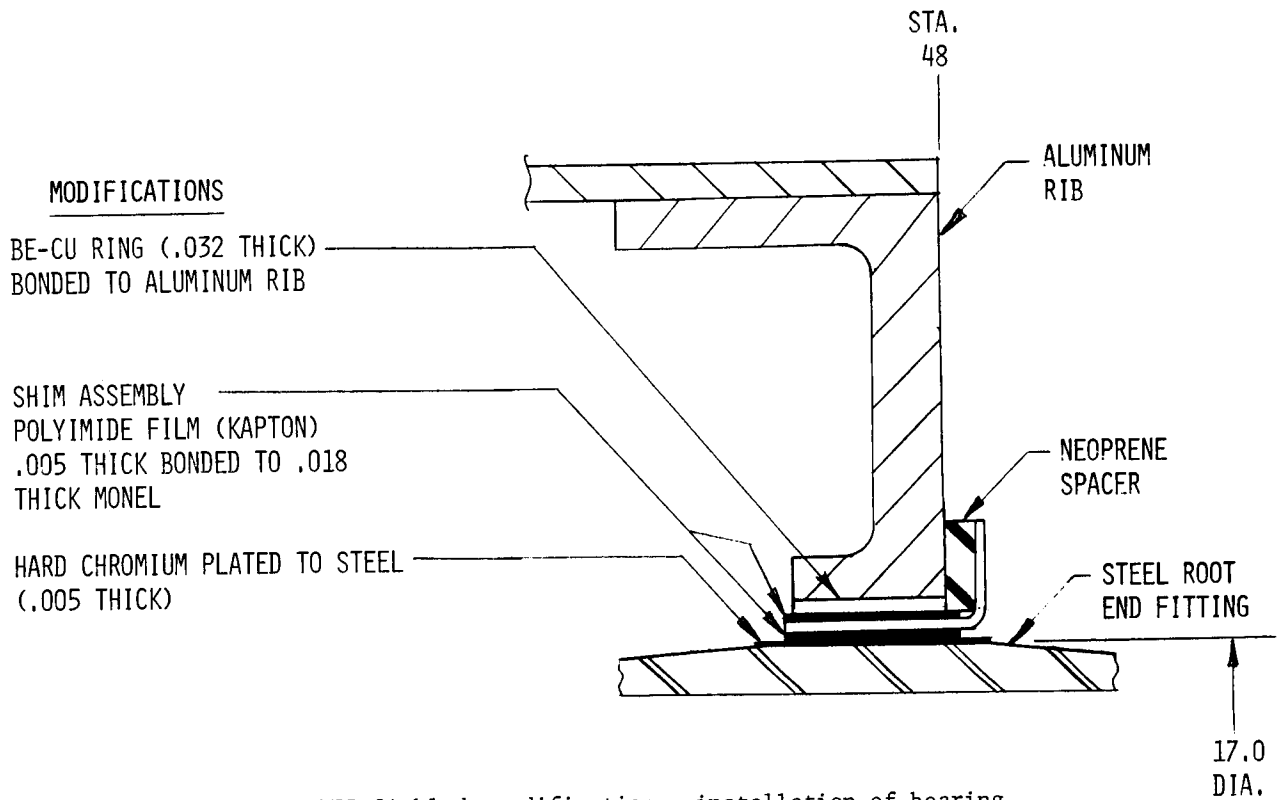
Figure 7. - MOD-0A blade modification - installation of bearing.

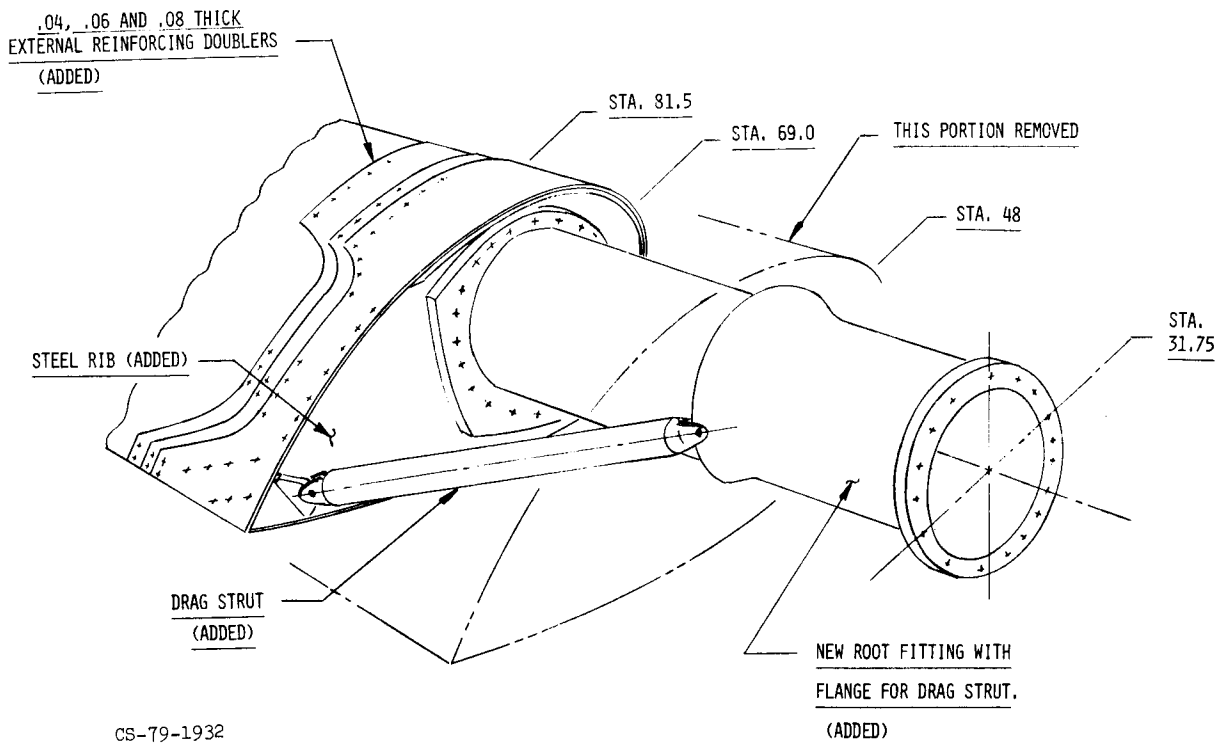
Figure 8. - MOD-0A blade. Alternate modification.

Figure 8 shows an alternate method for securing the steel root end fitting to the blade. This modification is currently being made to the MOD-0 aluminum wind turbine blades. This design eliminates the need for a bearing at station 48. A new steel rib, installed at station 69, carries load from the new root end fitting directly into the D-spar. The new rib at station 69 eliminates the need for the rib at station 81.5. As a result, no structural modification to the heavily damaged rib at station 81.5 was needed. When the blades are complete, they will be installed and operated on a MOD-OA wind turbine. Operational experience with the newly modified blades will allow NASA to assess the structural integrity of the new design.
