FAILURE ANALYSIS OF NICKEL-HYDROGEN CELL SUBJECTED TO SIMULATED LOW EARTH ORBIT CYCLING

Vernon C. Mueller
McDonnell Douglas Astronautics Company - St. Louis Division

ABSTRACT

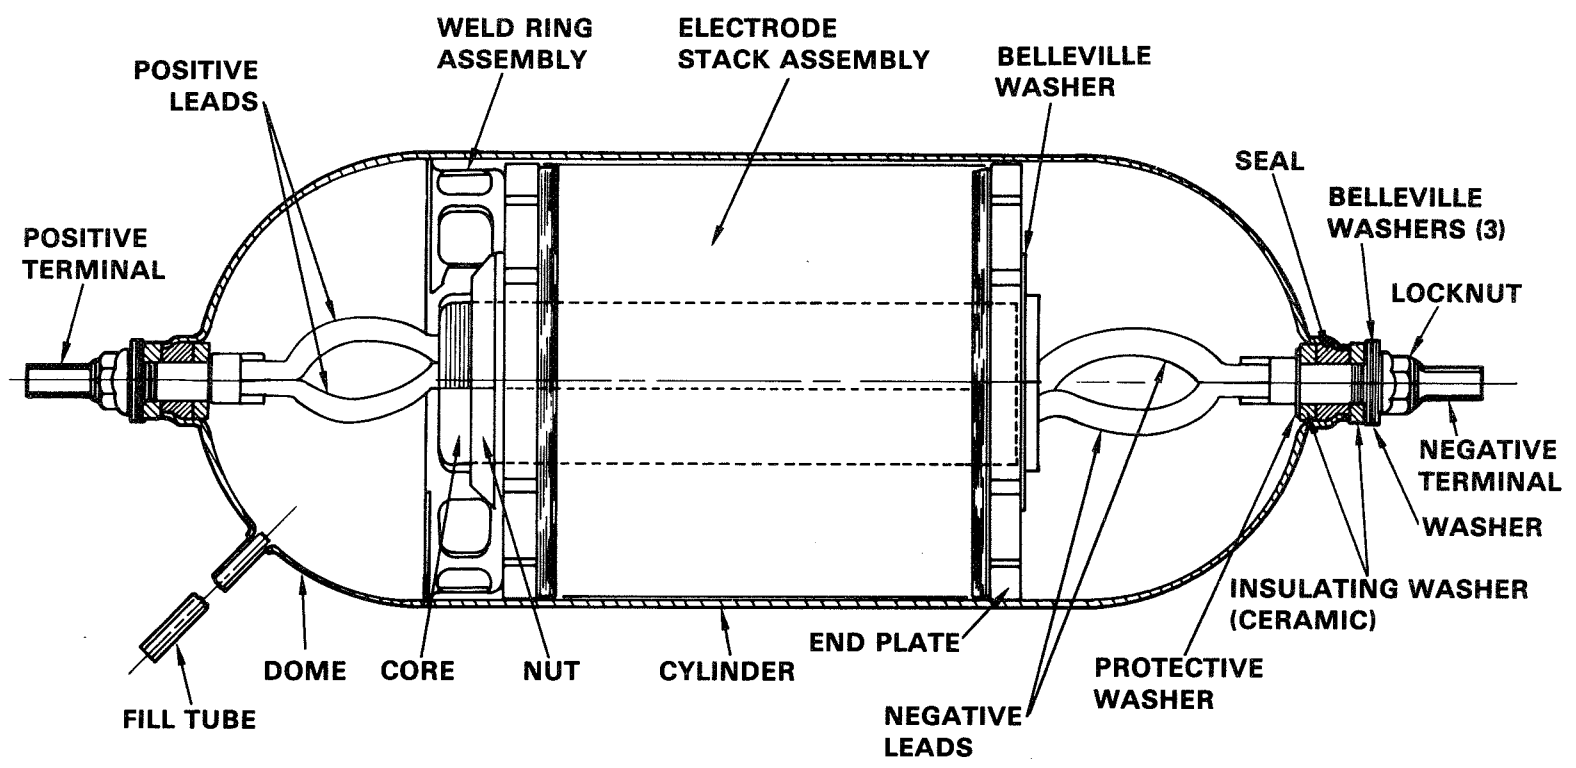
Figure 1. 50 ampere-hour nickel-hydrogen cell.

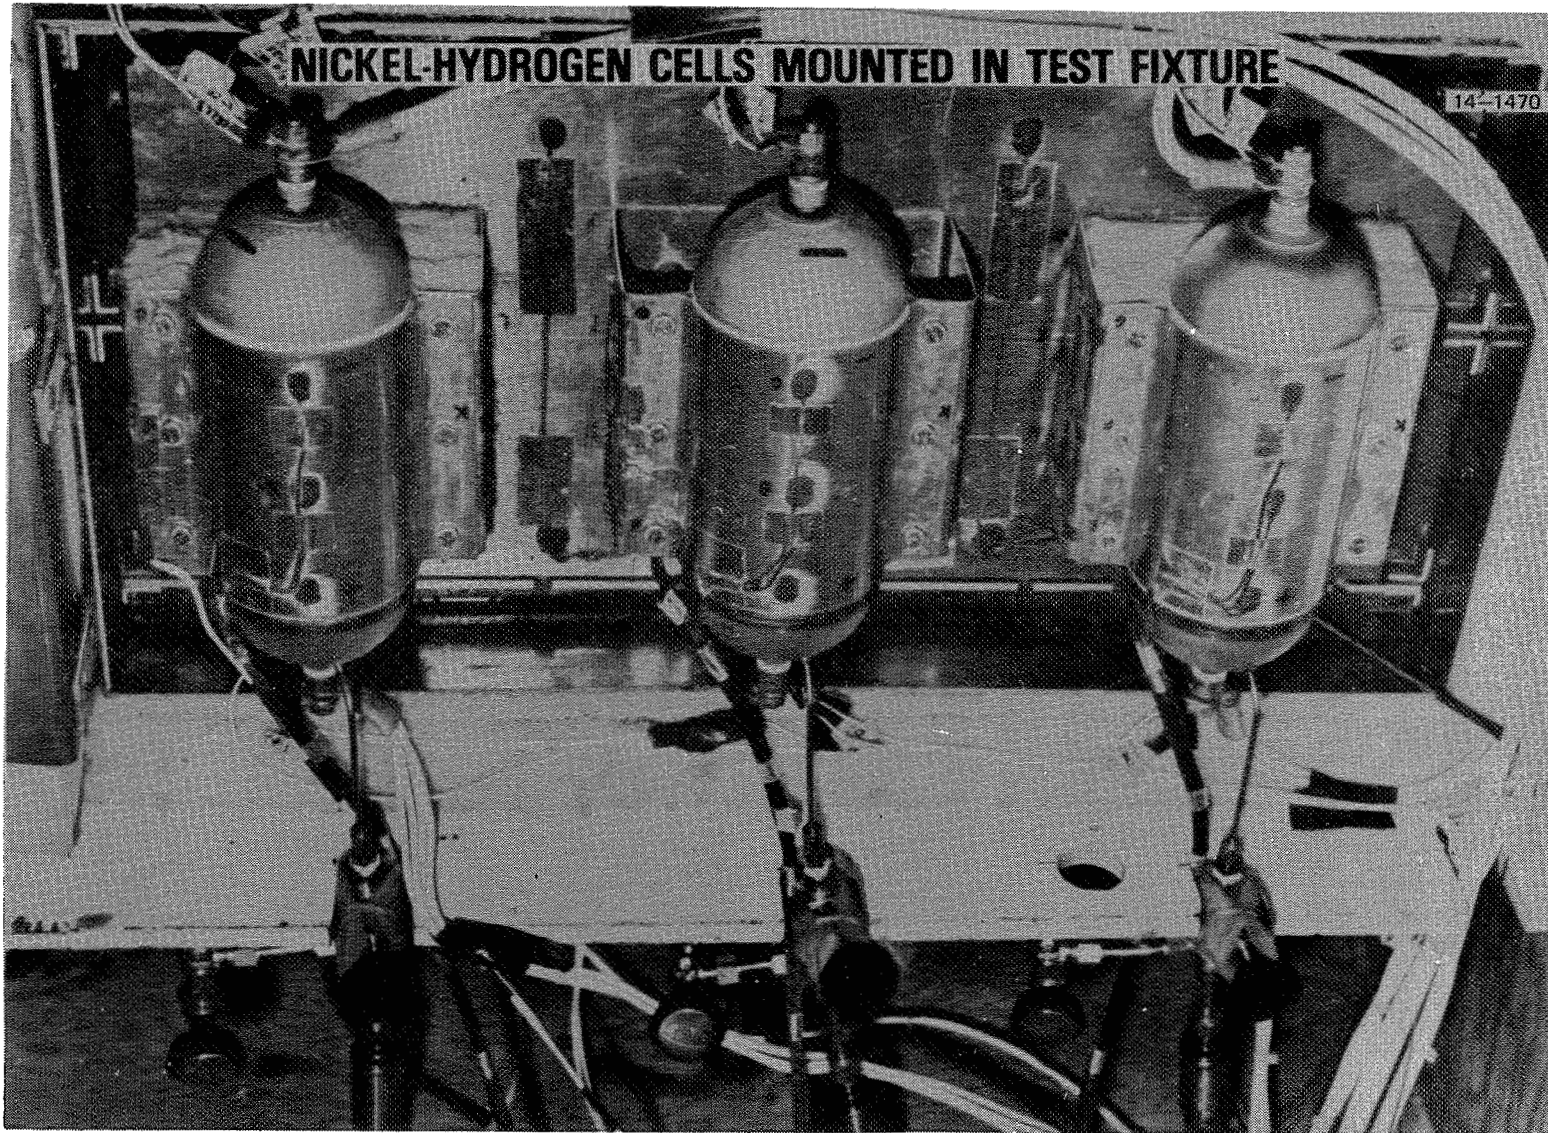
Figure 2. Nickel-hydrogen cells mounted in test figure.

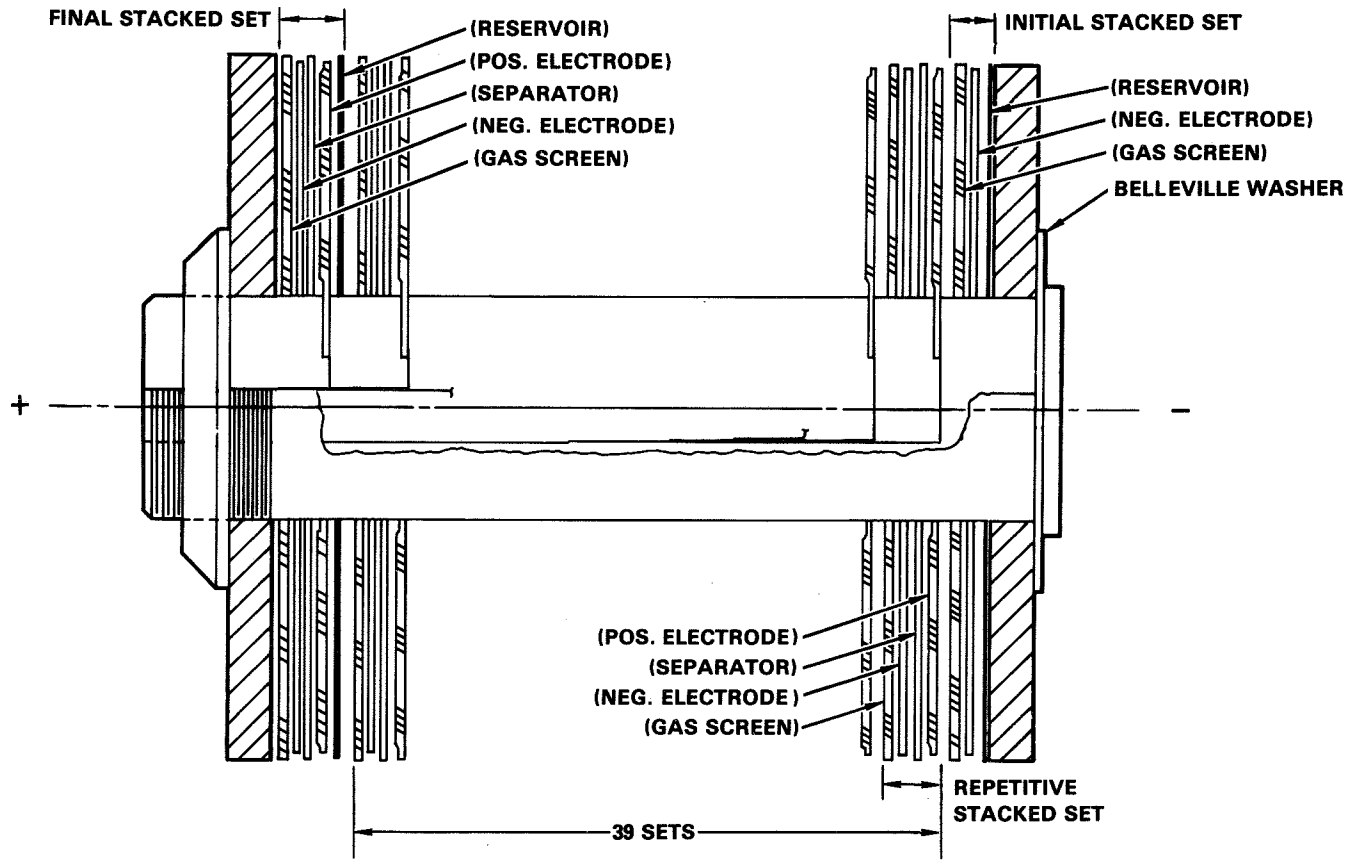
Referring to Figure 3, for purposes of identification the electrodes are numbered consecutively from the positive end (weld ring end). Therefore, negative plate number 41 is the first electrode encountered when disassembly proceeds from the fractured end of the polysulfone core. It was discovered during disassembly that this particular cell had been constructed with an additional reservoir between each set of plates rather than one at each end of the stack as shown in the artist's sketch of Figure 3. Mr. Don Warnock of AFWAL confirmed that some early cells had been constructed in this manner. The sequence of stack components was positive electrode, separator, negative electrode, gas screen, and reservoir. This sequence was repeated throughout the electrode stack. Another observation of general interest was that many of the positive plates had irregularly shaped depressed areas randomly dispersed over the surface. There appeared to be two distinct levels of material similar to looking over a broad plain with mesas protruding from it. Finally, the positive electrodes had grown in thickness considerably due to extended cycling.

Figure 3. Electrode stack sketch.

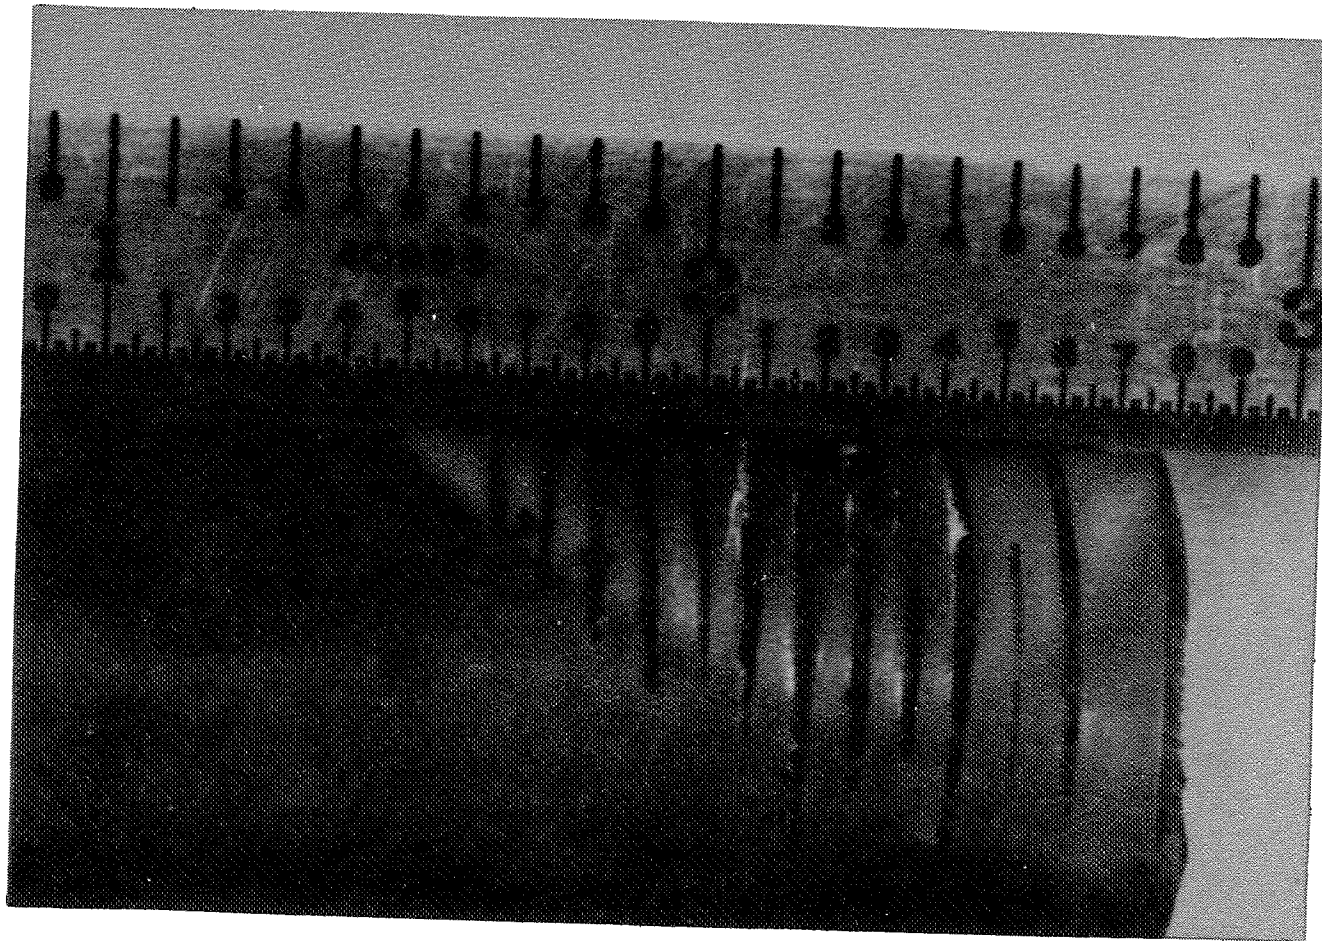
The heat pulse generated when the shorting occurred appeared to discolor and swell the polysulfone core, such that a ribbed appearance was created and a black deposit was left where the positive plates restricted this swelling. Figure 8 is a photograph illustrating this phenomenon at the fractured end of the core (negative end of electrode stack). The dimension from the end of the core to the first indentation caused by a positive plate is less than the combined thickness of the end plate and Belleville washer, which implies that the end of the core fractured prior to the occurrence of the short.

Figure 8. Fractured end of polysulfone core.
