EFFECTS OF SURFACE CHEMISTRY ON HOT CORROSION LIFE*

R. E. Fryxell

General Electric Company

* Contract NAS3-23926

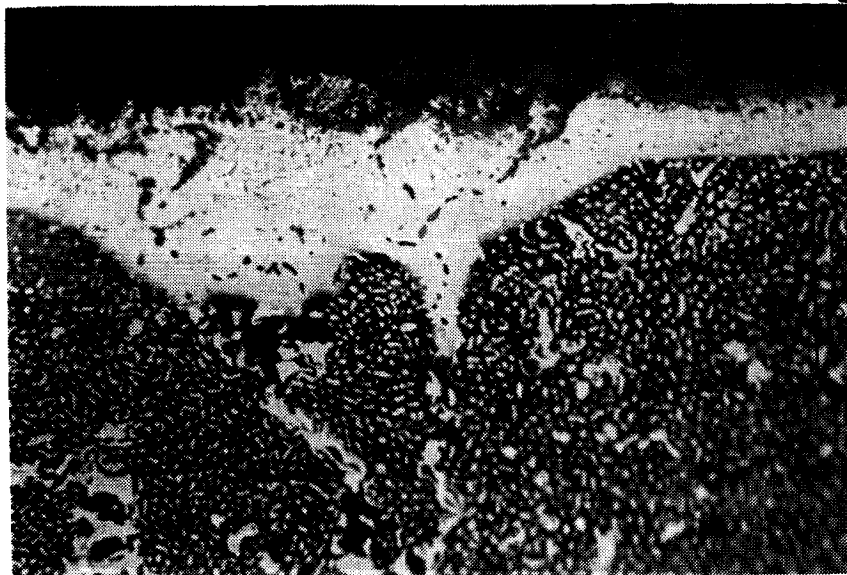
Typical sulfidation was noted at some locations in all of these blades, including development of a depletion layer (loss of aluminum) in the coating or substrate alloy. Typical microstructures are shown in Figures 1 and 2. However, sulfides were found in the most distressed areas in only two of these blades. In the other two blades, although sulfides were found, the most severely distressed regions did not contain any detectable sulfides.

Figure 1. Photomicrograph on the concave airfoil of a Stage 1 high pressure turbine blade from a Northern Africa CF6-50 engine. Sulfides are present in the Rene' 80 depletion zone. Etched, 500X.

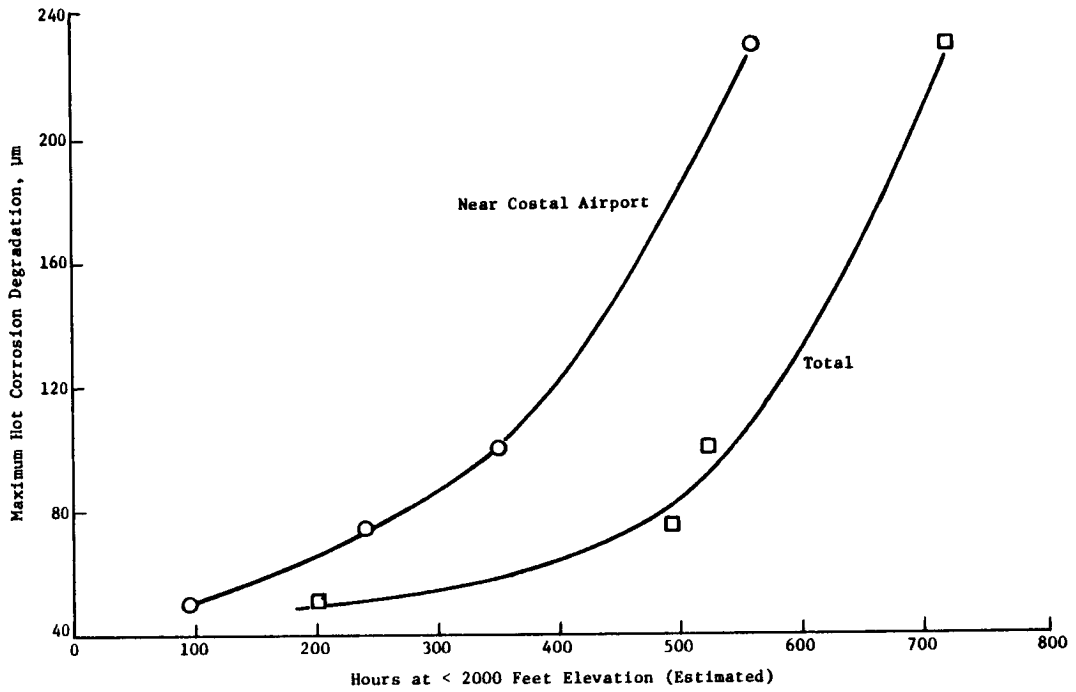
Alternatively, the trends shown in Figure 3 may reflect total times at takeoff/thrust reverse (higher) temperatures, a parameter which is clearly related to total hours at low altitudes. This is shown in rate units (Figure 4). The highest rates correspond to the shortest lengths of mission for which the percentage of time at higher temperatures (or lower altitude) is greater.

Figure 3. Hot Corrosion Degradation for CF6-50 Stage 1 High Pressure Turbine Blades as Function of Time at Less Than 2000 Feet Elevation.

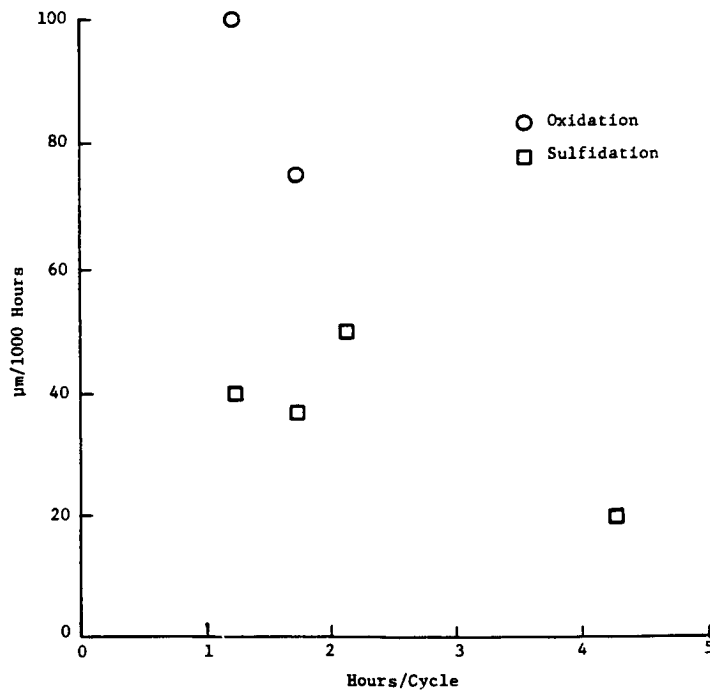
The trend shown in Figure 4 has, however, long been recognized in a qualitative sense and hopefully continued quantitative evaluations coupled with compilations of operating histories will lead to a reliable choice between various possible correlations such as those depicted in Figures 3 and 4.

Figure 4. Maximum Degradation Rates for CF6-50 Stage 1 High Pressure Turbine Blades as Function of Average Mission Duration.

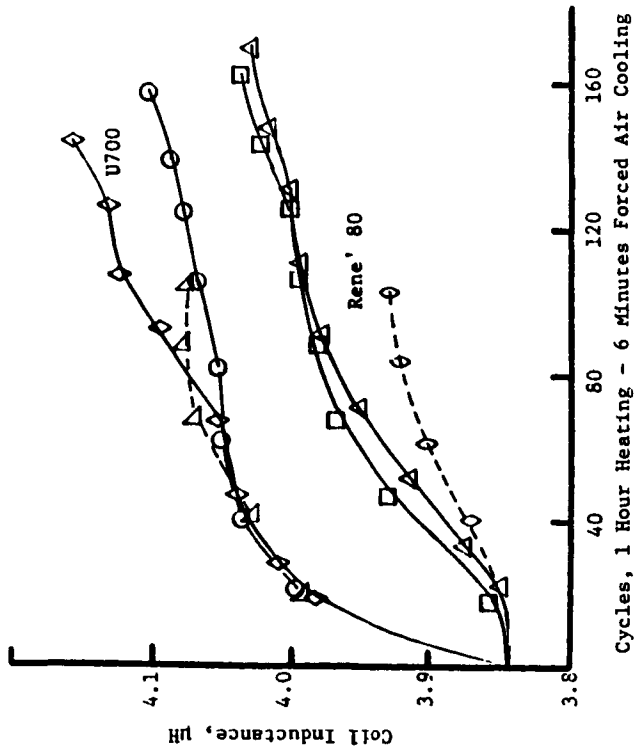
The Task II burner rig test has been completed. Coil inductance measurements are shown in Figure 8 for six uncoated specimens. The four long term specimens were removed at the third inspection interval at which hot corrosion was visually observed. Although Rene' 80 and U700 survived about the same

Figure 8. Uncoated Alloy Coil Inductance Changes with Hot Corrosion at 900° C, Cyclic Exposure.

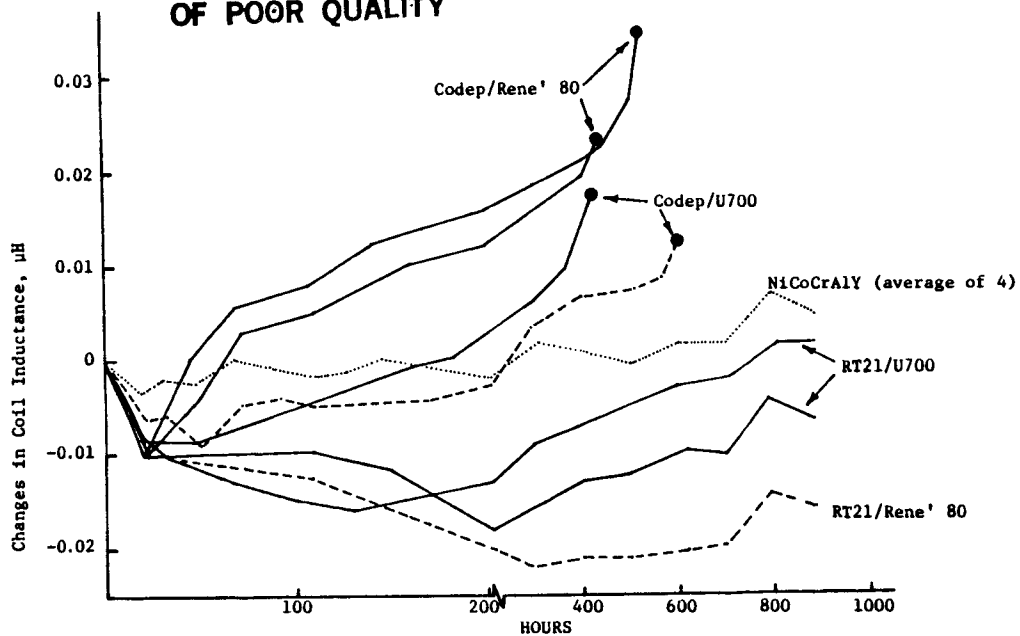
Coil inductance measurements for coated specimens are shown in Figure 10 with an expanded scale below 200 hours to show clearly the negative changes which appeared at the first inspection, particularly for the aluminide coated specimens. The overall changes are in all cases much smaller than for the uncoated alloys (Figure 8) reflecting the corrosion protection offered by all of the coatings. The four Codep coated specimens are shown in Figure 10 to their time of removal and the greater coil inductance changes suggest a greater corrosion rate; for all of these, coating penetration was confirmed metallographically. The three RT21 coated specimens shown in Figure 10 ran the full term 1000 hours with only minor visual evidence of hot corrosion. However, metallographic evaluation showed essential coating penetration in all three, although clearly less extensive than for the Codep coated specimens. One specimen of RT21 coated Rene' 80 (not shown in Figure 10) was removed at 697 hours and did exhibit coating penetration with additional corrosion of the substrate to about 100 μm depth. All of the NiCoCrAlY coated specimens showed extensive alloy depletion within the coating, occasional pits, but no complete penetration was observed. Typical microstructures are shown in Figure 11.

Figure 10. Changes in Coil Inductance with Hot Corrosion at 900C, Cyclic Exposure.

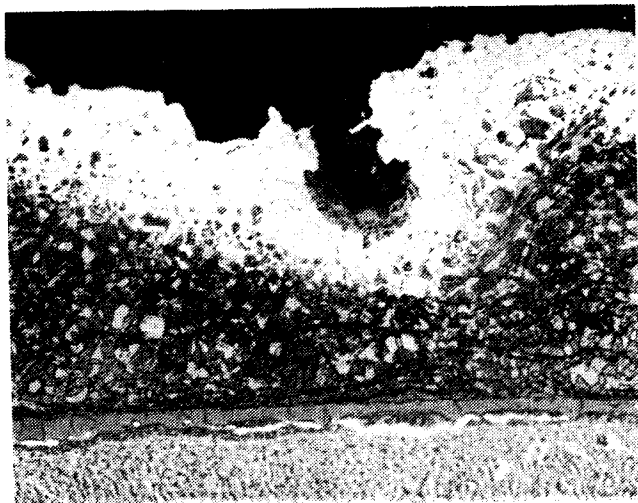
Figure 11. Photomicrographs of specimens from burner rig hot corrosion test. Type 1 sulfides are present. Etched.

- (a) NiCoCrAlY coated U700, 1004.6 hours (500X)
- (b) RT21 coated Rene' 80, 697.1 hours (200X)
