99th Congress, 2d Session ----- House Report 99-1016

**INVESTIGATION OF THE CHALLENGER
ACCIDENT**

**COMMITTEE ON
SCIENCE AND TECHNOLOGY
HOUSE OF REPRESENTATIVES**

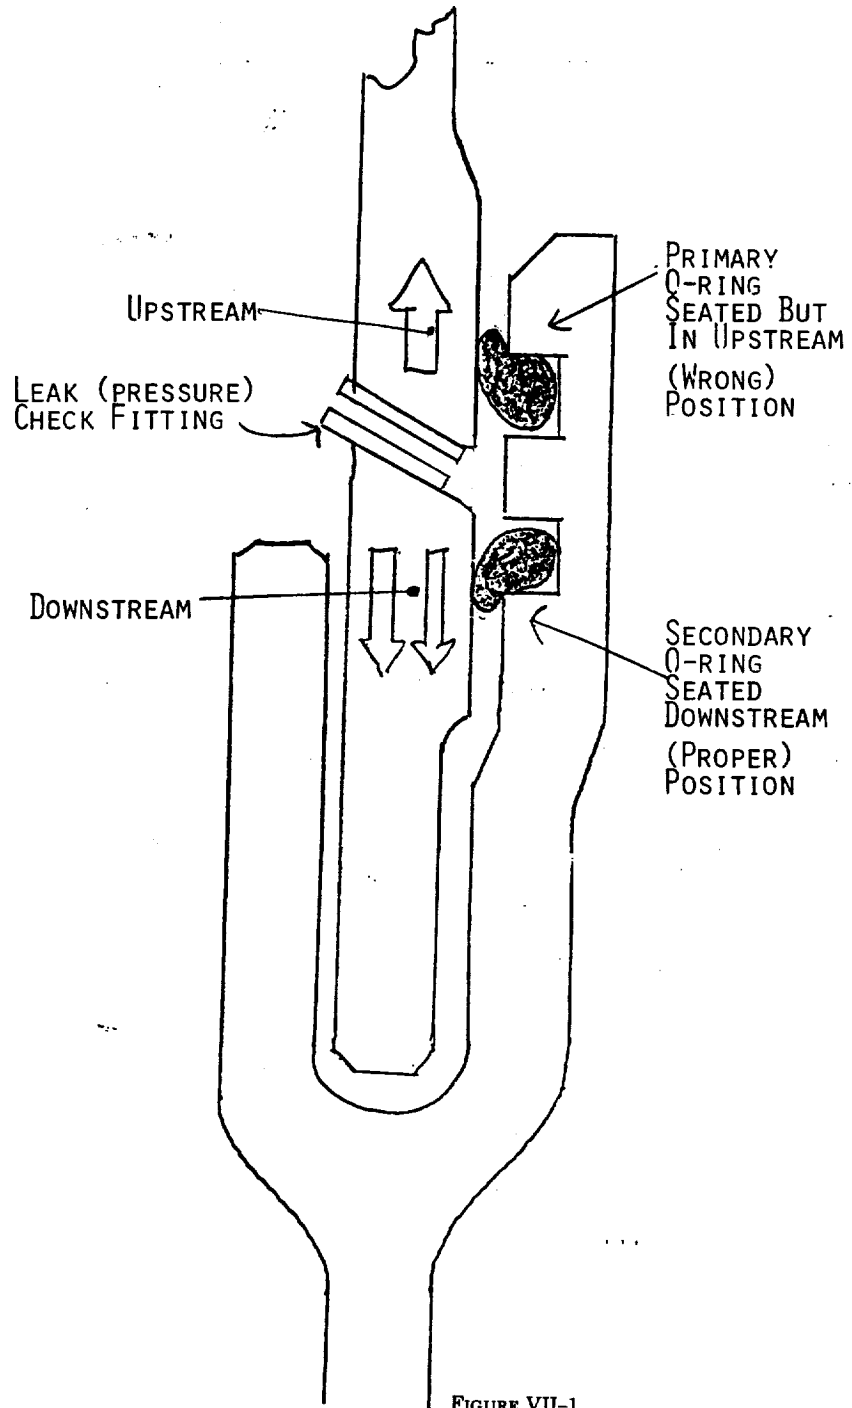
FIGURE VII-1

1. Both the primary O-ring and the secondary O-ring were seated when the steel casings were mated. The pressure check verified this fact. However, from experience, the primary O-ring was seated in the upstream position as had been previously recognized by NASA and Thiokol engineers. (See Figure VII-1.)

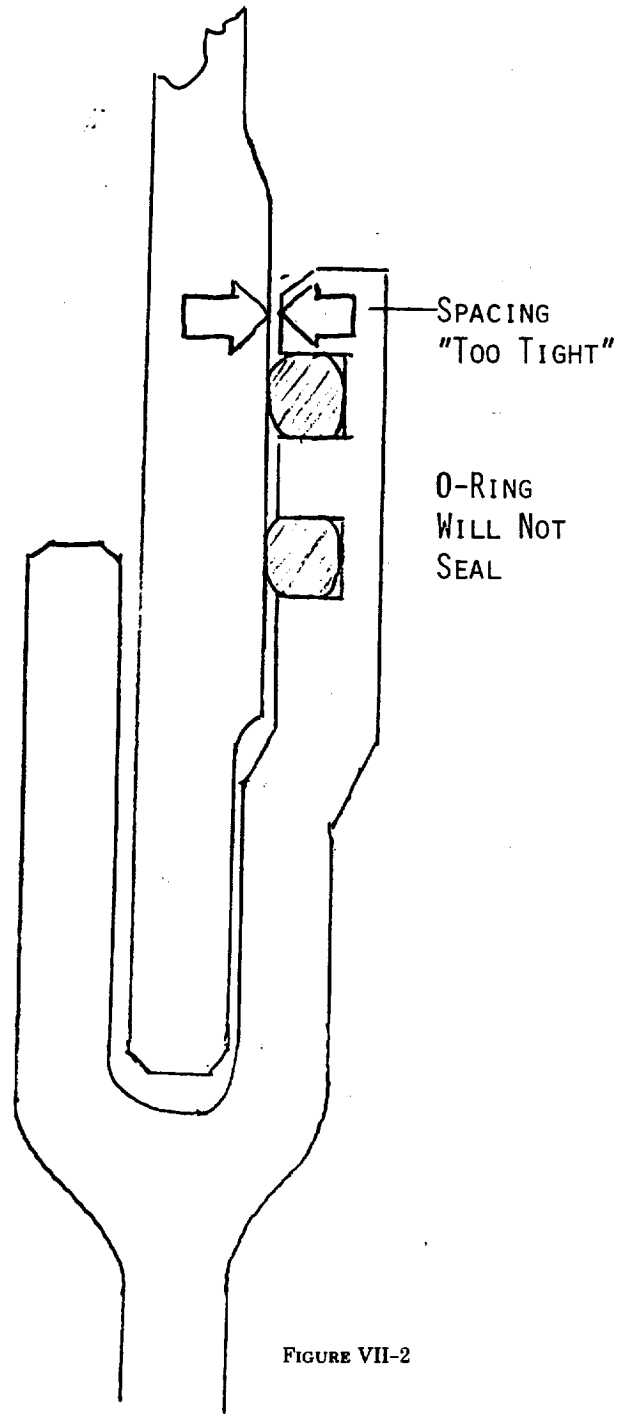
2. Upon ignition, the primary O-ring could not reseal at the 300 degree location in the downstream position, where it needed to be in time to prevent blowby. At this point there were too many deficiencies acting in unison which prevented the O-ring from reseating in that location. First, proper spacing between the inner face of the tang and the opposing face of the inner leg of the clevis approximately 0.020 inches, is critical. That spacing for Flight 51-L was too small, at the 300 degree location where the smoke was observed, to facilitate prompt reseating of the primary O-ring. Calculations of segment diameters indicate the gap spacing was only 0.004 inches, near metal-to-metal contact. The ignition gases passed the O-ring at this location (See Figure VII-2). This condition did not exist elsewhere in the joint around the casings since the primary O-ring was able to seat around the joint in other locations.

Second, the low temperature throughout the night prior to launch left the fluorocarbon elastomer primary O-ring stiff and lacking in ability to spring into the downstream (seated) position at the 300 degree location in time, relative to the buildup of motor pressure, to provide a tight seal. The temperature of the aft field joint at time of launch was calculated by Thiokol after the accident to be 16 degree F. Part of the reason for this low temperature was the heat transfer away from the joint, by conduction through the aft attachment strut. The conduction was driven by liquid hydrogen, which remained in the external tank overnight. The supercold fuel created a 430 degree temperature differential across the ship, drawing heat out of the joint and O-rings.

At ignition, blowby occurred, either with erosion of the primary O-ring or without erosion.
