# DETECTION, LOCATION, AND CLASSIFICATION OF SPACE SHUTTLE MAIN ENGINE NOZZLE LEAKS BY TRANSIENT THERMOGRAPHIC INSPECTION

Samuel S. Russell  
Nondestructive Evaluation Team  
NASA Marshall Space Flight Center  
256-544-4411  
[sam.russell@msfc.nasa.gov](mailto:sam.russell@msfc.nasa.gov)

James L. Walker  
Center for Automation and Robotics  
University of Alabama in Huntsville  
256-890-6578 ext. 207  
[walkerj@email.uah.edu](mailto:walkerj@email.uah.edu)

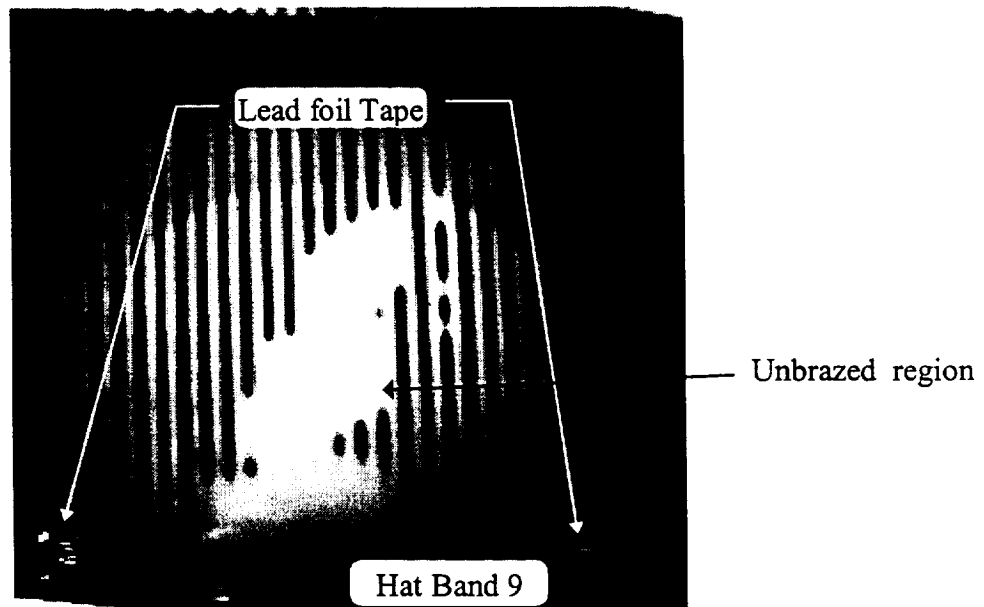
and appear dark in these images. Areas containing discontinuities (such as the programmed defect or the interstitial gaps between the cooling tubes and jacket) did not conduct the heat away from the jacket as well, and appear bright in these images. Figure 3 shows a region of large unbrazed between the tubes and the structural jacket due to a manufacturing defect in a nozzle. However, large regions of the nozzle can not be inspected using Flash Thermography due to the interference of structural stiffeners, insulation, or piping. But, mapping of braze integrity in the open bays is possible.

Figure 3. Flash Thermography of unbraided area.

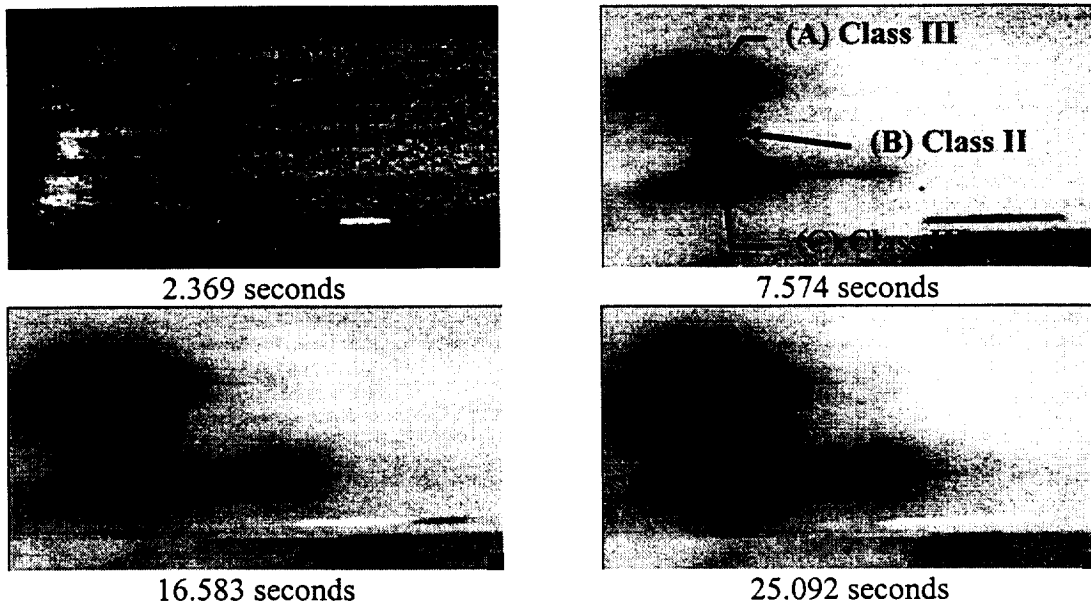
Figure 5 shows the resulting Thermograms over 4 time intervals obtained by rapidly pressurizing the nozzle segment to 40psig (less than 2 seconds to reach maximum pressure) with Nitrogen gas. These Thermograms were made by subtracting an image prior to pressurization from the later images. Hence, the temperature change is accented. Also included (Figure 6) is the Time-Temperature plot for four points on the image which provide an indication of the degree to which the defects can be detected. By re-running the test at several pressure levels, it was determined that the temperature change observed at a leak source increased approximately linearly with increasing pressure. Also, it was determined experimentally that Nitrogen and Argon gas produced larger thermal indications as compared to the Helium gas used for the liquid leak check investigations.

Figure 5. Thermograms of Region 1 of panel shown in Fig. 4.

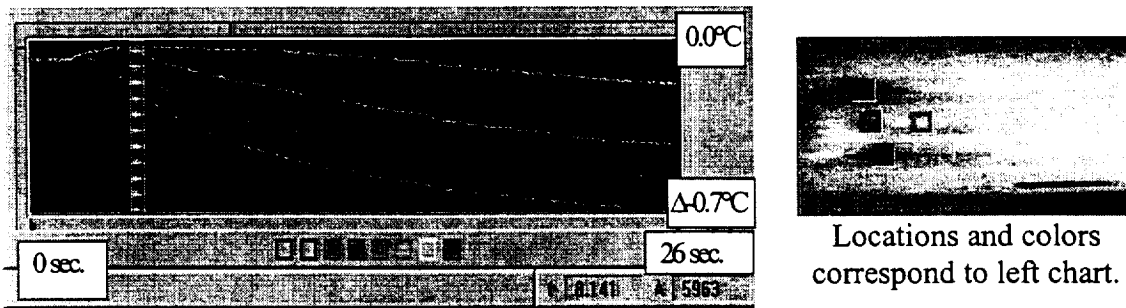
Figure 6. Time vs. Temperature for Class II and Class III leaks in test panel.

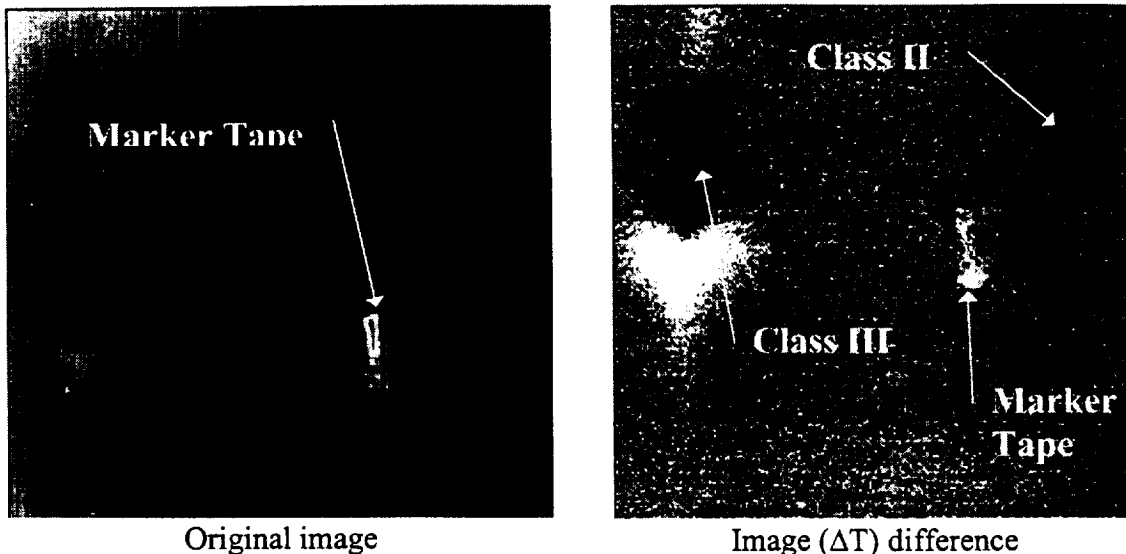
A second panel cut from the upper end of a nozzle was prepared with artificial weld defects that were classified as Class II and Class III as shown in Figure 7. The cooling tubes grow continuously from the top to the bottom of the nozzle creating a somewhat different problem at the top because of the much smaller tubes and interstitials. The Thermograms generated by rapidly (< 2 seconds) pressurizing the segment with 40 psig Nitrogen are shown in Figure 8. The difference between a Class II leak on the right and a Class III on the left is very apparent.

Figure 8. Thermogram of leaks in panel cut from upper portion of nozzle.

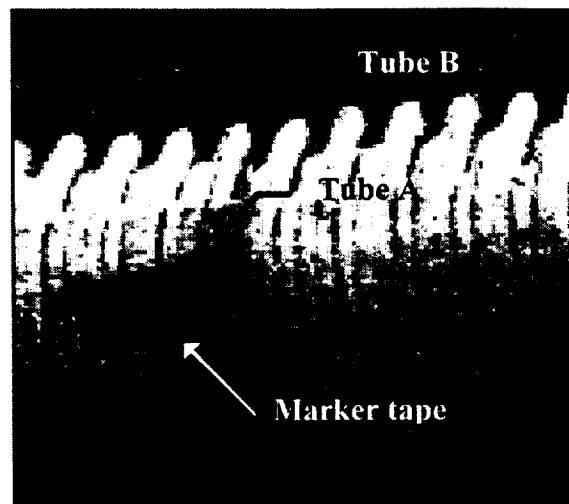
Figure 10. Thermogram of upper edge of nozzle showing leaking tubes.
