HUBBLE SPACE TELESCOPE METALLIZED TEFLON® FEP THERMAL CONTROL MATERIALS: ON-ORBIT DEGRADATION AND POST-RETRIEVAL ANALYSIS

J.A. Townsend¹, P.A. Hansen¹, J.A. Dever², K.K. de Groh²,
B. Banks², L. Wang³ and C. He³

1. NASA Goddard Space Flight Center, Greenbelt, Maryland, 20771 USA
2. NASA Lewis Research Center, Cleveland, Ohio 44135 USA
3. Unysis Corporation, Lanham, Maryland 20705 USA

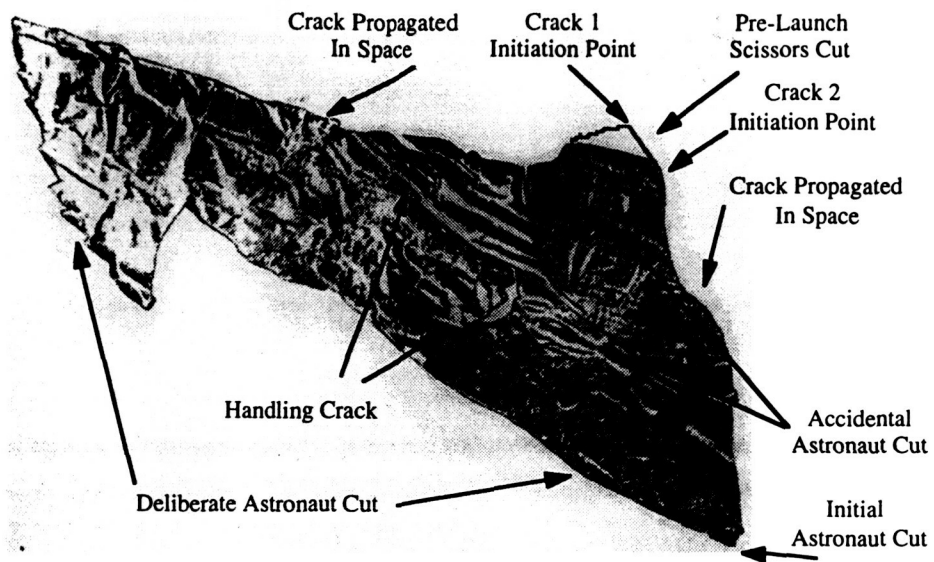
FIGURE 4: SM2 LS SPECIMEN POST-RETRIEVAL

The first task was to document the SM2 LS specimen and assemble the four pieces received into the single specimen that was cut in orbit. Both SEM and optical microscopy were used in this effort. Once the original configuration had been determined, the edges were identified as either a deliberate cut, a handling artifact, or an on-orbit fracture (Figure 4). From this information, the fracture initiation site became apparent.

The image above was taken during post-retrieval analysis, when the SM2 LS specimen was uncurled and placed between glass plates. The edges of the specimen are identified as scissors cut, handling crack, or orbit crack. The top-right corner of the specimen contains the crack initiation sites.

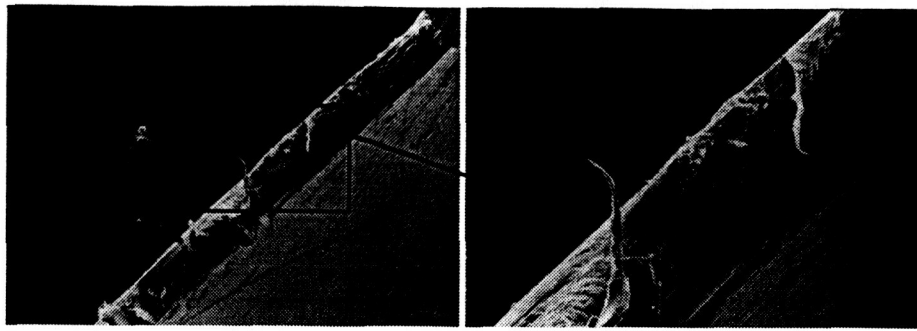
Figure 8: SM2 LS Specimen Scissors Cut Features 300X

SEM images of the initiation region showed clear differences between the scissors cuts that occurred prior to launch and on orbit, the cracks that propagated while in orbit, and the cracks from subsequent handling. The fracture surface of the scissors cut surfaces showed shear and tear features (Figure 8). The orbital fracture surfaces were extremely smooth (Figure 9). Attempts to duplicate this smooth fracture with the SM2 specimen under bending or tensile stress resulted in fractures with more fibrous features (Figure 10). These fibrous cracks were found on the specimen as well, and were identified as handling cracks.

Edge-on view of shear fracture near the crack initiation point. This region of the blanket was cut during installation in order to fit around a handrail. This fracture surface has common shear and tear features, indicating the material was cut. Astronaut cuts that occurred on-orbit during specimen retrieval had a similar appearance.

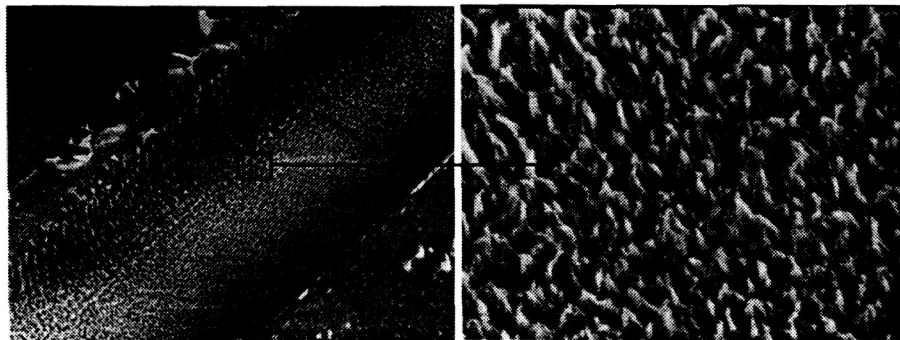
Figure 10: SM2 LS Specimen Handling Features 5000X

Edge-on view of a crack that occurred due to specimen handling. The fibrous features of this crack surface showed ductile peaks that formed as the two surfaces of the crack pulled away from one another. Cracks that occurred from tensile and bend testing had a similar appearance.
