THE GROWTH OF MULTI-SITE FATIGUE DAMAGE IN FUSELAGE LAP JOINTS

Robert S. Piascik
NASA Langley Research Center
Hampton, VA, 23681 USA.
Tel: (757) 864-3483
Fax: (757) 864-8911
E-Mail: r.s.piascik@larc.nasa.gov

Scott. A. Willard
Lockheed Engineering and Sciences Co.
Hampton, VA, 23681 USA.

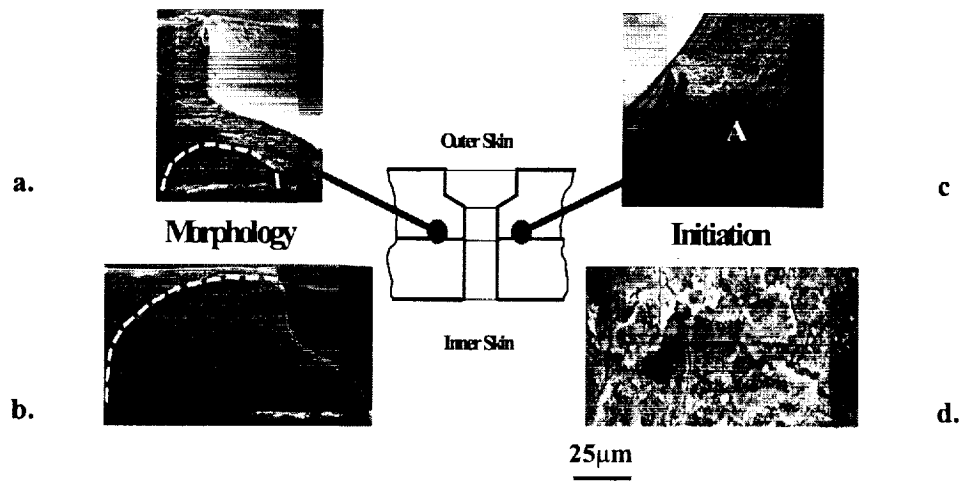
shown in Figure 2. Here, clad layer fretting along the faying surface was caused by repeated relative movement of the inner and outer skin in a highly localized contact area around the rivet hole. A black aluminum oxide on the faying surface marked the fretted region that containing debris and microcracks shown in Figures 2c and 2d. From this highly localized damaged region, fatigue cracks grew initially in a near semicircular manner (Figure 2a). As fatigue crack length increased, the crack front became elliptical in shape (Figure 2b). Many outer skin fatigue cracks propagated to a length of nearly two skin thicknesses prior to breaking through the outboard surface of the outer skin. A likely cause for subsurface cracking is lap joint bending loads and/or compressive residual stress produced from rivet head expansion into the counter bore region of the rivet hole. Figure 3 shows a typical region of crack initiation for the straight shank rivet. Figure 3a shows the fretting damage area (region A in Figure 3c) along the inboard surface of the straight shank hole. Figure 3c shows the fatigue crack and rivet hole region at an oblique angle. The micrograph shown in Figure 3b reveals an abraded surface containing microcracks similar to that observed in Figure 2d. Examination of the rivet shank mating surface (directly opposite of the abraded hole surface) revealed a black aluminum oxide region characteristic of fretting. The elliptical crack front shape shown in Figure 3d suggests the presence of lap joint bending loads (similar to that observed for the counter bore rivet (Figure 2)). The three examples shown in Figure 4a are typical examples of cracking observed in the 100°-countersink lap joint. Inboard corner cracks and shank/countersink corner cracks are located in regions of high stress concentration. These regions also exhibited some evidence of rivet/hole contact suggesting that fretting may have contributed to crack initiation. The third small fatigue crack shown in Figure 4a is located along the rivet hole surface in the rivet shank region; here, fretting is a likely cause for crack initiation. The dashed lines in Figures 4a and 4b mark the crack fronts and show that the small cracks in Figure 4a are circular in shape and at longer crack lengths, shown in Figure 4b, the crack front is somewhat circular in shape.

Figure 2. Counterbore rivet outer skin cracking: a) and b) SEM micrographs showing the progression of fatigue cracks (dashed lines mark the crack front), c) micrograph shows the rivet hole at an oblique angle and the location of fretting damage (region A) along the faying surface (site of crack initiation), and d) high magnification micrograph showing fretting debris and microcracks in “ region A of Figure 2c”.

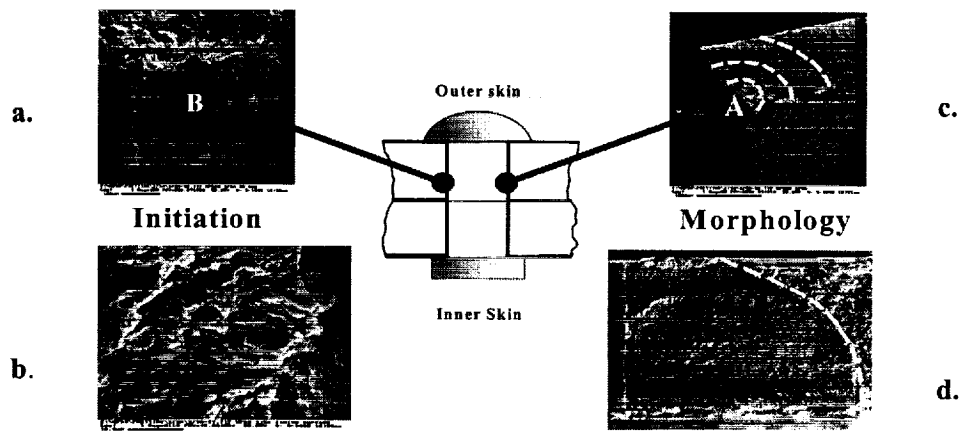
Figure 3. Straight shank rivet outer skin cracking: a) Micrograph of the crack initiation site (region A in “c”), b) high magnification micrograph of fretting surface at region B, c) the micrograph shows the region of crack initiation (region A) along the inside surface of the rivet hole near the inboard corner (dashed lines depict the progression of the fatigue crack), and d) micrograph showing a fatigue crack with multiple initiation sites (arrows) along the surface of the rivet hole (dashed line marks the crack front).

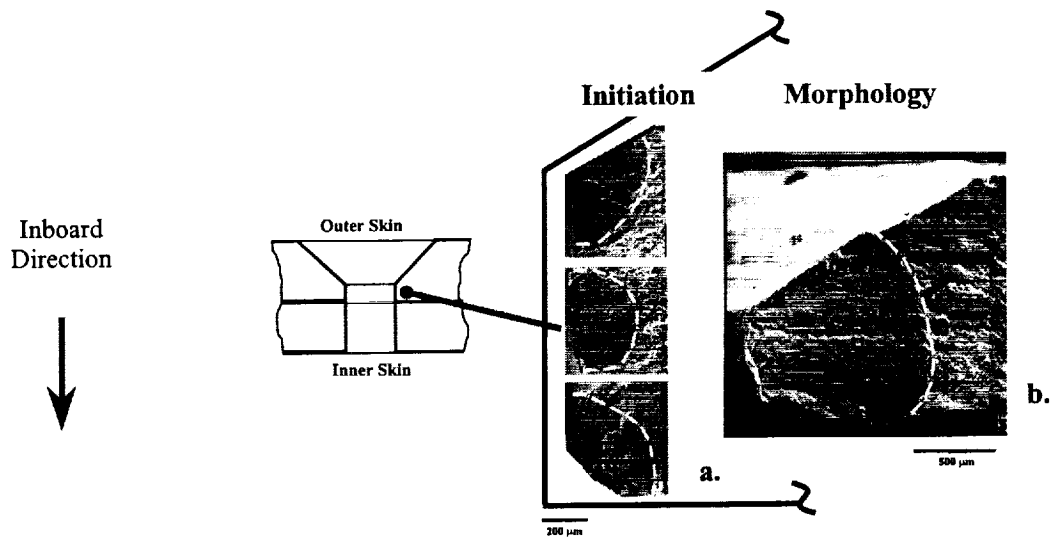
Figure 4. 100° countersink rivet outer skin fatigue cracking: a) Depicted is the outline of the rivet hole and the micrographs show the typical crack initiation sites along the rivet hole surface and crack morphology (dashed lines mark the crack front) and b) shows the typical crack front shape of a fatigue crack that has propagated nearly one-half the length of the counter sink.

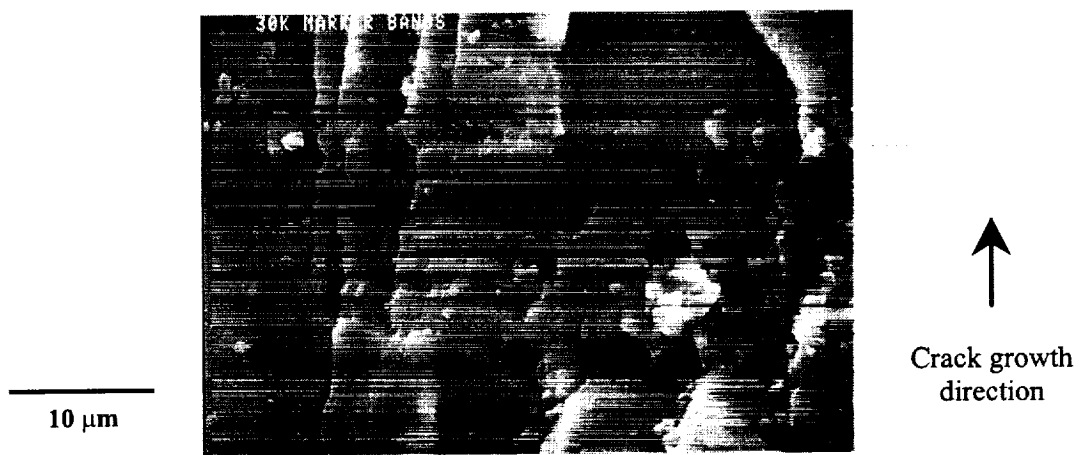
Figure 5 The micrograph shows a markerband from a fatigue crack surface in panel 1. This markerband locates the crack front at 30,000 pressure cycles.

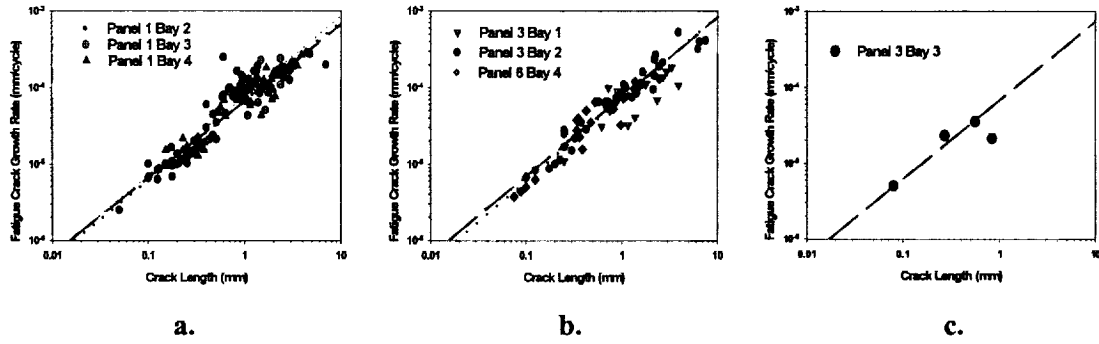
The data shown in Figures 6 and 7 show that upper rivet row fatigue cracks contained in panels 1, 3, and 6 exhibit identical crack growth characteristics. Figures 6a, 6b, and 6c are plots showing marker band based fatigue crack growth rate (da/dN) data for cracks propagating from counter bore rivet holes, straight shank rivet holes, and 100° counter sink rivet holes, respectively. A comparison of the linear regression analysis (dashed and dotted lines) in Figures 6a and 6b reveal that:

- all counter bore cracks in panel 1 (bays 2, 3, and 4) exhibit the same crack growth characteristics, and
- all straight shank cracks in Panel 3 (bays 1 and 2) and Panel 6 (bay 4) exhibit the same crack growth characteristics.

A minimal amount of data from 100° counter sink rivet holes is shown in Figure 6c for panel 3 (bay 3). The excellent agreement of 100° counter sink crack growth rate data with the linear regression

analysis from Figures 6a and 6b (dashed line in Figure 6c) suggests that all fatigue cracks contained in the three different rivet configurations exhibit similar crack growth rate characteristics. A summary of all marker band based da/dN data is presented in Figure 7. This plot reveals that fatigue crack growth in riveted lap joint fuselage structure is well behaved; here, no appreciable difference is observed for data obtained from three rivet configurations, seven lap joint bays, and three different fuselage locations. The quantitative data in Figure 7 strongly suggest that the fatigue crack growth behavior of lap joint cracks ranging in size from 50 μm to 10 mm is deterministic and predictable.

Figure 6. Plots of fatigue crack growth rate versus crack length for the a) counter bore rivet, b) straight shank rivet, and c) 100° counter sink rivet.

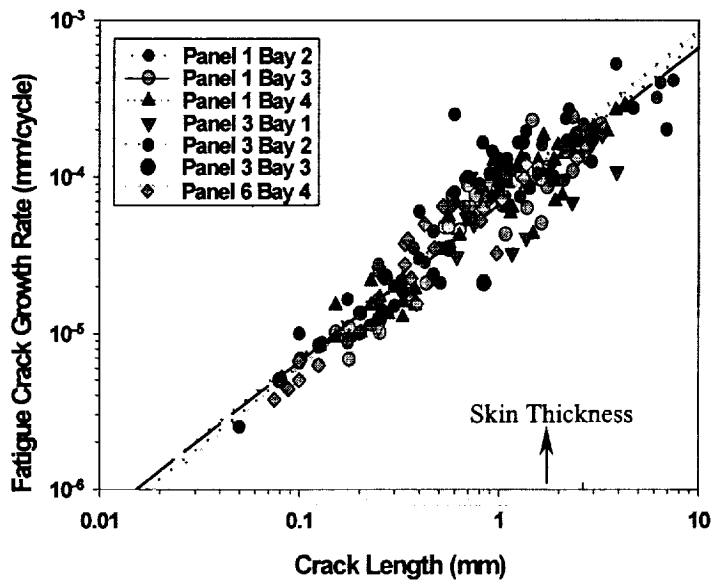
Figure 7. Summary of marker band based fatigue crack growth data from panels 1, 3, and 6.

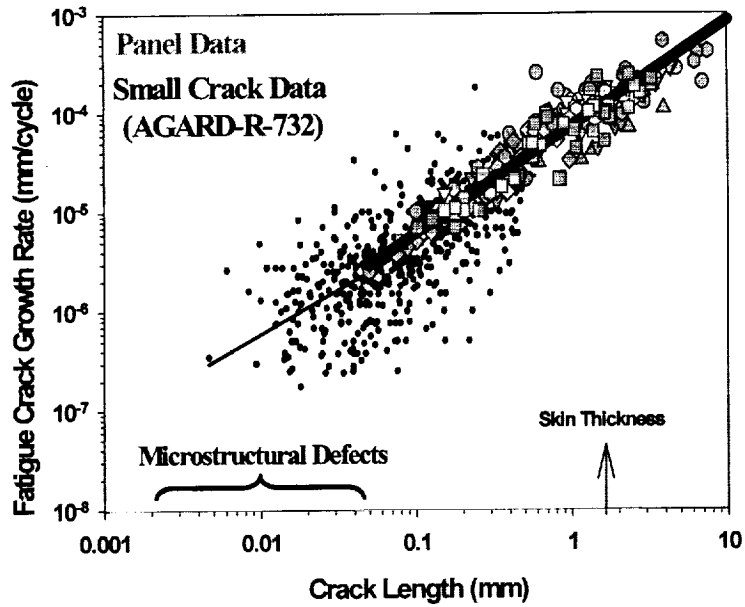
Quantifying the fatigue crack growth rates for cracks of length less than 100 μm is problematic. Within the microstructural small crack regime (crack lengths < 50 to 100 μm), marker band analysis becomes extremely difficult and little data was obtained from the riveted structure. To estimate the growth rate behavior of microstructural small fatigue cracks in the lap joint, laboratory test results were used. The local stress at the rivet hole was estimated using the same procedure used for previous predictions of fatigue crack growth in panel 1 (5). Here, a neat pin (rivet) was assumed and a local stress of 143 MPa was estimated from the following parameters: $S_{\text{remote}} = 90$ MPa (remote stress in based on test article operational pressure) (6), 29% of the load is carried by the upper rivet in a four rivet row lap joint, and bending is $S_{\text{bending}} = \gamma S_{\text{remote}}$ where $\gamma = 0.5$ (7,8). A large body of small crack growth data for aluminum alloy 2024-T3 was generated by a "round robin program" conducted by thirteen laboratories (9). Each laboratory used a single edge (blunt) notch specimen and a replica technique for monitoring the growth of surface and corner fatigue cracks propagating from the blunt notch tested at a local stress level of 145 MPa. Because the small crack growth data were generated at a local stress level similar to the estimated local stress in the lap joint rivet hole, a comparison of laboratory and lap joint fatigue crack growth characteristics can be made. The laboratory microstructural small crack data are compared to the marker band data from panels 1, 3, and 6 in Figure 8 with the general assumption that local stresses due to rivet expansion are second order (neat pin assumption). The results shown in Figure 8 reveal the typical large scatter in microstructural small crack growth data; here, wide variations in small crack growth data are a result of crack front / microstructure interactions (10). A comparison of the linear regression analysis for the lap splice panel data (thick line) with the laboratory small crack data (thin line) suggests a strong correlation between the two data sets. Assuming that rivet fit-up effects are second order, the combined data base shown in Figure 8 represents the fatigue crack growth characteristics for riveted lap joint fuselage structure for crack lengths ranging from the microstructural small regime to 10 mm.

Figure 8. Comparison of small crack growth laboratory data and lap joint marker band based crack growth data from panels 1, 3, and 6.

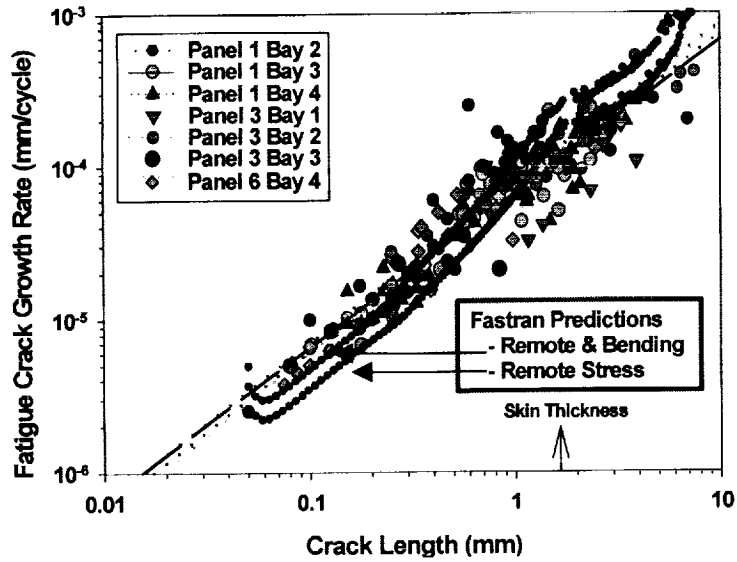
Fatigue crack growth predictions made by FASTRAN, a plasticity-induced crack closure based code, are in excellent agreement with lap joint marker band derived crack growth data. Compared in Figure 9 are the fatigue crack growth data and linear regression analysis results (dashed and dotted lines) from the destructive examinations conducted on panels 1, 3, and 6 and the results of two FASTRAN predictions (5). The combined remote and bending load prediction is in good agreement with the panel data for crack lengths of less than one skin thickness and nearly duplicate the linear regression results. The prediction, using only remote stress, under predicts crack growth rates in the short crack regime (<1 mm). The abrupt transition in the predicted results at crack lengths equal to the skin thickness is due to the change in the crack-tip stress intensity factor expression as the subsurface crack emerges through the outer skin thickness. The results shown in Figure 9 demonstrate that fracture mechanics based analytical methods accurately predict the fatigue crack growth rate behavior in lap joints from distinctly different fuselage locations and containing different rivet configurations (counter bore, straight shank, and 100° counter sink rivets).

Figure 9. Comparison of two FASTRAN Code predictions (remote plus bending stress and bending stress) and crack growth rate data obtained from real aircraft lap joint structure.

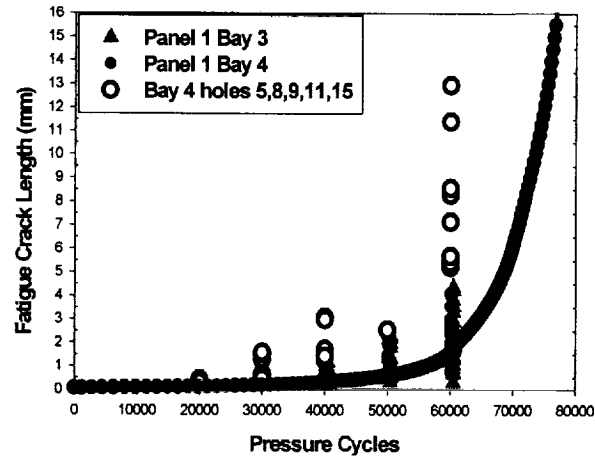
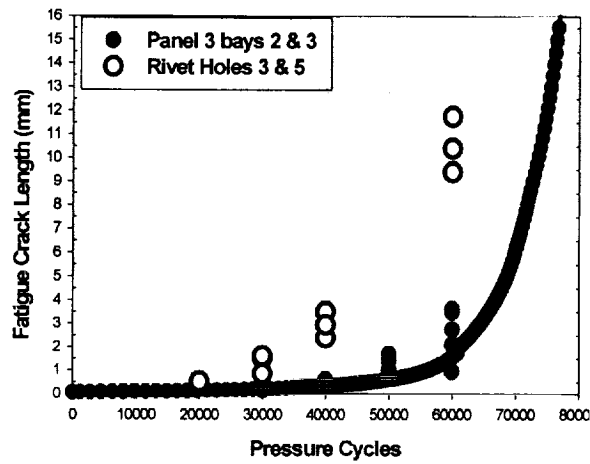
The FASTRAN prediction using remote and bending lap joint loads is compared to the marker band based crack length versus load cycle data in Figure 10. Two distinct populations are noted in Figure 10, the open circle data are those cracks that initiated first and grew to longer lengths and the solid data points are cracks that initiated later in life. The straight hole / neat pin prediction shown in Figure 10 assumes an EIFS of 50 μm . The EIFS was based on early destructive examination results suggesting that faying surface fretting in the clad layer (nominal thickness of 50 μm) initiated most upper rivet row lap splice fatigue cracks (2). These assumed parameters resulted in predictions that are in good agreement with most of the counter bore riveted lap joint data (solid data points) in Figure 10a and straight bore riveted lap joint data (solid data points) in Figure 10b. A twenty-percent error is observed between the predicted crack length and the measured crack length (open data points) at 60,000 pressure cycles. It is speculated that the life prediction did not approximate crack (a versus N) behavior (open data points) because fit up stresses may have been significant for those cracks that initiated earlier in life. As these first fatigue cracks grew, fit up forces at neighbor rivet locations decreased. More rigorous predictions are required; they should include, (1) accurate crack-tip stress intensity expressions for observed crack configurations, (2) accurate local stress concentration factor for the rivet hole configuration, (3) understanding of lap splice rivet hole local stress relaxation as a function of fatigue life, and (4) an appropriate EIFS for each fatigue crack initiation type.

Figure 10. Comparison of FASTRAN Code prediction and marker band based crack length versus load cycle data obtained from a) counterbore riveted and b) straight shank riveted structure.
