ON-ORBIT TEFLON® FEP DEGRADATION

Jacqueline A. Townsend, Patricia A. Hansen
NASA/GSFC
Greenbelt, Maryland 20771
301-286-6685
jacqueline.a.townsend.1@gsfc.nasa.gov
patricia.a.hansen.2@gsfc.nasa.gov

Joyce A. Dever
NASA/LeRC
Cleveland, Ohio 44135
joyce.a.dever@lerc.nasa.gov

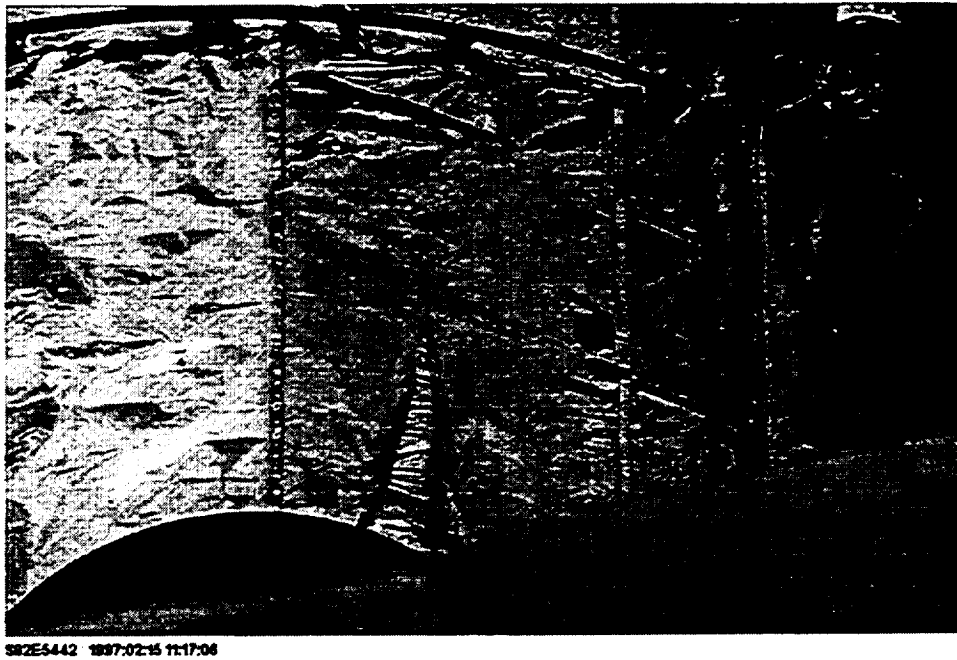
During SM2, a specimen from the outer layer of the MLI, shown in Figure 2, was taken from the upper light shield (LS) region of the telescope. The roughly triangular specimen was tightly curled, forming several rolled layers (Figure 2). The astronaut cut the specimen from right to left, with a change in the initial direction as the astronaut realized he was cutting through the roll of the specimen. In Figure 3 the specimen is shown flat with the cracks identified. The specimen was stored in a reclosable polyethylene bag and stowed in a mid-deck locker for the duration of the mission.

The fractures that resulted in the SM2 LS specimen initiated at an edge of the MLI that had been cut to fit around a handrail (Figure 2). From small defects in this cut edge, two fractures developed and propagated in orbit almost normal to one another, resulting in a roughly triangular specimen. The VDA was completely missing from the SM2 LS specimen in regions where the Teflon® FEP was bonded to the rest of the blanket, which included the region where the cracks initiated.

Although the blankets were relatively flat when deployed, photos of the SM2 LS specimen in orbit showed that it was tightly curled, with the space-exposed Teflon® FEP surface as the inner surface and the VDA exposed. This curling indicated a volume shrink gradient in the specimen. Based on the diameter of the curl (1.5 cm) the estimated strain difference between the outer and inner surface of the Teflon® FEP was ~1.5% (3).

FIGURE 2: SM2 LS SPECIMEN ON-ORBIT
 The top-center of this image shows the roughly triangular SM2 LS specimen on the Light Shield at SM2 prior to retrieval. A handrail and standoffs are apparent across the top of the image. The specimen is curled very tightly, so that it is detectable here as a triangular region where the next layer of the MLI is visible. The raised feature at the bottom edge of the triangular opening contains the entire specimen that covered this triangle prior to the damage. At the bottom of the image, the tip of the largest crack on HST is seen propagating vertically towards the top of the telescope. This large crack also opened to reveal the next MLI layer.

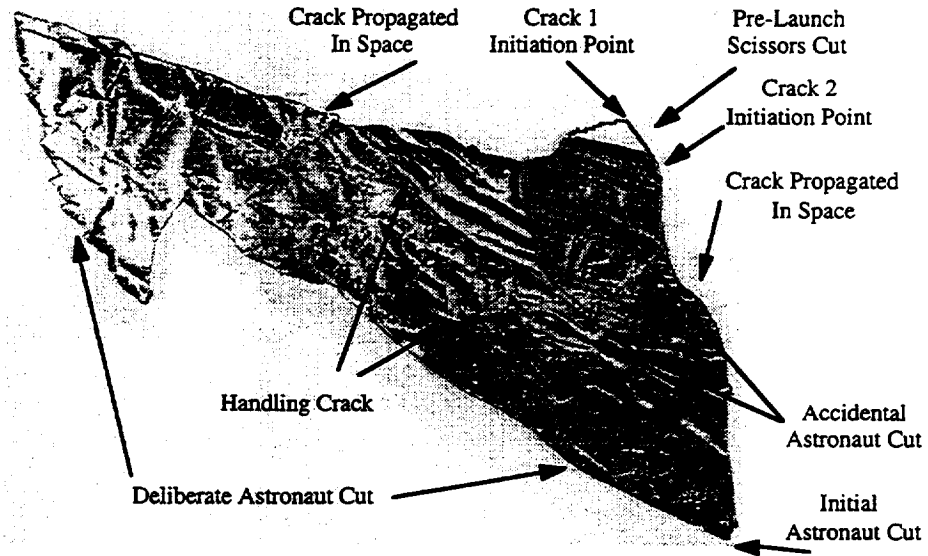
FIGURE 3: SM2 LS SPECIMEN POST-RETRIEVAL

The first task was to document the SM2 LS specimen and assemble the four pieces received into the single specimen that was cut in orbit. Both SEM and optical microscopy were used in this effort. Once the original configuration had been determined, the edges were identified as either a deliberate cut, a handling artifact, or an on-orbit fracture (Figure 3). From this information, the fracture initiation site became apparent.

The image above was taken during post-retrieval analysis, when the SM2 LS specimen was uncurled and placed between glass plates. The edges of the specimen are identified as scissors cut, handling crack, or orbit crack. The top-right corner of the specimen contains the crack initiation sites.
