# Failure Analysis of Discrete Damaged Tailored Extension-Shear-Coupled Stiffened Composite Panels

Donald J. Baker\*

*Vehicle Technology Directorate – ARL, NASA Langley Research Center, Hampton, VA 23681*

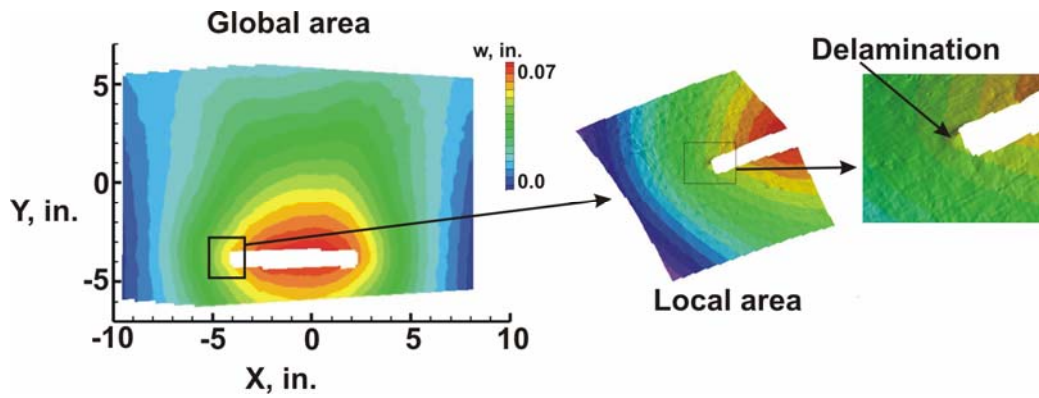
An obvious advantage of the VIC-3D system is the recording of events at timed intervals through out the test is that phenomena that occur temporarily have a good chance of being recorded. An intermediate result from the VIC-3D system is shown in Fig. 20 for panel TP-7 where the global view indicates that the panel is bulging in the middle as determined by the concentric out-of-plane contours around the slot. These *Horizontal cut* panels also had a second VIC-3D system recording the response at a local area as defined at the left end of the slot as shown in Fig. 20. This local area, shown in Fig. 20, indicated a delamination was in progress at the corner of the slot for panel TP-7. The delamination shown is for a load of  $N_y = 5.1$  kips/in. and is near the end of the slot. The appearance of the delamination started at approximately  $N_y = 4.6$  kips/in. and continued to grow until  $N_y = 5.61$  kips/in. The delamination could have started at a lower load but would be missed due to a strip of image data on all edges that is lost in the analysis process. There could also have been a delamination on the right end of the slot as it was not be monitored with a local set of cameras. Up to a load of  $N_y = 5.61$  kips/in the delamination was only visible in the local area images. At  $N_y = 5.76$  kips/in the delaminations/damage grew in size and was visible in the global view image on the L/H side of the slot as shown in Fig. 21a and the delamination/damage does not appear on the R/H side of the slot until  $N_y = 5.82$  kips/in. as shown in Fig. 21b. Increasing the axial displacement until failure the damage progresses up and to the left and down and to the right as shown in Fig. 22, which is the last image frame before failure. The damage progressed to the edge of the skin, adjacent to the thickness transition to the stiffener padup as shown in Fig. 22. This damage/delamination growth compares well with the predicted damage growth shown in Fig. 7 where the damage grew to the stiffeners at reaching the maximum load. Panel TP-4 did not exhibit the local delamination as was seen in panel TP-7. Panel TP-4 appeared to fail in the skin from the corner of the slot to the edge of the skin as shown Fig. 23. The first appearance of any out-of-plane displacement in the local images is shown in Fig 23a. At the same time the out-of-plane displacements appeared in the global image as shown in Fig. 23b indicating failure from the end of the slot to the edge of the skin. Panel TP-4 reacts the same as TP-7 and the progressive failure analysis predictions that of the skin failing to the stiffeners as the load increases to the maximum load. Increasing the load resulted in the damage to grow into the padup area of the stringer on the right hand side as shown in Fig. 24.

Figure 20. Measured delamination at end of slot in panel TP-7 at a load of  $N_y = 5.1$  kips/in.

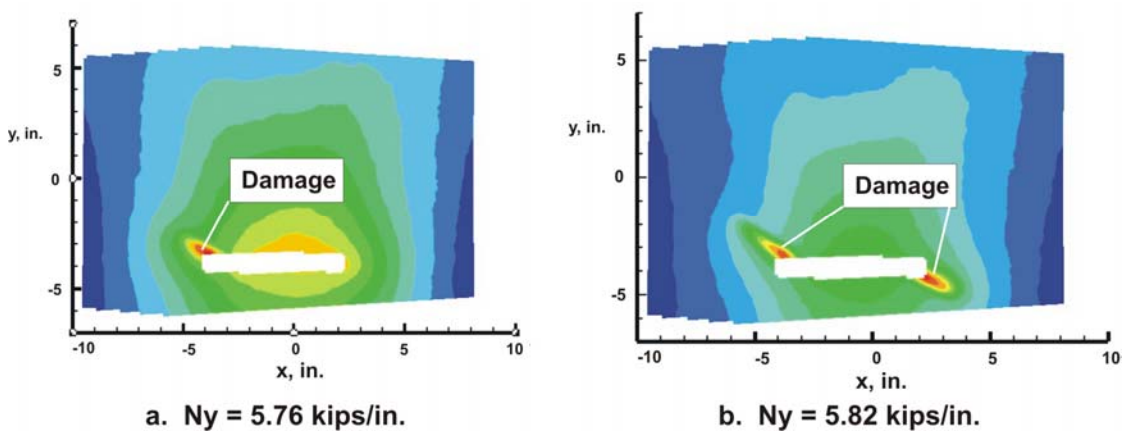
Figure 21. Measured delamination/damage at end of slot at loads shown.

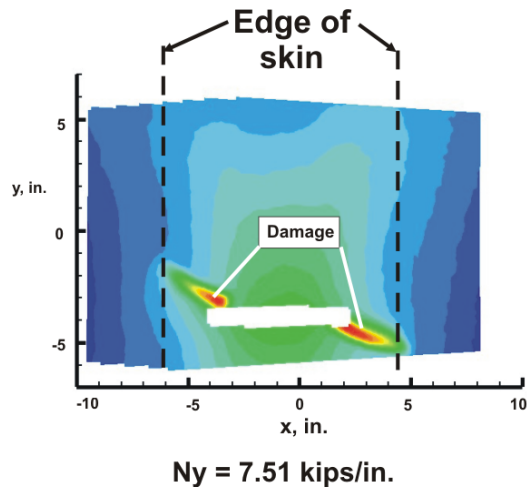
Figure 22. Measured damage propagation in panel TP-7 prior to failure.

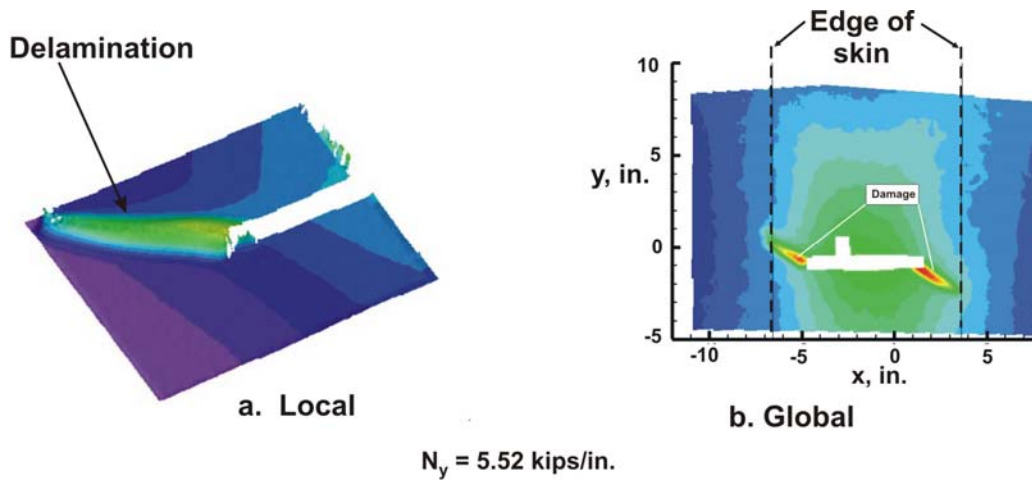
Figure 23. Local and global view of measured delamination on TP-4 at  $N_y = 5.52 \text{ kips/in.}$

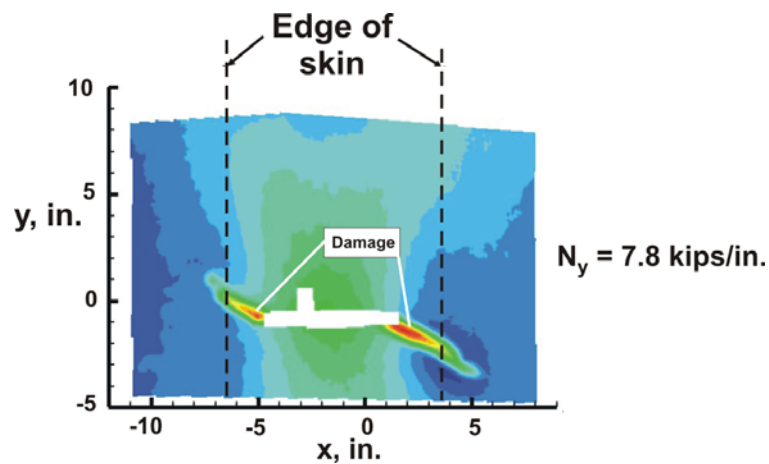
Figure 24. Measured out-of-plane displacements of TP-4 at near failure.

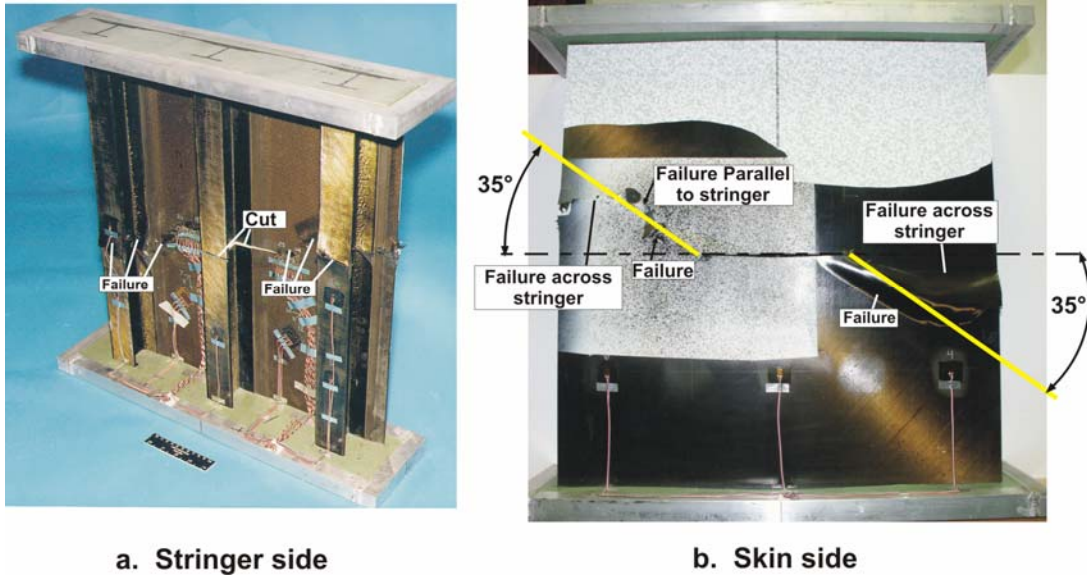
Figure 28. Failed *Horizontal cut* panel.

A photograph of the stringer side of a failed *Horizontal cut* specimen is shown in Figure 28a. As indicated in the figure, the failure progressed from each end of the slot up or down across the skin. A view of the skin side of the specimen is shown in Figure 28b. This figure indicates how the failure progressed from the right end of the slot down at approximately a  $35^\circ$  angle until it intersected the stringer then turned and crossed perpendicular to the stringer. Likewise, failure started at the left end of the slot and progressed up at approximately  $35^\circ$  until it approached the stringer, the damage turned parallel to the stringer for a short distance, then turned and crossed perpendicular to the stringer. The progressive failure analysis noted earlier, predicted that the failures would be at  $35^\circ$  to the specimen centerline then turn and cross perpendicular to the stringer which is a very good match with the experimental results. Both of the *Horizontal cut* panels (TP-4 and TP-7) failed in a similar manner and indicates that the fabrication sequence did not contribute to the failure where the panels were manufactured at different times.

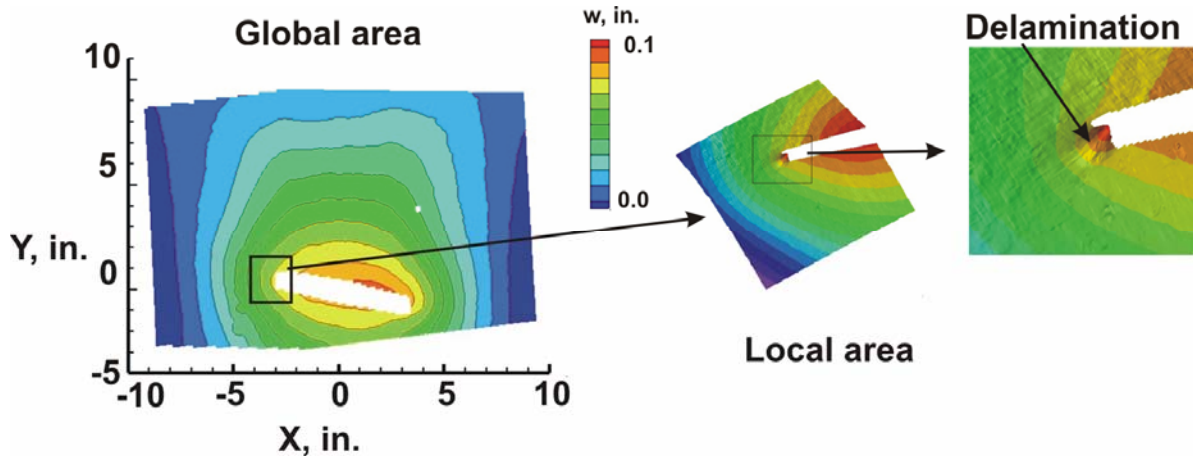
An intermediate result from the VIC-3D system at  $N_y = 6.32$  kips/in is shown in Fig. 31 and indicates that the panel is bulging as indicated by the concentric displacement contours around the slot. This out-of-plane deflections is different from the predicted displacement shown in Fig. 15 where one end of the slot deflects in one direction with the opposite slot end deflecting in the opposite direction. The local area image indicates a delamination at the corner of the slot. The delamination shown in Fig. 31 first appeared at  $N_y = 5.32$  kips/in. and increased in size until  $N_y = 6.32$  kips/in. Damage started to show up in both ends of the slot as shown in Fig. 32 after a very small perturbation

Figure 31. Measured delamination at end of slot in *Inclined cut* panel at a load of  $N_y = 6.32$  kips./in.

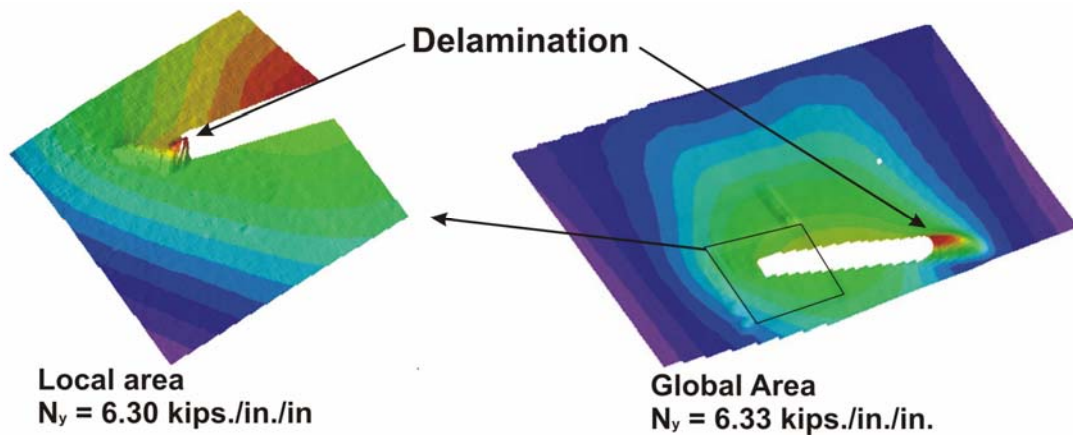
Figure 32. Measured initial failures of *Inclined cut* panel.

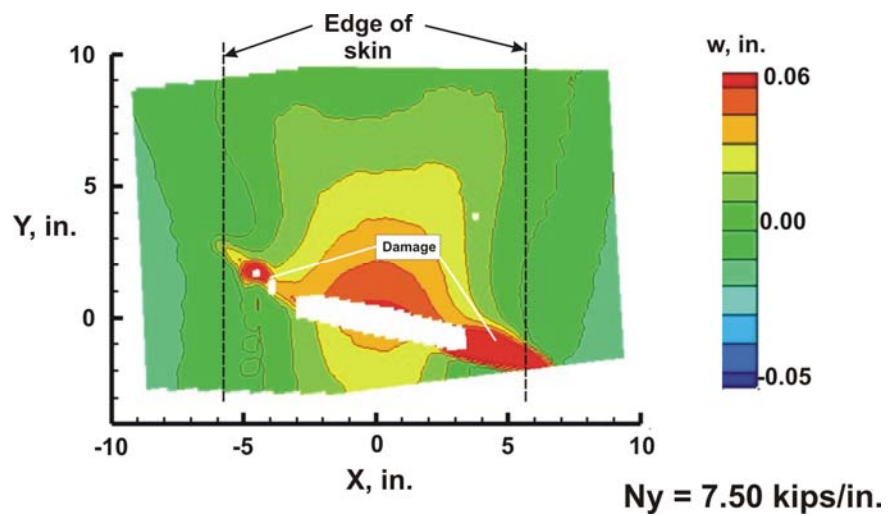
in the load. Increasing the axial displacement resulted in the damage progressing to and into the stiffeners as shown in Fig. 33 which is the last image before panel failure. Comparing Fig. 33 with the predicted failure direction shown in Fig. 14 indicates the failure direction is the same, down to the right for one end of the slot.

Figure 33. Measured out-of-plane displacements of *Inclined cut* panel at near failure.

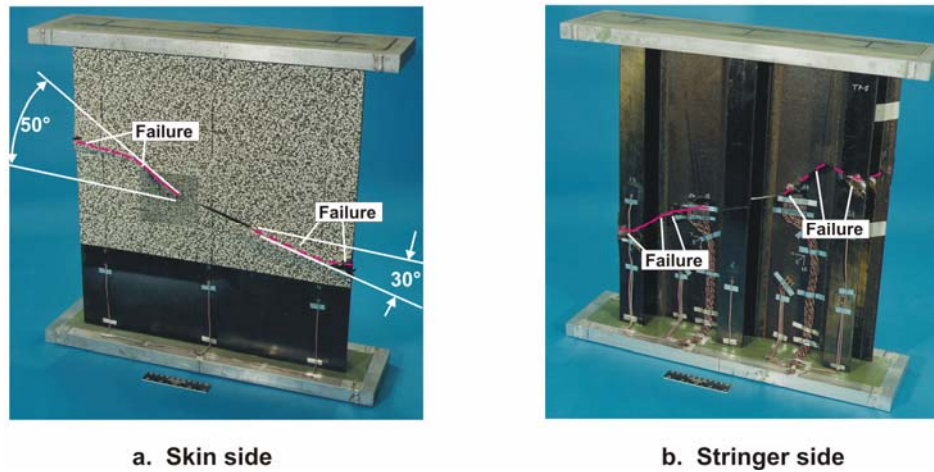
Figure 36. Failed *Inclined cut* panel.

A photograph of the failed *Inclined cut* panel is shown in Fig. 36. As indicated in Fig. 36a the failure in the skin progressed up from the L/H end of the slot at approximately a  $50^\circ$  angle and then turned to cross the stringer. Failure progresses in the skin from the right hand end of the slot at a  $30^\circ$  angle from the horizontal and then turned to cross the stringer. The progressive failure analysis predicted that failure would progress from the slot end at a  $50^\circ$  angle to the edge of the skin and turn to cross the stringer which matches the experimental results. Failure from the opposite slot end was not predicted by the analysis.
