## ***Microwave and Millimeter Wave Nondestructive Evaluation of the Space Shuttle External Tank Insulating Foam***

**S. Shrestha<sup>1</sup>, S. Kharkovsky<sup>1</sup>, R. Zoughi<sup>1</sup> and F. Hepburn<sup>2</sup>**

*<sup>1</sup>Applied Microwave Nondestructive Testing Laboratory (amntl)  
Electrical and Computer Engineering Department  
University of Missouri-Rolla  
Rolla, Missouri 65409*

*<sup>2</sup>NASA George C. Marshall Space Flight Center  
Marshall Space Flight Center, AL 35812*

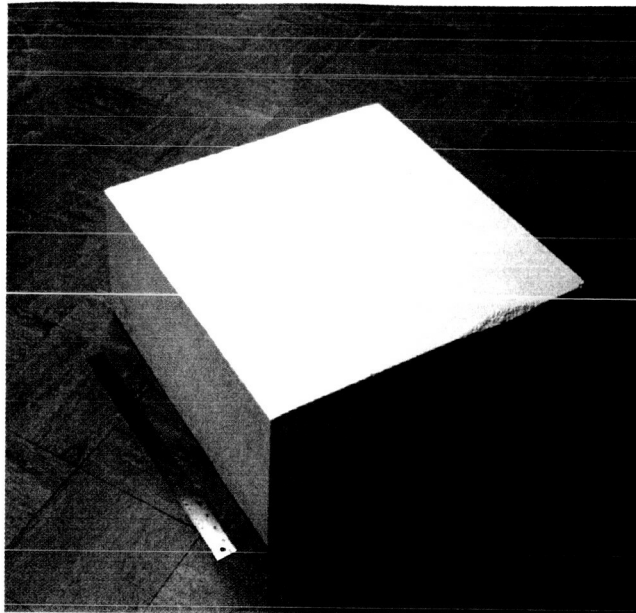
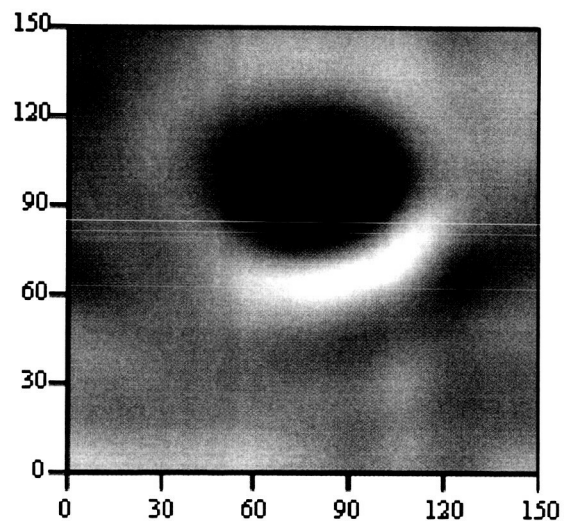
Figure 1

As mentioned earlier, several initial flat panels were used to determine the basic effectiveness of these microwave measurements for inspecting thick insulation foam structures. The foam thickness in these panels varied from 6" to 9" and metallic and rubber washers were embedded inside the foam approximately 2" above the aluminum plate backing. Figure 1a shows the picture of a 9"-thick panel, while Figure 1b shows the X-band image of the embedded washer (dimensions are in mm). The image clearly shows the washer and provides a close estimate of its relative size (considering the distance between the probe and the washer).

- Figure 1: a) Picture of a 9"-thick flat insulating SOFI foam panel, and b) image of an embedded washer at X-band (dimensions in mm).
- Figure 2: Image of a disbond in a flat foam panel with a cork substrate applied to the aluminum backing at K-band.

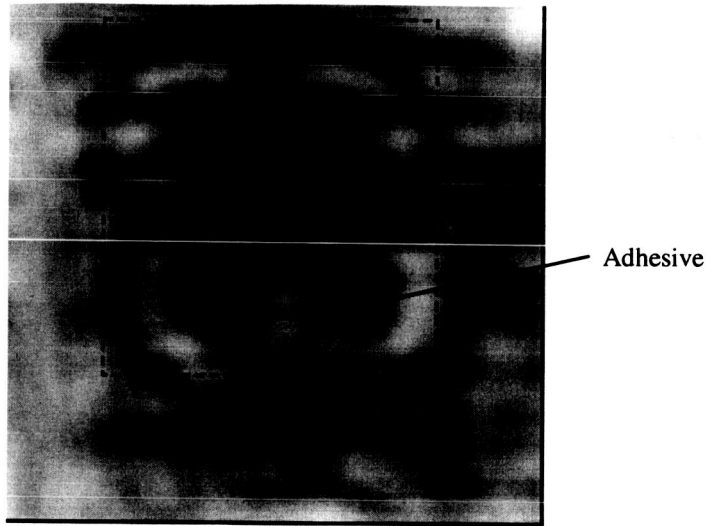
Figure 2

Another 4"-thick flat panel was produced having a thin cork (~3/8" thick) substrate/base applied to the aluminum backing and several disbonds and air voids were embedded on and underneath the cork substrate. All anomalies were detected at K-band and Ka-band. Originally when a disbond was detected in this panel, an interesting "clover-like" pattern was detected in its image. Upon further discussions with those who produced this panel it became evident that the disbond was created by using a thin squared-shaped foam which was secured to the cork substrate using small daps of adhesive at each of its corners. The microwave image of this manufactured disbond at K-band is shown in Figure 2, which clearly shows the disbond and the "clover-like" pattern due to the individual daps of adhesive. The result was significant as it showed the relatively high spatial resolution that may be obtained using these microwave methods. It also indicated the presence of a thin air gap between the cork and the foam section, which is a "real" disbond (the region in the center of the "clover-like" pattern). Another interesting feature was also encountered when inspecting this panel. The microwave images of a set of four voids indicated them to be located at a different place and relative configuration than the schematic of the panel indicated. Once more, upon further discussions it became evident that the actual placing of the voids was not according to the original schematic, but was according to what was indicated by the microwave image.

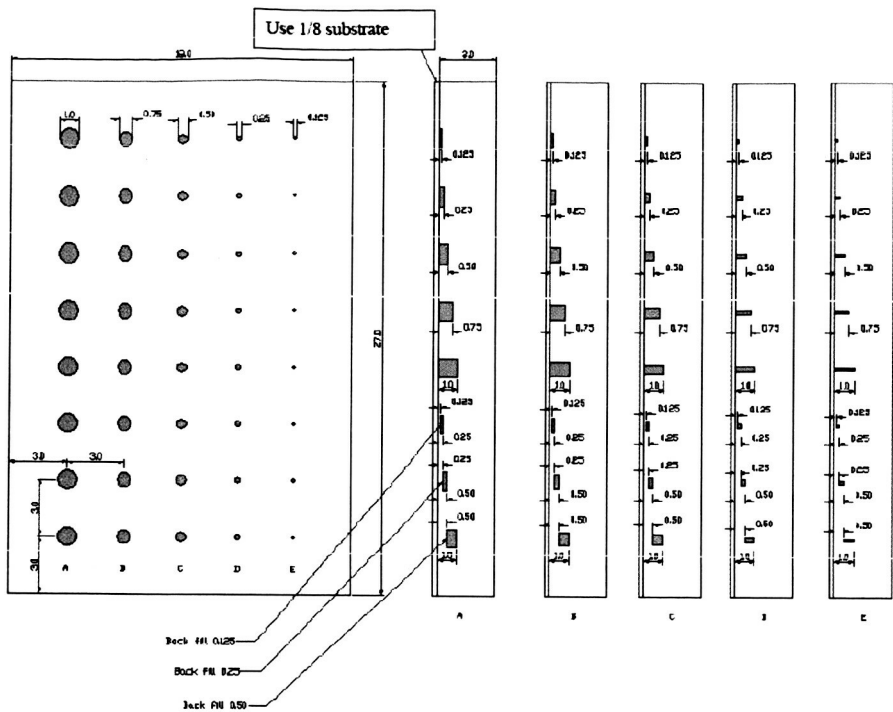
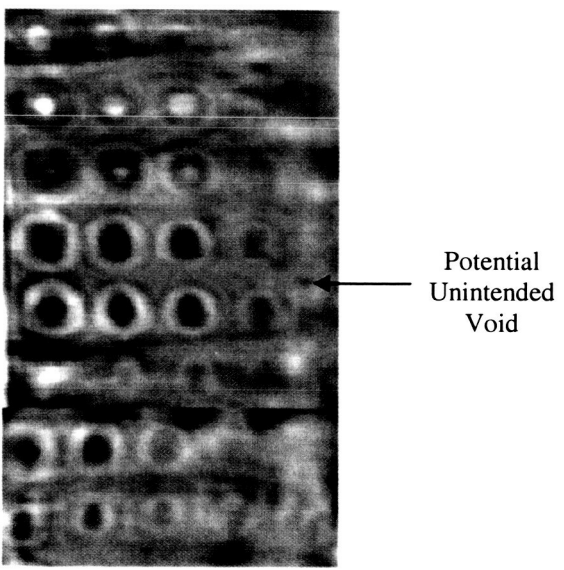
Figure 3

A 2" inch-thick panel was investigated, at Ka-band and V-band, in which 40 embedded air voids existed. The schematic of the panel is shown in Figure 3a. The limited scan area associated with the scanning table could not accommodate scanning the entire panel at once. Consequently, several sections of this panel were individually scanned first, and then the resulting images were

augmented to produce an image corresponding to the entire panel. Figure 3b shows an image of this panel obtained at V-band. From this image, one can see that air voids as small as 0.25" in diameter were relatively easily detected throughout the panel thickness. Potentially, an additional indication such as an unintended rollover void, which was most likely produced during the manufacturing of the panel, was also detected as shown in the image. The outcome of this experiment and the resulting image confirms the potential of these microwave measurement for producing significant detail about the relative size and location of an anomaly in the SOFI foam. The different intensity levels associated with the air voids of similar size gives indication of the relative depth of the voids. In addition, this image revealed some features that are associated with the spraying process (the curved patches in the bottom right side of the image).

- Figure 3: a) Schematic of the panel with 40 voids, and b) augmented image of the panel at V-band.
- Figure 4: Picture of a 3' by 3' panel prior to the application of SOFI foam layer showing the location of several embedded anomalies.

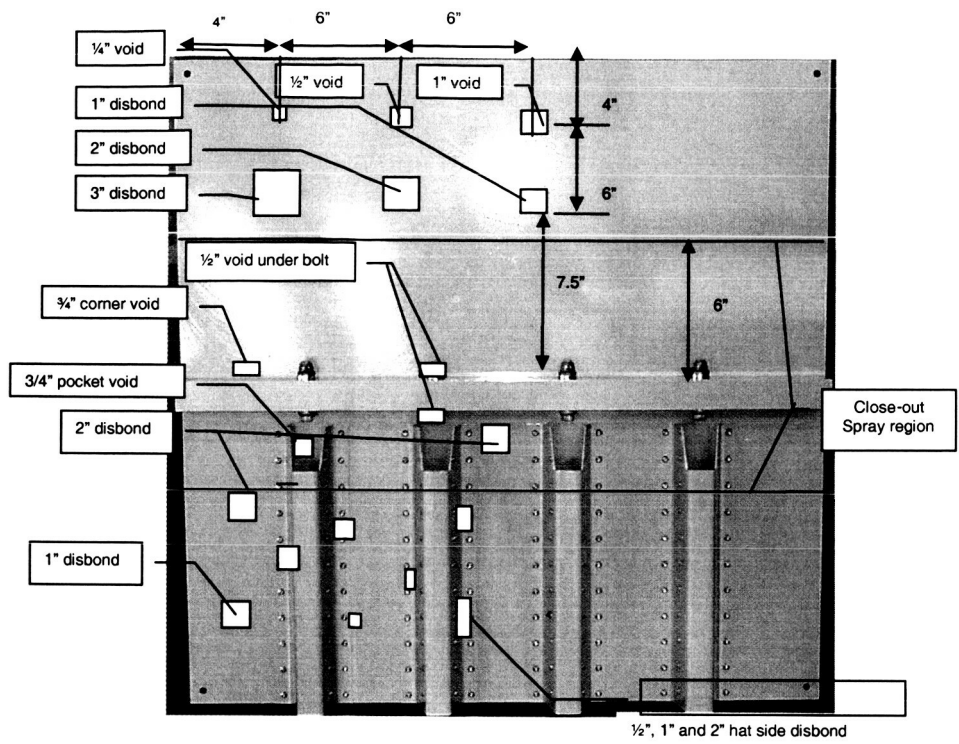
The panels investigated thus far did not include any complicated structural features in their conductor backing, and their foam thicknesses were relatively constant. The next experiment involved a panel containing similar structural features and complexity to that of the external fuel tank. Figure 4 shows a 3' by 3' panel, prior to spraying it with SOFI foam on it, showing various structural components such as four open-top stringers bolted to the metal backing, four bolts joining two vertical metal flanges producing a ridge of about 1" in width, and a relatively large flat area (i.e., approximately the top half of the panel). The approximate locations of various embedded air voids and disbonds are also shown in Figure 4. This panel was then sprayed with SOFI foam in the same manner and geometry as the real respective section of the external fuel tank. Many of the embedded anomalies were detected and their microwave images were produced, with several of these examples discussed here. Figure 5 shows the image of the 3/4" corner void (to the left of the left most bolt) at K-band. The image clearly shows the void and its boundaries in the presence of the bolt. This image was minimally processed to remove the influence of changing SOFI foam thickness in this region. Figure 6a shows the 2" disbond in between the second and the third stringers, at K-band. The presence of the row of bolt heads on both sides of this anomaly is also shown in this image. To better demonstrate this, Figure 6b shows the image of a section of a stringer (devoid of anomalies) showing the rows of bolts on either sides of it.

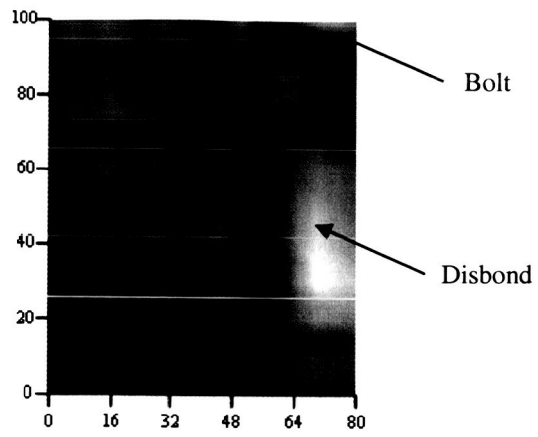
Figure 5

- Figure 5: Image of the 3/4" corner void in presence of a bolt.
- Figure 6: a) Image of a 2" squared disbond in between the stringer regions, and b) image of the region between two stringers with no anomaly showing the row of bolt heads.

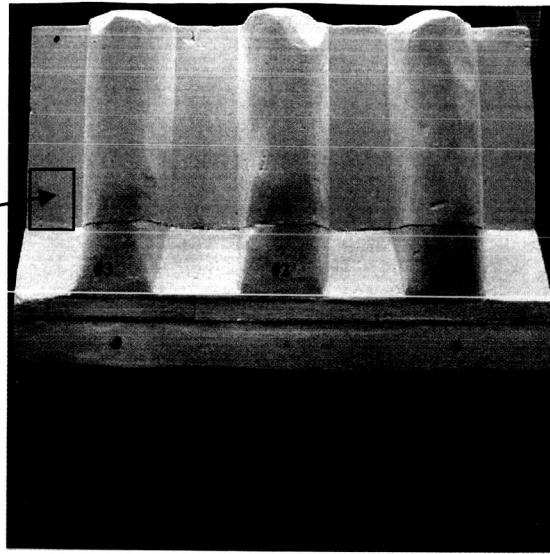
Subsequent to demonstrating the capability of these microwave methods for detecting and evaluating anomalies in various locations within simple and thick SOFI foam panels and more typical and structurally complicated panels, a blind test was conducted. This test involved inspecting a section of a panel, similar in geometry to that shown in Figure 4, possessing three stringers. Additionally, several anomalies had been embedded in this panel. The locations of these anomalies were not revealed to the investigating team (e.g., a blind panel). The metal backing also included several equally spaced drilled holes around its edges. These holes are strong scatterers, however they are not anomalies for the purpose of this investigation. Figure 7 shows a picture of this panel with the stringers numbered as shown.

- Figure 7: Picture of the 2' by 2' "blind" panel.
- Figure 8: a) Patched image of the entire "blind" panel at K-band at horizontal polarization, and b) at vertical polarization.

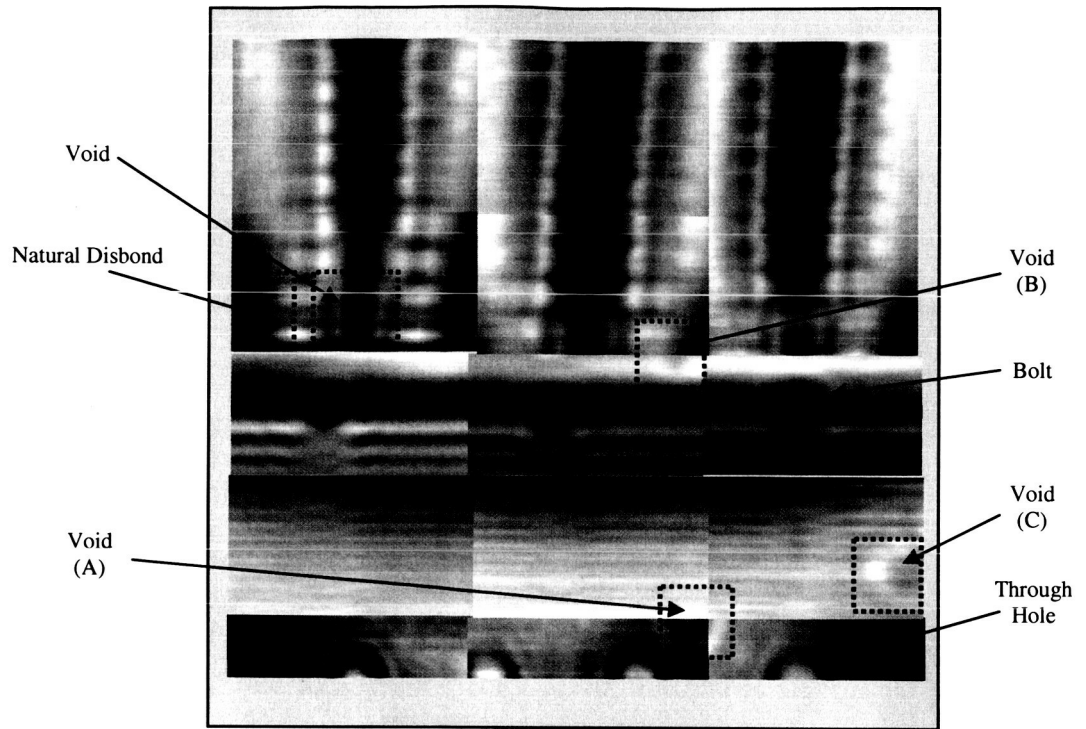
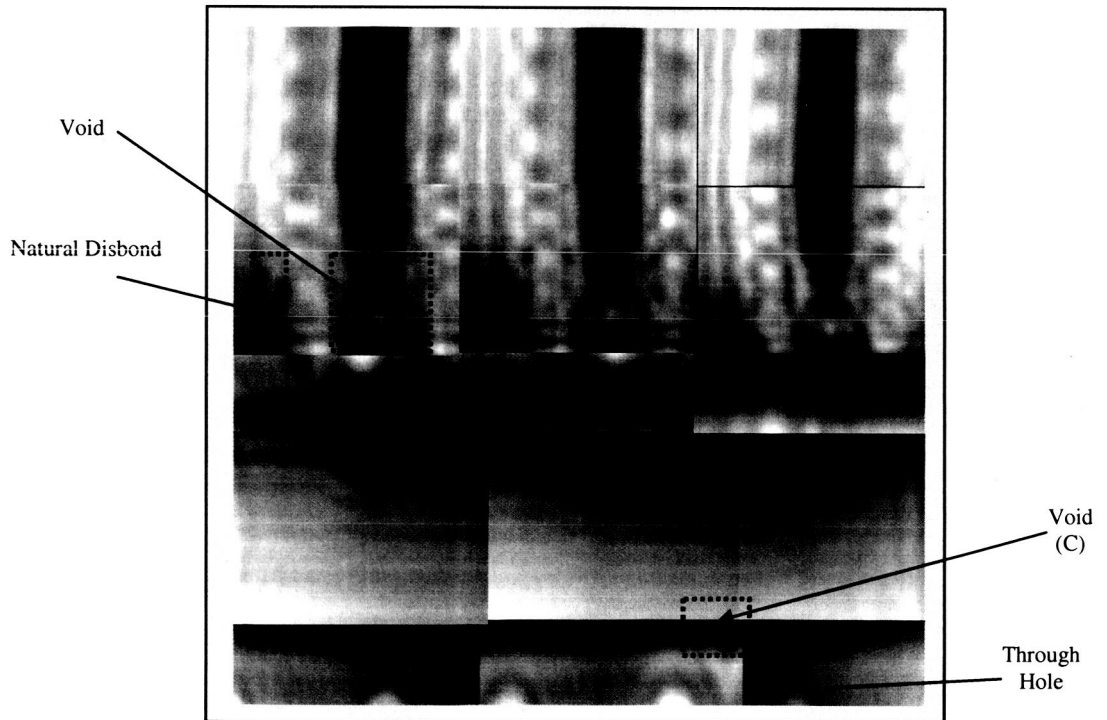
Figure 8

It must be noted that structural features, whose primary axes are parallel to the incident wave polarization vector, are expected to be more clearly detected. This fact is evident in Figure 8a when considering the image from the stringers and the bolt heads. Both of these features have axes parallel to the incident electric field polarization vector and hence are clearly detected. The rings around the bolt heads are due to edge scattering from the bolts.

Both images clearly show the presence of the through holes around the bottom edge of the panel. The panel also possessed a natural and visible disbond at the bottom of the ramp adjacent to stringer #3. Figures 8a and 8b clearly show the presence of this disbond (when compared to the

same region near stringer #1). Figure 8a also shows three distinct indications of potential voids (labeled A-C). It is important to note that two of these potential voids are near strong scattering objects, namely a through hole and a bolt head, respectively. Nevertheless, their presence is clearly indicated in this image. To better illustrate the presence of potential void A, Figure 9 shows the region immediately surrounding this anomaly using parallel polarization. One can clearly see the indication associated with the presence of this potential void.

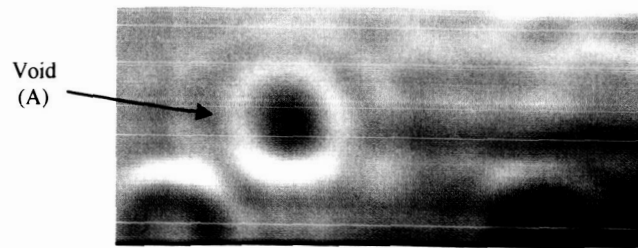
Figure 9

- Figure 9: Localized image of Void (A) in the presence of two through holes.
- Figure 10: Augmented images of the three stringer openings.

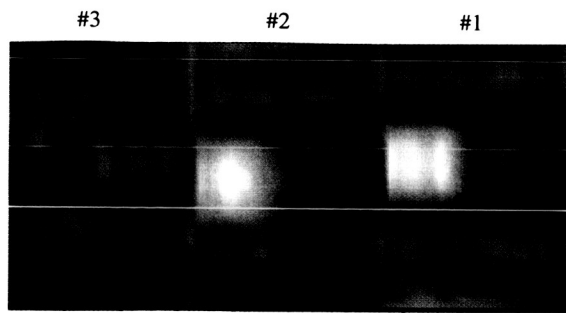
Figure 10

Stringer #3 opening region is clearly different than the same region for the other two stringers. Initially it was determined that there must be a void in the opening region of stringer #3. This decision was partially due to the fact that the other two stringer opening regions produced very similar images. To increase the level of confidence in associating a potential embedded void in this region, the image of the three stringer opening were also produced at Ka-band. Figures 10 shows the augmented images of these three regions, indicating a clear difference in the image obtained from stringer #3 opening region than the other two stringers. Consequently, the investigating team decided that stringer #3 opening region must have a potential void in it. It is very important to note that there are many stringers around the real external fuel tank. Consequently, images from many of these areas which can be compared and a decision about the presence of potential voids can be made with much higher levels of confidence and certainty on the real external tank. In this investigation we only had three such areas available and the decision to indicate a potential void in stringer #3 opening region was made based on the obtained images from these limited number of stringers.

Subsequently, the foam was destructively inspected for the presence of the potential anomalies. The "potential" voids (A-C) were verified to exist and be located where the microwave images indicated them to be. However, something interesting was discovered when inspecting the stringer opening regions. It turns out that two similar voids were embedded in the opening regions of stringers #1 and #2. All images from these two regions show extreme similarity corroborating the fact that these regions were indeed similar. However, an unintentional void was discovered in the stringer #3 opening region. All images produced from this region showed significant difference between it and the same regions in stringers #1 and #2. This finding is
