# INSPECTION OF THE SPACE SHUTTLE EXTERNAL TANK SOFI USING NEAR-FIELD AND FOCUSED MILLIMETER WAVE NONDESTRUCTIVE TESTING TECHNIQUES

S. Kharkovsky<sup>1</sup>, F. Hepburn<sup>2</sup>, J. Walker<sup>2</sup> and R. Zoughi<sup>1</sup>

<sup>2</sup>*NASA George C. Marshall Space Flight Center  
Marshall Space Flight Center, AL 35812*

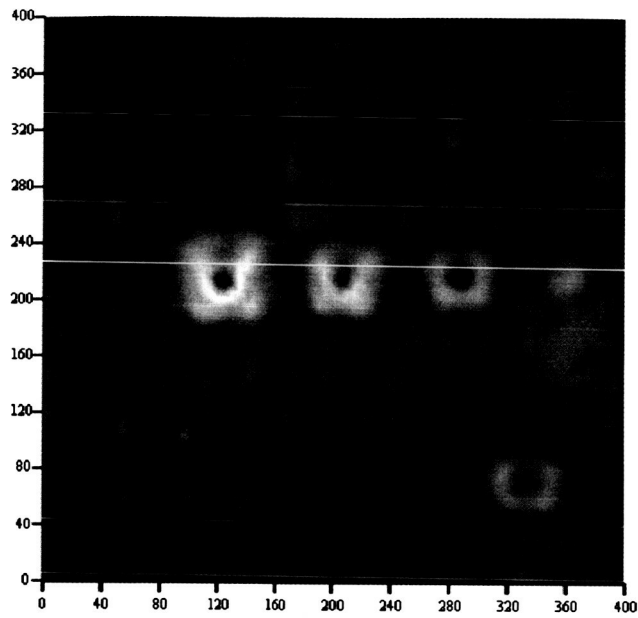
A 40 cm (15.7") by 40 cm (15.7") area of panel #1 was scanned using the lens and the small horn antennas, as shown in Figures 9 and 10, respectively. In Figure 9 the distance between the surface of the substrate and the lens was 25.4 cm (10"). In this image all eight anomalies are clearly detected. The square shape associated with all of these anomalies are also clearly indicated in the image. Four distinct bright spots are seen at the four corners of the unbond located at the lower left corner. These spots correspond to four small drops of adhesive that were used to adhere the unbond insert to the SLA surface. The dimensions associated with each anomaly in the image are very close to their actual dimensions. Throughout this image several superimposed diagonal lines are seen as well. These correspond to regions of the foam with slightly higher density and subsequently different dielectric properties.

In both images of this panel there are several indications (i.e., three around the upper right unbond). These may be due to the presence of small natural voids that may have been produced during the manufacturing of this panel. This fact may be validated in the future when and if this panel is dissected or imaged with a higher resolution system (intended future work).

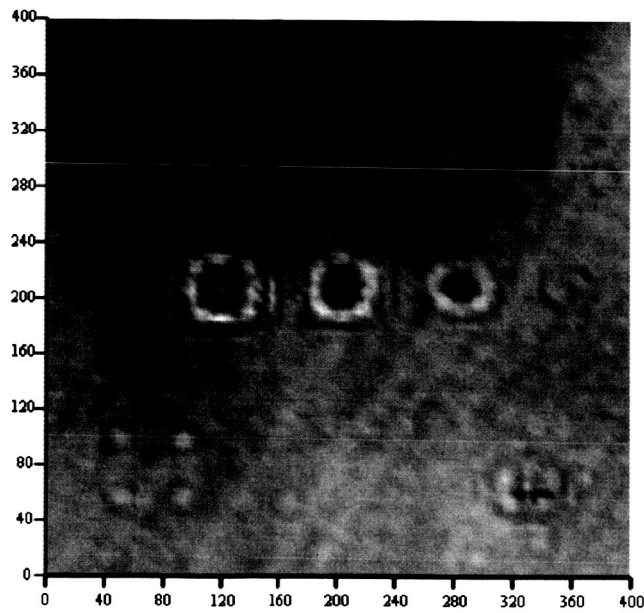
Figure 10 shows the image of this panel when the distance between the small horn aperture and the top surface of the foam sample was 0.6 cm (0.24"), putting the horn aperture distance to the top of the substrate at 10.6 cm (4.17"). When comparing the images in Figures 9 and 10, one can see much similarity between them. The dimensions of the embedded anomalies associated with their images closely correspond to their actual dimensions. Except for the upper central regions of the image, for the most part this image is more clear and sharp than the one shown in Figure 9. The four small drops of adhesive and the boundaries of the unbond associated with them are clearly visible in this image.

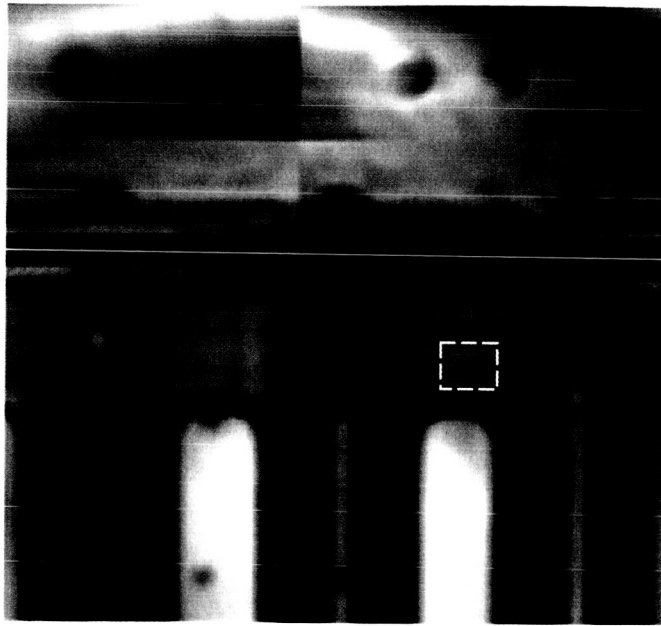
Figure 11 shows the image of this panel using the lens antenna at a distance of 25.4 cm (10”) from the substrate with the polarization vector parallel to the stringer axes. Due to the scanning size limitation associated with the scanning table, this image is a composite of four separate images that are augmented to produce the final image. The results clearly indicate the detailed structural features of the panel when compared to its picture shown in Figure 5. The three stringers, the flange, the three bolts through the flange, the bolts along the stringers, the stringer opening and the cut foam pattern between the stringers (see Figure 6) are all clearly visible in this image.

The two sets of three square rubber inserts and round foam void inserts are also clearly detected at the top of the image. The square shape of the rubber inserts (particularly the largest one) and the round shape of the foam voids can easily be deciphered from their respective images.

The flange is also clearly detected in addition to a long indication in the middle of the flange. This is the indication of the boundary between the two separate pieces of aluminum that are bolted together to produce the flange. The three bolts through the flange are also distinctly shown. The rubber and foam inserts under the bolt heads are not separately detected. However, a closer inspection of the bolt head images reveals that the bolt head with the rubber insert extending out from under it (on the left) has a wider image than the one with a small foam insert under it (on the right). The same is also true for the middle bolt head. On the other hand, there is no real indication of the rubber insert under the nut (on the left) when its image is compared with the other two nuts.

The two rubber inserts between the left and the middle stringers are detected since the rubber dielectric properties are more substantially different than the foam as compared to air and foam. The voids between the middle and the right stringers can barely be seen in the image with the smaller void having a much fainter intensity in the image (this void can be seen better in later images). The same can also be said for the rubber and foam inserts on the tops of the middle and right stringers. The rubber and foam inserts on the sides of these two stringers are not detected in this image. It must be noted that an additional and unexpected indication was detected between the upper portions of the middle and the right stringers, marked with the dashed square in Figure 11. This indication was more prominently detected using the small horn antenna, as will be shown later. It is believed that this is the indication of the presence of a natural void that was produced during the manufacturing of the panel. This fact may be verified by dissecting the foam to reveal the presence of this void. In the future we plan on imaging this panel at higher millimeter wave frequencies which should give more information about the nature of this indication.

Finally, one can clearly see indications in the centers of all three stringer openings (the dark curved features). However, a foam void was placed in the right stringer opening region and none in the other two. As a matter of fact the indication in the middle stringer opening is the strongest of all three. It turns out that during the manufacturing of this panel, three cavities were unintentionally produced in the foam directly above these three stringer opening areas. Additionally, the cavities in all three regions possess a distinct curved shape. Figure 12 shows a close up picture of the foam surface indicating these three cavities.

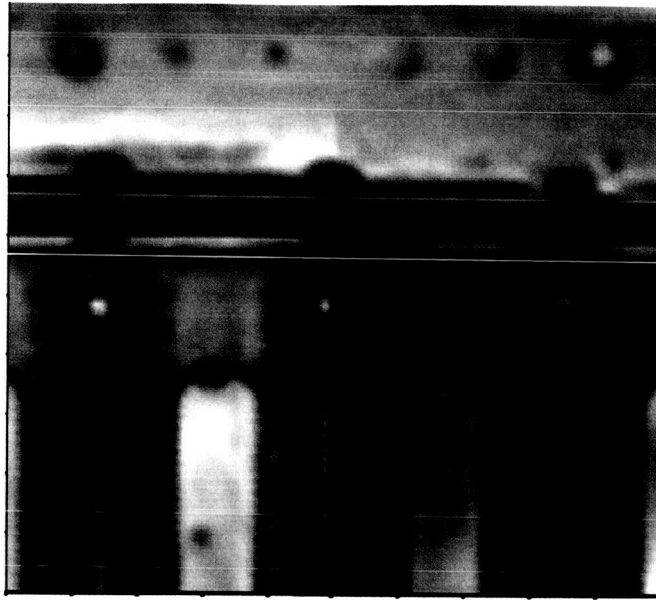
Figure 13 shows the image of this panel using the lens antenna at a distance of 25.4 cm (10") from the substrate with the polarization vector perpendicular to the stringer axes. Due to the scanning size limitation associated with the scanning table, this image is a composite of four separate images that are augmented to produce the final image. The bright line through the middle stringer and the slight misalignment in the middle of the flange and the bolt at this location are an artifact of augmenting these four images and is not an indication of embedded

anomalies. Similar to the image shown in Figure 11, with the exception of the inserts on the sides of the stringers and those under the flange bolts, all other inserts are detected, at least to some degree. The foam void between the middle and the right stringers are more clearly detected in this image. This is not a polarization effect and most likely has to do with the arrangement of the panel prior to imaging this section.

When compared to Figure 11, it is clear that at this polarization the images of the flange areas are clearer, revealing more of its structural detail. One may also see more indications of the inserts as they extend out from under the flange bolts at this polarization. The stringer opening regions are more vivid in this image as well. In this image, the horizontal terminating edge at the top of the stringers is somewhat more distinctly detected.

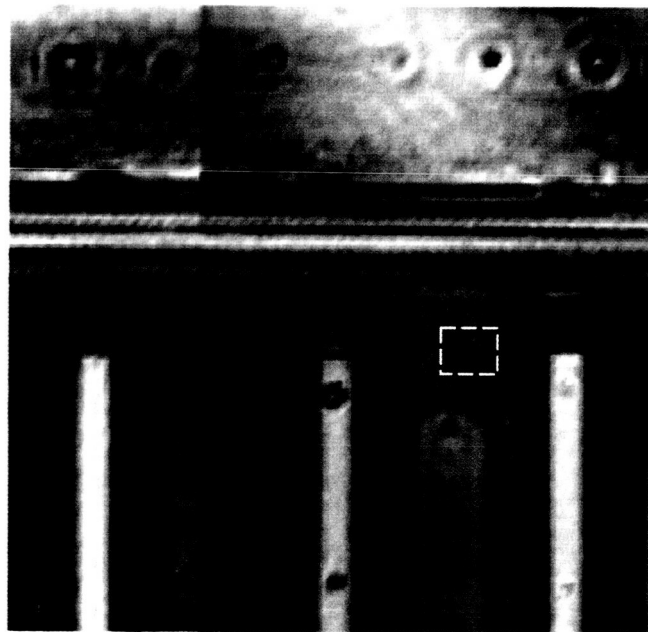
Figure 14 shows the image of this panel using the horn antenna at a distance of 10.5 cm (4.13”) from the substrate with the polarization vector parallel to the stringer axes. This image is a composite of four separate images that are augmented to produce the final image. The line through the image and in the middle of the left and the middle stringers is an artifact of augmenting these four images and is not an indication of an embedded anomaly. This image shows all of the anomalies and features that were shown in the images using the lens antenna (Figure 11). However, due to the fact that during the scan some of the inserts and anomalies were at different distances from the horn aperture (in its near-field region), their indications are much more distinct than those in Figure 11. Examples of these are the foam inserts on top of the right stringer in which even the smaller foam insert is clearly detected and the foam inserts between the middle and the right stringers which shows the smaller foam insert better than its counterpart in Figure 11. The presence of the unintended void in the upper portion of the region between the middle and the right stringers is also more strongly sensed (shown by the dashed square). The stringer opening regions have a clearer image with the horn than with the lens. The strong indication in the center of the right stringer opening is due to the presence of the foam void placed there (see Figure 5) in addition to the natural cavity in the foam at this location. The presence of the cavities in the foam at the other two stringer openings is also detected but more consistent with the size and features of these respective voided regions (see Figure 12). The

square shape associated with the rubber inserts and the round shapes associated with the foam inserts in the top region of the panel are more clearly illustrated in this image than those using the lens antenna. Finally, it may also be argued that the presence of the rubber insert extending out from under the flange bolt caused more signal perturbation using the horn antenna than when using the lens antenna.

Similar to the two previous images of this panel, the presence of the rubber inserts and foam voids on the sides of the stringers was not detected with the horn antenna either. The stringer bolts were not as distinctly detected using the horn antenna since at that distance the spatial resolution associated with the antenna footprint is larger than that with the lens antenna.

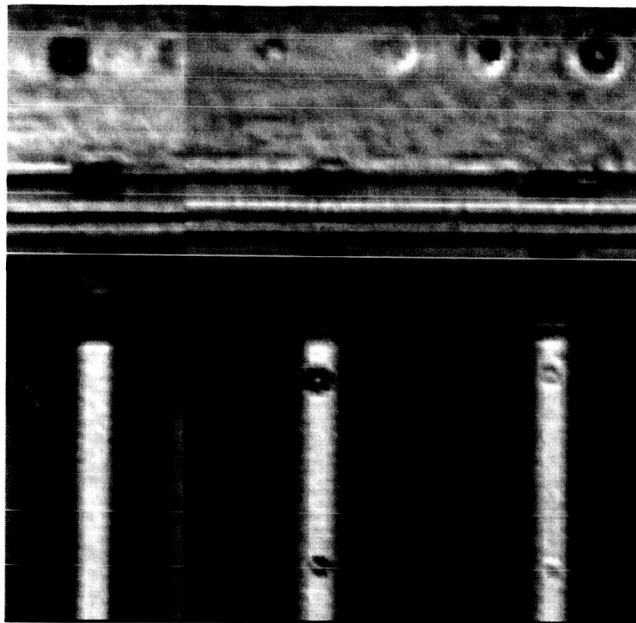
Figure 15 shows the image of this panel using the horn antenna at a distance of 10.5 cm (4.13”) from the substrate with the polarization vector perpendicular to the stringer axes. As in the previous case, many of the embedded inserts are clearly detected at this polarization. However, overall this image is less clear than its parallel polarization counterpart. The stringer opening regions do not clearly indicate distinct presence of the voids (embedded and natural) in the order of sizes they actually are.

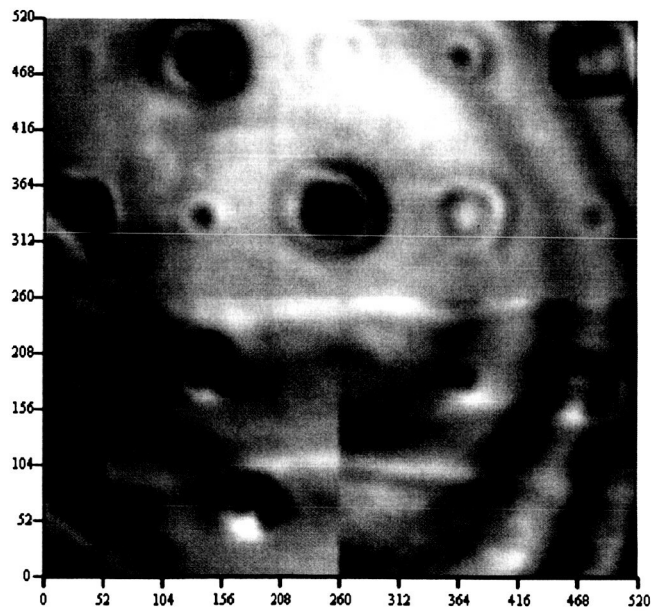
Figure 16 shows the image of this panel using the lens antenna at a distance of 45.7 cm (18”) from the substrate. This distance was used in this case since it produced better images of this panel. All of the embedded inserts at the substrate (as shown in Figure 8) corresponding to the top half of the image are distinctly detected showing their relative sizes. Moreover, the hollowness associated with the voids is visible through the slight shadows (i.e., the dark boundary indications) produced due to the fact that the corners of the panel were lifted up, as explained earlier (see Figure 7). The rings and halos around the voids and the unbonds are due

to the fact that that at this distance the influence of the radiating beam sidelobes may have been more significant than at its designed focal length. The “big diagonal” void in lower left corner of this section is also clearly detected.

With the exception of three unbonds, the rest of the inserts are also detected when placed in the middle of the panel depth corresponding to the lower half of the image. It should be noted that the 1” and the 0.5” voids are shifted with respect to their positions shown in the schematic (see Figure 8) due to a manufacturing error. The three unbonds may at least be partially masked by the prominent rings, fringes, in this image, in particular in the lower right corner, which are artifacts of interference effects caused by the raised corners of the substrate. Consequently, the distance between the lens and the substrate varied throughout the sample producing these rings. The “little diagonal” void in the lower left corner of the image, is also detected.

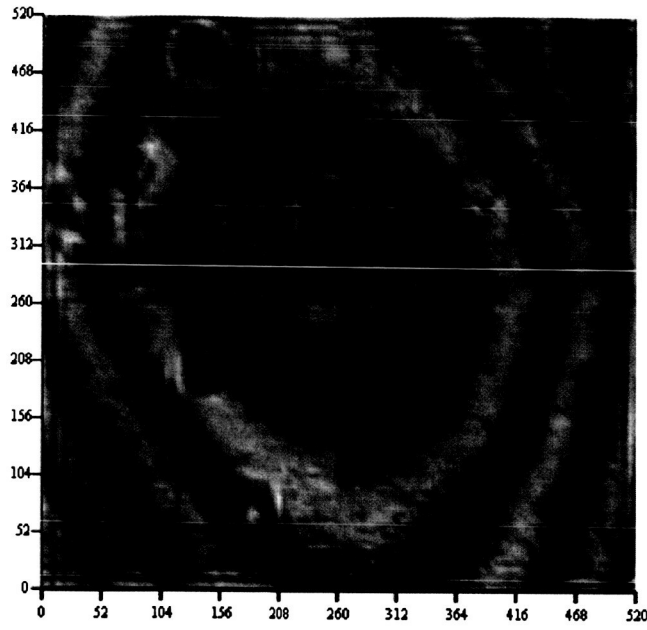
Figure 17 shows the image of this panel (composite of four separate images) using the horn antenna at a distance of 20.9 cm (8.24”) from the substrate. At this distance the footprint associated with this horn is substantially larger than that of the lens resulting in an image with an expectedly degraded spatial resolution. This fact is clearly shown in this image since primarily only the larger voids are detected. The larger unbonds at the substrate are detected but not those placed in the middle of the foam thickness. Some weak indication of the “big diagonal” void can be seen in this image but not of the “little diagonal” void. The superimposed ring pattern is also shown in this image due to interference effects caused by the raised corners of the panel. Overall, the results for this panel, when using the horn antenna, are not as good as when using the lens antenna due to better focusing capabilities of the lens.
