EVALUATION OF A COMPRESSION-LOADED-STITCHED-MULTI-BAY FUSELAGE PANEL WITH BARELY VISIBLE IMPACT DAMAGE*

Donald J. Baker
Vehicle Technology Directorate - ARL
NASA Langley Research Center
Hampton, Virginia 23681

Jian Li
Structural Integrity Department
The Boeing Company
Mesa, Arizona 85215

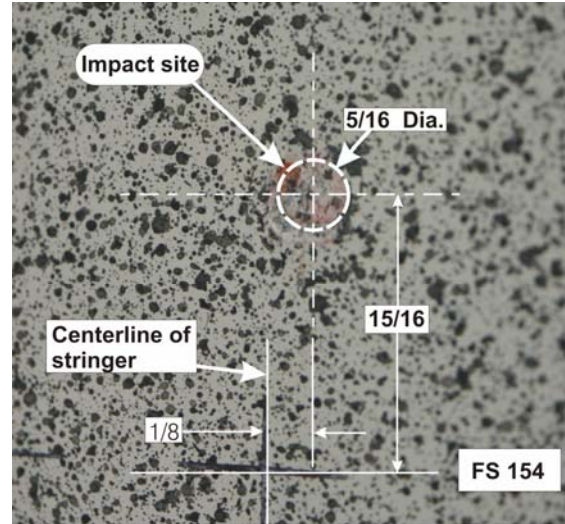
Panel *C-1* was placed under the impact tower shown in Figure 3 and a 5-lb weight with a 0.5-inch spherical radius impactor was dropped on the specimen. Lead shot bags was placed on and around the specimen to dampen the vibrations. The impact location was at the end of a center stringer termination adjacent to FS 154 on the Outer Mold Line (OML) side of the panel. The energy required to produce barely visible damage was determined on a different panel of the same design. The impactor was dropped 4-feet to give an energy level of 20 ft-lbs. Barely visible impact damage occurred on the specimen skin surface with the 20 ft-lbs of impact energy. A photograph of the impact site with the actual impact location is shown in Figure 4. The final impact site was 1/8-inch from the centerline of the panel. The profile of the contact force as determined from a load cell in series with the impactor is shown in Figure 5 and indicates a loss of stiffness as given by the contact force drop of approximately 150 lbs. after reaching the peak force of 908 lbs. The contact force recovered some but never exceeded the peak value of 908 lbs.

Figure 4 – Location of impact damage.
(Dimensions in inches)

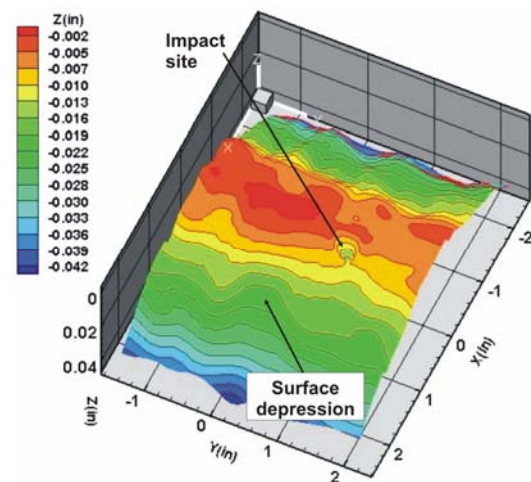
After impact and before any loading the profile of the impacted panel *C-1* was determined. The profile of the full panel did not show any significant changes due to the impact but results of the local area (3-inch by 4-inch) shown in Figure 6 indicates an impact dent depth of 0.008 to 0.010-inches deep. Deviations from the constant cross-section radius of 55.9-inches are shown in Figure 7 at a section through the impact site and at 2.0-inches from the impact site. This data indicates the dent is approximately 0.01-in. below the surrounding surface. This figure also indicated the cross-section radius is within 0.03-in. of the 55.9-in. radius.

Figure 6 – Surface geometry after impact.

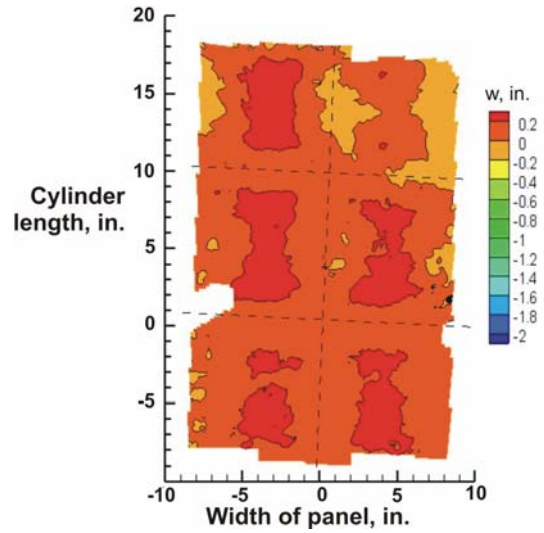
Displacements Panel *C-1* was loaded to failure at a low load rate of approximately 1,000 lbs. per minute. An obvious advantage of using the VIC-3D system is the full field recording of events at timed intervals through out the test. During loading, panel *C-1* had five of the bays that bowed out-of-plane in the positive direction (0.0 to over 0.01-inches) as shown in Figure 8a for $N_y = 0.75P_{cr}$. The upper R/H bay had out-of-plane displacements ranging from -0.01-inch to +0.01-inches as shown in the figure. The dashed lines superposed on the figures are the approximate locations of the frames and stringers. The positive displacement direction is away from the OML, or toward the viewer when looking at Figure 8a. Review of the image data for the

test to limit load indicated similar type of deformation patterns, except those images did not indicate an area of negative deformation between the two upper bays as shown in Figure 8a. It is possible that there was some damage under the stringer flange as the impact area was between the lower end of the stringer and the flange of the frame. Increasing the load to $N_y = 0.96P_{cr}$ the same five bays still bowed in the positive direction while the upper R/H bay changed into three half-waves as shown in Figure 8b. Increasing the load to $N_y = 1.006P_{cr}$ the upper R/H panel buckles as shown in Figure 8c. The only significant change in the other bays is the increase in size of the area of the positive out-of-plane displacement to over 0.02-inches. A second bay (middle L/H) buckled when the load was $N_y = 1.075P_{cr}$ as shown in Figure 8d. The second buckle was not present at the load of $N_y = 1.006P_{cr}$ although the presence of two positive displacement areas is noted. These areas could be the start of three half waves as seen in the upper R/H bay. The upper L/H and middle R/H bays increased in positive displacement as the load increases. The effect of loading was insignificant on the out-of-plane displacements of the lower two bays. This result was due to the fact that the lower skin was 40% thicker than the upper and middle bays (see Figure 1) and the outer two stringers on the lower two bays are twice the thickness of the other stringers. Increasing the load to 1.5 times the buckling load produces a deformation pattern as shown in Figure 8e. It appears that the deformation from the buckle in the upper R/H bay extends into the edge of the stringer. Increasing the load to $N_y = 1.63P_{cr}$ produced the deformation pattern shown in Figure 8f. This is the last image before maximum load of $N_y = 1.64P_{cr}$ is achieved. Note the major change between Figures 8e and 8f is in the upper L/H bay and the change in shape of the buckle in the upper R/H bay. The depth of the buckle in the upper R/H bays is increasing while the depth of the buckle in the middle L/H bay is decreasing. The change in shape of the deformations on the upper bays would indicate the center stiffener in the upper bay has lost some of its effectiveness. The contours of positive out-of-plane displacement shown in Figure 8f indicates the entire cross section is bending.

Figure 8a – Out-of-plane displacements for $N_y = 0.75P_{cr}$.

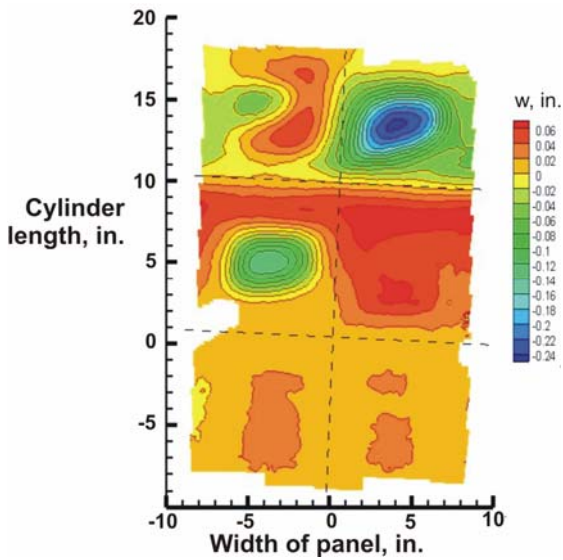
Figure 8f – Out-of-plane displacements for $N_y = 1.63P_{cr}$.

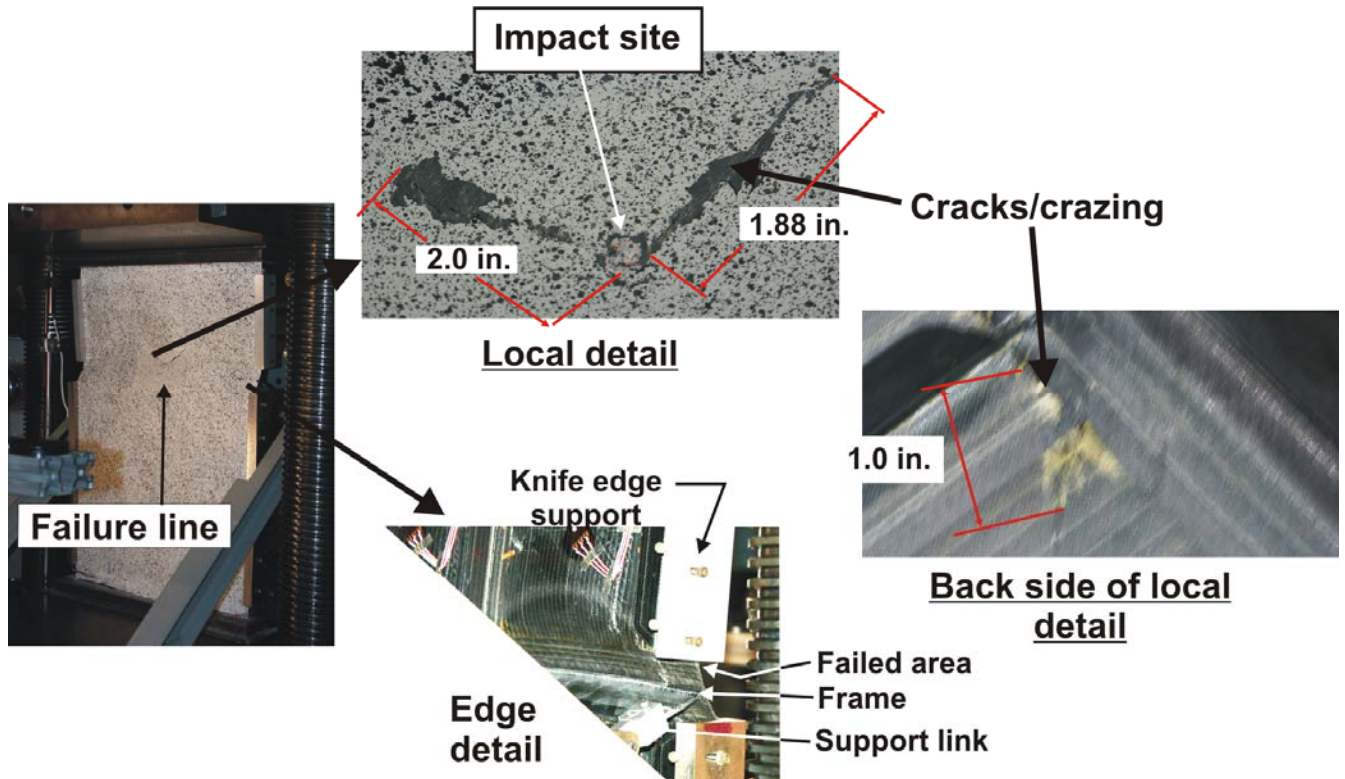
Panel C-1 failed at $N_y = 1.64P_{cr}$ and a photograph of the failed specimen in the test machine is shown in Figure 11. The panel failed by folding in the skin adjacent to the flange of frame at FS 154. The edge view detail shows the out-of-plane displacement. The impact site is in the failure line but did not appear to have any significant effect on the failure mode. Close up photographs of the area at the impact site indicate cracks/crazing radiating from the impact site.

Figure 11 - Failed panel C-1.

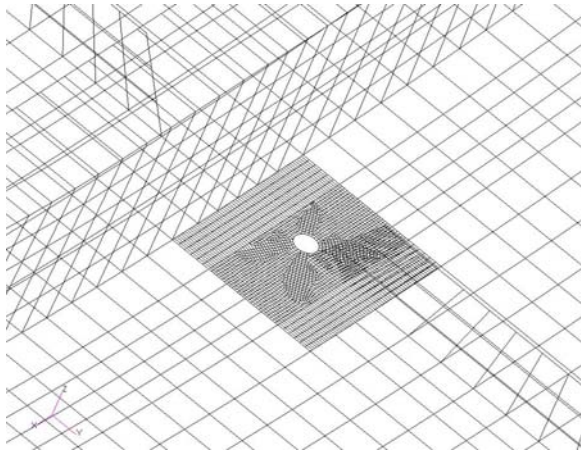
From the actual measurement and location of the impact damage shown in Figure 4, an accurate representation of the impact damage was created through local modeling that takes into account the damage size and location with respect to the center stringer centerline and distance from FS 154. A close-up of the finite element model of the impact site is shown in Figure 12. The nonlinear analysis used in reference 3 was modified to include the barely visible damage and was used to predict the panel response. Tie boundary condition was used to enforce displacement compatibility between the local model and the global model developed in Reference 3. The axial strain (y-direction) distribution at the OML ply predicted by the nonlinear analysis at $P=1.63P_{cr}$ is shown in Figure 13. The results in Figure 13 demonstrate a global instability along FS 154 due to stringer web terminations. Also of interest is the fact that at the stringer termination location, the compression strain has a higher compression strain than anywhere else including the impact damage location. The predicted deformed shape of folding along FS 154 shown in Figure 13 compares well with the experimental observation shown in Figure 11.

Figure 12. Barely visible impact damage modeling for panel C-1.

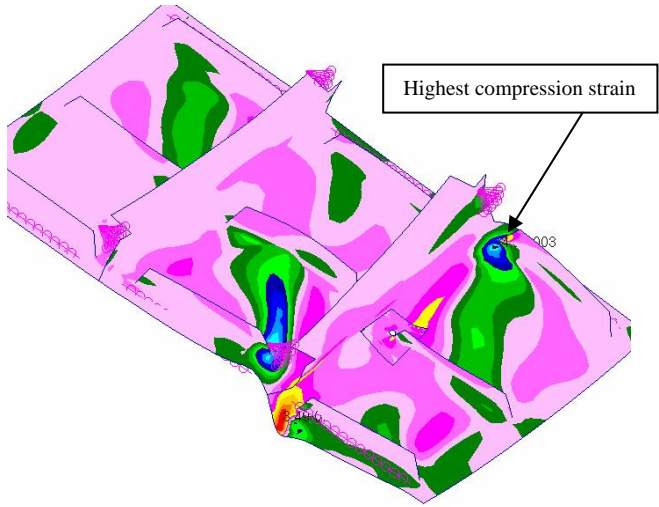
Figure 13. Axial strain prediction by nonlinear analysis at $N_y=1.63P_{cr}$.
