## Ballistic Impact of Braided Composites with a Soft Projectile

### Abstract

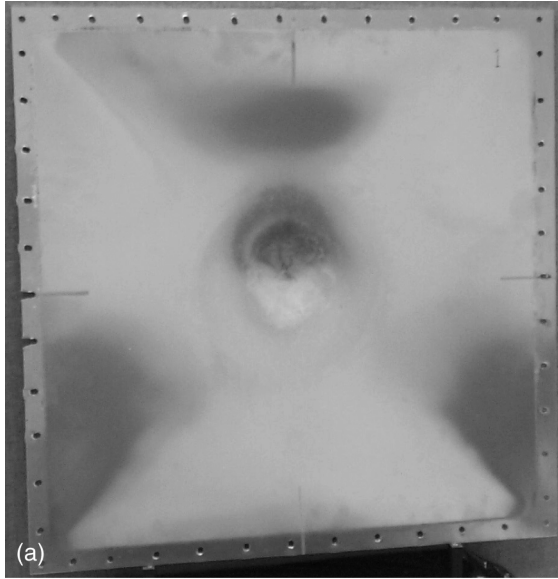
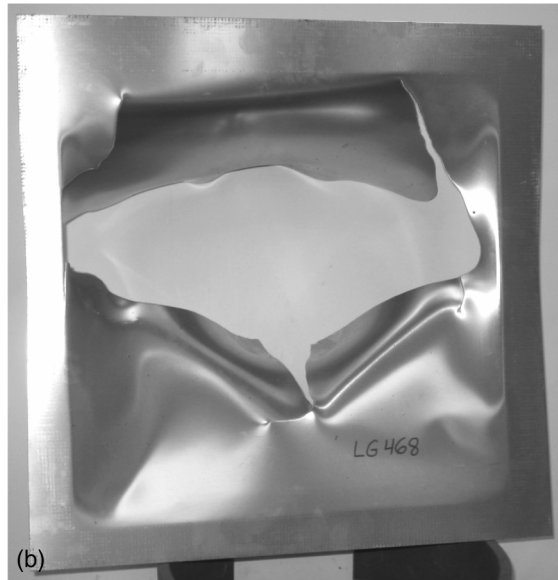
An initial set of 4 tests were done on aluminum plates using the 55.9 cm (22 in.) frame opening and impact velocities ranging from 156 m/s (513 ft/s) to 235 m/s (770 ft/s). In this test configuration the clamped area is only one inch wide, and even the use of pins through the plate was insufficient to prevent slipping of the edges out of the frame. Figure 6(a) shows the plate tested at 156 m/s (513 ft/s). Some tearing of the pin holes resulting from slipping is evident in the left edge of the plate in Figure 6(a). The type of damage that occurred was similar for all 4 plates, except that the extent of deformation and the amount of slipping from the frame were much more severe at the higher velocities. Each of the 4 plates had a circular region of extensive plastic deformation at the center that is about the size of the initial contact area and less extensive plastic deformation in the region between the initial contact area and the edges of the plate. The four folds beginning at the corners of the plate and directed at 45° toward the center of the plate are an artifact of the stress field imposed by the square boundary conditions. It was somewhat surprising that the aluminum plates were not penetrated with an impact velocity of 235 m/s (770 ft/s). In order to determine if penetration would occur if the edges of the plate were held tightly in place, two more tests were done on the remaining plates using the new frame with the 50.8 cm (20 in.) opening. This frame allows for a 5.08 cm (2 in.) clamping width at the edges of the plate. A plate tested at 226 m/s (743 ft/s) in this frame is shown in

Figure 6(b). With the edges of the plate now held more tightly in place, penetration did occur along with extensive cracking of the plate. High speed video of the impact event clearly showed crack initiation near the initial contact area and dynamic crack propagation toward the boundaries. Figure 6(b) illustrates the effect of having a high strain energy density in the plate at the onset of failure. A second plate tested at 199 m/s (654 ft/s) was not penetrated by the projectile. However, some slipping occurred at the boundaries, even though the new test frame was used. Further testing would therefore be needed to determine the penetration threshold in a test where the boundaries are held completely fixed.

Fig. 6. Aluminum panels after impact. (a) 156 m/s (513 ft/s). (b) 226 m/s (743 ft/s).

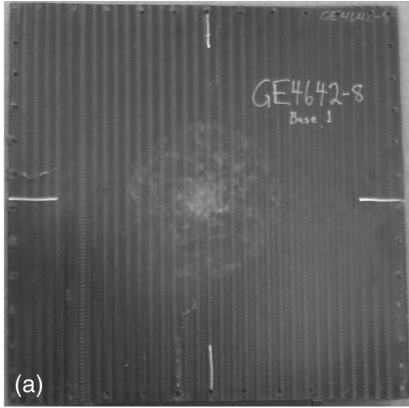
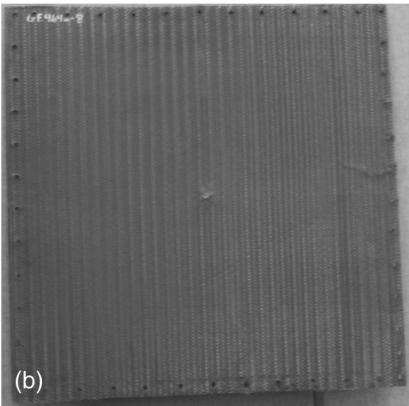
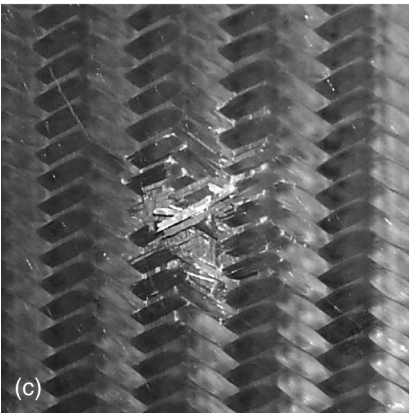
Eight composite plates were tested with impact velocities ranging from 103 m/s (338 ft/s) to 198 m/s (648 ft/s). The failure mode for the composite plates differed from that for the aluminum plates in several ways. First, when tested at velocities below the penetration threshold, the composites did not have a permanent deformation analogous to the plastic deformation in the aluminum plates. Second, the penetration threshold was lower for the composite plates. Third, when tested above the penetration threshold, the damage did not propagate beyond an area approximately the size of the initial contact area. Slipping at the edges of the plates was a problem in the initial tests using the frame with the 55.9 cm (22 in.) opening and only the bolts around the edges to hold the plates in place. Addition of pins through the steel frame and the composite plate reduced the slipping considerably. However, elongation of the holes in the composite and cracks emanating from the holes in some tests indicated that slipping was probably not completely eliminated. Using data only from tests in which the slipping appeared to be very small, the penetration threshold was determined to be between 150 m/s (491 ft/s) and 161 m/s (528 ft/s). Figure 7 shows the front and back surfaces of the composite plate tested at 150 m/s (491 ft/s). In Figure 7(a) the small whitened circular region at the center of the plate is the initial contact area. The larger, less distinctive, whitened area is the region over which the gelatin projectile was spread when it was completely flattened into a disk before rebounding. There is no visible damage on the front side of the plate. However, in Figure 7(b) there appears to be a small circular region of fiber tensile failure at the center of the back side of the plate. A magnified view of this damage is shown in Figure 7(c). This type of damage in the back ply is reasonable since the maximum strain should occur at this point. Fiber fracture also occurred on the back of other composite plates tested at velocities well below the penetration threshold. It was not possible to determine the threshold velocity for the onset of this failure mode because of the limited number of

plates available and because the test results can not be considered to be reliable in tests where slipping occurs at the boundaries. A lower bound for this threshold can be estimated from results of one test at 103 m/s (338 ft/s). There was no visible damage in this plate after the test. However, high speed video showed the projectile to be misaligned and partially torn before impact. Further testing would be needed to establish a threshold for onset of detectable damage.

Fig. 7. Composite flat panels after impact at 150 m/s (491 ft/s). (a) Front. (b) Back. (c) Back, close-up.

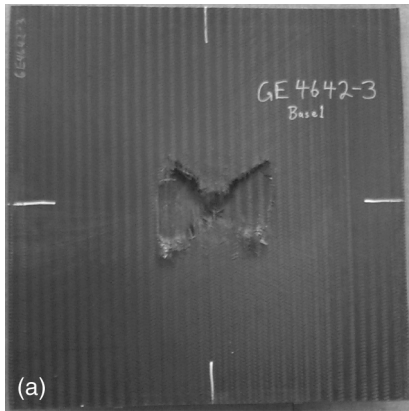
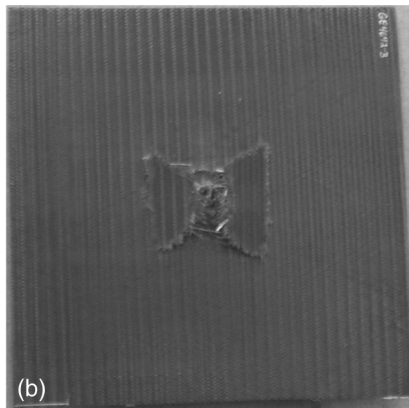
At impact velocities of 161 m/s (528 ft/s) and above, the projectile perforated the composite plates with the damage pattern shown in Figure 8. The plate in Figure 8 was tested at 192 m/s (629 ft/s). Penetration is initiated at the center of the plate where fiber tensile failure has occurred on the back ply. Cracks then propagate along the  $\pm 60^\circ$  bias fiber directions. When these cracks extend beyond the initial contact area, triangular flaps fold back along  $0^\circ$  axial fibers. Two remarkable results are that the cracks do not propagate far from the initial impact area and that there is no apparent delamination between plies. It was anticipated that these damage modes would be present and would have to be controlled by the use of buffer strips or other methods. The damage tolerance demonstrated in these tests suggests that such methods for limiting crack growth may not be needed in fan case structures. A possible contributing factor to the damage tolerance is that the interlaminar stresses available to induce damage are small because the triaxial braid is quasi-isotropic within each ply. This issue is currently being investigated both experimentally and by analysis.

Fig. 8. Composite flat panels after impact at 192 m/s (629 ft/s). (a) Front. (b) Back.

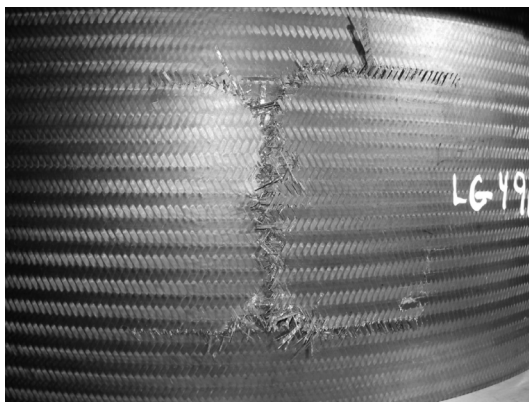
Two half-rings were tested using the fixture shown in Figure 5. The half-ring composites were fabricated so that the  $0^\circ$  fibers are oriented circumferentially in the fixture. The damaged region after a test at 150 m/s (492 ft/s) is shown in Figure 9. Because the damage is localized around the initial contact area, it is possible to perform three separate impact tests on each half-ring. Slipping of the edges out of the fixture was not a problem in any of these tests. The penetration threshold was between 133 m/s (436 ft/s) and 138 m/s (454 ft/s). This is lower than the range of 150 m/s (491 ft/s) to 161 m/s (528 ft/s) determined for the composite flat plates. The penetration thresholds are not expected to be the same for the flat plates and the half-rings because the stress state induced in the composite by impact is different for the different geometries. Some of the failure modes observed in the flat plates also occurred in the half-rings. For velocities below the penetration threshold, a small circular region of fiber fracture occurs in the back ply directly behind the center of the initial impact area. Similar to the flat plates, this region of fiber fracture is the initiation site for crack propagation when the impact velocity exceeds the penetration threshold. However, in the half-ring tests the cracks initially propagate from the initiation site in a direction transverse to the  $0^\circ$  fibers rather than along the  $\pm 60^\circ$  fibers. As the cracks reach a location near the edge of the initial impact site, each of the transverse cracks split into two cracks that travel a short distance along the  $\pm 60^\circ$  directions. These cracks then turn again to travel along  $0^\circ$  fibers. Square flaps then open by folding along a line transverse to the  $0^\circ$  fibers. Similar to the flat plates, the damaged area is only slightly larger than the initial contact area.

Fig. 9. Composite half-ring after impact at 150 m/s (492 ft/s).
