CHARACTERIZATION OF CERAMIC MATRIX COMPOSITE VANE SUBELEMENTS SUBJECTED TO RIG TESTING IN A GAS TURBINE ENVIRONMENT

Michael Verrilli and Anthony Calomino
NASA Glenn Research Center
21000 Brookpark Road
Cleveland, OH 44135

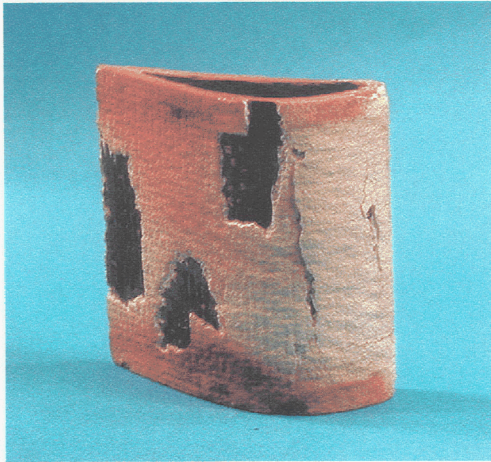
Figure 6 – SiC/SiC vane (number 909) after inadvertent water exposure followed by rig testing for 3.5 hours.

The rig was disassembled to inspect the test section after completion of 50 hours of testing. Water was found in the test section. One of the water-cooled thermocouples was found to have leaked prior to the beginning of the last 3.5 hours of testing. This led to the accumulation of water in the test section between rig runs. During this period of time, the SiC/SiC vane absorbed some of this water. Upon restarting the test, the absorbed water vaporized, producing spallation damage (Figure 6). About 26% of the total coating surface area had spalled.

Because of the damage to the first test vane (number 909), a second EBC-coated vane subelement (number 910) was prepared for continued testing. A 2-minute thermal cycle was employed for this stage of the testing. This cycle consisted of holding the gas temperature at a constant minimum value for 45 seconds, then heating to a maximum over 15 seconds, holding for 45 seconds, and finally cooling back to the minimum temperature in 15 seconds. Initial peak temperatures were based on experience obtained during the steady state testing. However, higher gas temperatures of up to 1420 °C were used for latter cycles. Under the higher gas temperatures, a peak material temperature of 1320 °C was obtained. After 102 cycles were completed, the rig was disassembled.

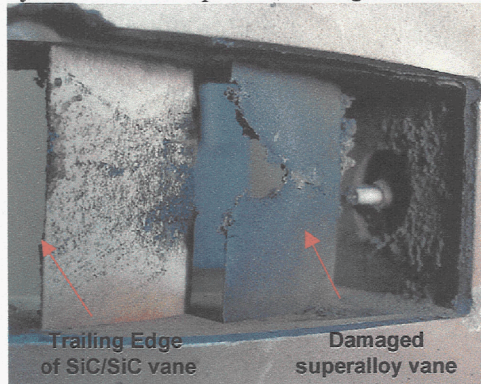
Figure 7 – SiC/SiC (number 910) and superalloy vane subelements after the cyclic testing.

Inspection of the test section after 102 cycles revealed considerable damage of the test section metal hardware. Melting of the superalloy vanes occurred, as well as other test section metal hardware. The SiC/SiC vane subelement was intact but had deposits on the EBC surface (Fig. 7). X-ray diffraction revealed evidence of the Co-based Haynes 188 vane on the suction side of the SiC/SiC vanes, (which can be seen in Fig. 7) and deposits of Ni-based Waspaloy on the pressure side. Note that both these alloys melt above 1400 °C and were used to fabricate test section hardware.

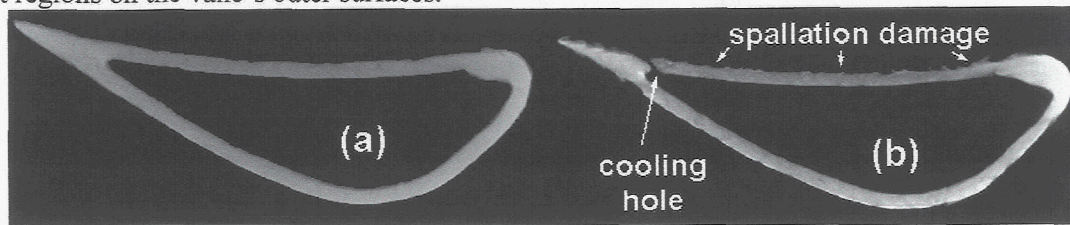
in Figure 8. Spallation damage can be seen in the post-test image, particularly on the pressure (i.e. concave) side of this vane. No composite damage in vane 910 was detected after rig testing using the CT inspection technique (Fig. 9). The superalloy deposits (as can be seen in Fig. 7) appear as the irregular bright regions on the vane's outer surfaces.

Figure 8 – Computed tomography images of vane 909, a) as-fabricated, b) after rig testing for 50 hours under steady state conditions.

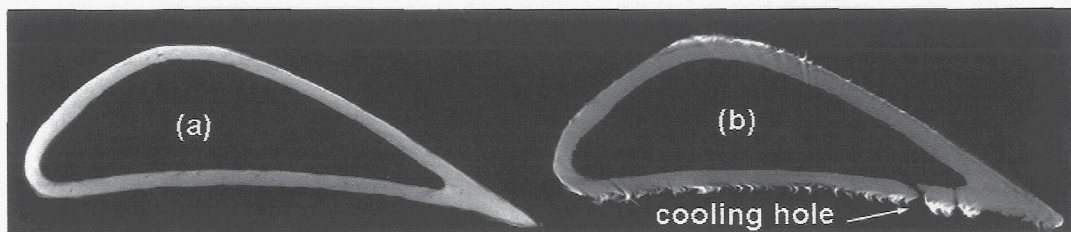
Figure 9 – Computed tomography images of vane 910, a) as-fabricated, b) after rig testing for 102 2-minute cycles.

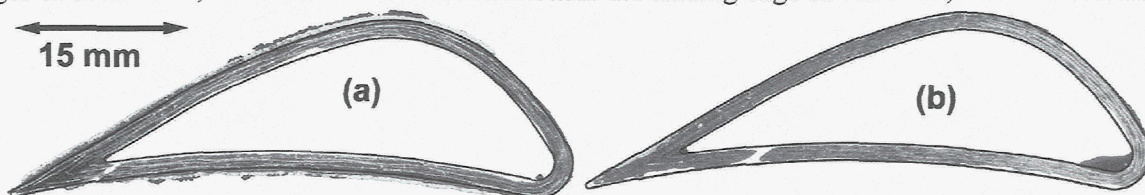
The cross sections of both vanes are shown in Figure 10. Engineering drawings of the inside and outside vane nominal profile are superimposed over the micrographs of the vanes. Both vanes retained their shape even after exposure to severe test conditions. Cooling holes can be seen near the trailing edges of both vanes, and excess matrix is evident near the leading edge of vane 909, on the inside surface.

Figure 10 – Cross sections of SiC/SiC vanes after rig testing, a) vane 910 tested under cyclic conditions, b) vane 909 tested under steady state conditions.

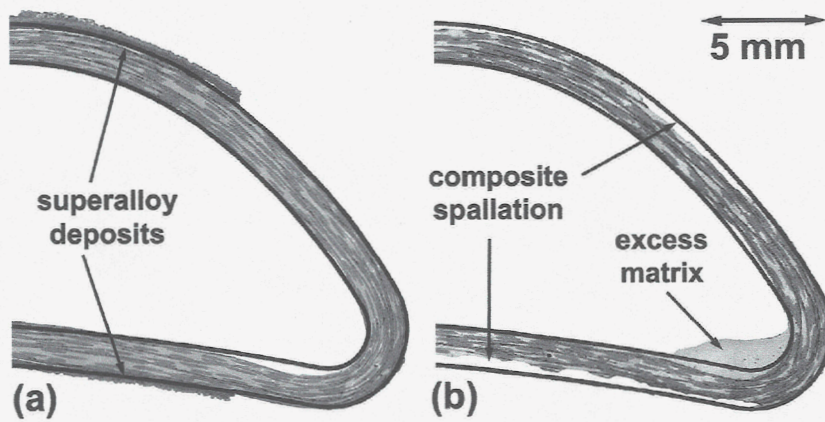
Since the finite element analyses predicted the highest stresses to exist in the leading and trailing edges, it is important to examine the microstructure in these regions. In Figure 11, details of the leading edges are shown. A coating of superalloy can be seen on vane 910 on both the pressure and suction sides, but not at leading edge. Spallation of outer composite plies exists in vane 909 at locations away from the leading edge. However, no cracks exist. In both vanes, the gap on the ID between the actual vane profile and the drawing near the leading edge are the result of the manufacturing process.

Figure 11 – Microstructure of the leading edge of SiC/SiC vane subelements after rig testing, a) vane 910 tested under cyclic conditions, b) vane 909 tested under steady state conditions.

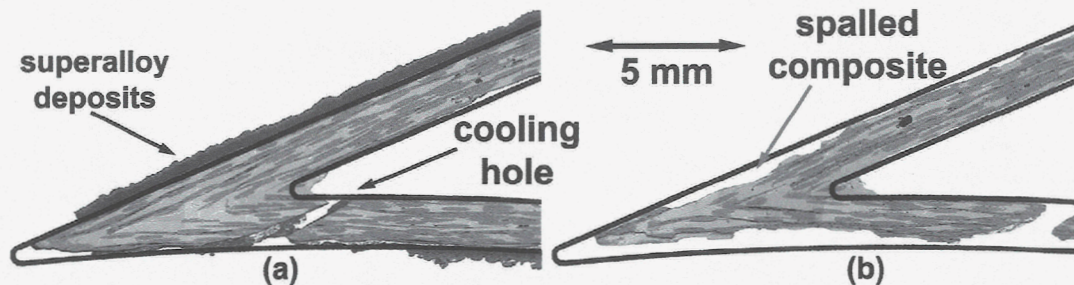
Details of the trailing edge microstructures (Figures 12 and 13) revealed features similar to those seen in the leading edge. Superalloy deposits of about 0.4 mm thickness extend toward the trailing edge radius in vane 910. The deposits cover the EBC but no obvious reaction with the SiC/SiC substrate is evident (Fig. 13a). Composite ply spallation and a crack are visible near the trailing edge of vane 909 (Fig. 12b). The outer ply is missing near the cooling hole while three outer plies

spalled off in the most damaged regions. Figure 13(b) shows a region with one missing ply. The EBC exists in a region with the original six plies. It is likely that this spallation, which occurred during rig start up, resulted in higher stresses in the trailing edge of vane 909 during subsequent rig operation, leading to the cracks as seen in Figs. 12 and 13. In spite of this damage, the trailing edge of vane 909 remained intact.

Figure 12 – Microstructure of the trailing edge of SiC/SiC vane subelements after rig testing, a) vane 910 tested under cyclic conditions, b) vane 909 tested under steady state conditions.

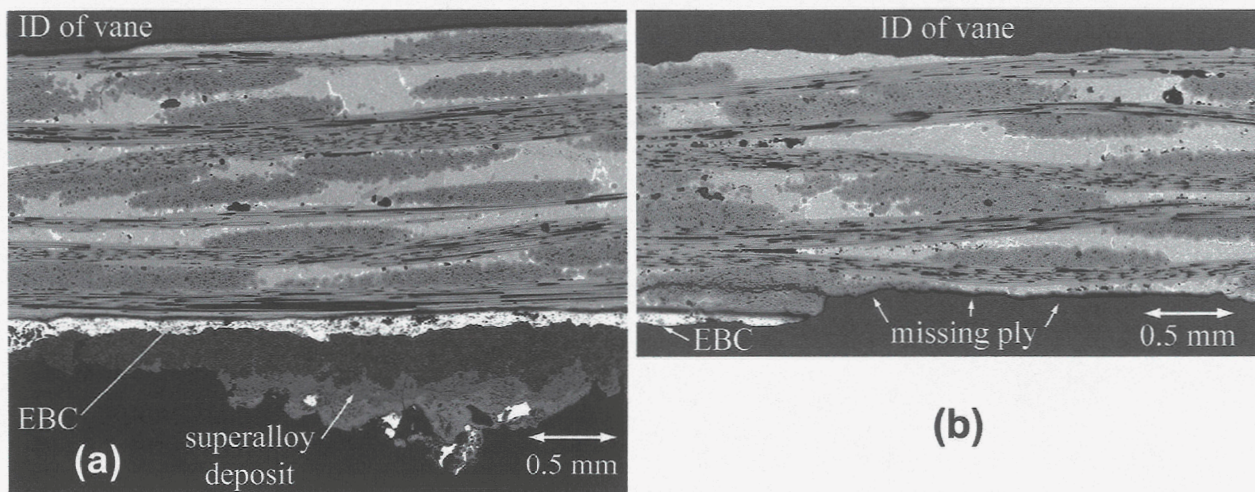
Figure 13- Microstructure of the pressure side of the vanes, 20 mm away from the tip of the trailing edge, a) vane 910 tested under cyclic conditions, b) vane 909 tested under steady state conditions.
