Fractographic Examination of the Vertical Stabilizer and Rudder from American Airlines Flight 587

Matthew R. Fox* and Carl R. Schultheisz†
National Transportation Safety Board, Washington D.C.

The first major structural component failure of a composite part on a commercial airplane occurred during the crash of American Airlines Flight 587. The fractured composite lugs that attached the vertical stabilizer to the aircraft tail and the fractured composite honeycomb rudder were examined as part of the National Transportation Safety Board investigation of the accident. In this paper the composite fractures are described and the resulting clues to the failure events are discussed.

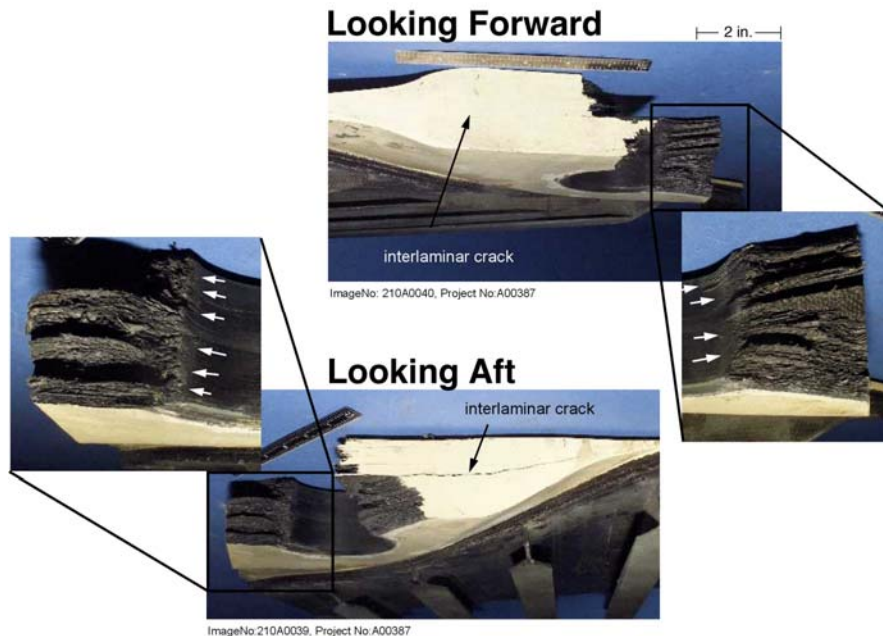
Figure 5. Right aft lug translaminar fractures (pictured from below the lug).

The right aft lug failed by translaminar fracture through the bolt hole as shown in Figure 5. The translaminar fracture surfaces had a rough appearance consistent with fracture primarily under tensile loading. Fractures on each leg of the lug were on different translaminar planes, and the change in planes occurred near the center of the lug thickness. On the aft side of the bolt hole, the outboard side of the fracture was in a plane nearly perpendicular to the zero-degree fiber direction, and the inboard side of the fracture was in a plane approximately parallel to the 45-degree fiber direction. On the forward side of the bolt hole, the outboard side of the fracture was in a plane approximately parallel to the zero-degree fiber direction, and the inboard side of the fracture was in a plane nearly

indicating that fracture occurred at the forward side first, and then the lower ligament hinged about the aft side.

parallel to rib 1. Bearing damage was observed at the bore surface near both fracture surfaces, as indicated by white unlabeled arrows in Figure 5.

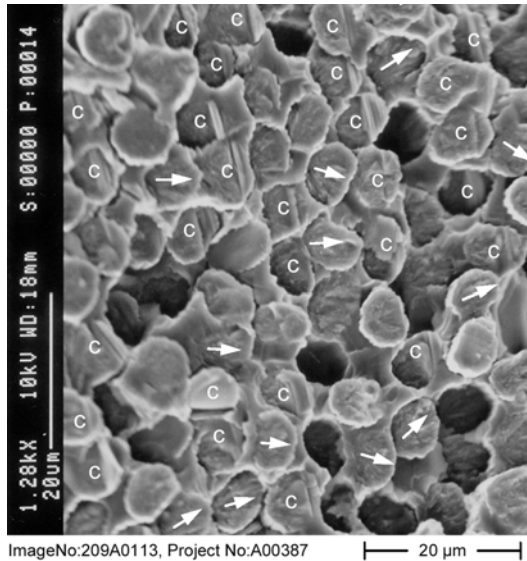
Figure 7. Fractured carbon fibers showing compression chop marks (C).

Fractures on the right forward lug intersected the lug hole. Translaminar fracture features were relatively rough, consistent with overstress fracture under tensile loading. Some evidence of local compressive loading was observed near the aft side of the lug,
