## **Development of Non Destructive Evaluation Techniques for the In-Situ Inspection of the Orbiter's Thermal Protection System**

José M. Hernández  
NASA – Johnson Space Center  
Houston, Texas

**IEEE Symposium  
Guadalajara, Mexico**

**Jose M. Hernandez  
NASA - Johnson Space Center  
April 2, 2004**

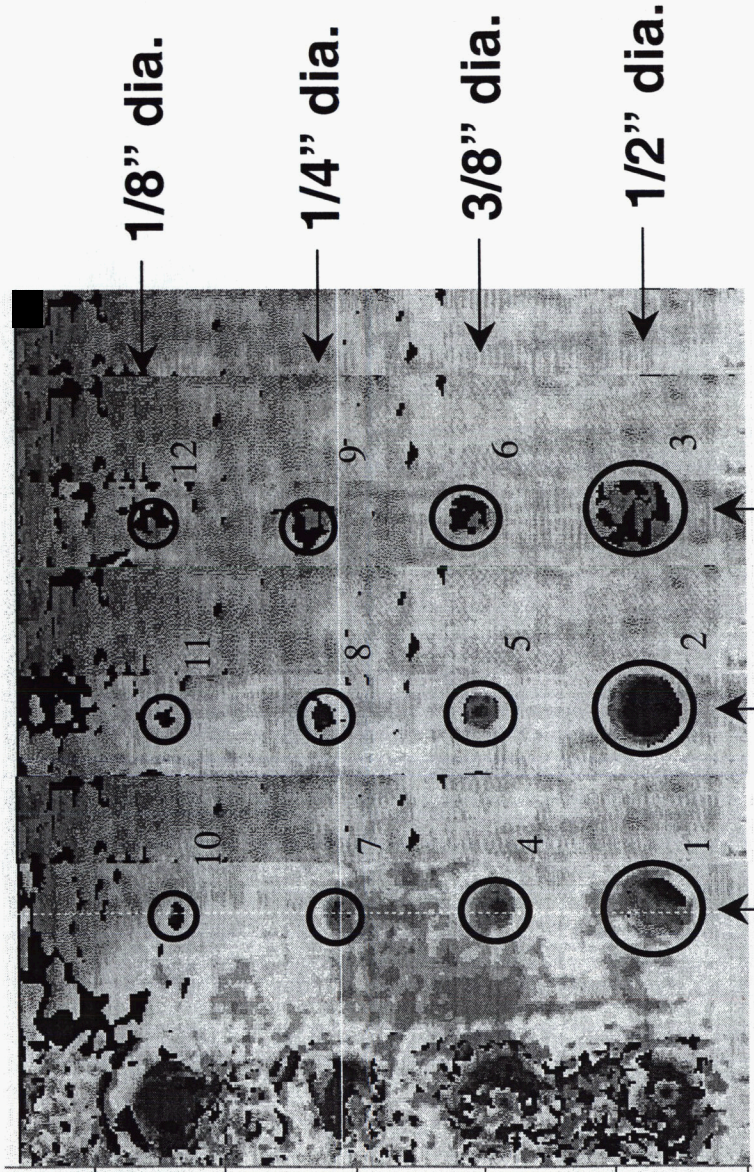
## 0.24" Thickness Sample

Back\* Side  
Mid  
Front\* Side

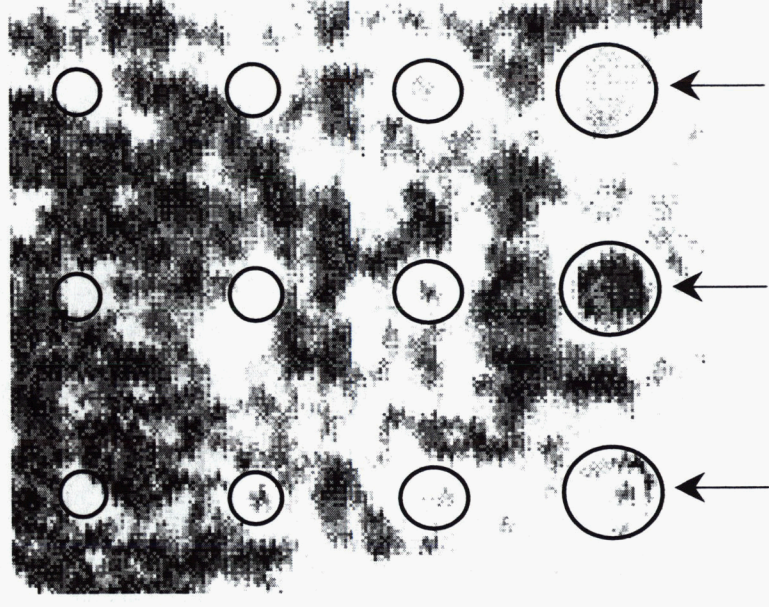
## 0.44" Thickness Sample

Back Side 0.4"  
Mid 0.22"  
Front Side 0.04"

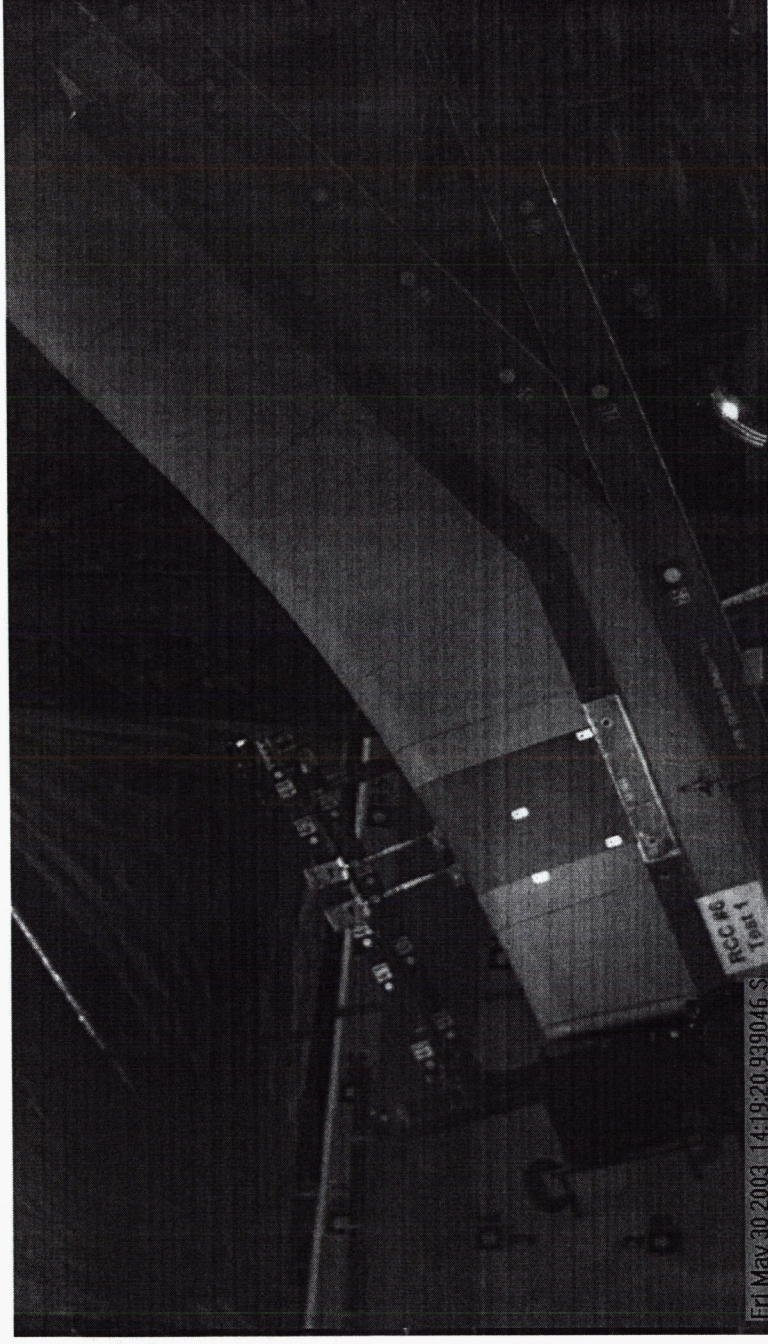
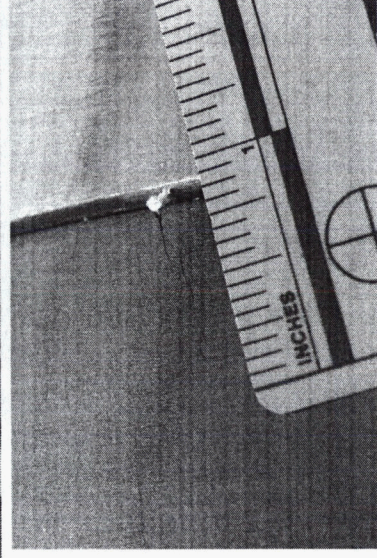
- Panel 6
  - Material: BX 250 foam
  - Dimensions: 5.63" x 11.56" x 21.38"
  - Mass: 763.8 g (1.68 lb)
  - Actual launch velocity: 768 ft/sec
  - CG angle of impact: 20.6°
  - 5½" long through thickness crack
  - Located on the lock side approximately 6" below the stagnation
  - Transverses the entire rib width, extends through the lock side channel and onto panel lower face.
  - Approximate 3/4" crack on the lower face
  - T-seal crack 2.5" long on rib

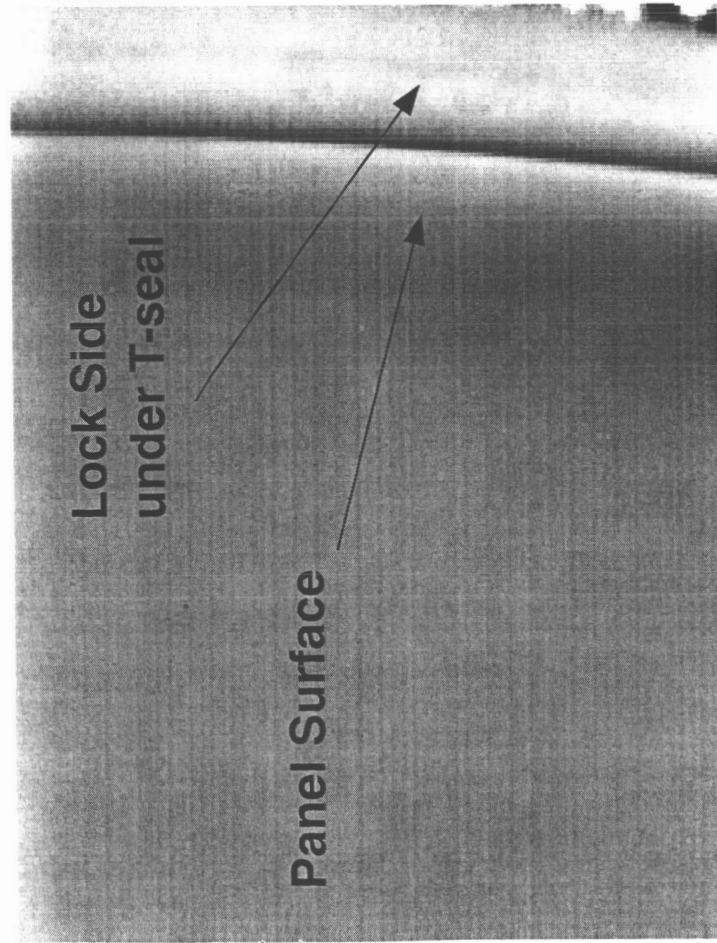
## OV-103 6L Pre Impact

Thermal Image of the location of the crack

**Outboard  
(W/out T-seal)**

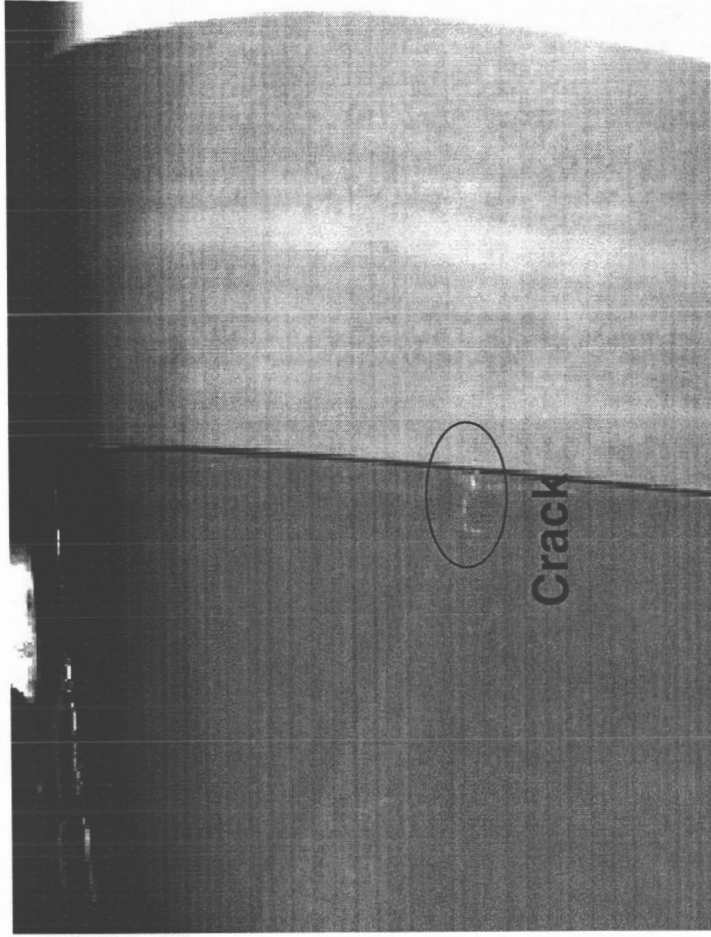
## OV-103 6L Post Impact

Thermal Image of the crack through the part

**Outboard  
(W/ T-seal)**
