# Materials Examination of the Vertical Stabilizer from American Airlines Flight 587

Matthew R. Fox<sup>1</sup>, Carl R. Schultheisz<sup>1</sup>, James R. Reeder<sup>2</sup>, and Brian J. Jensen<sup>2</sup>

<sup>1</sup>National Transportation Safety Board, 490 L'Enfant Plaza, SW, Washington, DC 20594

## Abstract

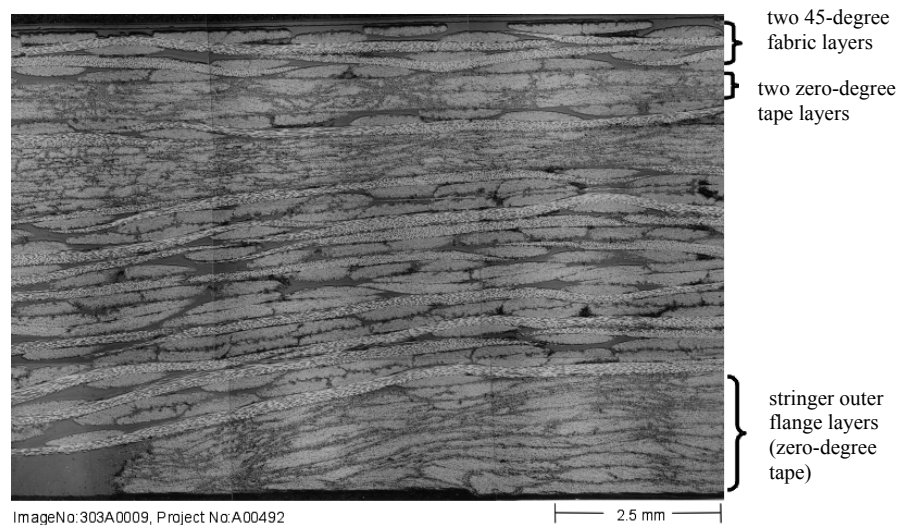
Figure 3: Microstructure of sample RS1.

content were determined using computer optical image analysis of polished micrographs. The layup in each sample was determined from optical micrographs of the specimens that were assembled into mosaics such as that of Figure 3.

Results of the microstructural examination and analysis indicated that the composite structure of the vertical stabilizer was constructed to the desired fiber volume fraction with acceptable void content. No evidence of microcracking was observed. The observed layups were compared to the engineering drawings obtained from the manufacturer, and among the 15 samples, only one sample from the right forward lug (sample RF4) showed any discrepancies. Within the 124 layers of sample RF4, 2 layers had orientations that were different from the drawing. Also, two layers appeared to be missing from one position through the thickness, but two additional layers were present at another position. The total number of layers for each orientation in sample RF4 was correct, and the discrepancies represented a small fraction of the total number of layers.

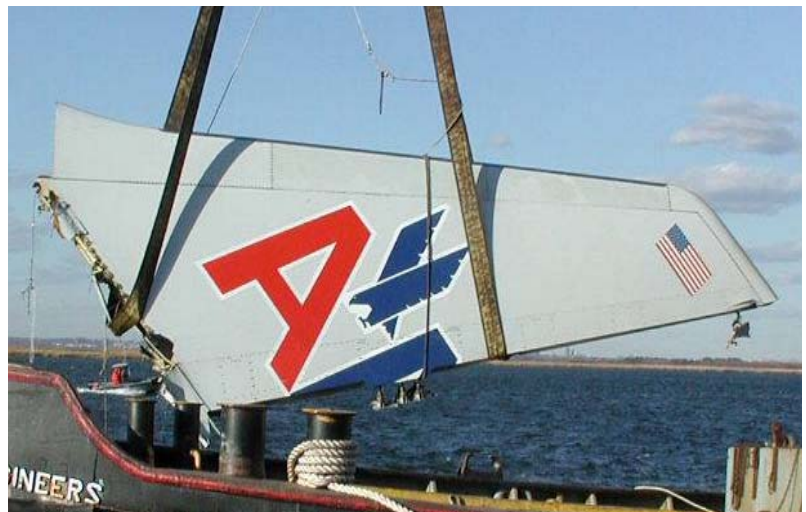
Figure 4: Vertical stabilizer as recovered from Jamaica Bay.

The vertical stabilizer was largely intact with no significant areas of skin buckling. An overall view of the vertical stabilizer as it was being recovered from the water of Jamaica Bay is shown in Figure 4. At the lower end, each of the six attachment locations were separated either by fractures that intersected the lug attach hole or by fractures through the

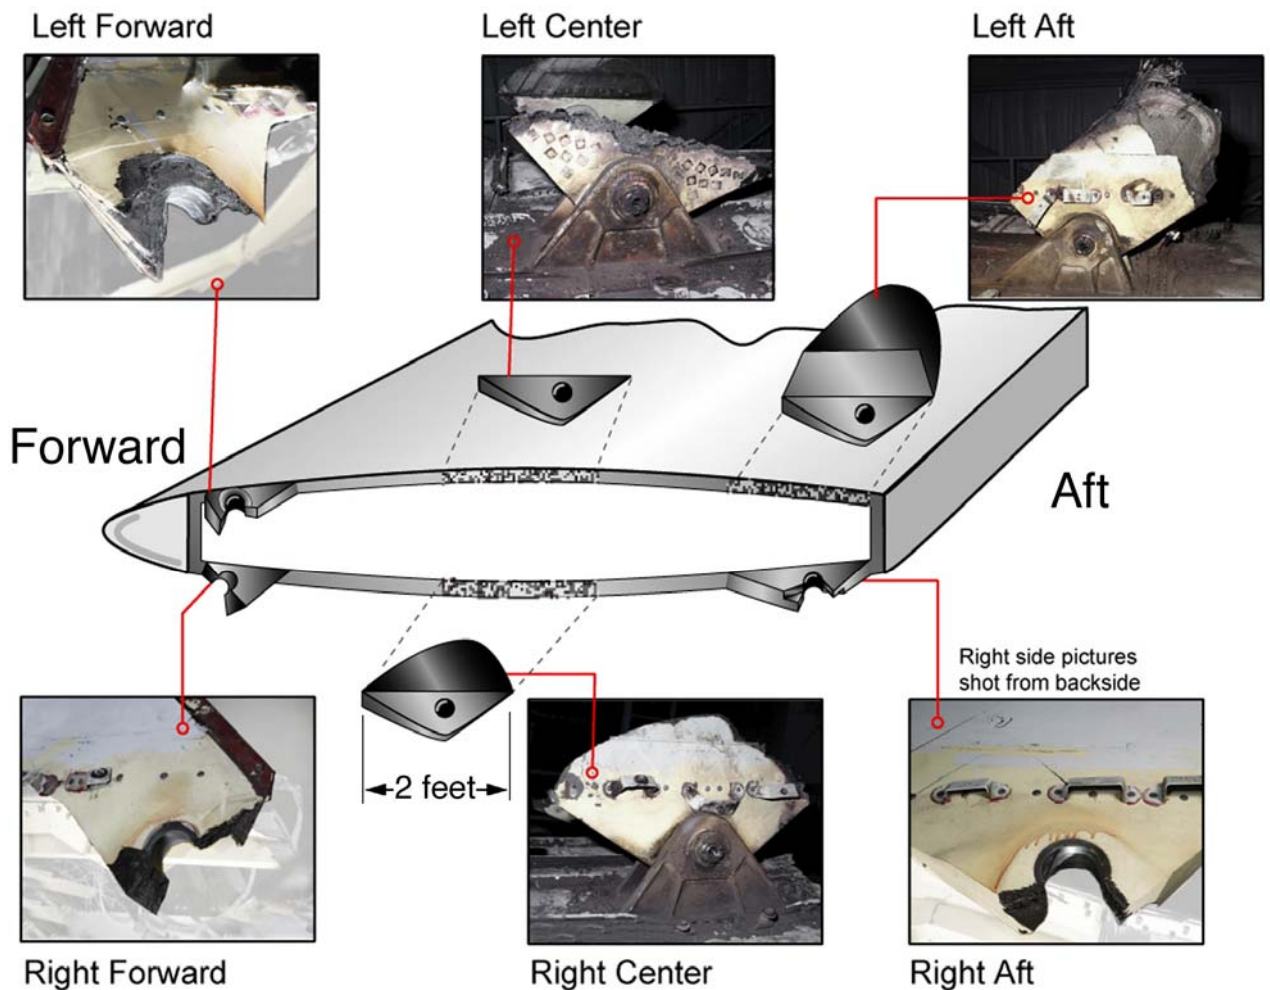
Figure 5: Overall views of main lug fractures with relative locations on vertical stabilizer.

structure above the hole. A schematic drawing of the lower end of the vertical stabilizer is shown in Figure 5, where a general fracture location for each lug is shown with overall views of each of these lug fractures. Portions of rib 1, the rib 1 rib-to-skin attach angle, and the lower end of the forward spar also were fractured. Along the trailing edge, the trailing edge panels were damaged in several locations. A more detailed description of the damage is presented in reference 6.

The right aft, right forward, and left forward main lugs had translaminar fractures that intersected the attachment hole, and the remaining three main lugs had translaminar fractures in the structure above the lug. Each of the lugs had delaminations in the lug area and/or in the structure above the lug. Details of the fractographic examination are presented in references 7 and 8. Some of the delaminations extended into the main portion of the vertical stabilizer, and the extents of these delaminations were determined using nondestructive inspection (NDI), including ultrasonic inspection and x-ray-computed tomography scanning and imaging. Results of the NDI of the vertical stabilizer are presented in references 9 and 10.

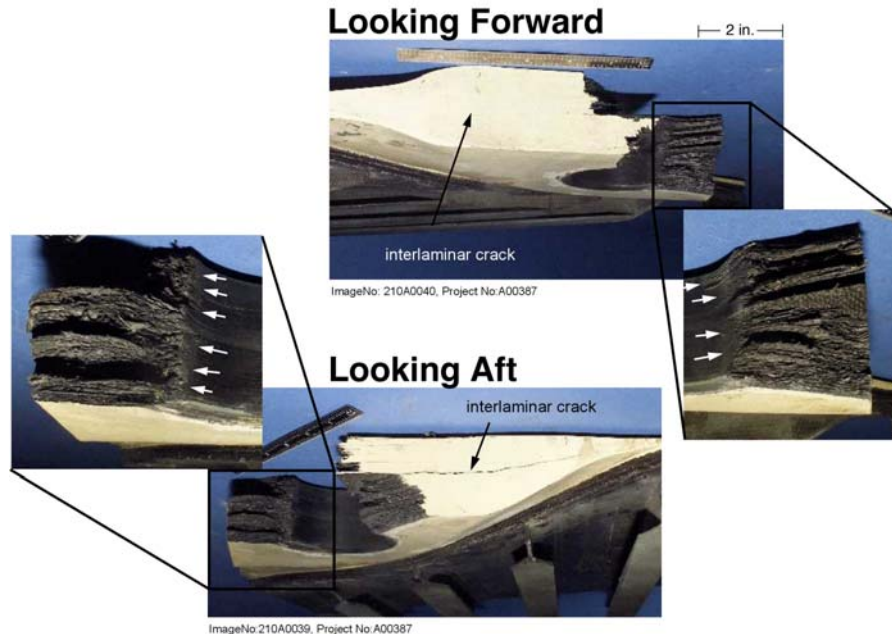
The right aft lug failed by translaminar fracture through the bolt hole as shown in Figure 6. The translaminar fracture surfaces had a rough appearance consistent with fracture primarily under tensile loading. Fractures on each leg of the lug were on different translaminar planes, and the change in planes occurred near the center of the lug thickness. On the aft side of the bolt hole, the outboard side of the fracture was in a plane nearly perpendicular to the zero-degree fiber direction, and the inboard side of the fracture was in a plane approximately parallel to the

Figure 6: Right aft lug translaminar fractures (pictured from below the lug).

45-degree fiber direction. On the forward side of the bolt hole, the outboard side of the fracture was in a plane approximately parallel to the zero-degree fiber direction, and the inboard side of the fracture was in a plane nearly parallel to rib 1. Bearing damage was observed at the bore surface near both fracture surfaces, as indicated by white unlabeled arrows in Figure 6.

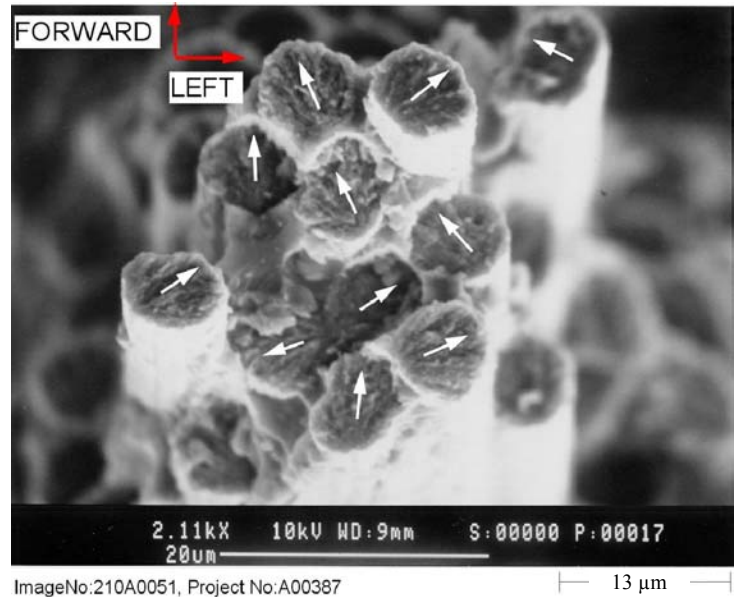
On translaminar fractures, the ends of some fibers were oriented roughly perpendicular to the fracture plane. A typical SEM view of these fiber ends on one of the translaminar fracture surfaces is shown in Figure 7. Fiber ends such as those shown in Figure 7 were examined using SEM to help determine the fracture mechanism and propagation direction. For fibers having radial patterns indicative of tensile fracture, the local fracture propagation direction could be determined from the direction of the radial pattern of several fibers [11, 12]. Then, general directions of fracture propagation for the translaminar fractures could be determined by averaging the directions indicated by the radial patterns across many areas of the fracture surfaces. Also, since fatigue and overstress fractures can appear similar from a macroscopic view, the microscopic examination of the fracture surfaces included looking for evidence of fatigue such as rounded edges on fiber ends [13] or striations in the matrix [5, 12, 14], however, no evidence of fatigue was observed on any of the translaminar fracture surfaces.

Figure 7: Fractured carbon fibers showing crack growth directions.

At high magnification, fiber end fractures for fibers oriented perpendicular to the fracture plane generally showed radial fracture features consistent with fracture under tensile loading. In an area near the outboard surface of the left center lug, fiber ends showed chop marks (lines across the fractured fiber ends), indicative of local compressive loading. Examples of these chop marks can be seen in Figure 8 on the fiber ends marked with a “C”. The combination of tension on the inside edge and compression on the outboard surface is associated with an overall lug bending to the left. Using the radial patterns on the lug translaminar fractures, fracture propagation directions were determined to be extending from the lug holes for the right aft, right forward, and left forward lugs (all lugs that had fractures intersecting the lug hole). For the right center lug, fracture propagated from aft to forward, and for the left center and left aft lugs, fracture propagated from forward to aft.

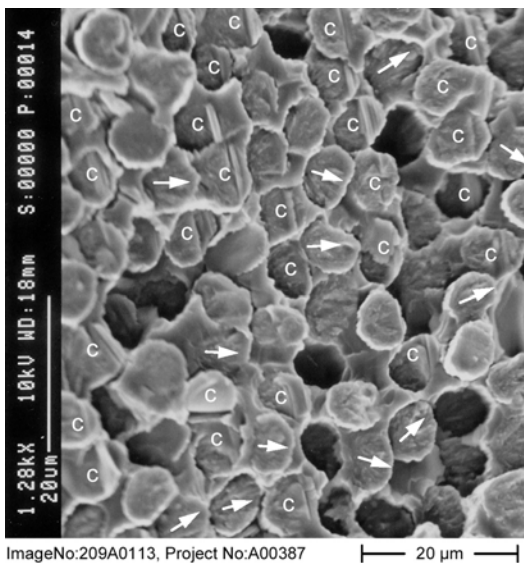
Figure 8: Fractured carbon fibers showing compression chop marks (C).

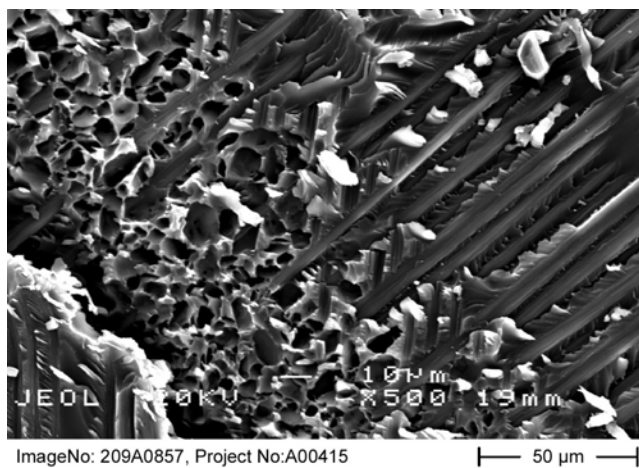
Figure 10: Porosity in matrix rich regions where bundles cross.

At the matrix-rich areas where bundles crossed, some porosity was observed having a somewhat angular appearance as shown in Figure 10. These pores were identified as arising from excess curing agent that had crystallized within the matrix. Such crystals

could have been physically removed in the fracture process or dissolved by the water from which the vertical stabilizer was recovered.

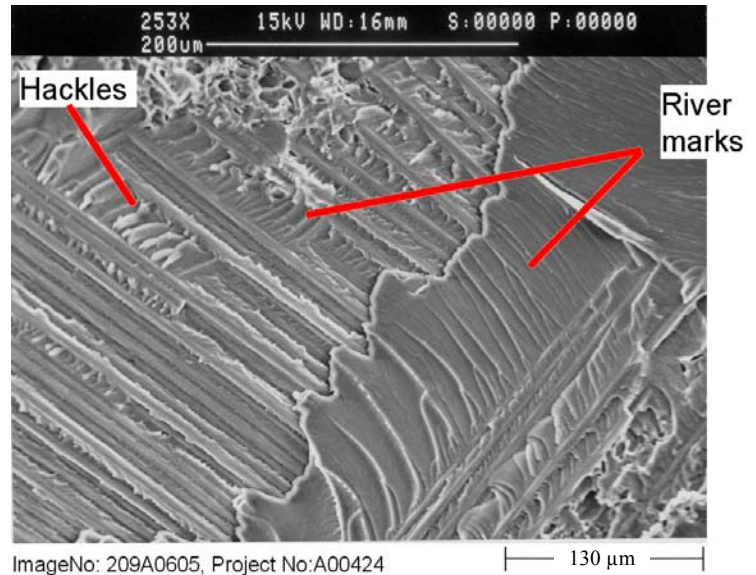
Samples of the delamination fracture surfaces were examined in the scanning electron microscope to determine the orientation of the shear stress at the fracture and to identify the direction of crack propagation. Fracture features that were used to make these determinations included hackles (thin plates of fractured matrix material between fibers oriented perpendicular to the fiber axis, with free edges that point in a general direction opposite to the local shear applied at the fracture surface) [15, 16] and river marks (related to the initiation of matrix cracks that coalesce into larger cracks, indicating the direction of propagation) [4]. A typical view of hackles and river marks observed on one of the delaminations is shown in Figure 9. The samples also were carefully examined for indications of fatigue crack propagation, such as striations in the fiber impressions in the matrix [5, 12], matrix rollers (pieces of fractured matrix material rolled into cylindrical shapes by the relative motion of the fracture surface during cyclic loading) [5, 12], or rubbed hackle formations [5], however no evidence of fatigue was observed on any of the delamination surfaces.

When hackles form in CFRP's, the hackles orient perpendicular to the fiber axes, so the hackles in the orthogonal bundles of the woven fabric would generally point in two orthogonal directions. In some cases, the superimposed imprints of unidirectional tape at 45° to those bundles also added hackles at a third direction. Hackles also point generally opposite the locally applied shear at the fracture surface, so the multiple orientations of hackles from the different fiber bundles bound the direction of the local shear within an angle of 90°.

Figure 9: Delamination fracture features.

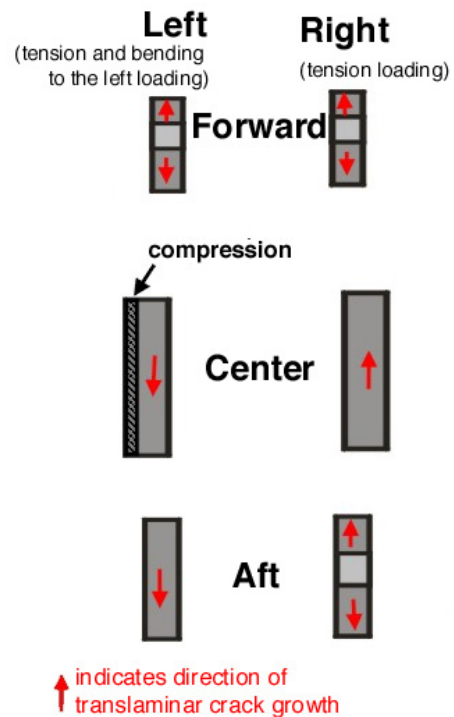
A summary of the observed fracture patterns is shown in Figure 11. The schematic drawing represents a horizontal cross-section of the vertical stabilizer through the main attachment lugs as viewed from above. Lug cross-sections with a light band at the center represent the lugs that failed through the bolt hole. Solid lug cross-sections represent fractures above the bolt holes. Arrows on the lug surfaces indicate the approximate direction of fracture observed on the translaminar surface. On the left center lug, the area of compression fracture features near the outboard side is indicated. The results showed that the failure pattern of fracture in tension on the right side was consistent with an overall bending of the vertical stabilizer to the left. On the left side, the failure pattern of tension and bending to the left was consistent with an overall bending of the vertical stabilizer to the left after fracture of the lugs on the right side.

It was noted that the only compression translaminar failure features were present on the vertical stabilizer at the outboard side of the center aft lug. Typically, composites have less strength in compression than tension. However, the design of the vertical stabilizer was such that the magnitude of the load needed to fail a lug in tension was less than the load needed to fail the lug in compression. Furthermore after failure of the lugs on the right side, the curvature of the panel would cause tension loading in the forward and aft lug and compression in the center lug with continued bending to the left. Other unknown factors, such as changes in air loading as the vertical stabilizer deflected after the initial fractures on the right side, would further influence the failure patterns on the left side.

Figure 11: Main lug fracture pattern summary (viewed from above).

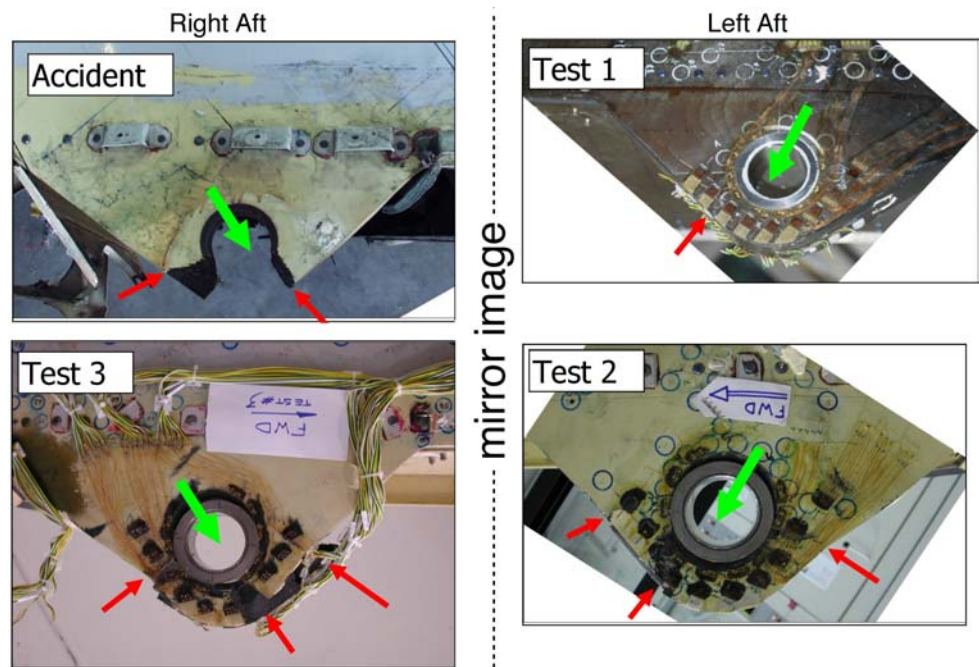
Overall views of the lugs from each test are shown in Figure 12 (outboard surface view). A similar view of the accident right aft lug also is shown in Figure 12. Unlabeled red arrows indicate where translamina cracks or fractures intersected the outboard surfaces of the lugs, and an unlabeled large green arrow indicates loading direction (the force vector for the horizontal and vertical loading components for each lug). The lugs from the first and second tests were left aft lugs, and as such, the orientations are mirror images of the accident right aft lug and the third test lug.

Results from the fractographic examination showed that fractures in the test lugs occurred at locations similar to those on the accident right aft lug. In the first test, loading was interrupted after a translamina crack occurred at the location indicated by the red arrow in the upper right photo in Figure 12. The translamina fracture was located at a position on the forward part of the lug in a plane nearly parallel to the resultant force direction, similar to one of the translamina fractures in the accident right aft lug.

Figure 12: Aft lugs from accident and subsequent subcomponent tests.

parallel to the loading direction and another translaminar fracture at the aft side of the hole in a plane approximately perpendicular to the loading direction, fractures similar to that of the accident lug. In addition on the outboard sides, a compression buckling fracture was observed on the forward sides of each lug above the fracture parallel to the loading direction, which is different from features on the accident lug but was attributed to constraints of the loading fixture. On the inboard sides of lugs 2 and 3, fracture locations were on translaminar planes different from that of the outboard side of the lug. This change in fracture planes was similar to that of the accident right aft lug.

A delamination was present within the first test lug having an extent similar to that of the accident right aft lug and in a location through the thickness slightly outboard of that of the accident right aft lug. Delaminations also were detected above the translaminar fractures in lugs 2 and 3. In lugs from tests 2 and 3, the locations of the delaminations through the thickness were similar to that of the accident right aft lug, but the extents of the delaminations in the test lugs were slightly less.

Each subcomponent test lug had translaminar fractures that intersected the lug hole and had delaminations that were located within the lug, features similar to the accident right aft lug. Each lug had a translaminar fracture at the forward lower side of the hole on the outboard side of the lug, including the first test, which was interrupted and had no other translaminar fractures. The fracture at the forward lower side of the hole corresponds to one of the translaminar fracture locations on the accident lug. The second test lug showed changes in translaminar fracture planes that were qualitatively similar to that of the accident right aft lug. These results indicated that the accident right aft lug had fracture features consistent with being the first lug fracture from a substantially intact vertical stabilizer and rudder under accident load conditions.
