NASA/TM—2005-214021

# Analysis of Carbon/Carbon Fragments From the Columbia Tragedy

David R. Tallant and Regina L. Simpson  
Sandia National Laboratories, Albuquerque, New Mexico

Nathan S. Jacobson  
Glenn Research Center, Cleveland, Ohio

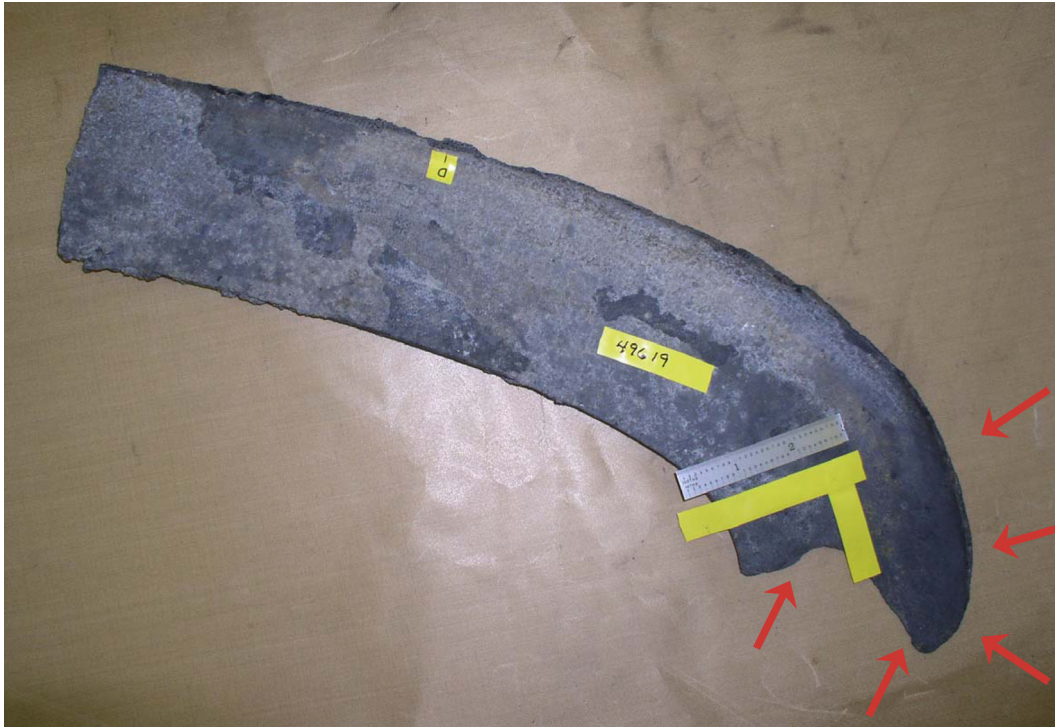
The accident investigation determined that the breach was in the underside of panel 8L, allowing the entry of the hot plasma and a subsequent series of catastrophic events. Several factors led to this conclusion. As noted, panels 8 and 9 are among the hottest panels on re-entry. Several fragments of these panels showed a sharp 'knife edge' appearance on their sides, as shown in Figure 4. When an exposed edge of RCC is exposed to a high velocity plasma stream, a 'knife edge' develops (Ref. 3). Such edges were not observed on fragments collected from other panels.

Figure 4.—Recovered portion of panel 8L, showing knife edge.

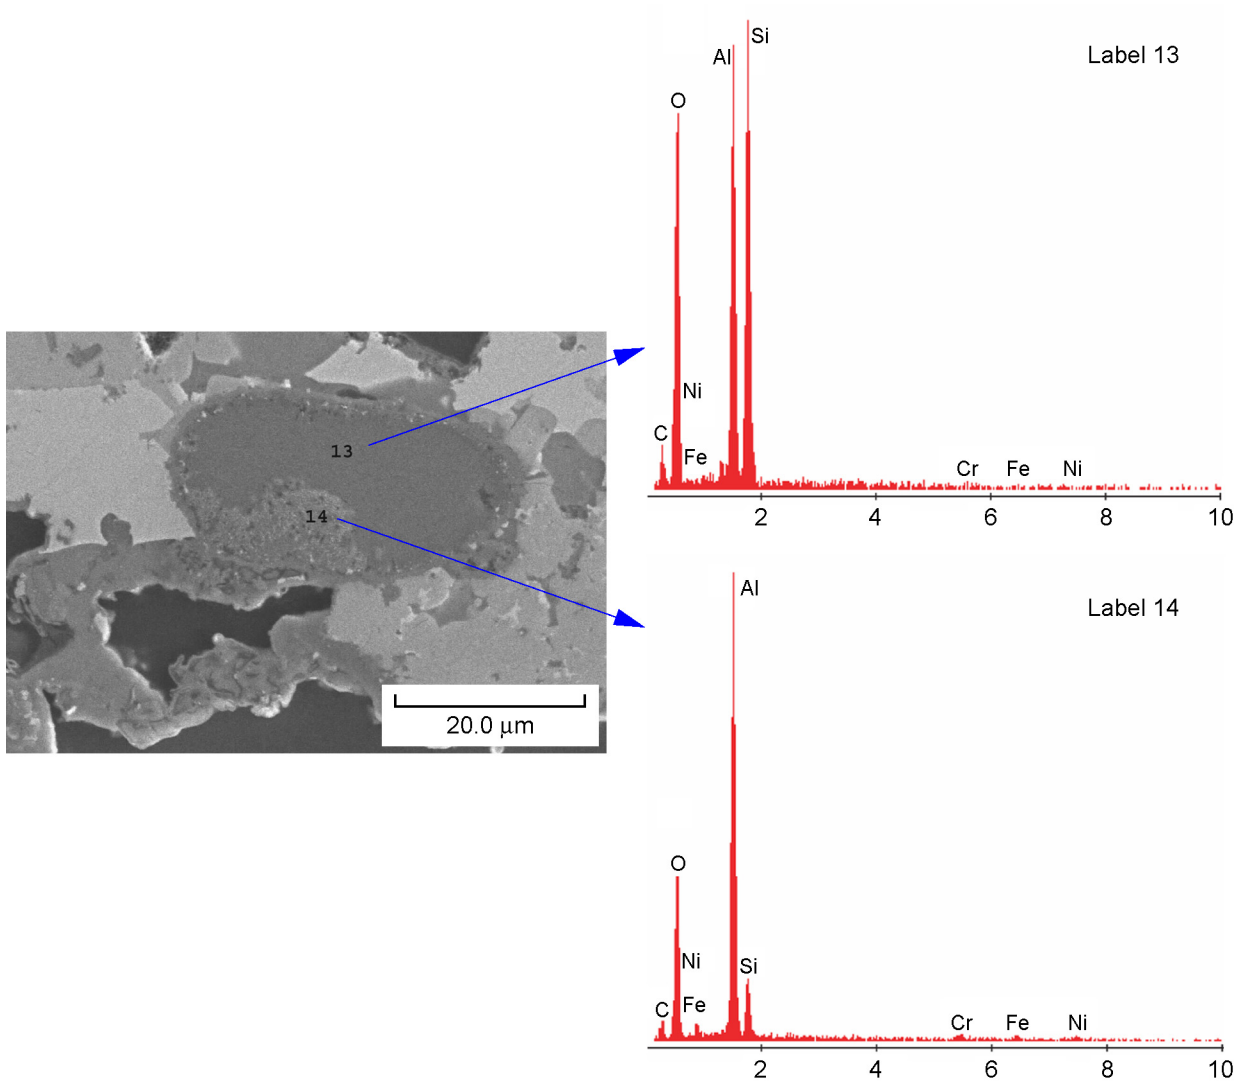
Nonetheless, some regions showed melted and solidified Cerachrome insulation. The center region in Figure 5 was not melted as it is not faceted and has a composition similar to the as-fabricated Cerachrome. The outer regions had melted and solidified, precipitating out alumina. The fact that the Cerachrome appeared to have melted and solidified set the temperature near the breach at 1760 °C or greater.

Figure 5.—Micrograph and EDS of probable melted and solidified Cerachrome® insulation.

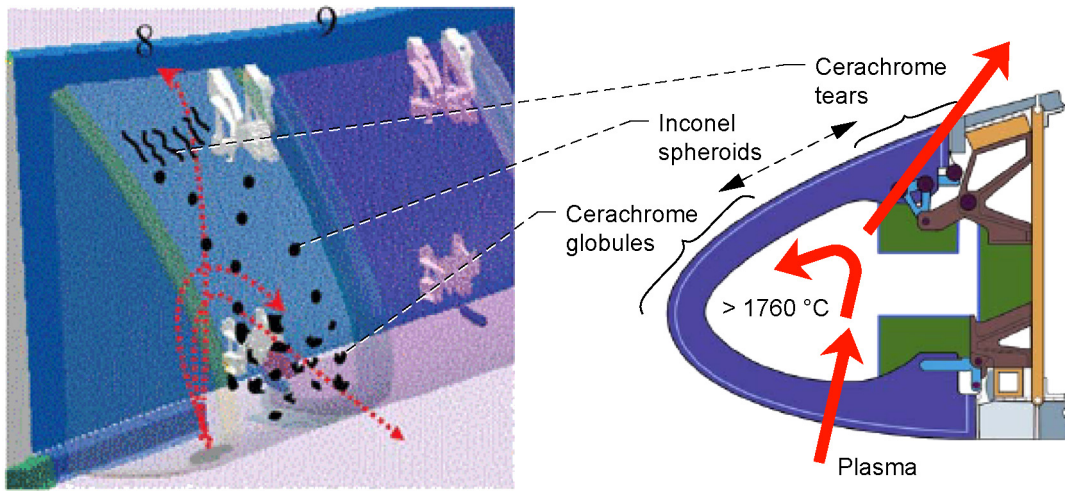
Figure 6 is a diagram showing the probable path of plasma entry from the breach on the underside of panel 8L. The location of the slag deposits are also shown. The upper portion of panel 8L was recovered and only a small amount of panel 9L was recovered.

Figure 6.—Schematic showing breach and entry of hot plasma gases on the underside of panel 8L.

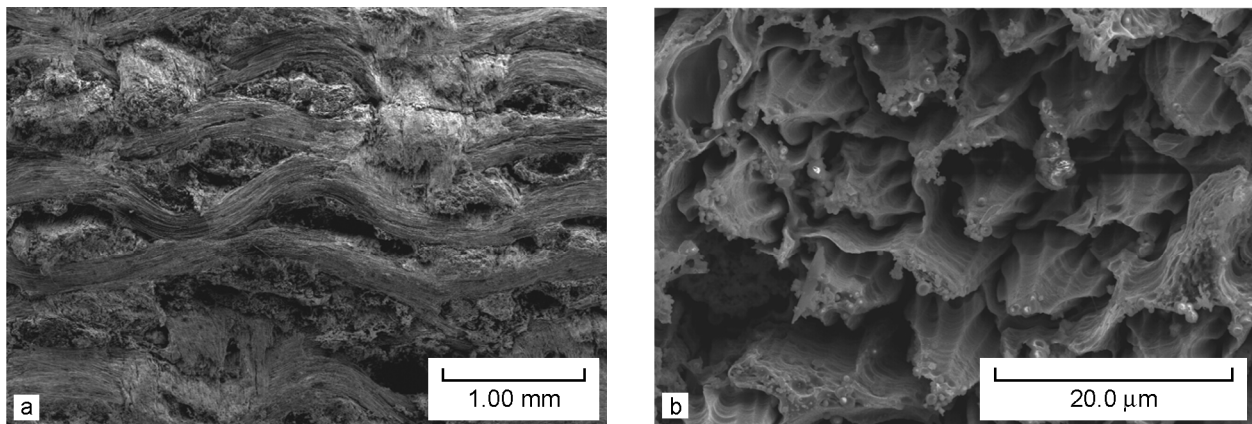
Specimen 38223B (Panel 9) had a fracture face with exposed carbon/carbon, as shown in Figure 11(a). Figure 11(b) shows a high magnification micrograph of a longitudinal fiber bundle. Note the pointed ends of the fibers, which is a morphology characteristic of high temperature oxidation (Refs. 8 and 9). This indicates that the fibers were exposed to hot oxidizing gases during the break-up of Columbia and that the fracture probably did not occur on impact to the ground. However, we cannot ascribe a temperature from this. Oxidation of carbon begins at about 500 °C and leads to this pointed morphology over a range of temperatures (Refs. 8 and 9).

Figure 11.—Electron micrograph of sample 38223B. (a) Low magnification view showing transverse and longitudinal fibers and slag (bright areas). (b) High magnification view, showing pointed fibers.

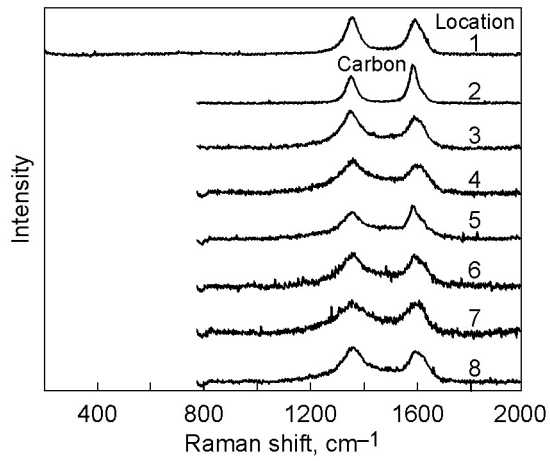
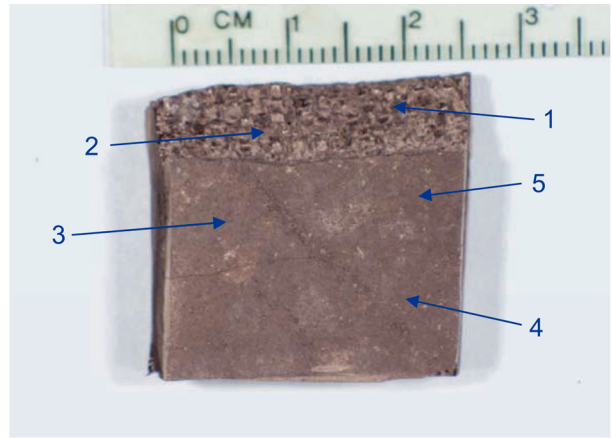
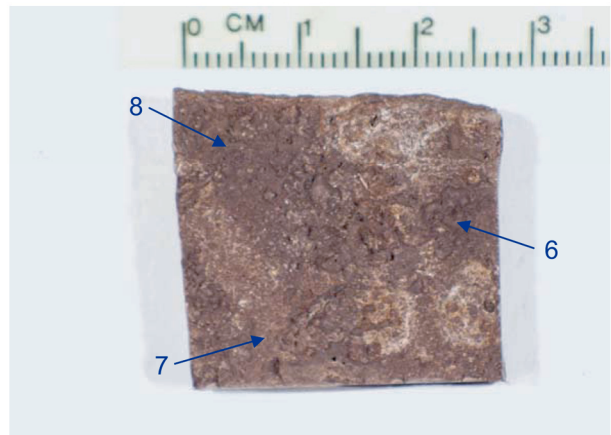
The Raman spectra for this sample 38223A (Panel 9) are shown in Figure 12. Locations 1 and 2 are from the fracture surface, similar to that examined with the SEM. Locations 3 to 8 are from the SiC surface and the carbon detected may be a contaminant from the exposed, pyrolyzed phenolic or soot deposited during Columbia’s break-up. The temperatures listed are estimated from comparison to the reference materials.

Location	Location Description	Summary of Identified Bands
1	Slope, smooth side	2300 °C carbon
2	Slope, smooth side	2600 °C carbon
3	Flat, lower, smooth side	1700 °C carbon
4	Flat, upper, smooth side	1300 °C carbon
5	Flat, lower, smooth side	1800 °C carbon plus low temperature carbon
6	Flat, lower, rough side	1400 °C carbon
7	Flat, upper, rough side	1200 °C carbon
8	Flat, lower, rough side	1500 °C carbon

Figure 12.—Raman spectra and analyses of sample 38223A.

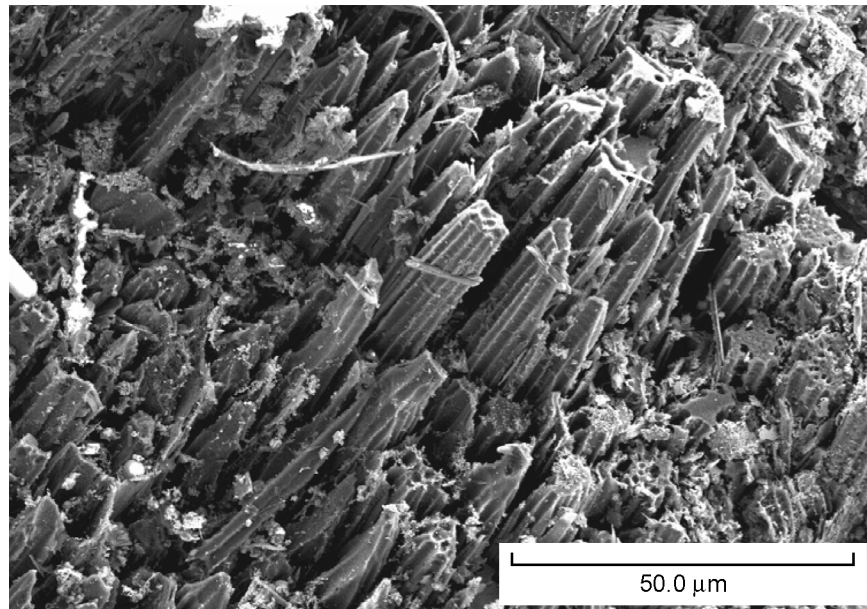
Sample 1860B (Panel 9) results are shown in Figures 13 and 14. The micrograph shows the pointed fibers, again indicating exposure to high temperature oxidizing gases. The Raman results are in Figure 14. Locations 1 and 2 are from the fracture surface. At location 1 the carbon Raman bands are low-temperature (400 to 1000 °C) and charcoal-like, which probably indicates deposition of pyrolysis products from after the break-up or contact with organic materials in the soil in which the part landed. However, the presence of Raman bands due to elemental silicon in the spectrum from location 1 indicates that, at some point, a much higher temperature was experienced. If the elemental silicon came from the

Figure 13.—Electron micrograph of exposed fibers from sample 1860B.

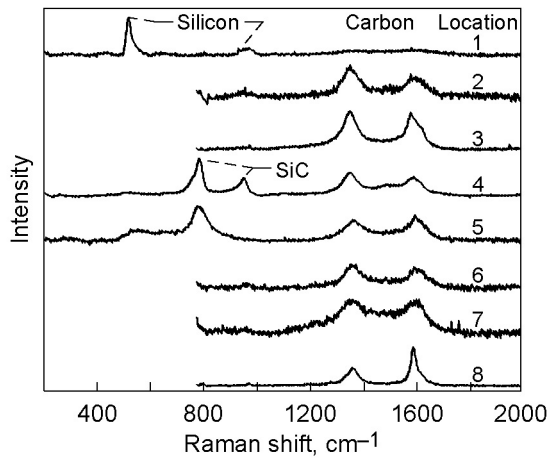
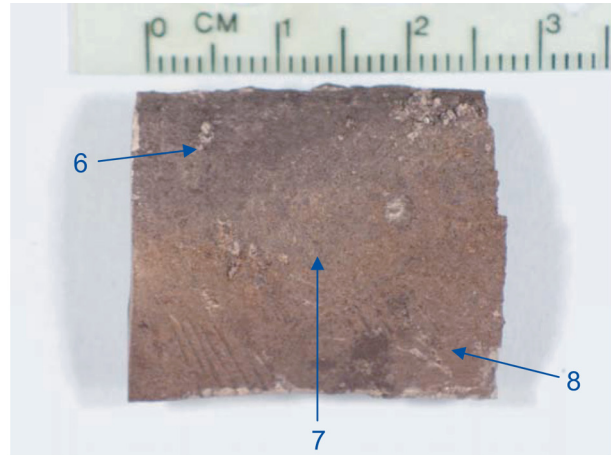
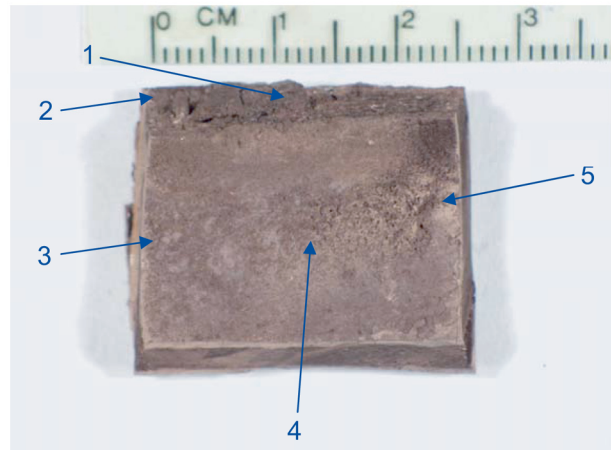
SiC layer of the RCC composite, the temperature at this location must have exceeded the point at which an appreciable Si(g) vapor pressure is generated (~2000 °C). Locations 3 to 7 indicate intermediate (1000 to 2000 °C) temperature carbon and silicon carbide, apparently a remnant of the SiC layer in the RCC composite. However, the Raman spectrum from location 8 indicates some very high temperature carbon, which may have deposited during the accident.

Location	Location Description	Summary of Identified Bands
1	Sloping edge, concave side	Microcrystalline silicon, 400 °C carbon
2	Sloping edge, concave side	1800–2200 °C carbon*
3	Edge, concave side	1800 °C carbon
4	Center, concave side	Silicon carbide, 1800–2200 °C carbon, amorphous carbon
5	Near side, concave side	Silicon carbide, 1600 °C ? carbon
6	Lower, convex side	1600 °C carbon
7	Center, convex side	1000 °C carbon
8	Upper, convex side	Silicon carbide (minor), > 2700 °C carbon

Figure 14.—Raman spectra and analyses of sample 1860A.

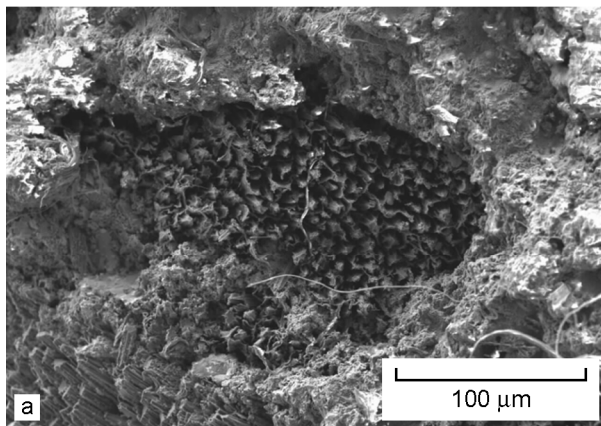
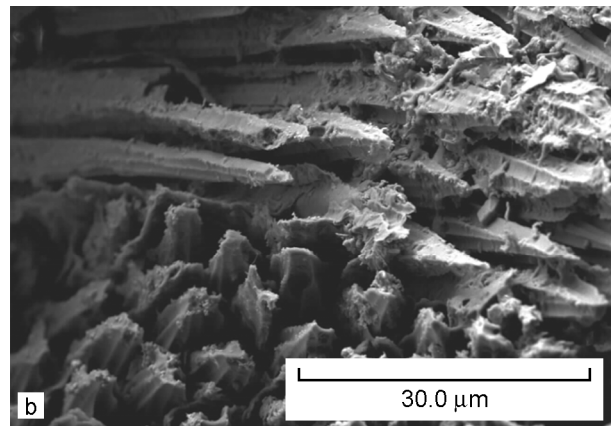
Sample 52018 (Panel 9) is shown in Figures 15 to 16. The micrographs show a bundle of pointed (oxidized) fibers along with some slag deposits. As shown in the lower macrograph in Figure 16, one of the SiC sides had spalled off, exposing a large region of carbon/carbon. The Raman spectrum from location 1 exhibits bands due to elemental silicon and carbon with an exposure temperature consistent with that required to decompose SiC (~2300 °C). Locations 4 to 6 were on the carbon/carbon and all showed high temperature carbon.

Figure 15.—Electron micrographs of sample 52018B. (a) Bundle of fibers surrounded by slag (brighter area). (b) Higher magnification view of pointed fibers.

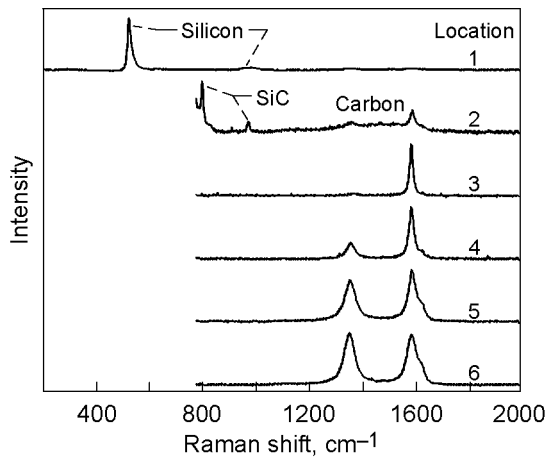
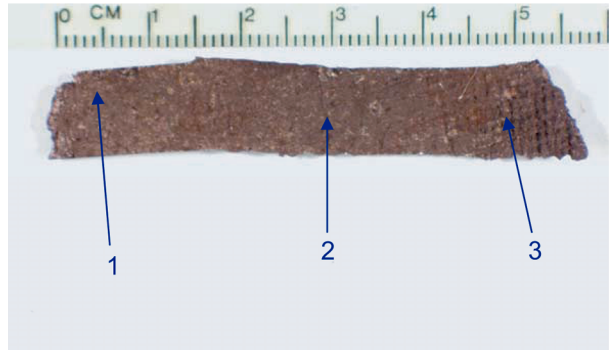
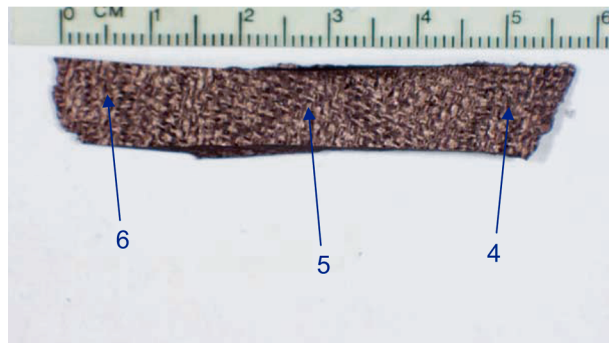
Location	Location Description	Summary of Identified Bands
1	Smooth side	Silicon plus low-intensity, 2300 °C ? carbon and low temperature carbon
2	Center, smooth side	Silicon carbide plus > 2700 °C carbon and low temperature carbon
3	Smooth side	>> 2700 °C carbon (off scale of reference carbons)
4	Rough side	> 2700 °C carbon (off scale of reference carbons)
5	Center, rough side	2500 °C carbon
6	Rough side	2300-2400 °C carbon

Figure 16.—Raman spectra and analyses of sample 52018A.

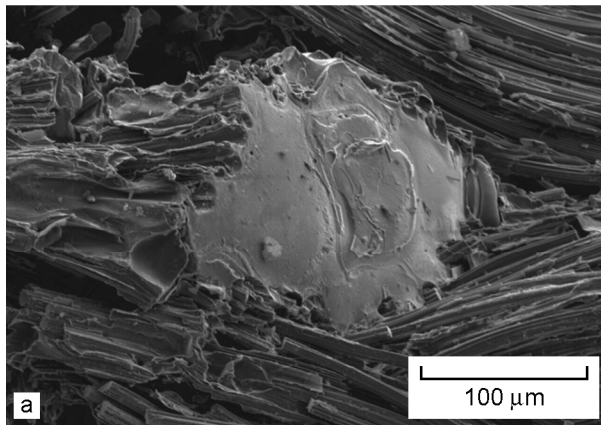
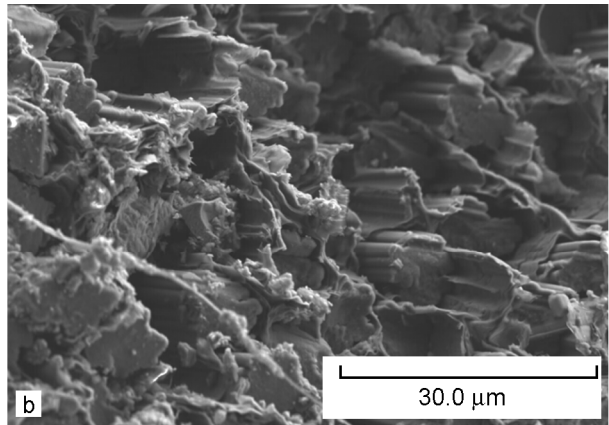
Sample 58291 (Panel 8) (Figure 17) showed some unusual microstructural features in the carbon/carbon. A large region of matrix is shown at the end of some fiber bundles in Figure 17(a). An EDS analysis of this region showed it to be all carbon. This may be a deposit of matrix material at the end of a fiber bundle; however this is an unusual morphology. Alternatively, this morphology may have resulted from the accident. It appears that the matrix has flowed, but it is unlikely that the melting point of carbon was reached (~3500 °C). The image in Figure 17(b) is a fracture surface with pulled out fibers and remaining matrix. There are no clear pointed fibers here but the microstructure is similar to that of eroded carbon/carbon (Ref. 10). In the Raman spectra of Figure 18 the bands indicate high temperatures were reached in locations 1, 5, and 6 in the exposed carbon/carbon. Note that the spectrum for location 6 shows high temperature carbon that is off the scale of the reference carbons. The lower temperature carbon in locations 2, 3 and 4 may be due to late-term deposition of pyrolysis products or soil contaminants.

Figure 17.—Electron micrograph of unusual features in sample 58291B. (a) Large area of matrix which had possibly flowed. (b) Longitudinal fibers, showing fractured and possibly eroded surface.

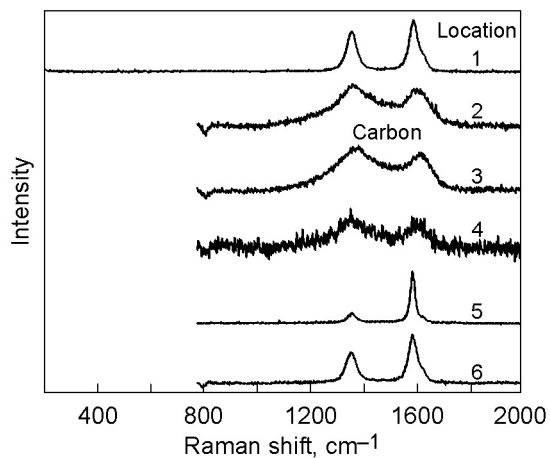
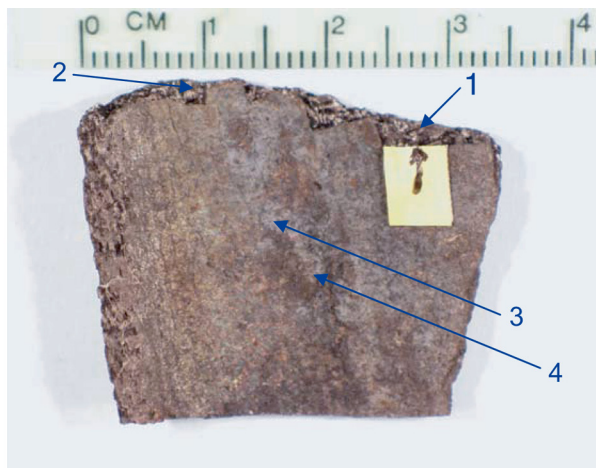
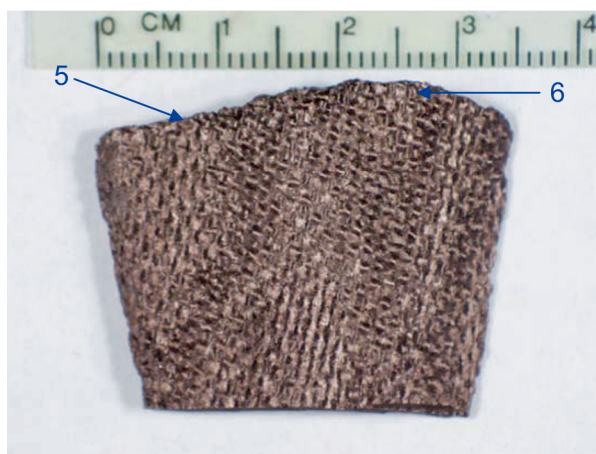
Location	Location Description	Summary of Identified Bands
1	Knife edge (arrow), smooth side	2500 °C carbon
2	Knife edge, smooth side	700–1000 °C carbon
3	Erosion hole, center, smooth side	700–1000 °C carbon
4	Erosion hole, center, smooth side	700–1000 °C carbon
5	Knife edge, rough side	> 2700 °C carbon (off scale of reference carbons)
6	Knife edge, rough side	2700 °C carbon

Figure 18.—Raman spectra and analyses of sample 58291A.

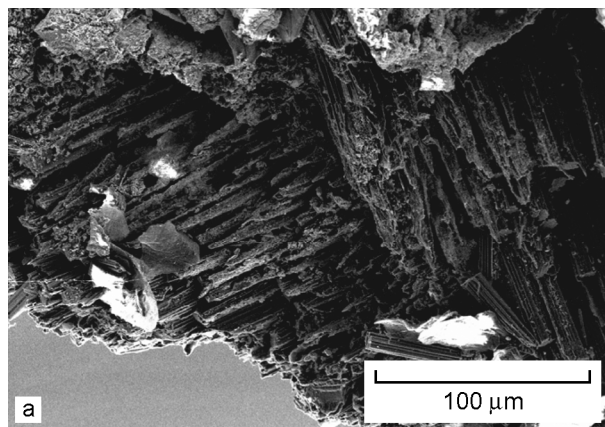
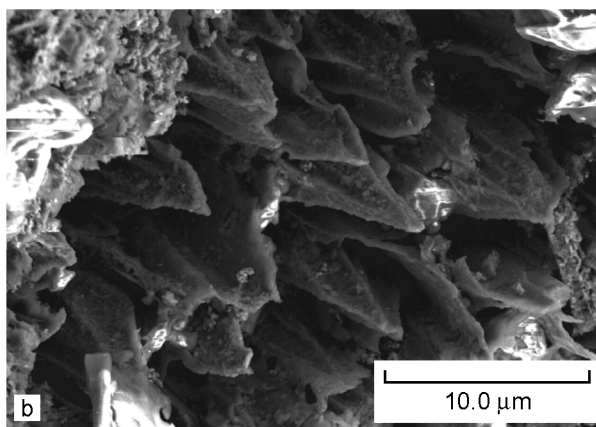
The remaining two panel 8 samples showed high temperature carbon. Sample 49619B (Panel 8) had slag deposits and fibers with flat fracture surfaces. However, at the knife edge of sample 49619B (Panel 8) regions of fibers were found exposed between surrounding slag, as shown in Figure 19. The pointed morphology observed is characteristic of exposure to high-temperature oxidizing gases.

Figure 19.—Electron micrographs of sample 49619B.

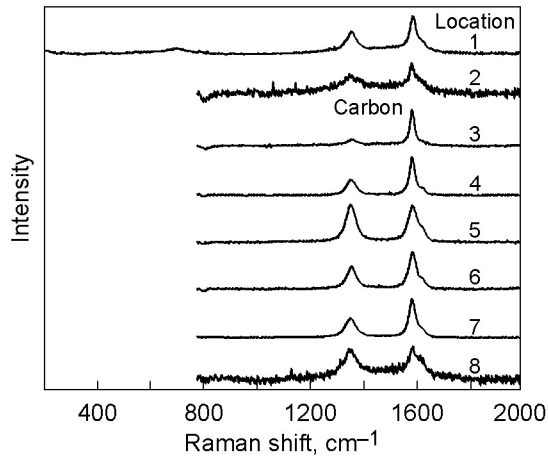
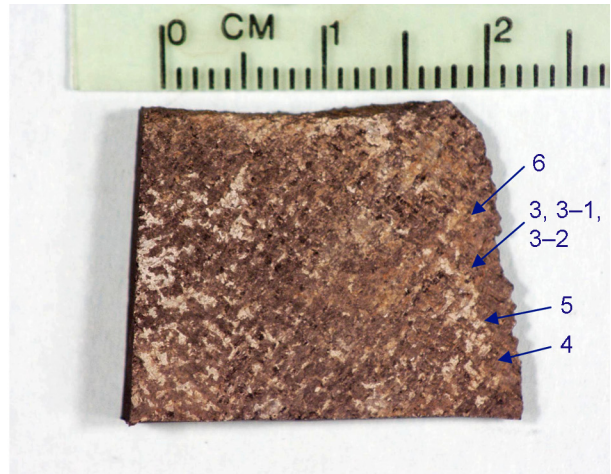
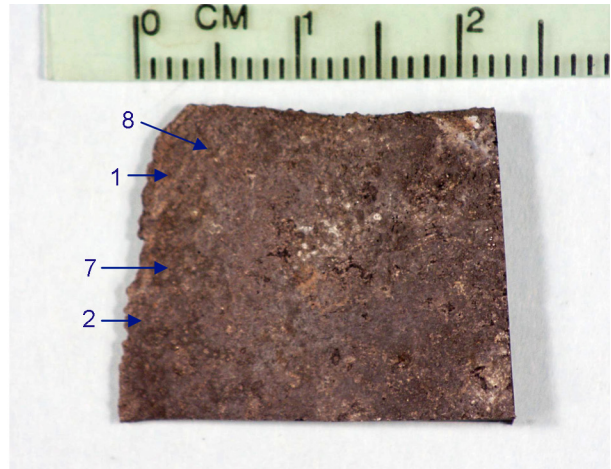
The Raman spectra for sample 49619A are given in Figure 20. Note the presence of high temperature carbon on several points of this sample. Location 3 in particular showed a carbon spectrum which was off the scale of the reference materials and estimated to have been exposed to temperatures much greater than 2700 °C. Note that the 1350 cm<sup>-1</sup> band in this case is barely observable. This location was studied in more detail to determine whether these extremely high temperatures are the result of exposure that occurred during the accident or whether they reflect processing temperatures reached during manufacturing of the RCC.

Location	Location Description	Summary of Identified Bands
1	Knife edge	2700 °C carbon plus small amount of low temperature carbon
2	Knife edge	2700 °C carbon plus small amount of low temperature carbon
3	Knife edge	>> 2700 °C carbon (off scale of reference carbons)
4	Knife edge	> 2700 °C carbon (off scale of reference carbons)
5	Up slope	2400 °C carbon
6	Up slope	2700 °C carbon
7	Up slope	> 2700 °C carbon (off scale of reference carbons)
8	Up slope	2400 °C carbon

Figure 20.—Raman spectra and analyses of sample 49619A.

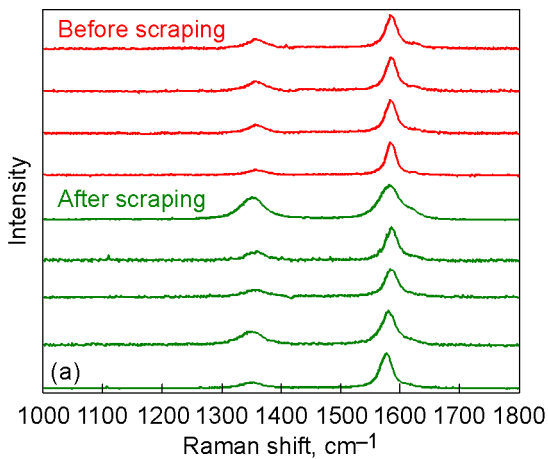
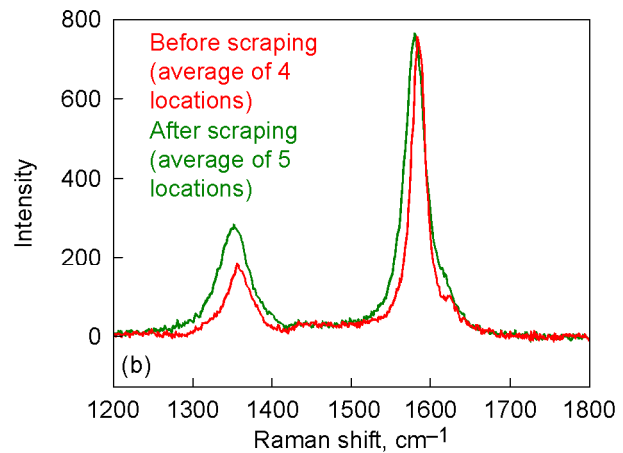
Figure 21(a) shows Raman spectra from the survey of RCC sample 49619A (Panel 8), near location 3 (designated 3-1), before and after scraping. An estimated 0.5 mm was removed by scraping to search for a possible thermal gradient. Prior experience indicates that substantial thermal gradients can be found in carbon/carbon exposed to re-entry environments (Ref. 5). The Raman spectra obtained before scraping are relatively consistent in band pattern and correlate to temperatures much greater than 2700 °C from the references. The Raman spectra obtained after scraping show a greater variation in band pattern. The average spectrum from after scraping has a more intense lower frequency band (Figure 21(b)), correlating to a lower average temperature. The before/after Raman spectra are consistent with a top layer of carbon uniformly exposed to very high external temperatures over layers more diverse in carbon structures (i.e., fiber and lower temperature matrix).

Figure 21.—Raman spectra from sample 49619A, location 3-1. (a) Spectra from multiple locations before and after scraping. (b) Average Raman spectra before and after scraping.

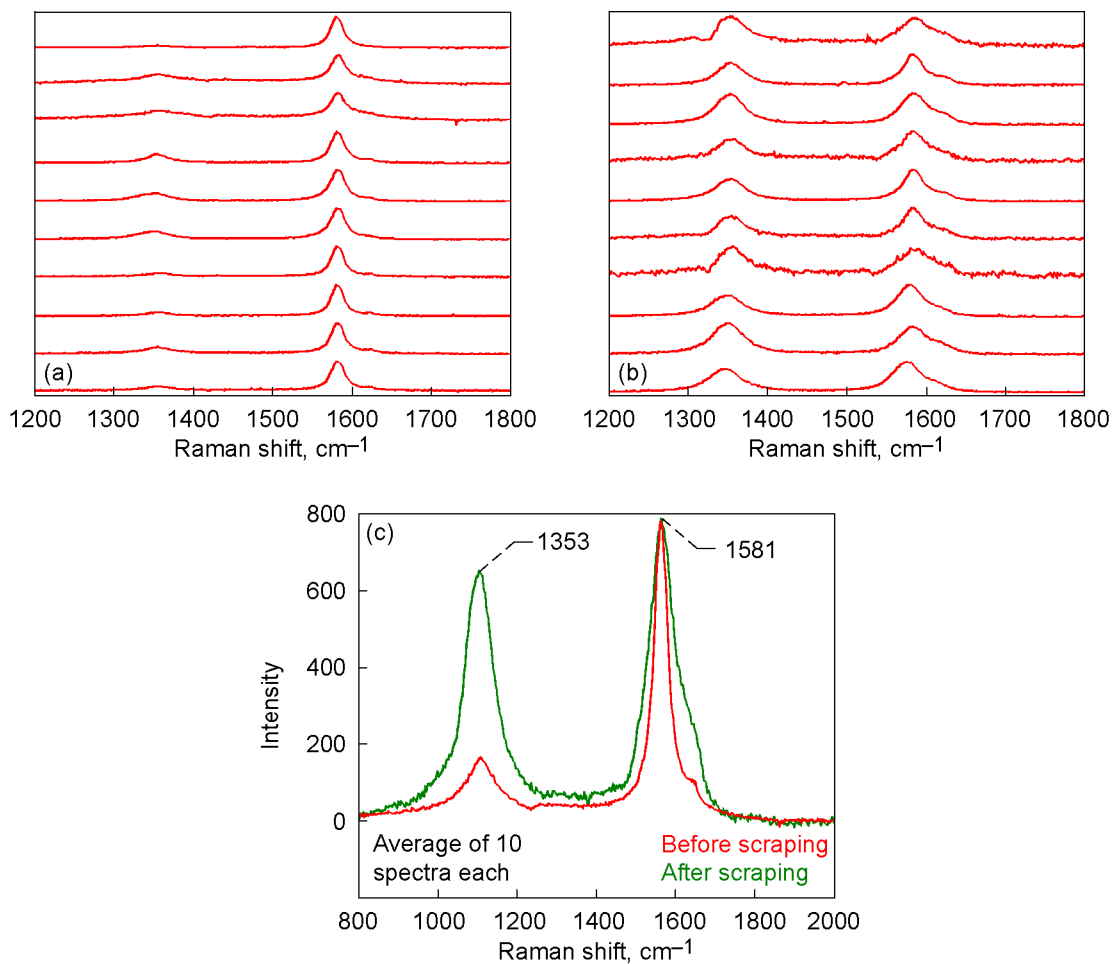
Figures 22(a) (before scraping) and 22(b) (after scraping) show ten Raman spectra each from RCC sample 49619A (Panel 8), also near location 3 (designated 3-2). The spectra obtained before scraping show some variability in band pattern but all correlate to temperatures greater than 2700 °C. The spectra obtained after scraping have a consistently different carbon Raman band pattern, with a more intense lower frequency band. The spectra obtained after scraping correlate to exposure temperatures near 2400 °C, lower and closer to that seen in the as-fabricated material (Figure 10(c)). The difference between the carbon Raman band patterns before and after scraping can be seen more readily from their average spectra, plotted in Figure 22(c). These scraping experiments indicate that the carbon at location 3-2 on

RCC sample 49619A (Panel 8) experienced a thermal gradient consistent with exposure to extremely high temperatures at the carbon/atmosphere interface, consistent with re-entry heating. It appears that the extremely high temperature exposures, inferred from the carbon Raman spectra at locations 3-1 and 3-2 on RCC sample 46919A, and probably at other locations as well, occurred during Columbia's break-up rather than during manufacturing of the RCC panels.

Figure 22.—Raman spectra from sample 49619A, location 3-2. (a) Spectra from multiple locations before scraping. (b) Spectra from multiple locations after scraping. (c) Average spectra before and after scraping.

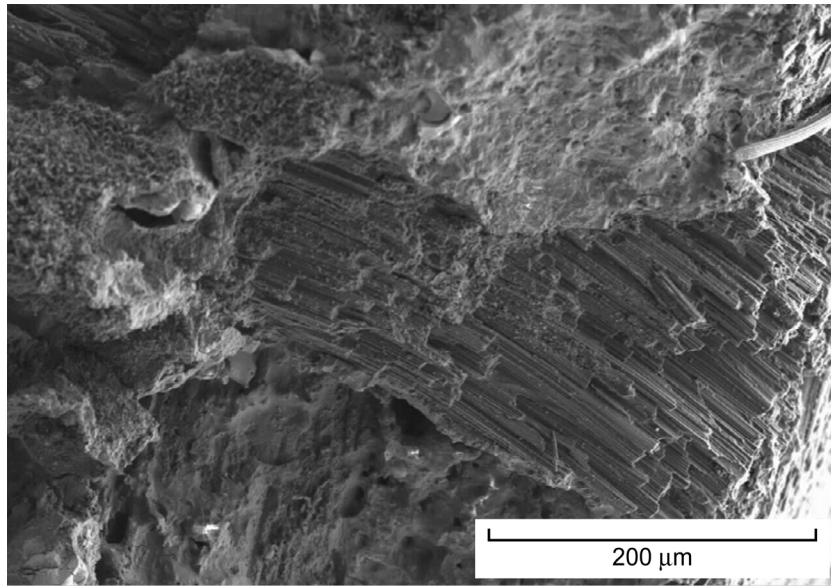
Figure 23 is a view of sample 2200B. As with the other samples, this sample had large amounts of slag deposits. On this microscopy sample, 2200B, no pointed fibers were observed. However the Raman sample, 2200A (Fig. 2), two of the locations (3 and 4) had spectra indicating high temperature carbon. As noted, the microscopy and Raman samples were adjacent, but may not be identical. The spectra from RCC sample 2200A also include bands due to remnants of the SiC layer in the RCC.

Figure 23.—Electron micrographs of sample 2200B. The portion near the top (brighter region) was covered with slag.

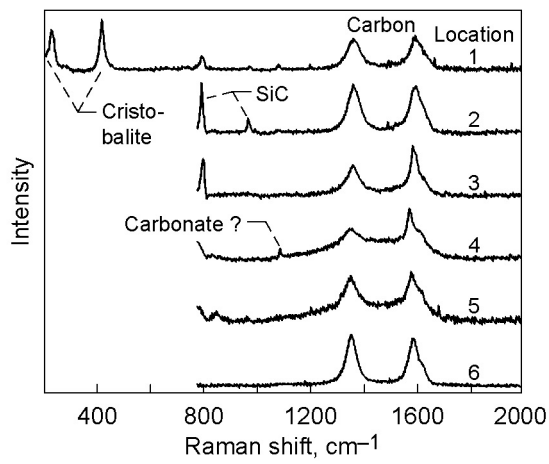
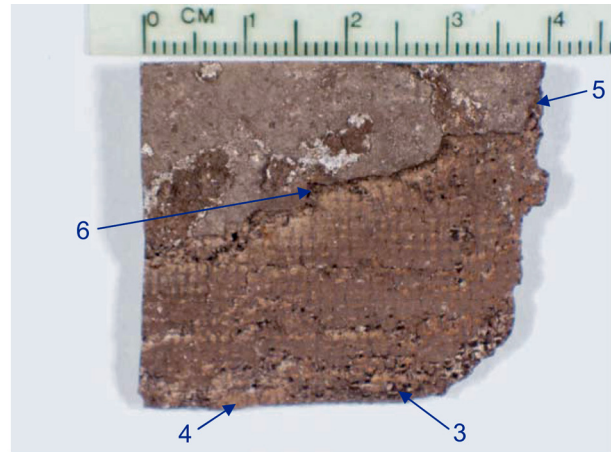
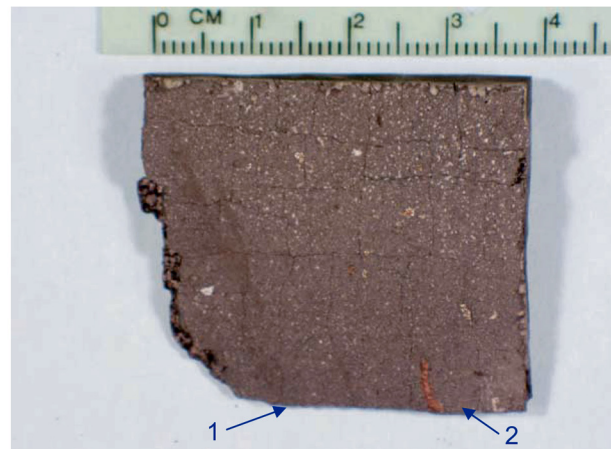
Location	Location Description	Summary of Identified Bands
1	Knife edge, smooth side	SiO <sub>2</sub> (cristobalite), silicon carbide, 2400 °C carbon
2	Knife edge, smooth side	Silicon carbide, 2400 °C carbon
3	Knife edge, rough side	Silicon carbide, 2700 °C carbon
4	Knife edge, rough side	Carbonates ?, 2700 °C carbon plus low temperature carbon ?
5	Crack, near edge, rough side	2100–2300 °C carbon plus low temperature carbon
6	Crack, near center, rough side	2300 °C carbon

Figure 24.—Raman spectra and analyses of sample 2200A.
