NASA/TM—2005-214092

Shuttle Rudder/Speed Brake Power Drive Unit (PDU) Gear Scuffing Tests With Flight Gears

Margaret P. Proctor and Fred B. Oswald
Glenn Research Center, Cleveland, Ohio

December 2005

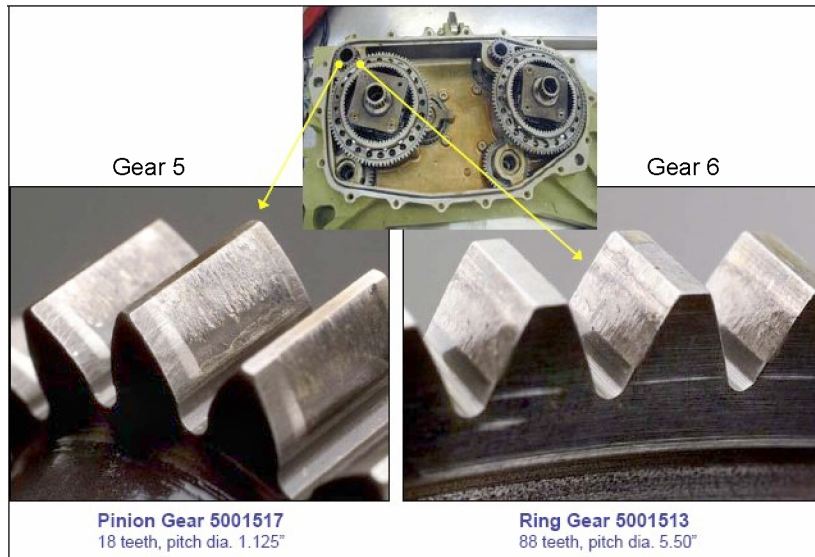
Gears used in the NASA space shuttle rudder/speed brake power drive units (PDU) have been damaged during transient events termed “backdriving”. The damage occurs to the working surface of the gear teeth. The damage is termed “scuffing”. Scuffing was observed on gears 5 and 6, on one side of the gear teeth, in the tooth-tooth contact area. The damage can be seen in figure 1 (from ref. 1). During back-drive, the outer teeth of the ring gear (gear 6) drive the smaller pinion gear (gear 5). In normal operation the pinion gear drives the ring gear. Motion of the PDU gears is produced by hydraulic motors, and so the backdriving event is torque limited. The maximum speed and power for gear 5, the pinion, during backdriving is estimated to be 50 hp at 14,000 rpm.

Figure 1.—Damaged gear teeth from shuttle power drive unit 2.

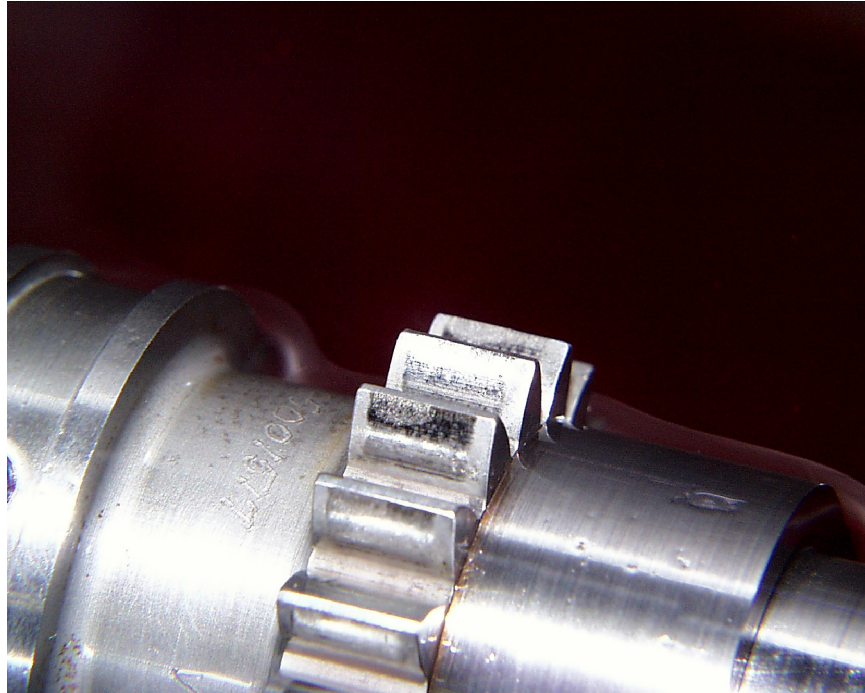
Visual inspection after the Back-3c test found half-moon-shaped wear marks near the tip of the driven side of all pinion gear teeth (fig. 12). These wear marks were slightly offset from the tooth center towards the drive motor. There were corresponding marks on the driving side of the ring gear teeth near the root (fig. 13). While the wear pattern is similar to the scuffing found on the shuttle flight gears, it is much less severe. The mark had no depth perceptible to touch.

Figure 12.—Wear marks on driven side of pinion gear teeth after Back-3c.

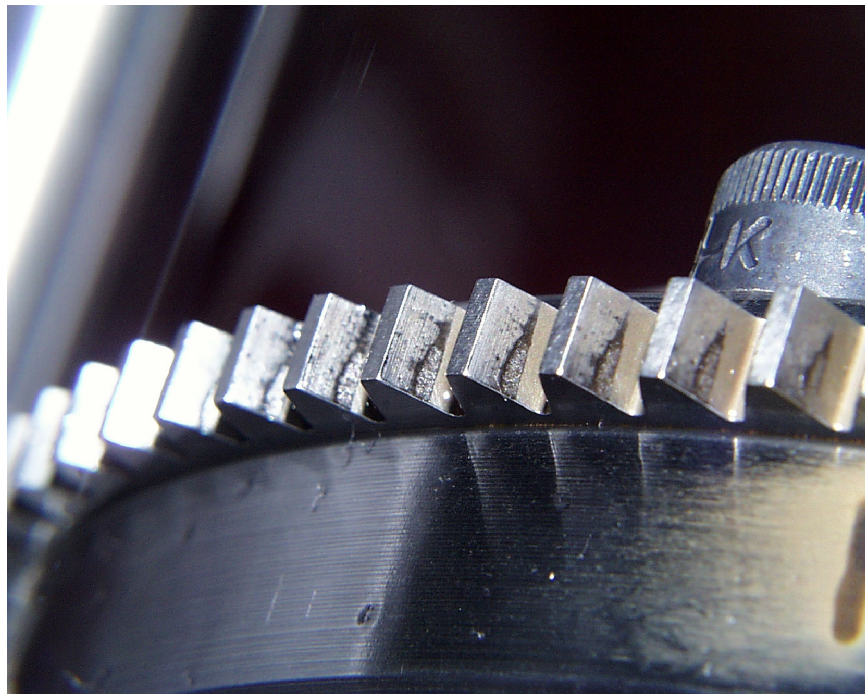
Figure 13.—Wear marks on driving side of ring gear teeth after Back-3c.

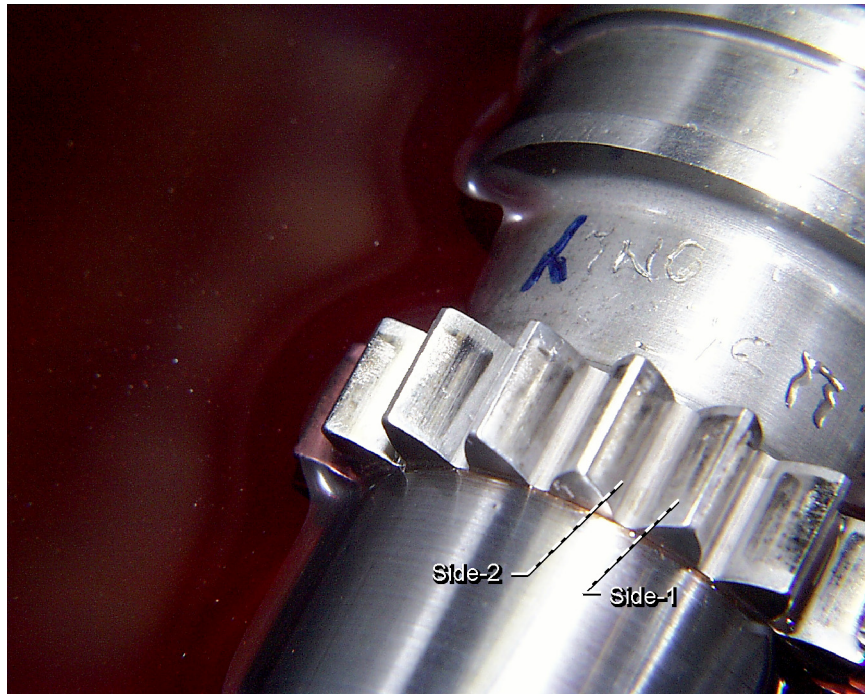
Small wear marks near the tips of the driven side of the pinion teeth (fig. 15), were generated during the Score-1 test on side-2, build-1 conducted at input speed, torque, and power of 2865 rpm, 1167 in.-lb, and 53 hp. No corresponding wear was observed on the ring gear teeth as shown in figure 16. The time histories of input speed, input torque, oil fling temperature, and pinion vibration are shown in figure 17. There is no distinct corroboration of vibration rise and fling temperature rise as in the Back-3c test. There are some high vibration levels in the test however. The drop in oil fling temperature is likely due to turning off the heat gun and heat lamp prior to rotation and some initial cooling due to flinging the oil to cooler surfaces above the oil bath.

Figure 15.—Wear marks on driven side of pinion gear teeth after Score-1 test on side-2, build-1.

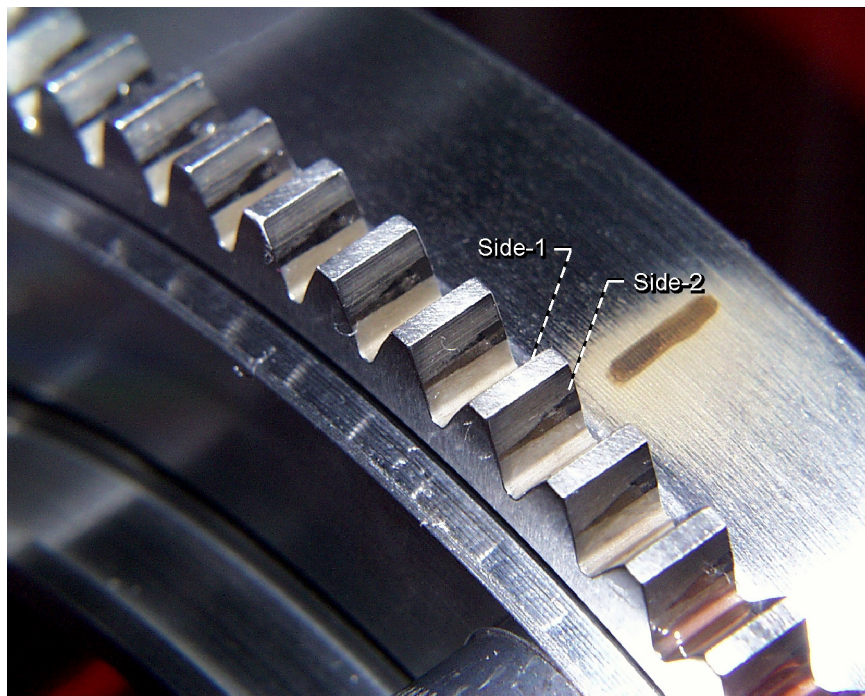
Figure 16.—No visible damage on driving side of ring gear teeth after Score-1 test on side-2, build-1.

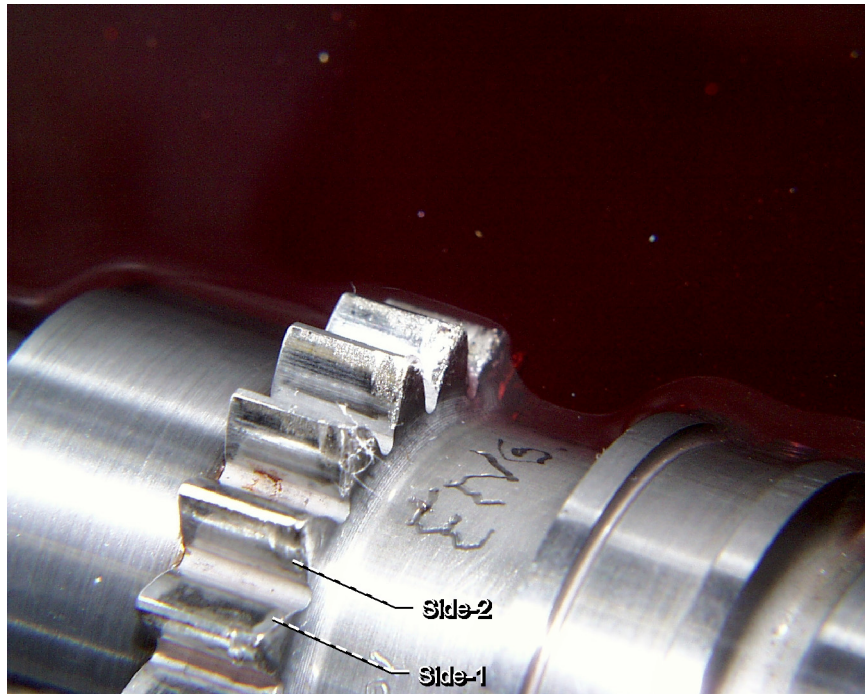
As mentioned previously, during the Score-2 test on side-2, build-1 the gear mesh disengaged at high speed. The resulting damage to the pinion and ring gear teeth is shown in figures 18 and 19, respectively. Note that cloth fibers are visible in these photos. The fibers were created by rough burrs on the damaged gears when the teeth were wiped for photographs.

Figure 18.—Damaged teeth of pinion gear after disengagement at 14,000 rpm pinion speed during the Score-2 test on side-2, build-1. White cloth fibers are caught on teeth from wiping oil.

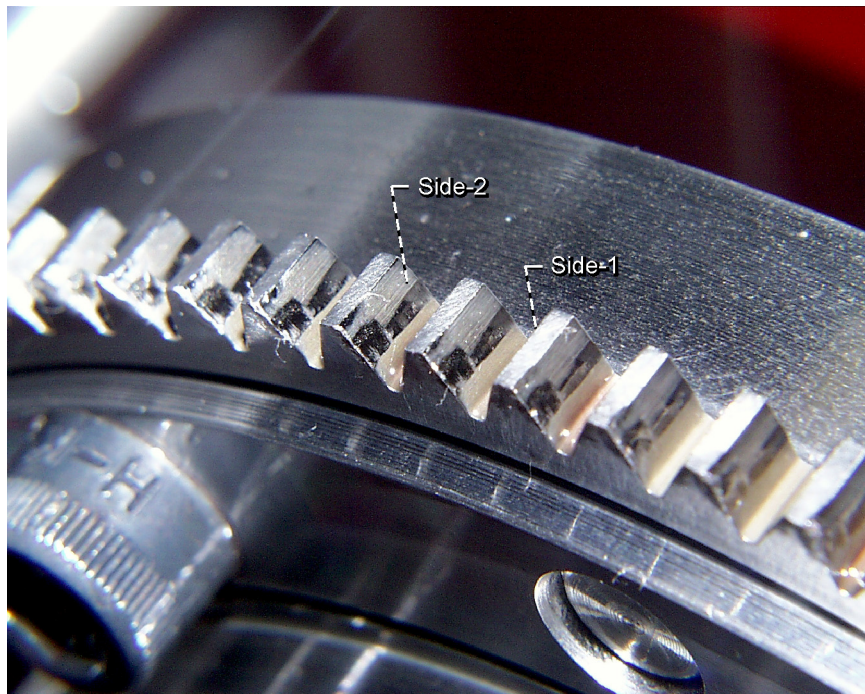
Figure 19.—Damaged teeth of ring gear after disengagement at 14,000 rpm pinion speed during the score-2 test on side-2, build-1. White cloth fibers are caught on teeth from wiping oil.

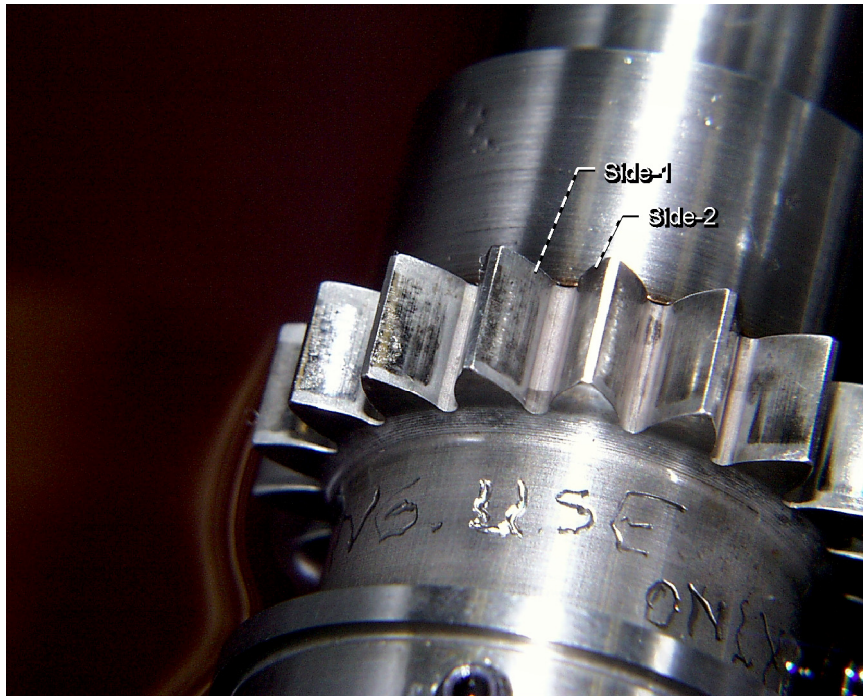
The condition of the pinion and ring gear teeth at the completion of testing (after the Final-5 test) is shown in figures 20 and 21, respectively. The tooth surfaces, including the mild damage created earlier, appear to have been polished.

Figure 20.—Driven side of pinion gear teeth after the test Final-5 are still in good condition.

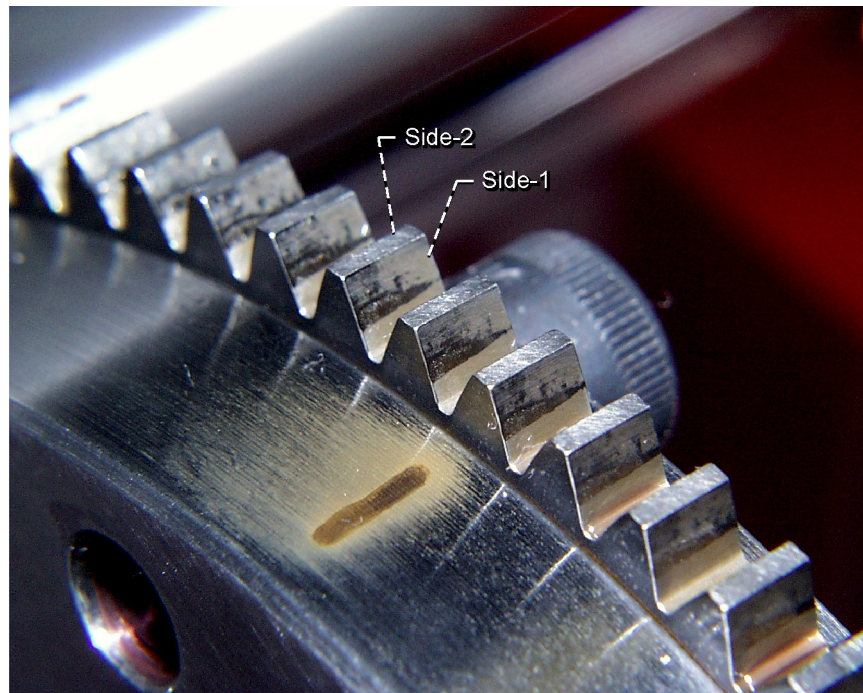
Figure 21.—Driving side of ring gear teeth after the Final-5 are still in good condition.
