2006-01-2240

Extravehicular Mobility Unit (EMU) / International Space Station (ISS) Coolant Loop Failure and Recovery

John F. Lewis
JSC NASA

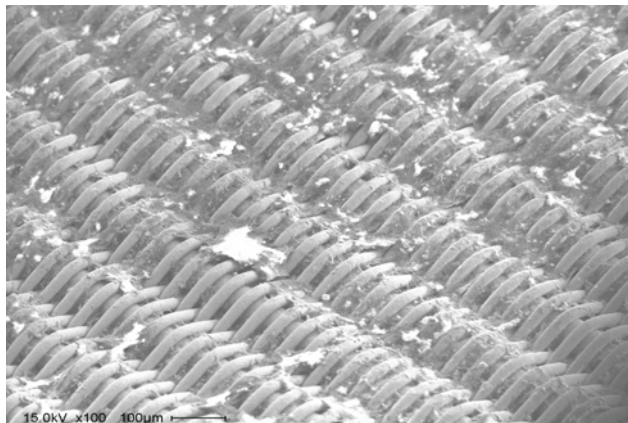
Item-141 Gas Trap - The EMU 3013 Item-141 Gas Trap influent and effluent surface high magnification images (Figure 3) showed the presence of significant agglomerations of organic material mixed with inorganic precipitates (nickel, silicon and aluminum), a number of which exceeded 100-microns in size. It is important to note that these agglomerations appeared to be made up of particulates that were significantly less than the 20-micron screen rating of the Gas Trap, but when joined together as agglomerations, exceeded 100-microns in size. Importantly, these agglomerations were in a size range that could cause a decoupling of the Item-123 Pump Rotor if they became dislodged, then re-deposited between the Item-141 Rotor and Rotor Cup. (1)

FIGURE 3: Outer Surface of EMU 3013 Gas Trap (100X)

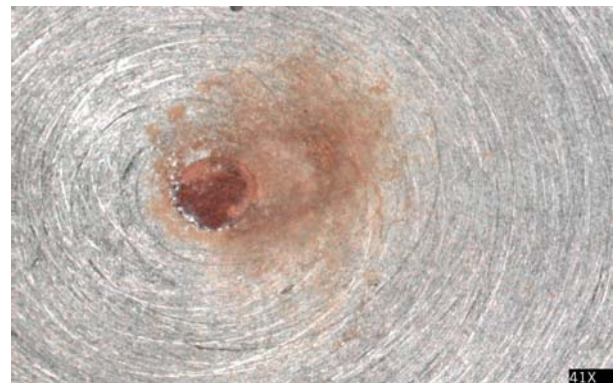
The EMU 3005 Item-141 Gas Trap was not functioning on-orbit. In that respect, the failure signature of EMU 3005 and EMU 3013 diverged. It was determined through examination that the center 0.155 in. diameter hole in the Gas Trap Cover of the EMU 3005 Item-141 Gas Trap was completely plugged. This prevented flow of water to the Water Separator. The contaminant blocking this hole was identified as primarily iron oxide,

with lesser amounts of non-volatile organic material. (Figure 4)

FIGURE 4: EMU 3005 Item-141 Gas Trap Cover Blocked Hole

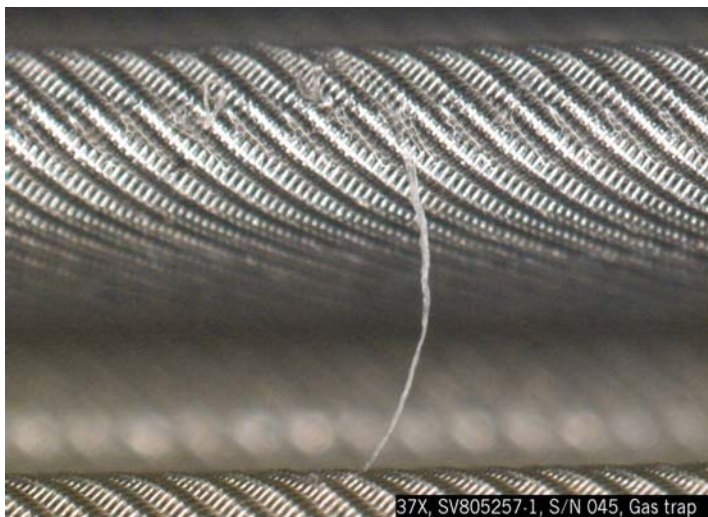
The OD screen material of the EMU 3005 Item-141 Gas Trap appeared to be covered with a clear, wet gelatinous material initially thought to be moisture. A higher magnification examination of this material revealed "stringers" that bridged the gap between the OD screen convolutions. A microbial count and speciation of this material collected on swabs, and the finding of high levels of protein, indicated the presence of biofilm and biofilm forming microorganisms. This is similar to what was observed with the EMU 3013 Gas Trap as well. (Figure 5)

FIGURE 5: EMU 3013 Gas Trap OD (~ 40X)

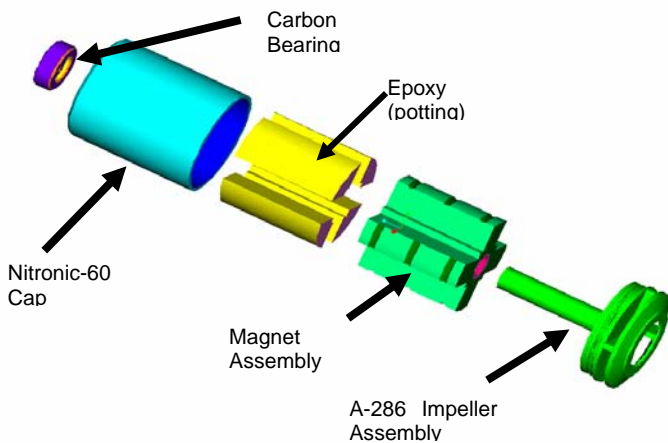
The initial examination of the EMU 3013 Pump Impeller Rotor indicated that it had increased by .003-.004 inches in length. The increase in length had occurred as a result of a widening in the gap between the Nitronic -60 cap and the impeller assembly (Figure 6). The impeller appeared to have de-bonded from the corroded steel core and appeared to be lifting out of the cap. The rotor is encased within a seal cup cavity and any increase in length would be expected to make the rotor more susceptible to fouling from contaminants. The chemical analyses of the contamination on and within the EMU 3013 Item-123 was consistent with the organic contaminants and nickel, silicon and iron corrosion products previously observed in the coolant and on the Item-141 Gas Trap. Observed rust colored deposits were rich in iron and oxygen, indicating the presence of iron oxide corrosion products.

FIGURE 6: Item-123 Rotor Schematic

The EMU 3011 rotor exhibited no growth in length in the gap between the Nitronic-60 cap and impeller assembly (Figure 6). No evidence of de-bonding was observed. It is theorized that the increased gap between the Nitronic-60 cap and the impeller assembly for the EMU 3005 and 3013 Item-123 rotors are the reasons this hardware experienced coolant flow disruptions before EMU 3011. It should be noted that the occurrence of a rotor growth in length is not necessary for an eventual disruption of Item-123 rotor functionality. Coolant quality remains as the primary reason for EMU coolant flow disruption, and rotor growth a significant other finding.

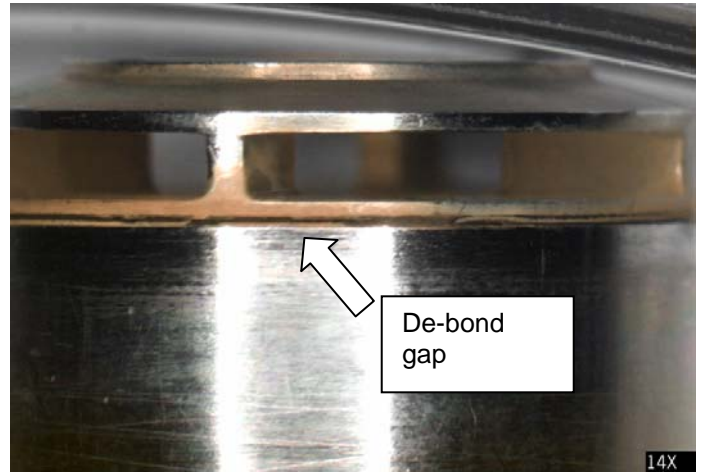
The EMU 3005 Item-123 Fan/Pump/Separator Pump Impeller Rotor exhibited more rust colored contamination than EMU 3013. This rotor showed a growth in length of approximately 0.005 inches. (Figure 7) This is slightly greater than the 0.003-0.004 inches growth seen in EMU 3013. Again, since the rotor is incased within a seal cup cavity, this growth in length would be expected to make the rotor more susceptible to fouling from contaminants.

FIGURE 7: EMU 3005 Item-123 Rotor De-bond Gap
