Tin Whiskers: A History of Documented Electrical System Failures

A Briefing Prepared for the Space Shuttle Program Office

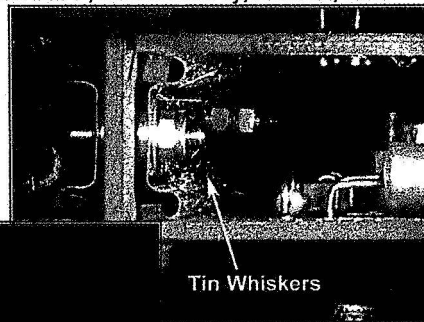
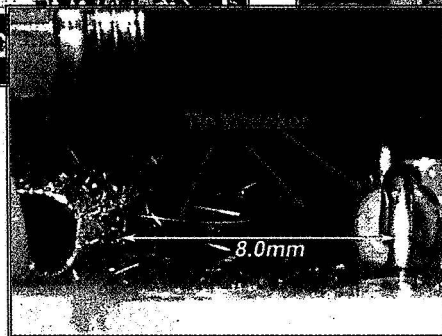
Tin Whiskers on PCB Card Guides

Ref: "Tin Whiskers Found on ATVC S/N 0034", Don McCorvey, March 8, 2006

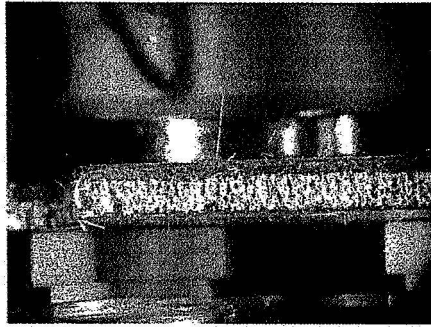
Catastrophic Damage Due to Tin Whisker Induced Metal Vapor Arc (*In Air!!!*)

*Is your supplier reliable?
This Electromagnetic Relay
Was Purchased
To MIL Spec Prohibiting
Pure Tin Finish Inside,
But IT WAS Pure Tin*

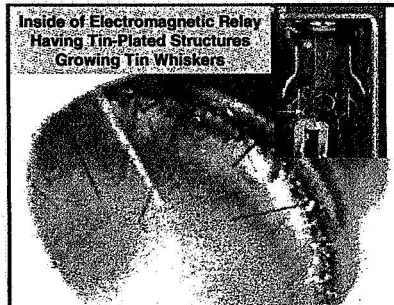
"Three relays were reported to have failed by an overseas electric power company. The customer indicated that energized relays inadvertently closed without the proper control signals. Such condition contributed to a false contact closure condition, which in turn produced unnecessary alarm protection signals initiating a plant shutdown."

- The Foxboro Company is recommending that each customer inspect for, and replace, N0152CK & C0147SS relays manufactured by Potter & Brumfield which display manufacturer's date codes between 7707 and 9352, with those replacement relays manufactured by Communications Instruments Inc.
- Inspection for those relays supplied by Potter & Brumfield will require removal of the N-2A0-L2C-R card from the nest. Visual inspection of the relay package allows easy identification of those relays manufactured by Potter & Brumfield.
- The U.S. Nuclear Regulatory Commission has been informed of this potential defect. The Foxboro Company sincerely regrets any inconvenience this potential defect may cause you and trusts that our actions will completely resolve this matter to your satisfaction.
