# ISS Internal Active Thermal Control System (IATCS) Coolant Remediation Project - 2006 Update

**Russell H. Morrison**  
The Boeing Company

**Mike Holt**  
NASA Marshall Space Flight Center

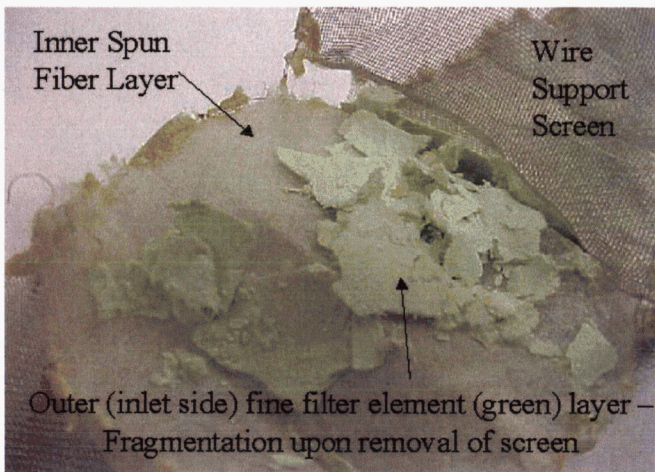
This filter was installed on the MTL in January 2002 after having been seeded with silver phosphate in an attempt to achieve some measure of microbiological control. After dissolution of the silver phosphate, pressure drop fell to the normal 1.9 psid. By October 2002, well into the main nickel phosphate precipitation event, the pressure drop in this filter had risen to 4 psid. It was replaced and returned on flight 9A. Green precipitate was quite obvious on this filter as seen in Figure 6. Scanning Electron Microscopy/Energy Dispersive X-Ray Fluorescence (SEM/EDXRF) analysis clearly showed strong nickel and phosphate peaks. Fourier Transform Infrared (FTIR) spectrum analysis also closely matched that for nickel phosphate. This filter was clearly consumed due to nickel phosphate precipitation.

**Figure 6. Green Filter - contaminated with nickel precipitates, primarily phosphate**

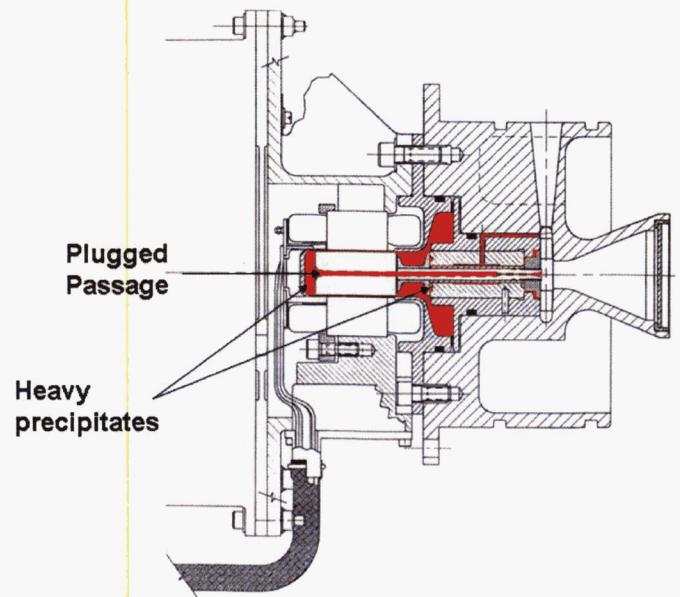
Nickel phosphate precipitates were found to have blocked passages providing flow and cooling to the hydrodynamic and hydrostatic bearings of the pump rotor assembly. Figure 7 is a cross-section of the rotating assembly with the coolant flow passages highlighted in red.

**Figure 7. PPA cross-section, bearing flow passages in red**

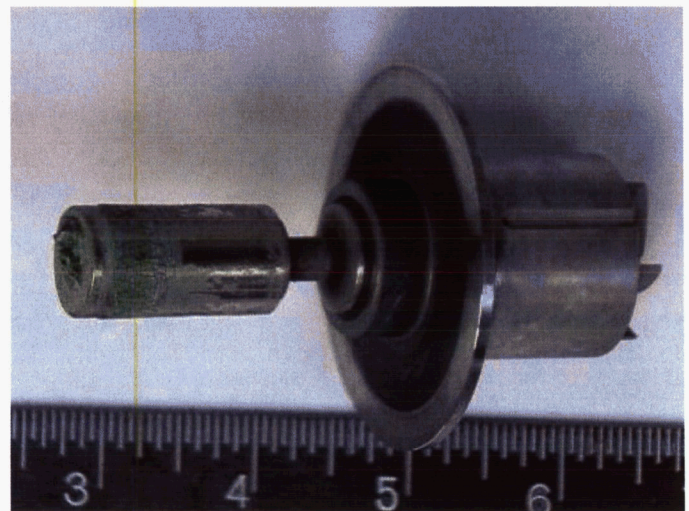
Figure 8 is the entire rotor assembly after removal from the PPA with visible green precipitation on the rotor OD and at the end. Figure 9 shows precipitates found in the bottom of the rotor seal in the stator and Figure 10 shows the precipitate buildup on the end of the rotor (both on left side of red area in Figure 7).

**Figure 8. PPA Rotor Assembly**

The precipitates were all positively identified as nickel phosphate by Scanning Electron Microscopy (SEM)/ Energy Dispersive Analysis X-ray (EDAX).

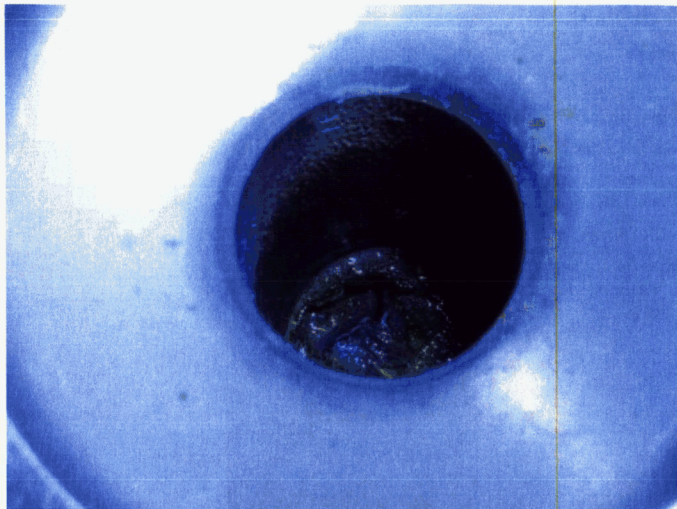
**Figure 9. Precipitate in bottom of rotor cover well**

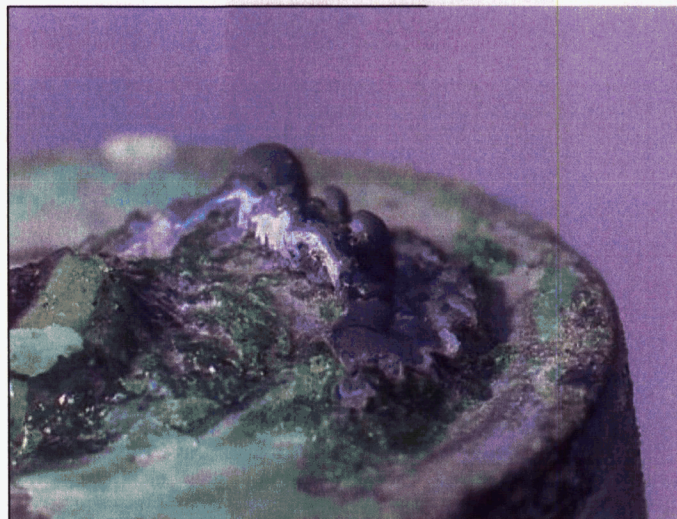
**Figure 10. Precipitate on end of rotor**

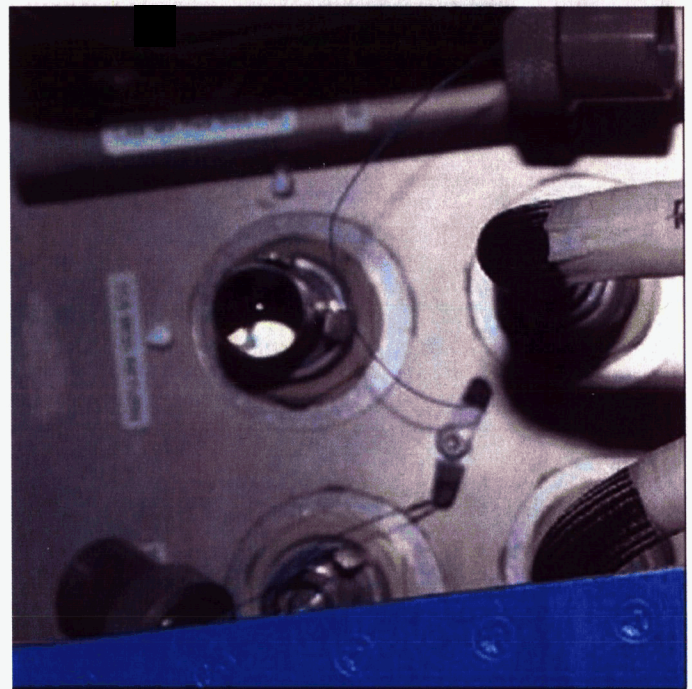
A temporary reconfiguration of the coolant loops to support Soyuz vehicle relocation on ISS left four normally mated male and female QDs in a de-mated state for a period of approximately 56 hours. Two of the QD halves, one male, one female, had water blobs on their open faces totaling approximately 100 ml just before they were re-mated. The male QD water blob is visible in Figure 11.

**Figure 11. On-orbit QD leak**

Procedural changes requiring the installation of caps or plugs on de-mated QD halves have been instituted. When this is not possible, the QD is cycled once before de-mating in the hopes of dislodging precipitate.

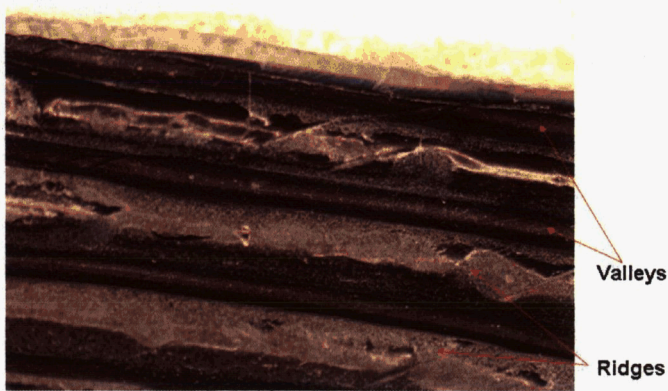
Microprobe, Time-of-Flight Secondary Ion Mass Spectrometry (TOF SIM), and X-Ray Photoelectron Spectroscopy (XPS). These tests indicated that virtually all of the precipitate in the coolant system was nickel phosphate.

**Figure 12. Valleys and ridges of flexhose returned on LF-1**

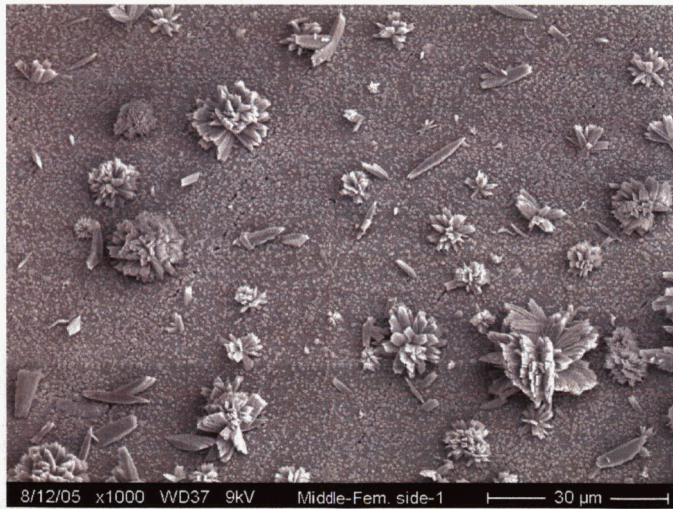
**Figure 13. Heaviest distribution of precipitate, from center of teflon flexhose returned on LF-1, showing flowerettes of nickel phosphate**

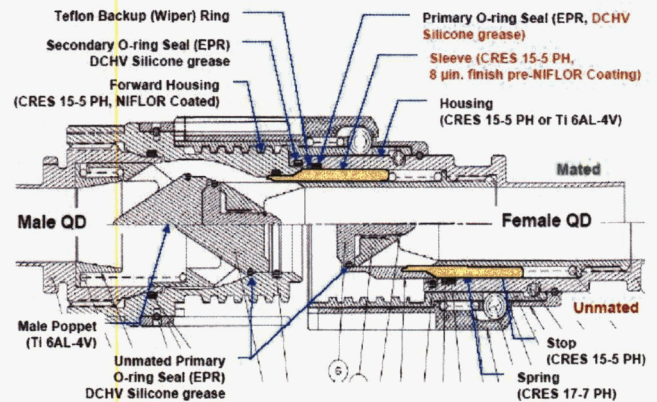
Disassembly of the female QD revealed a modest buildup of coolant residues and precipitates on the seals and sliding parts, Figures 14 and 15. There was no significant corrosion of the electroless nickel plated surfaces or any other surfaces in this QD. The cause of

leakage in the female QD is currently suspected to be low seat load at the stop plug after a de-mate cycle due to higher than normal friction between the OD of the female sleeve and the mating EPR o-ring in the housing brought on by deposition of coolant precipitates.

**Figure 14. QD cross-section with sticking sleeve highlighted in yellow**

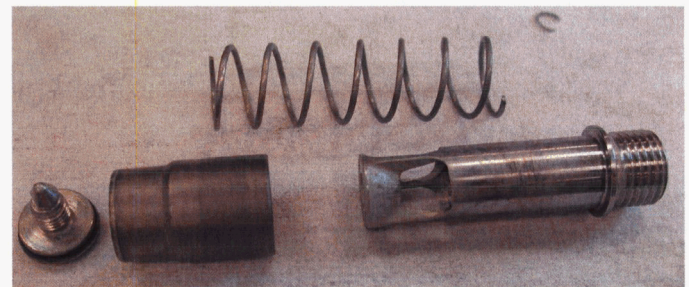
**Figure 15. LF-1 female QD stop plug assembly**

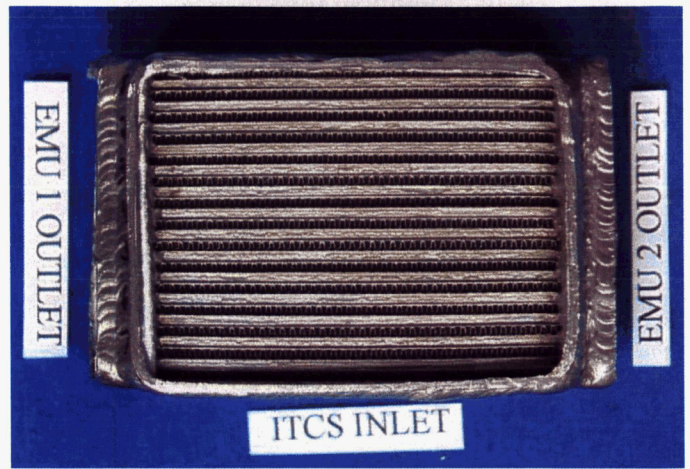
Figure 17. The ITCS passages of the dissected SPCU HX were visibly clean

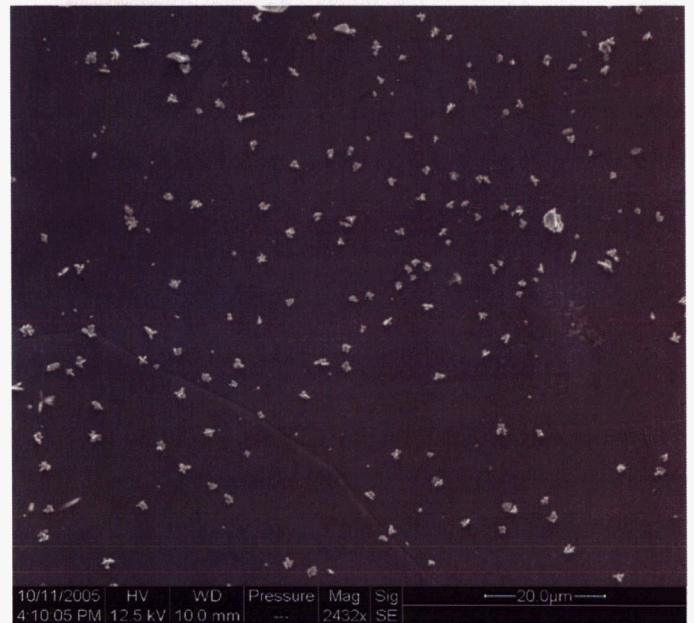
Nickel phosphate particles under magnification were smaller and less abundant than those found in the flexhose returned on flight LF-1, Figure 18.

Figure 18. SPCU HX surface distribution of nickel phosphate

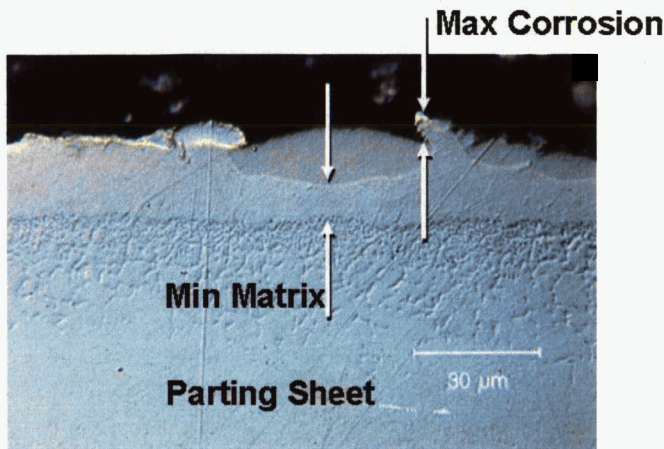
This SPCU HX had been exposed to IATCS coolant at pH less than 9.0 for 3.75 years. New life calculations were made for all single braze cycle BNi-3 components like the SPCU HX based on microscopic examination of many cross-sections of the braze layer and heat exchanger parting sheet from this unit, Figure 19. The life of such components in IATCS coolant service was extended from 4 years to 16 years. This is the predicted

time to penetrate the braze layer. Additional margin on life is contained in the underlying 0.006 inches of parting sheet.

**Figure 19. Braze cross-section with pure nickel matrix phase and faster corroding intermetallic phase nickel**
