GT2006-90833

CERAMIC MATRIX COMPOSITE VANE SUBELEMENT BURST TESTING

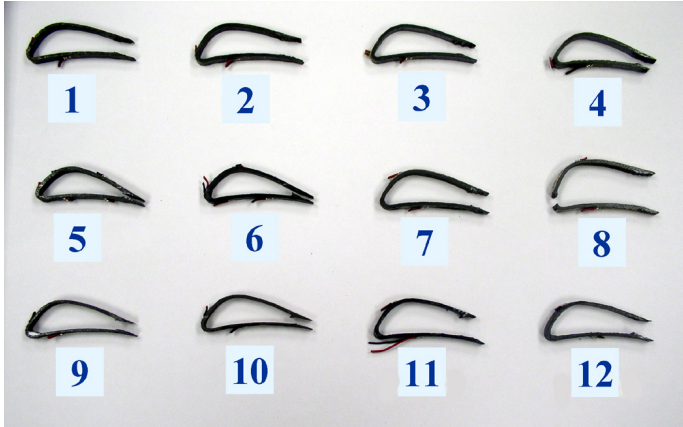
Figure 8 – Specimen Identification

All 12 specimens were tested to failure. Because of problems with bladder leakage, some specimens were reloaded to achieve burst. Figure 8 documents the final condition of the specimens after testing. Clipped wiring shows the approximate location of the strain gages. It is obvious from the figure that residual trailing edge opening is the dominant characteristic.

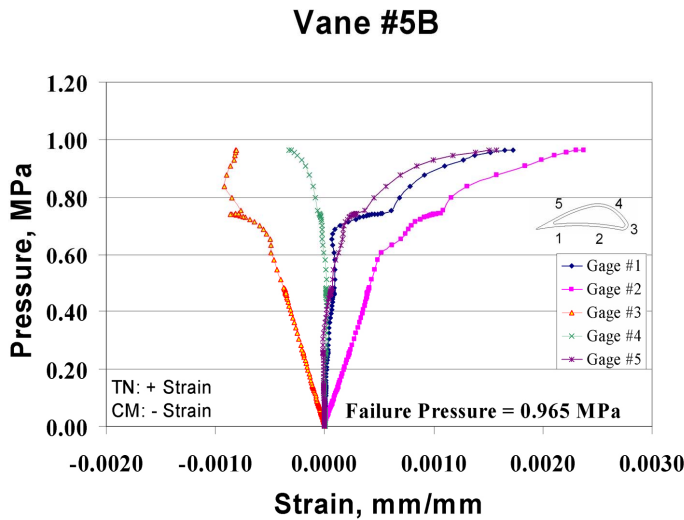
Figure 9 – Typical Pressure vs Strain, 5Gage Specimen

Typical pressure versus strain plots appear in Figure 9, for five strain gage specimens, and Figure 10, for two strain gage specimens. All specimens exhibited linear or near linear behavior during initial loading. Generally, deviation from

linear response occurred either as a softening of stiffness or in the form of a jump with decreased stiffness between strains of 0.0004 and 0.001. Non-linear behavior continued, as a combination of these two mechanisms, until failure.

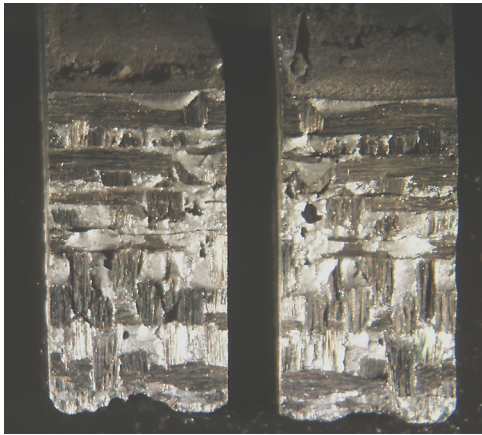
Figure 11 – Specimen 8, Trailing Edge

All vanes specimens failed in interlaminar tension, at the trailing edge, Figure 11. With the exception of one specimen, specimens remained in one piece. Specimen 8 was the only specimen to fail, in secondary mode, at the leading edge as well as the trailing edge. The leading edge failure was a result of failure to control the fixture bladder, at burst.

In a general, most specimens resisted at least 0.650 MPa internal pressure. The failure surface ran symmetrically through the trailing edge and exhibited a tortuous failure path with many broken fiber tows, Figure 11. Clearly, the failure surface was driven through the out-of-plane fibers in the Y-cloth, rather than along one single ply. The nonlinear strain records indicate that load was carried as damage proceeded through the trailing edge. This is strong evidence that the Y-cloth did the job of resisting interlaminar failure.

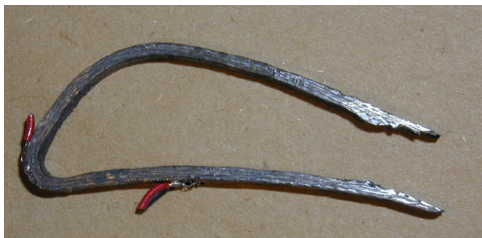
Figure 12 - Specimen 2 Post Test

Examination of leading edge damage supports the analytical conclusion that high interlaminar stresses were present. The qualitative amount of interlaminar ply separation at the leading edge appears commensurate with the residual crack opening at the trailing edge. Specimens 2, Figures 12 and 13, and 5, Figures 14 and 15, were chosen for comparison because they display the greatest and least residual openings, respectively. Figure 13 shows extensive inter-ply cracking at the leading edge of specimen 2. There is very little obvious damage in Figure 15, specimen 5. This result is consistent with the other specimens.

The correlation between residual opening displacement and leading edge damage, coupled with the lack of correlation between residual crack opening and maximum pressure resisted and the lack of out-of-plane distortion indicates that residual stresses from processing are not the cause of the residual opening. The most likely explanation for the residual opening is a wedging of material in the interlaminar ply cracks at the leading edge. This conclusion is supported by the failure of specimen 8, the only specimen to separate into two pieces. Specimen 8 failed as a result of the inability to control bladder deflections at the end of the test. This damage from over deflection suggests that the residual crack opening is likely an artifact of the test procedure..
