# Pitting and Repair of the Space Shuttle's Inconel<sup>®</sup> Honeycomb Conical Seal Panel

**During return to flight servicing of the rudder speed brake (RSB) for each Space Shuttle Orbiter, inspectors discovered numerous small pits on the surface of the #4 right hand side honeycomb panel that covers the rudder speed brake actuators. Shortly after detection of the problem, concurrent investigations were initiated to determine the extent of damage, the root cause, and to develop a repair plan, since fabrication of a replacement panel is impractical for cost, schedule, and sourcing considerations. This paper describes the approach, findings, conclusions and recommendations associated with the investigation of the conical seal pitting. It documents the cause and contributing factors of the pitting, the means used to isolate each contributor, and the supporting evidence for the primary cause of the pitting. Finally, the selection, development and verification of the repair procedure used to restore the conical seal panel is described with supporting process and metallurgical rationale for selection.**

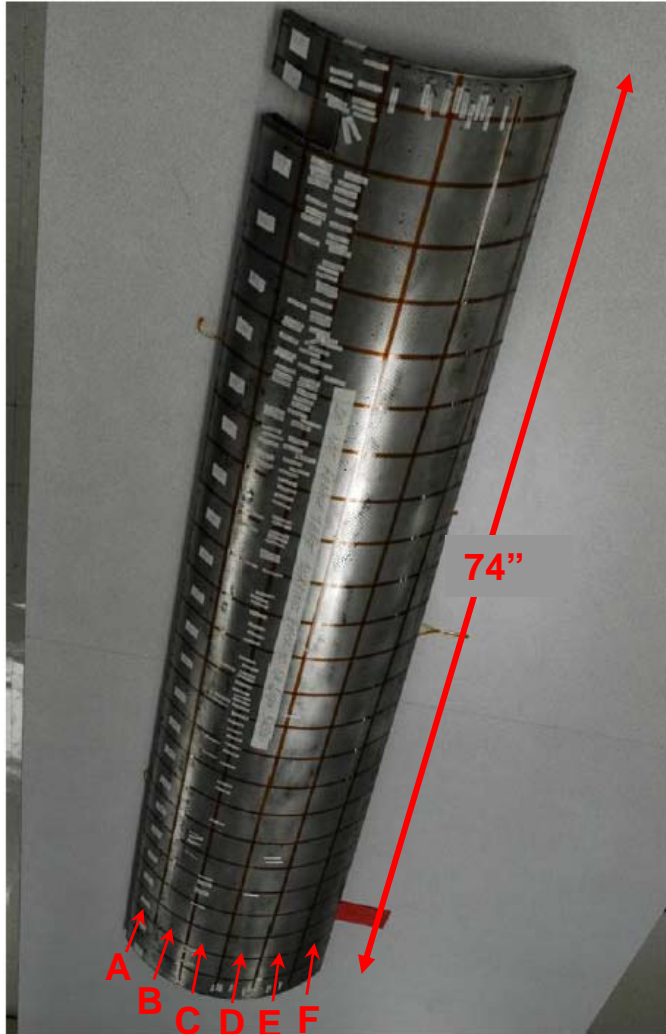
Figure 3. Photograph OV-105 RSB Conical Seal #4 Right Panel with a tape grid applied. Columns A-E parallel to the length of the panel correspond to columns A-E for the pit depth data in Fig. 9.

A grid of axial columns (A-F) and circumferential rows was overlaid on the panel with tape, as can be seen in Fig. 3. The grid location and dimensions of all pits greater than 0.003 inch in depth, as measured with an optical micrometer, were documented. The 0.003 inch threshold was selected based on a conservative structural analysis indicating that defects smaller than that depth would be inconsequential and the Material Review Board (MRB) accepted it for unrestricted use “as is.” The majority of the pits were located in the column designated as B; pitting was also clustered at the panel’s ends in columns C, D, and E (see Fig. 3). Figure 9 plots the depth of the pits as a function of grid location.

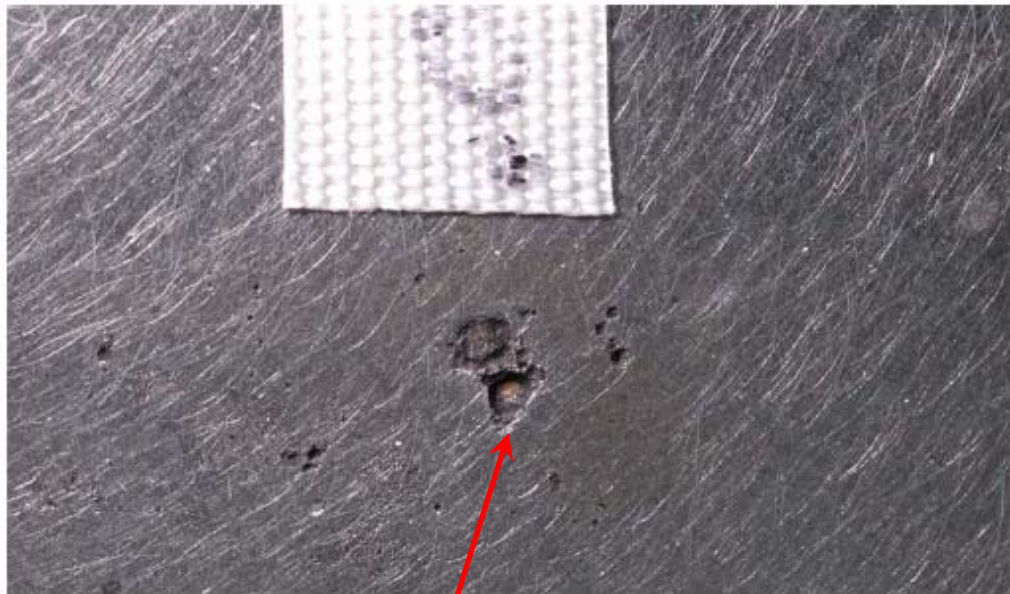
Visual inspection of the panel revealed 105 pits with a depth greater than 0.003 inch with some pits appearing to be through the thickness of the face sheet. Photographs of typical pitting and of molds from the pit interiors (replisets) are shown in Fig. 7 and Fig. 8.

Typical pitting (~10X)

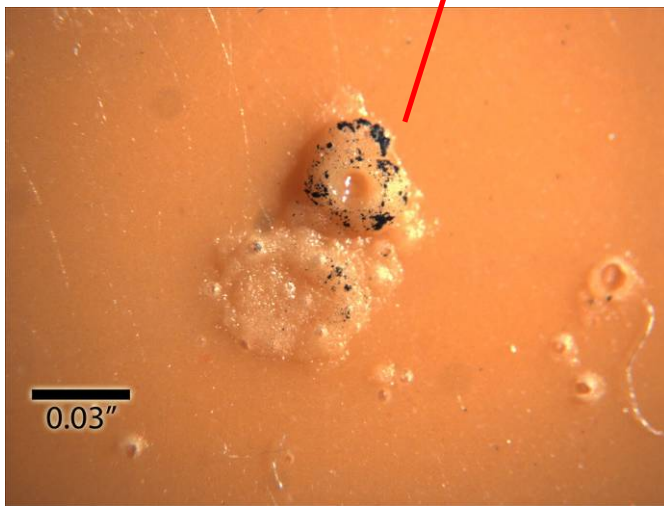
Figure 7. Photograph of typical OV-105 RH #4 conical seal pit (top) and mold of pit interior (bottom).

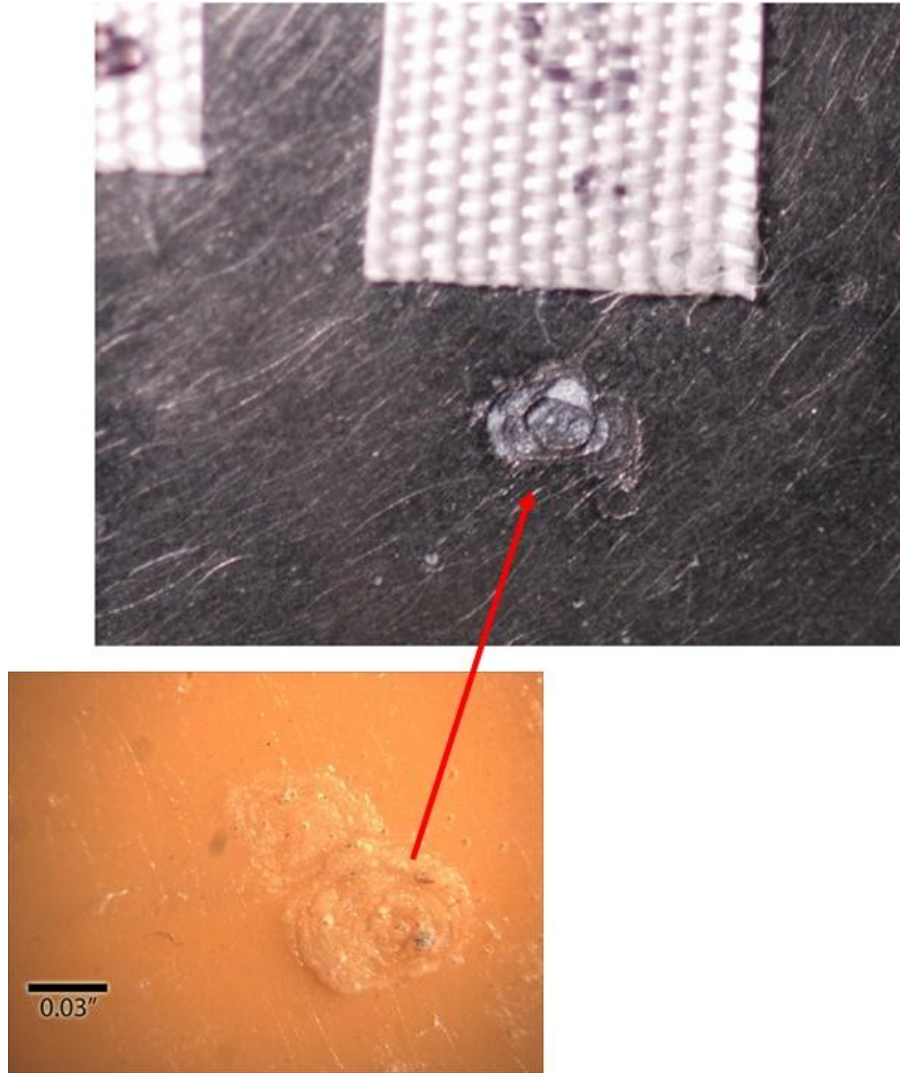
**Figure 8. Photograph of typical OV-105 RH #4 conical seal pit (top) and mold of pit interior (bottom).**

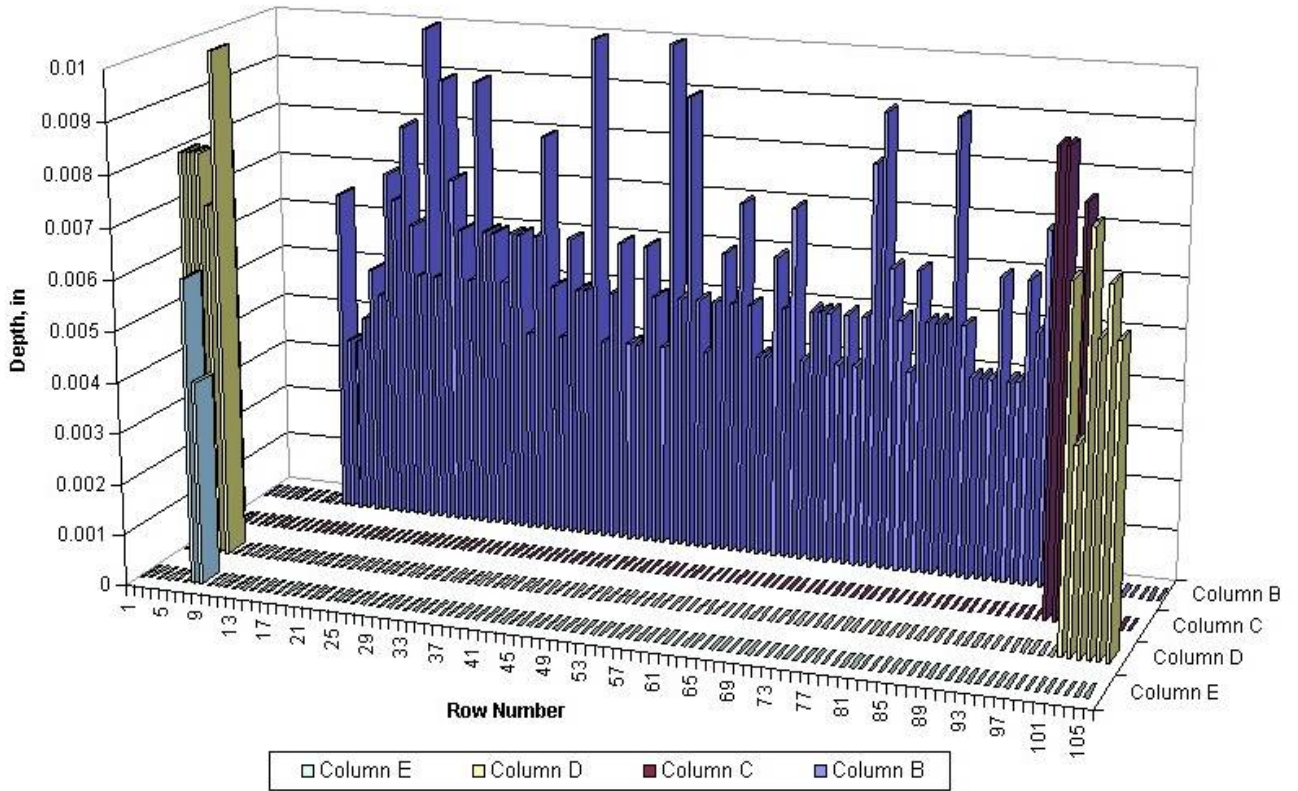
**Figure 9. OV-105 RSB #4 conical seal pit depth by grid location.**

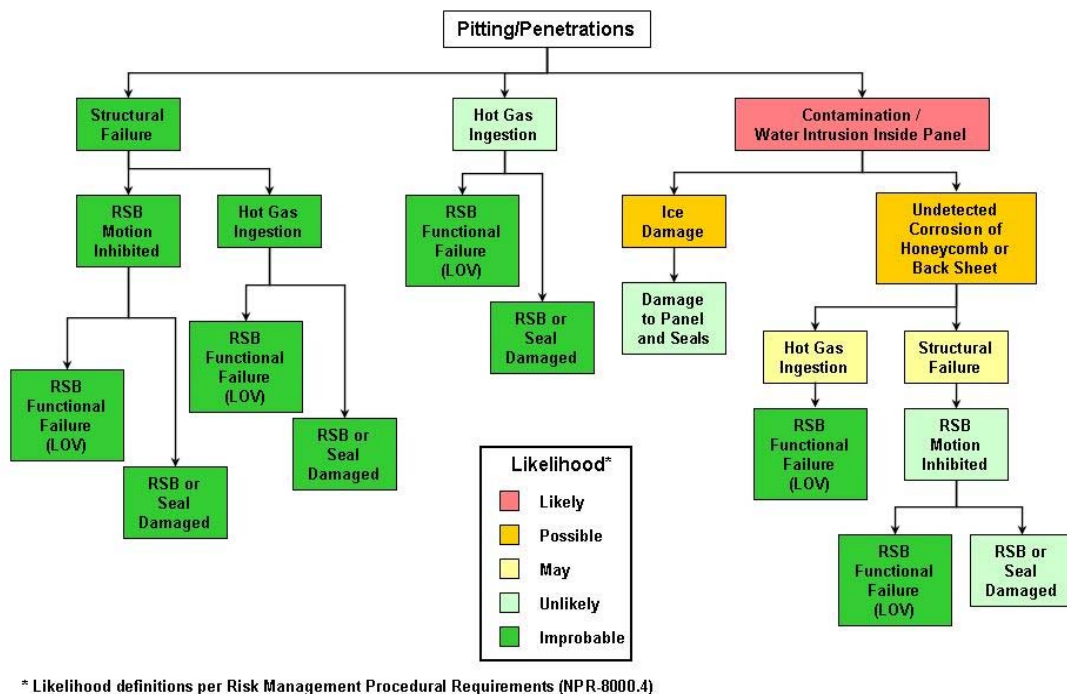
Figure 10. Simplified risk tree for OV-105 RSB RH #4 conical seal panel degradation.

The three top level primary risks considered were structural failure, ingestion of hot gasses, and contamination or water intrusion inside the honeycomb panel cells. The structural failure is applicable to new, “as is,” or repaired panel, and was addressed by structural analysis. Based on results from the analysis, structural failure is considered to be unlikely. The possibility of hot gas intrusion exists because the outboard face sheet has been penetrated in approximately 12 locations. Hot gas intrusion would occur only during reentry when vertical tail section temperatures are likely to reach 950°F. It is assumed that the inboard face sheet has not also been penetrated, although not verified except for X-rays. Thus it is unlikely that hot gas intrusion will occur through the panel due to the extent of pitting damage. Aero-thermo dynamic analyses would have to be completed to verify this assumption. It is likely that dust, water, sea spray, or other contaminants could, and may have already entered the honeycomb cells. Once contamination or water enters the cells, then a second tier of risks must be considered. Ice damage considered in this analysis is any damage resulting from the formation of ice within the cell prior to launch, and effects of the ice rapidly turning to steam during reentry in the event that the ice did not sublimate on orbit. The likelihood of this occurring is estimated somewhere between possible and may occur. The resulting damage is believed to be an unlikely flight risk, and would be observable by normal visual inspection during post flight checkout.

In summary, beyond restoring the structural characteristics of the panel per the structural analysis, the only significant risk is addressing the potential for undetectable corrosion inside the panel caused by contamination/water intrusion into the panel. Since it is likely that contamination did enter the cells during the sanding operation, if not before, this risk should be addressed in any repair plan.

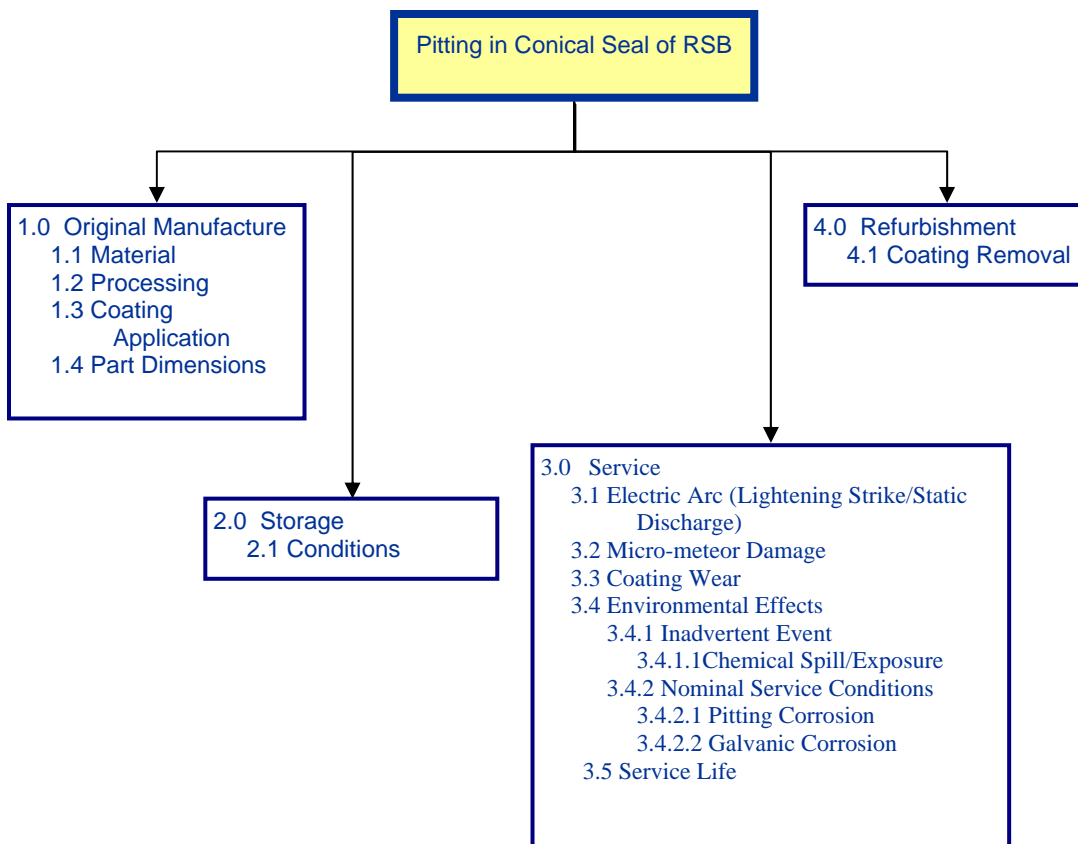
The assessment team performed a comprehensive, top-down fault tree analysis to aid in identifying and evaluating the contributing events for the pitting anomalies in the conical seal panel RH #4. Four main areas were assessed for potential proximate and root cause(s), which included: original manufacture; storage conditions; service; and refurbishment. Each of these four areas was addressed in detail by the NESC Assessment Team and will be discussed below. A graphical representation of the fault tree is displayed in Fig. 11.

**Figure 11. Fault tree for identifying and evaluating contributing conical seal panel pitting anomalies.**

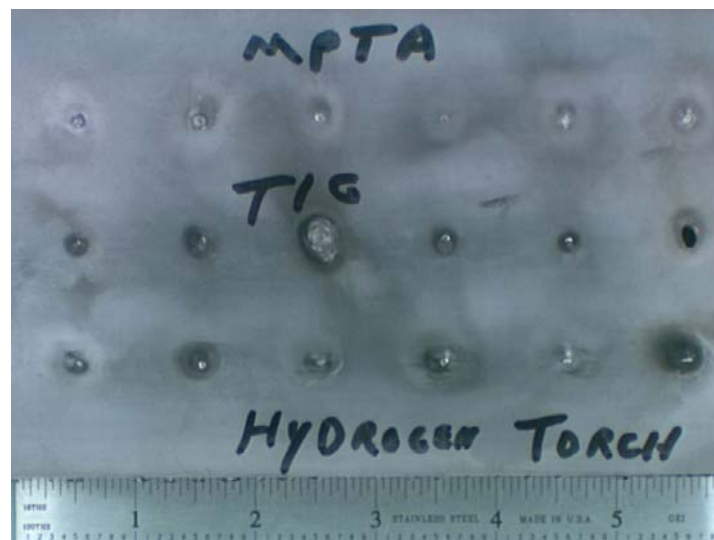
The project conducted both a welding/brazing test and a HVOF spray test and have noted preliminary results/observations. The welding test included 6 attempts at repair of through holes with gas tungsten arc welding (GTAW) – labeled as “TIG” in Fig. 12, micro plasma transfer arc (MPTA), and hydrogen torch techniques. The welds were executed by a qualified welder who has performed MPTA crack and pinhole repairs on the thin walled (0.008 inch) A286 coolant tubes of the Space Shuttle Main Engine (SSME) nozzle. The resulting welds are shown in Fig. 12. The project selected only MPTA welding/brazing for further consideration due to the level of technical maturity for similar Shuttle hardware and low heat input to the face sheet.

**Figure 12. Conical seal welding test panel**

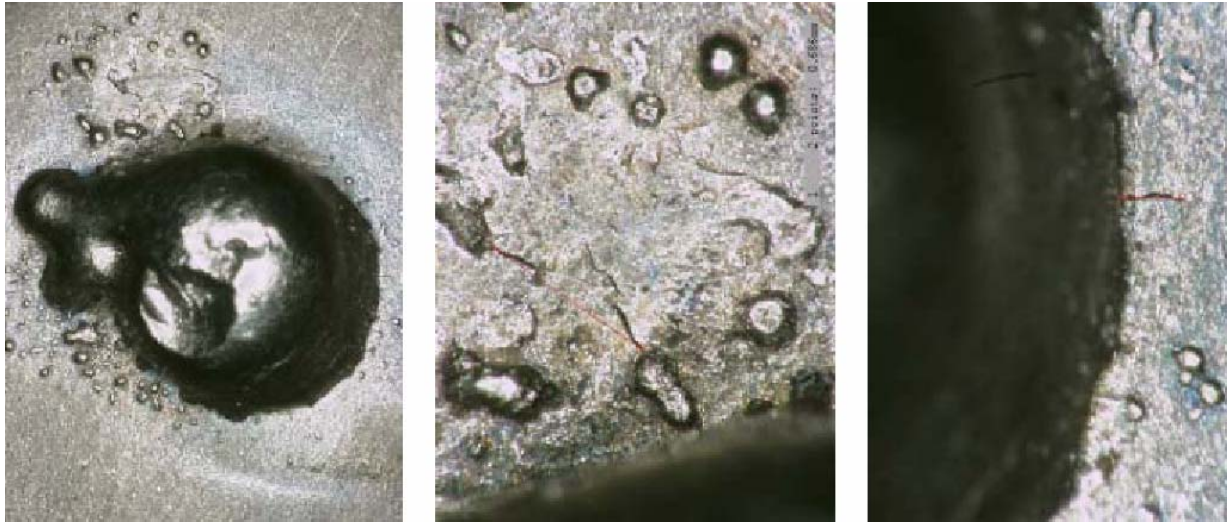
Seventeen (17) repairs were also produced honeycomb verification panels of Inconel<sup>®</sup> 718. Two of the repair attempts on the verification panel resulted in blow-outs at the repair site. The blow-outs caused holes up to 0.10 inches in diameter. Attempts to repair the blow-out areas resulted in heat affected zone (HAZ) and LME cracking of the 718 cover sheet. Metallography confirmed LME of 718 grain boundaries (Fig.13). After grinding six of the fifteen successful repairs flush to the panel surface, porosity was observed up to 0.008 inches in diameter within the braze deposits. The BAu-4 braze alloy was removed from further consideration because of the risk of LME cracking of the face sheet. Consequently, nickel-base braze alloys were evaluated to eliminate the cracking risk.

**Figure 13. Photographs at increasing magnification from left to right showing an MPTA repair with BAu-4 braze, and LME cracking in the heat affected zone of the MPTA braze repair.**

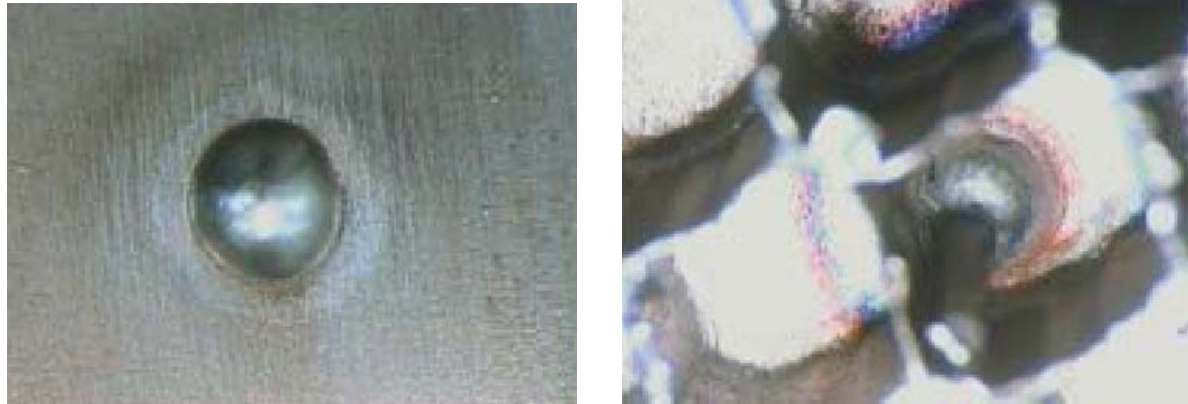
The welder melted the end of the wire protruding through the hole in the face sheet to form a ball that dropped down as the wire was consumed, covering the hole. This reduced the amount of heat that had to be put into the face sheet compared to a more traditional welding technique. Figure 14 shows the top side of the completed repair and the condition of the unconsumed pin in the honeycomb core.

**Figure 14. (a) Macrograph showing top surface of a repair made using a Hastelloy®-W “pin”. (b) Unfused bottom of wire “pin” protruding into honeycomb cell**

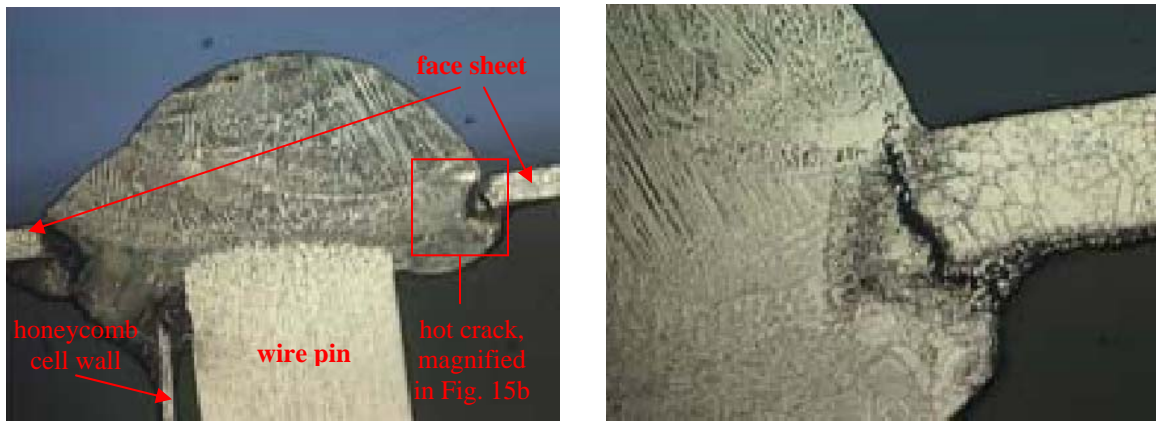
Figure 15 shows a cross section from one repair. Cracking was noted in most of the repairs. The defect observed was a hot crack caused by contamination of the weld pool by the preexisting nickel base alloy that attaches the core structure to the top and bottom sheets. Given the disparity of the melting ranges between the nickel alloy and the Hastelloy®-W, no effective means to prevent the hot cracking could be found.

**Figure 15. (a) Cross section of welded Hastelloy®-W pin repair. Note honeycomb cell wall just left of the unfused bottom of the wire “pin”. (b) Hot cracking caused by pre-existing nickel based braze alloy. Similar cracking was observed in all sections.**

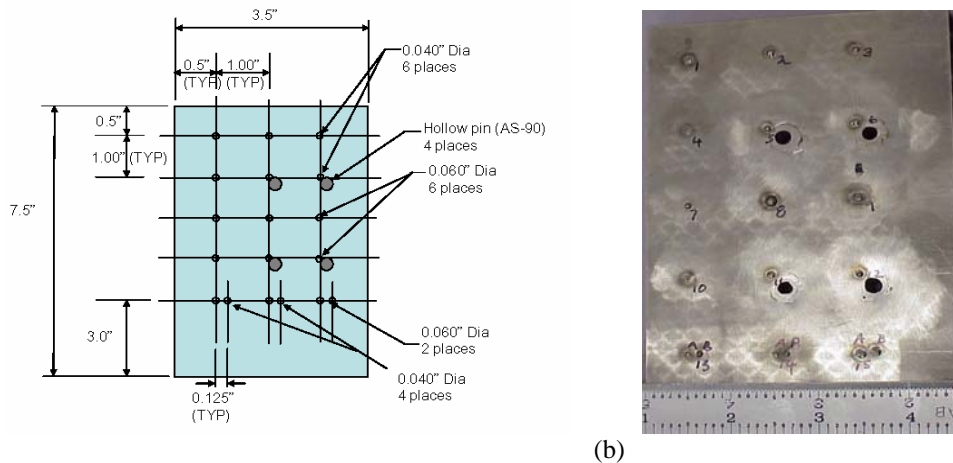
Honeycomb verification panels were prepared by drilling 0.040 and 0.060 inch diameter holes in the top and bottom face sheets. The configuration of the honeycomb verification test panel is shown in Fig. 16a. The drilled and repaired panel is displayed in Fig. 16b. The holes were repaired using the AMS 4777 alloy with the MPTA process, similar to that used with the BAu-4 previously. A typical deposit is shown in Fig. 17. Test deposits were free from the type of hot cracking observed in the Hastelloy®-W repairs.

**Figure 16. (a) Configuration of verification test sample. (b) Completed verification sample**

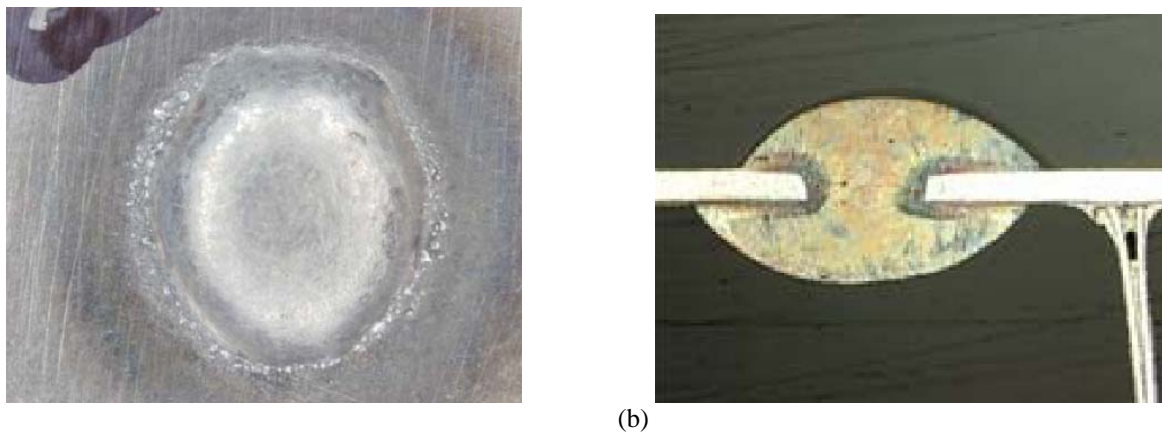
A more detailed metallographic analysis was also performed on all repair locations in the as-welded condition. Several internal defects were revealed by metallography that would have been found after grinding the deposits flush to the panel surface. Based on these results, it was decided to make additional samples that would be completed through flushing prior to metallography. Any defects visually detected after grinding would be repaired and the location re-ground. A sample containing 24 repairs was used to develop grinding and repair techniques. Grinding was accomplished using stone bits and a hand “mini-grinder”. A repair technique was developed and demonstrated on the sample. The procedure required grinding of a new through hole to remove the defect, followed by re-fill with the standard MPTA process.

**Figure 17. (a) Typical MPTA repair using AMS 4777 braze alloy. (b) Micrograph of a typical cross section of MPTA braze repair.**

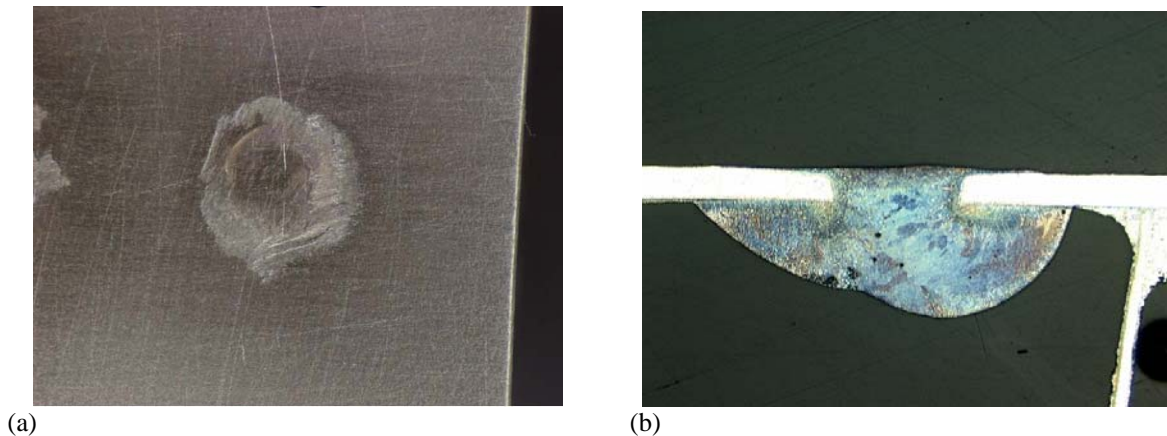
To verify the repair process on RH #4, a brazed honeycomb panel was used as a process control sample and was prepared in parallel by drilling a series of 0.040 inch diameter holes in the Inconel<sup>®</sup> 718 face sheet. Six locations were repaired using the same MPTA process and AMS 4777 alloy filler as RH #4. The completed welds were visually inspected with magnifications up to 30x. No cracking in the deposit or heat affected zones was noted. The six deposits were manually ground flush to the face sheet surface and were re-inspected at the same magnifications. Based on the visual inspection, all deposits appeared sound and free of rejectable defects. The six deposits were then sectioned, cold mounted, polished and etched for metallographic inspection. Figure 18 shows a typical deposit.

**Figure 18. (a) Macrograph showing a typical repair location on the in-process weld sample. Repair has been manually flushed after welding. (b) Micrograph of typical cross section of a flushed repair.**

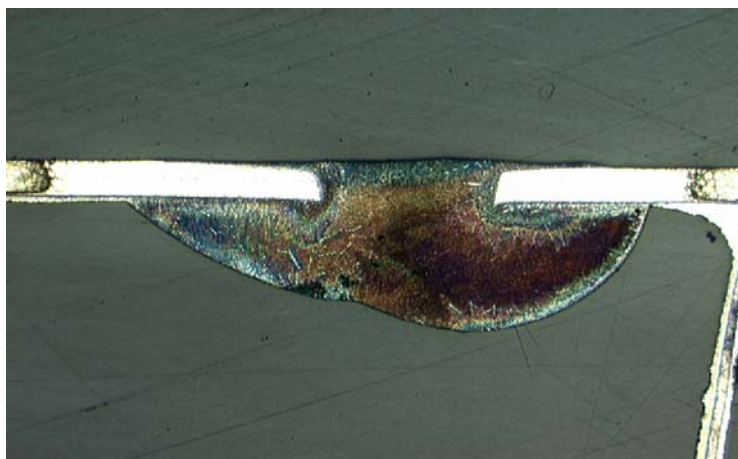
After metallographic examination each sample was re-etched with an electrolytic process using 10% oxalic acid, Fig 19. This procedure causes fully aged Inconel<sup>®</sup> 718 to stain while annealed areas remain shiny and unstained. The edge to edge distance observed on the etched samples was used to determine the diameter of the fusion and HAZ zones. The maximum allowable combined fusion and HAZ diameter is 0.187 inch, according to the repair work authorization. Figure 19 shows a repair cross section after oxalic acid etching.

**Figure 19.** Typical repair (same section as in Fig. 18b previously) after electrolytic etch with 10% oxalic acid. The area of Inconel<sup>®</sup> 718 face sheet not stained was annealed by the MPTA process. Such micrographs were used to measure the fusion zone and heat affected zone, which are required to be under a specified size.
