# Laboratory Reproduction and Failure Analysis of Cracked Orbiter Reaction Control System Niobium Thruster Injectors

**Jeremy B. Jacobs  
&**

**Willard L. Castner**

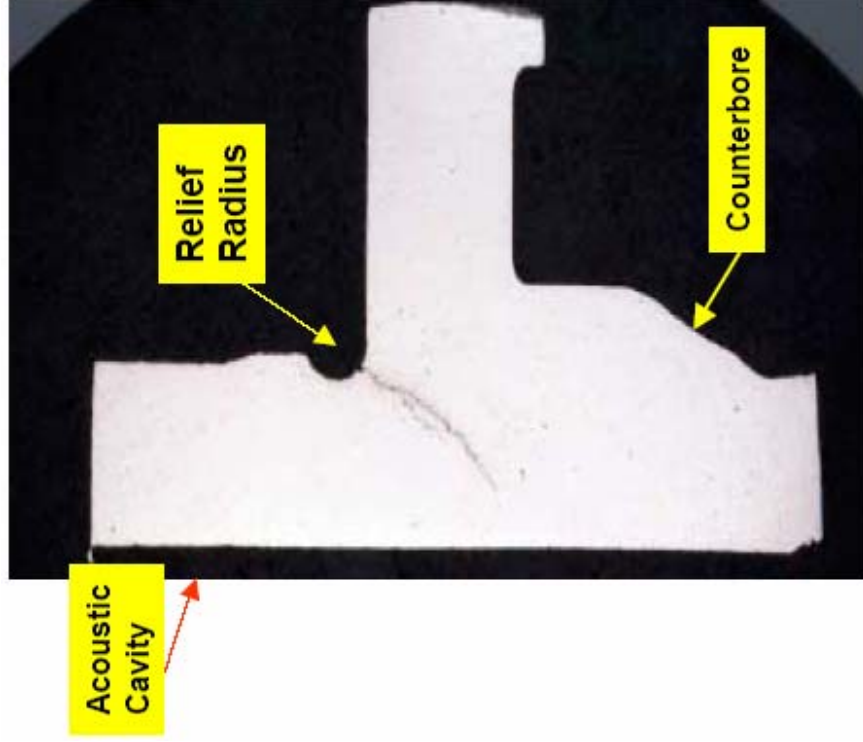
# Relief Radius Cracks

Crack extending from **relief radius** towards acoustic cavity

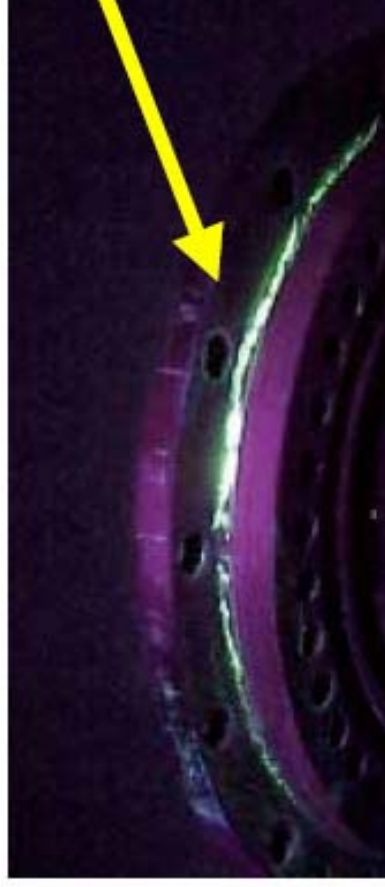
Penetrant indication

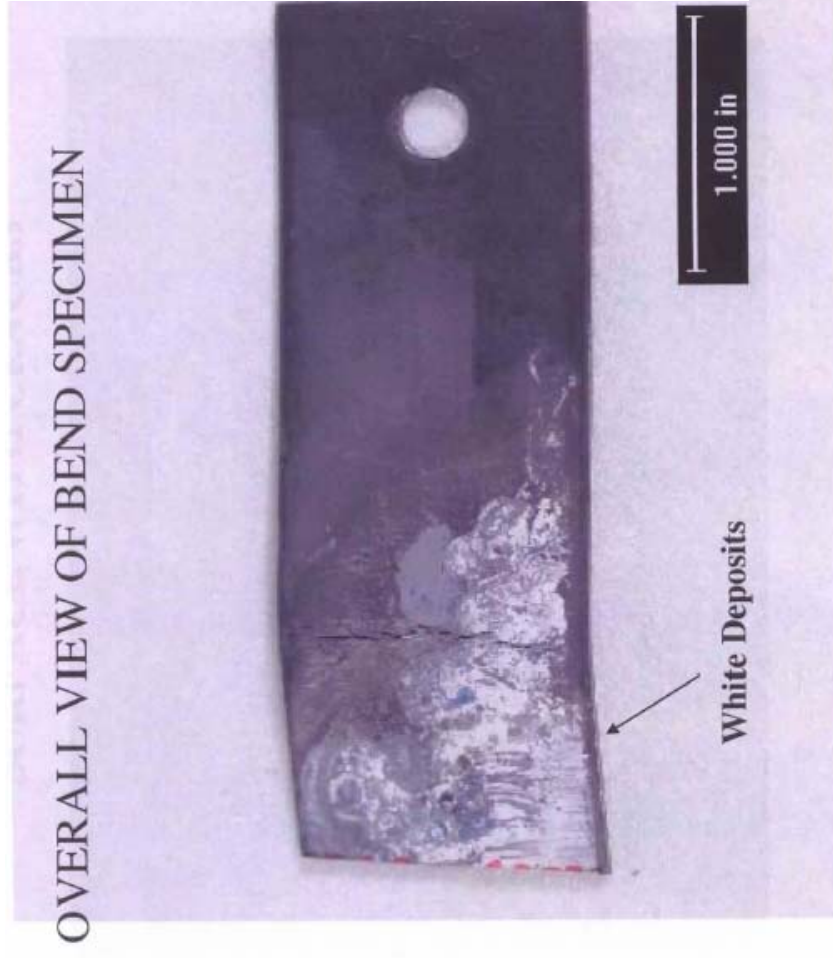
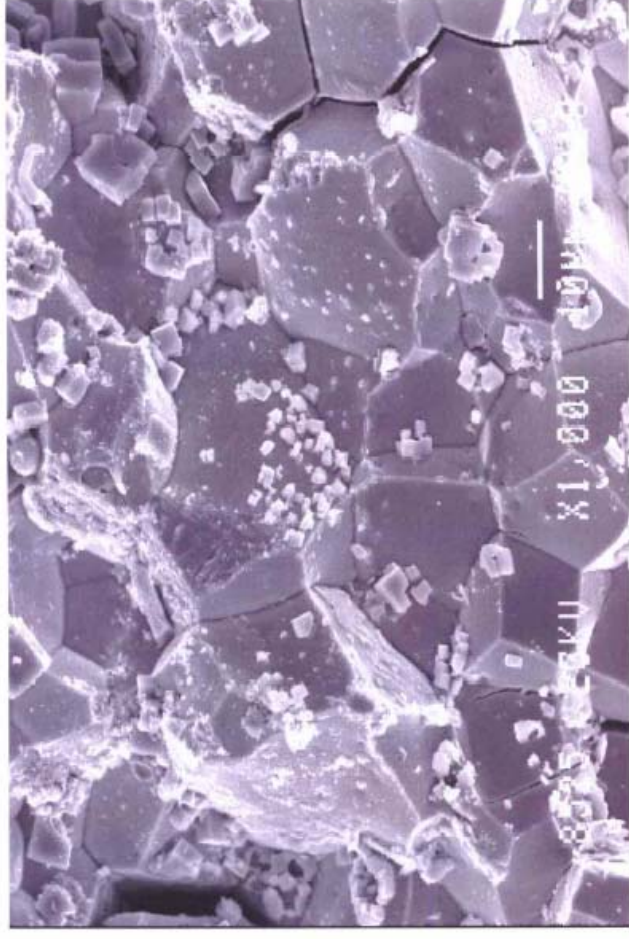
# The “Brownfield” Specimen...

SEM OF SLOW GROWTH AREA

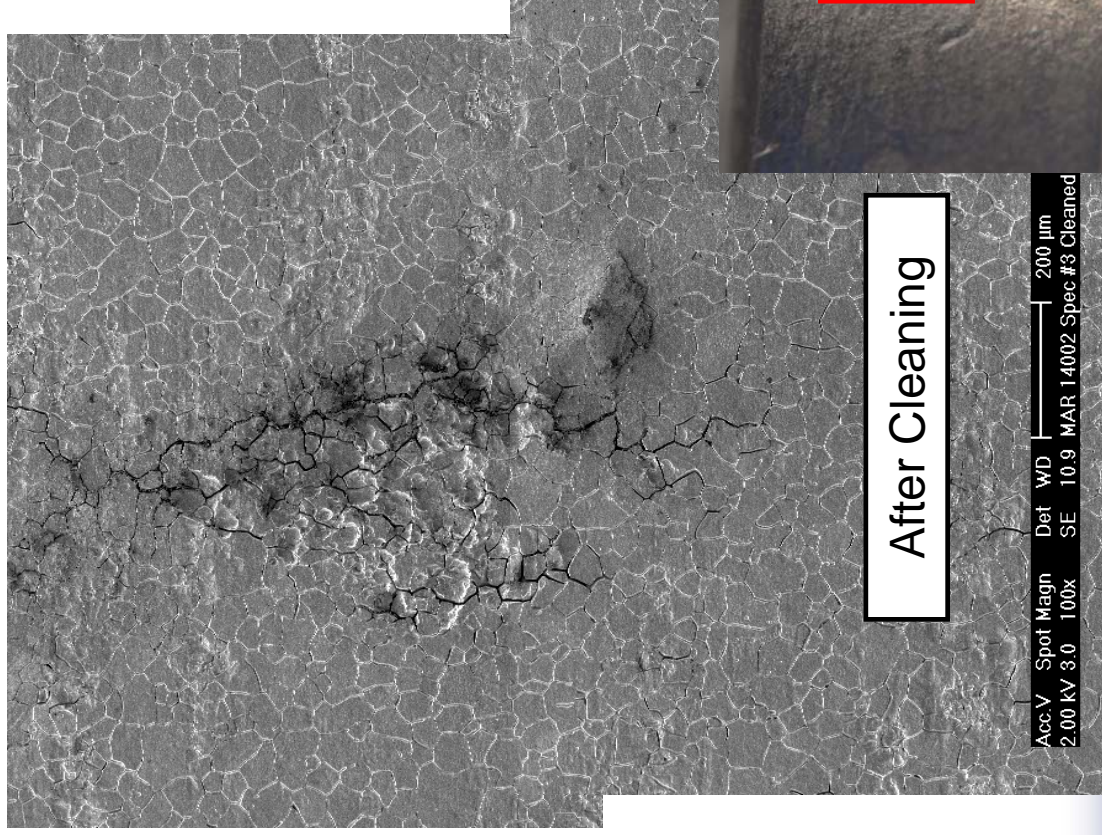
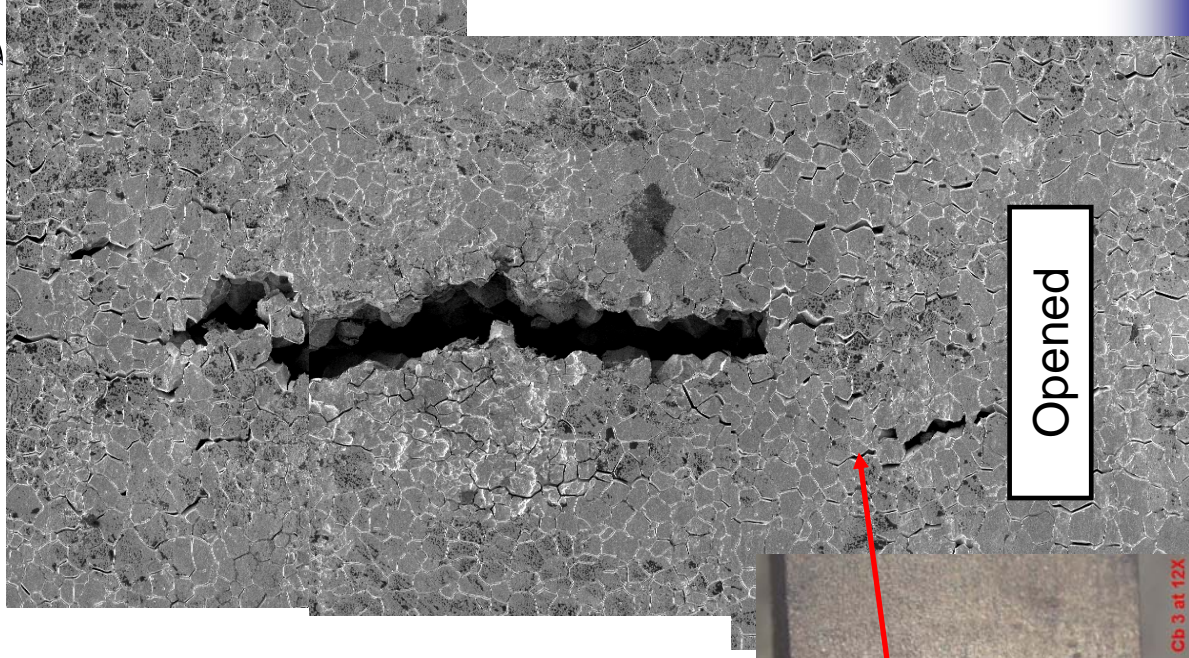
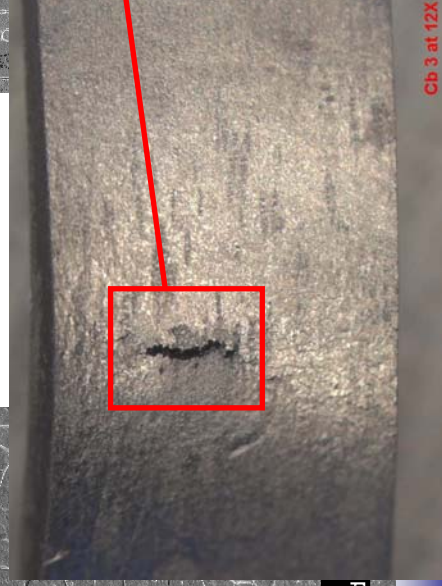
# Specimen #3 – HF + 600F

Cb 3 at 12X

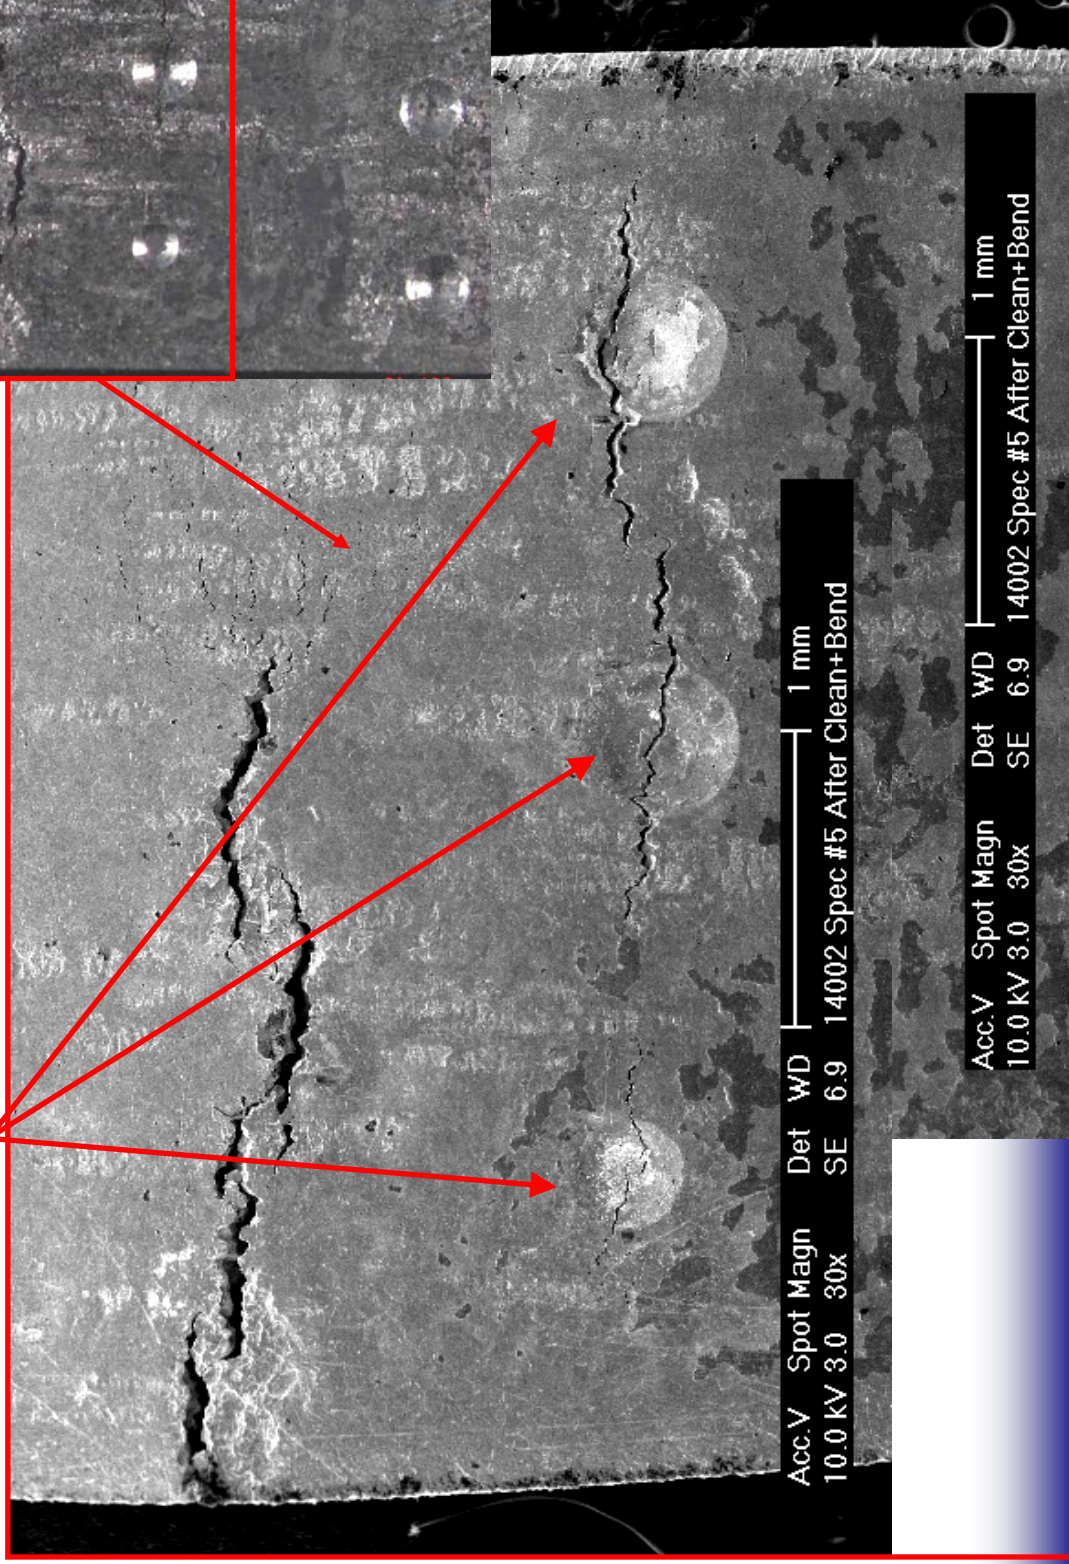
# Specimen #5 – HF + 600F

- 3 IG Crack Initiation Sites  
(Correspond to Hardness Indents)

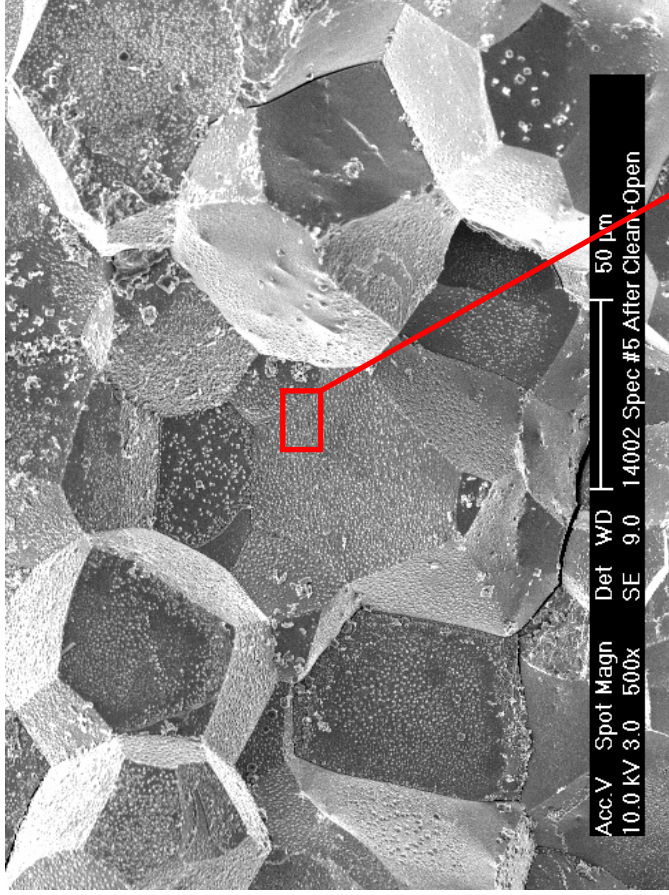
Near Origin

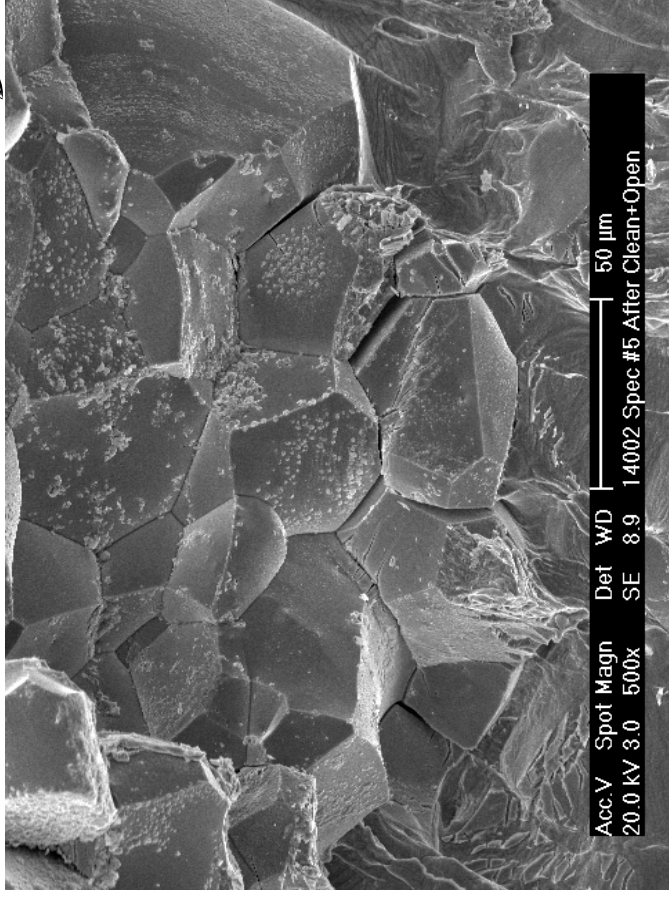
Near Termination

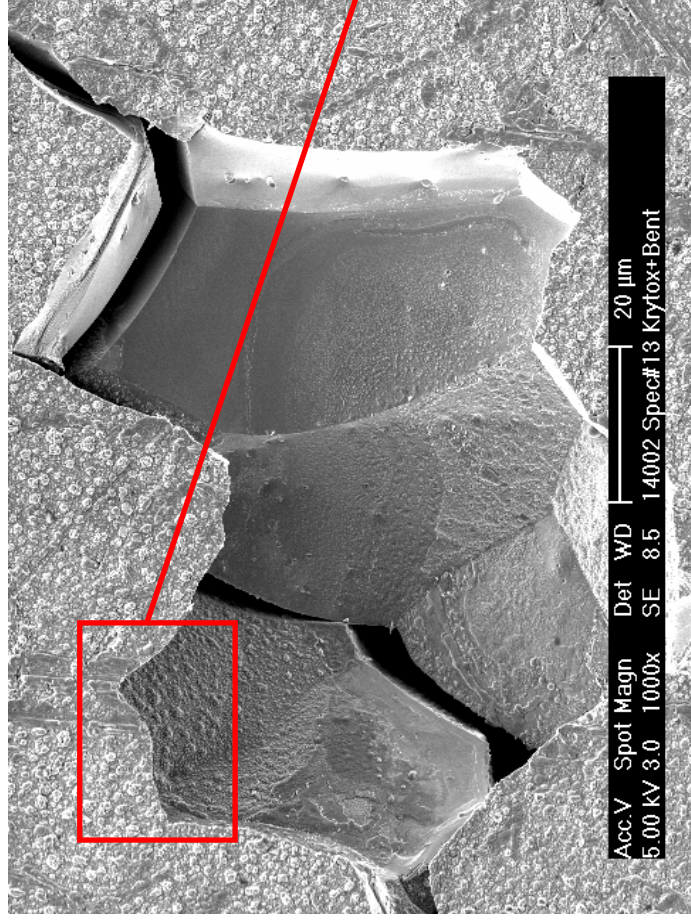
Missing Grains  
at Crack Origin

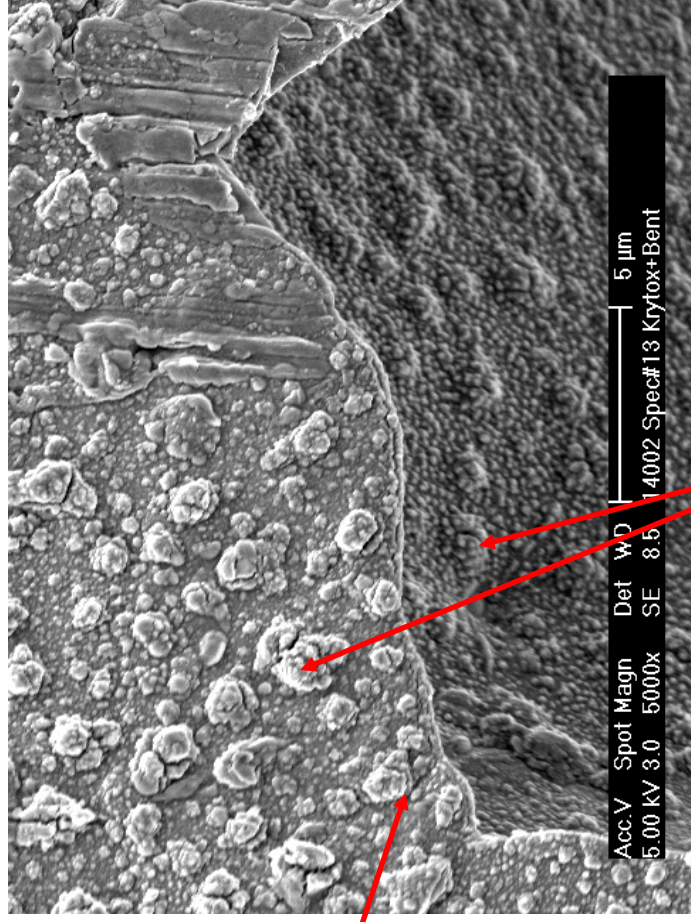
“Popcorn” on  
Free Surface +  
IG Crack

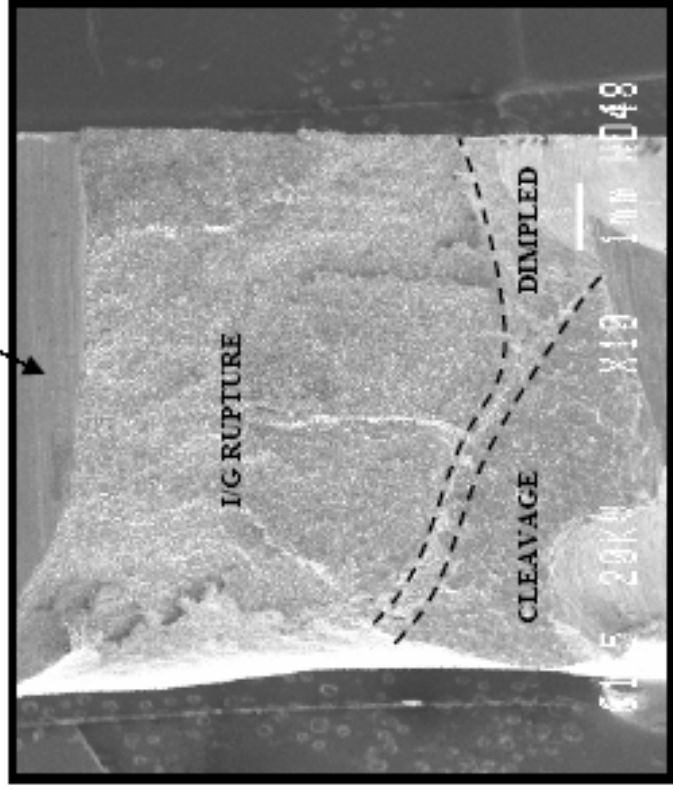
Overview of fracture face

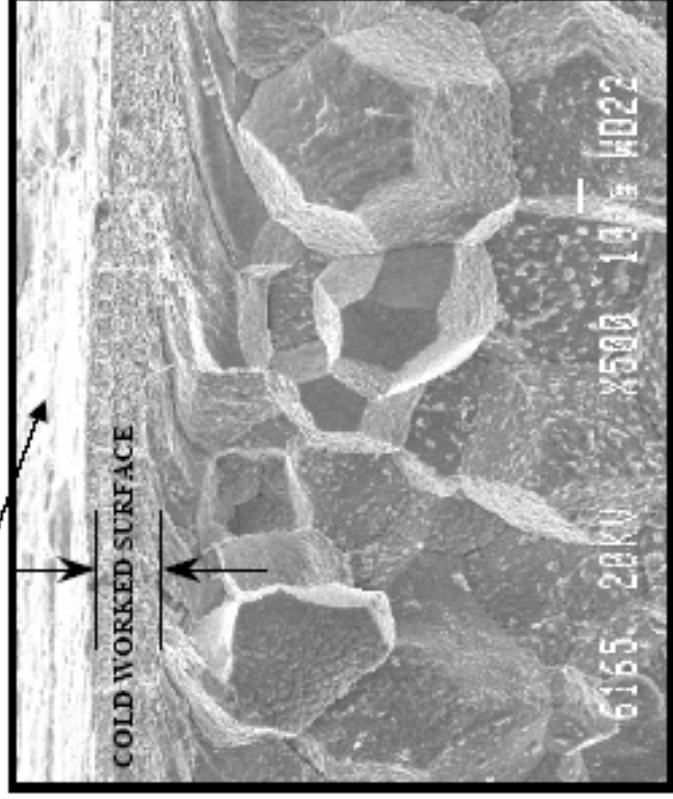
Cold worked surface layer and intergranular facets in failure origin area

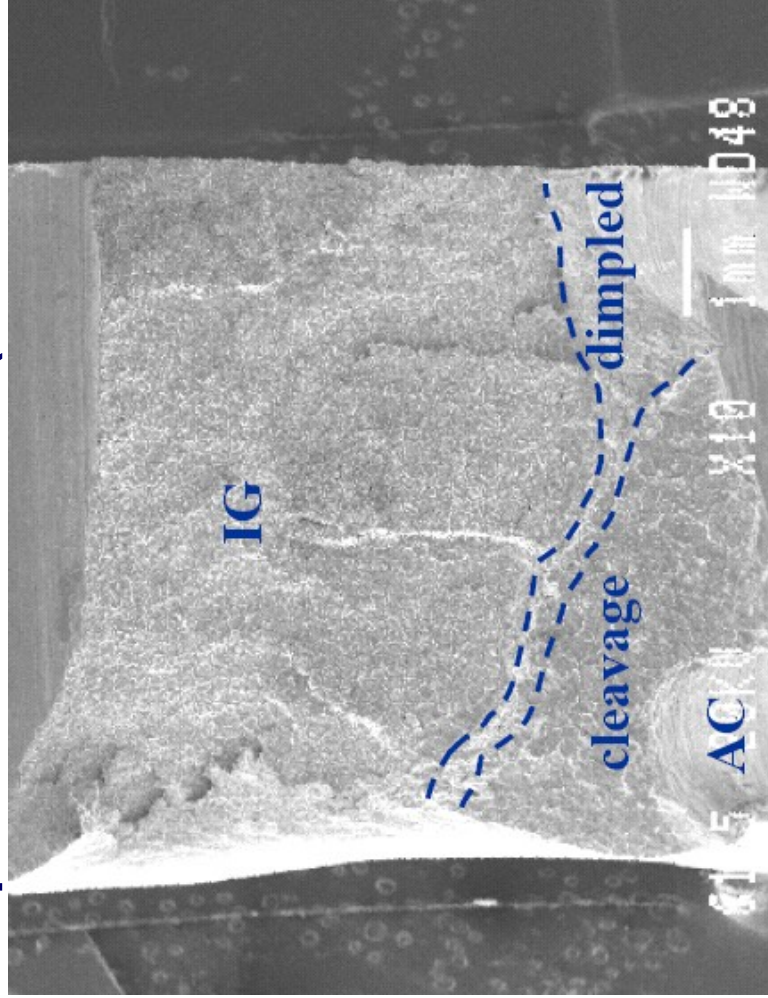
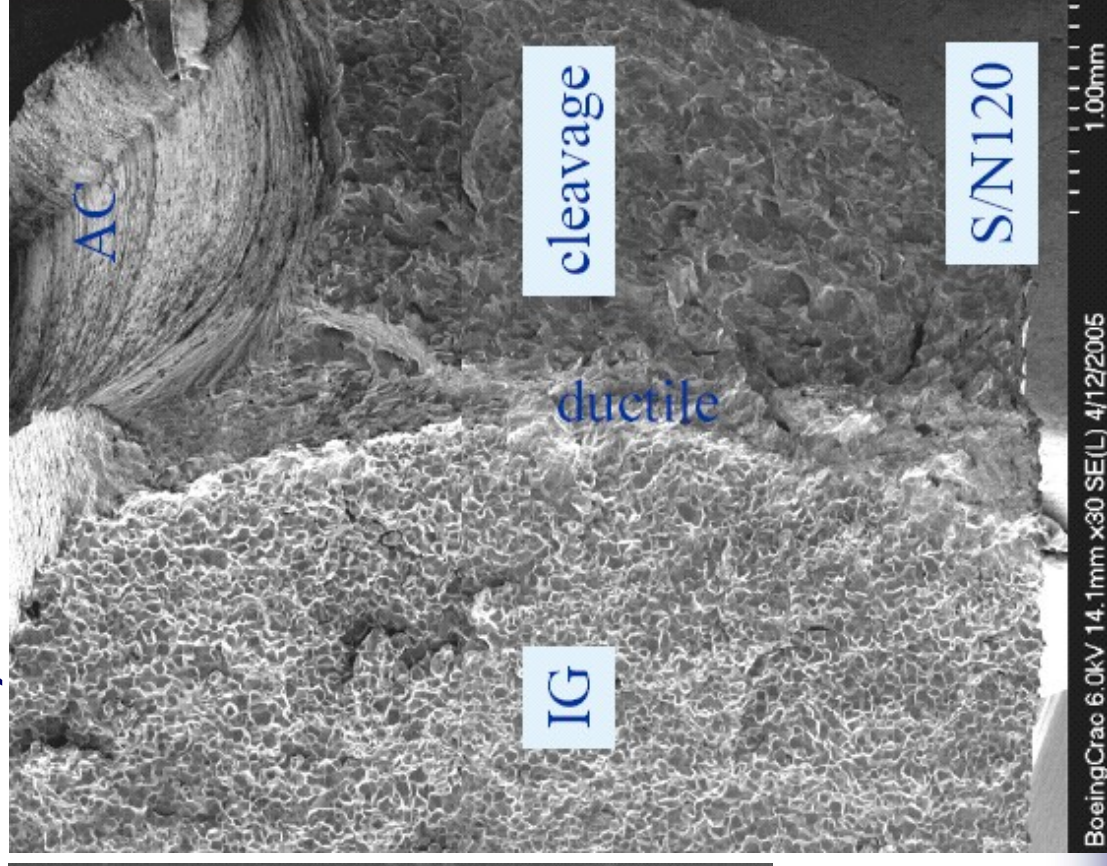
## Opened Relief Radius (Between Holes J & K)

# Cleavage Fracture on S/N 120
