Technical Findings, Lessons Learned, and Recommendations Resulting from the Helios Prototype Vehicle Mishap

Dr. Thomas E. Noll

NASA Langley Research Center
Hampton, VA 23681
USA

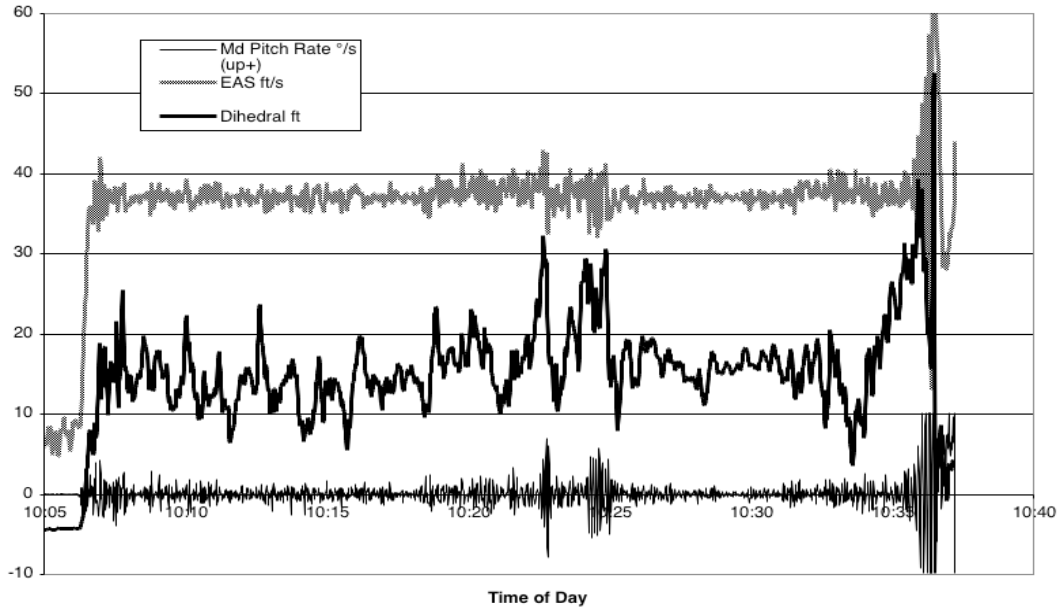
The aircraft impacted the ocean in mile-deep water 10 miles off the coast of Kauai. The vehicle structure including the main load carrying composite wing spars were severely damaged. The elapsed time from the first effort to diagnose and correct the high wing dihedral condition to the point at which the airplane began to break up in the air was 91 seconds. Figure 7 provides time histories of the aircraft's pitch rate and airspeed, and the wing dihedral for the 30-minute flight.

Figure 7: Wing dihedral, pitch rate, and airspeed history during mishap.

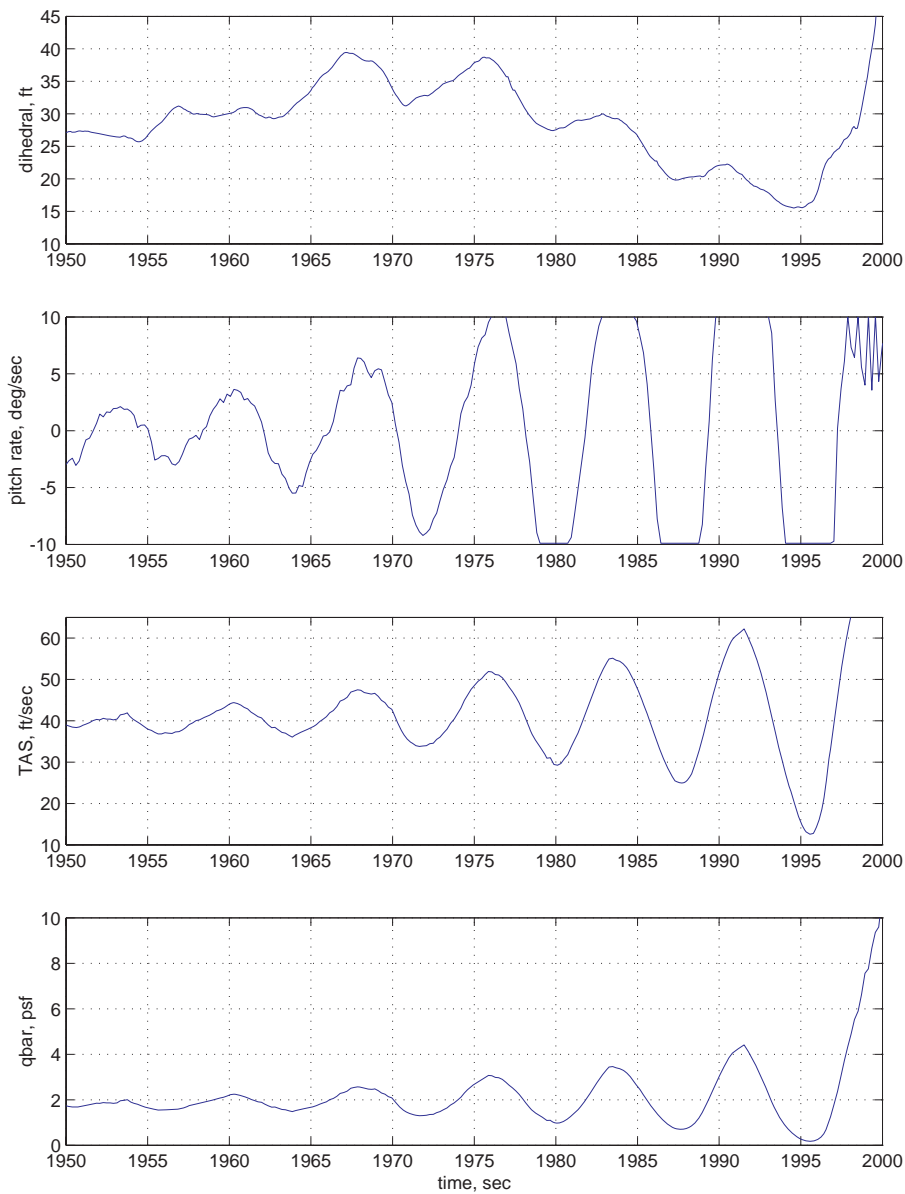
The 1st encounter with turbulence did not cause high wing dihedral. The next two encounters occurred in the space of three minutes. The aircraft developed high dihedral deflections of about 30 feet, began to oscillate in pitch, and then recovered on its own without pilot interaction. Since this type of pitch oscillation was a known flight dynamic characteristic of the Helios class of vehicles that had been predicted, observed, and controlled several times in prior flights with predecessor configurations, the MP and SP pilots and flight crews did not interpret the airspeed variations associated with the events as serious periodic oscillations, but rather as typical responses due to turbulence. On the 4th encounter with turbulence (Figure 9), the dihedral increased to an even higher magnitude of about 40 feet, and the pitch oscillation diverged rapidly.

Figure 9: Dihedral, pitch, vehicle airspeed, and dynamic pressure for mishap event.

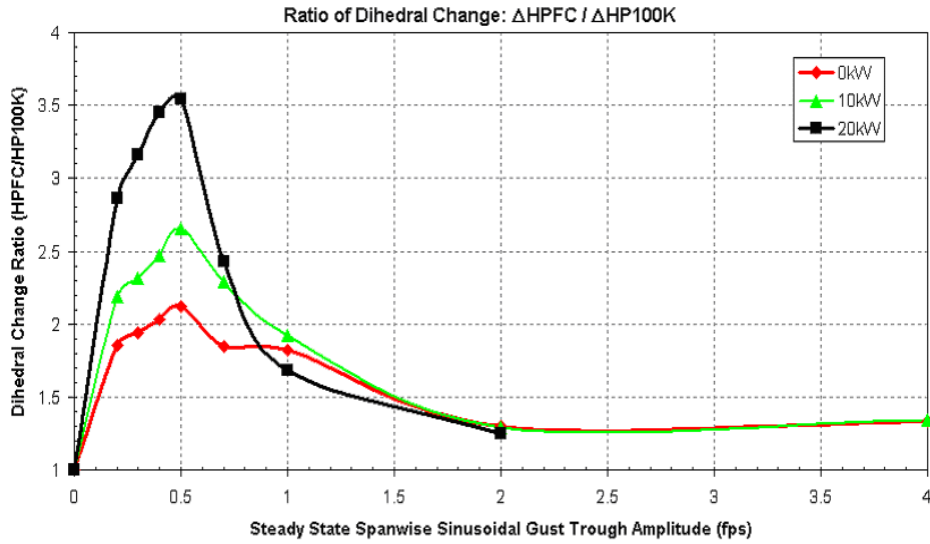
Turbulence Effects: In terms of the environmental effects, turbulence was determined to have initiated the high wing dihedral, however it was also determined the turbulence was not necessary to maintain it. Post mishap analysis revealed that spanwise lift redistribution (from the center of the aircraft to the outboard wing panels) was very sensitive to small amplitude gusts (Figure 10). It had been the experience of the Helios type aircraft that its dihedral varied as local airflow varied along the wingspan. Figure 11 provides a comparison of the wing spanwise lift distribution for the HP01 and HP03-2 aircraft configurations with a superimposed 0.5 ft/sec gust. For this study, it was assumed that the aircraft encountered a gust exhibiting a 0.5 ft/sec downward flow at the centerline and 0.5 ft/sec upward flow at the wing tips. Although the probability of the aircraft encountering such a gust is very low, the intent of the analysis was to show the sensitivity of the aircraft to gusts, even small gusts. The HP03-2 configuration has noticeably more lift outboard and less lift inboard. The increased lift outboard would be expected to lead to considerably increased dihedral. It is important to remember that the modeled sensitivity to local variations in sectional airflow is primarily a consequence of the aircraft's reactions to increasing dihedral, trailing edge up elevator,

and wing tip leading edge twisting up, not the first-order effects of airflow change. The airflow variation is only the transitory force. It was determined that elevator response and the change in wing twist contributed to the wing's slow return to nominal dihedral conditions. In the absence of a gust that flattens the wing (for example, a momentary gust having relative downward air motion on the tips and upward near the airplane centerline), these aerodynamic effects slowed the return to nominal dihedral.

Figure 10: HP03-2 increased sensitivity to small gusts.
