NASA/TM-2008-215100
NESC-RP-06-115/06-028-E

International Space Station (ISS) S-Band Corona Discharge Anomaly Consultation

International Space Station (ISS) S-Band Corona Discharge Anomaly

December 14, 2006

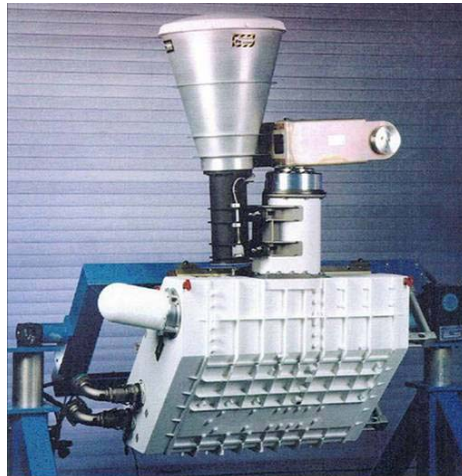
Figure 6.1-1. S-Band Assembly Contingency RF Group (ref. 5)

On April 13, 2006, there was a reflected RF power anomaly observed after four minutes nominal operation within the ACRFG (refer to Figure 6.1-1). This was in the “String 1 RFG” unit on S1 (S/N 002) as shown on the ISS in Figure 6.1-2. The “String 2 RFG” unit (S/N 003) on P6 is the primary unit. The spare unit (S/N 001) is stowed on Z1. Corona was examined as a possible root cause of the anomaly. Section 3.5 of the MDA ACRFG Reflected RF Power Anomaly Report (ref. 1) determined the necessary voltages to produce corona, at various pressures, in the narrowest electrode gaps in the coaxial cavity 5-pole diplexer and 3-pole bandpass filter (see Figure 6.1-3) assemblies. The results of the MDA analysis suggest the conditions present in the Bandpass Filter and Diplexer at 1 psia may have been favorable for the corona.

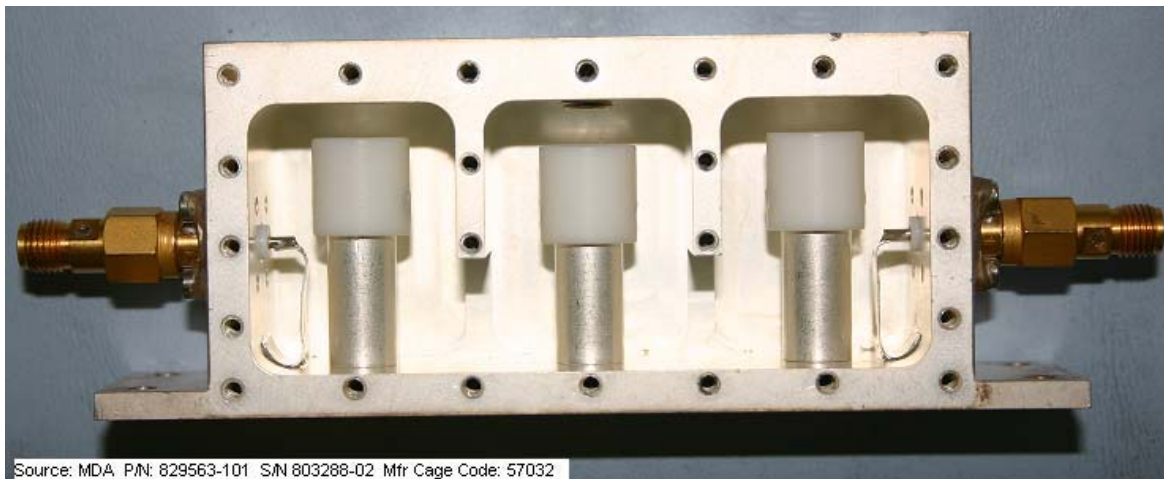
Figure 6.1-3. Bandpass Filter Assembly (ref. 5)

Section 3.5 of the MDA report determined the necessary voltages to produce corona, at various pressures, in the narrowest electrode gaps present in the subassemblies. As shown, the conditions present in the three pole Band Pass Filter and Diplexer at 1 psia may have been

favorable for corona. However, corona as a cause was judged unlikely because of the observed on-orbit conditions of four minutes normal operation and then degraded operation. The end of Section 3.5 states “Corona tends to be a violent occurrence and with permanent damage. Continued operation would not be sustained.”

The MDA report had concluded that a solder joint failure at the input of the bandpass filter was the most likely proximate cause of the on-orbit anomaly. The NESC Team noted that it is

possible that corona inside the filter cavity could erode (or more likely melt open) the solder connection attaching the injection loop's end to the case-wall, leading to a separation and result in observed signal loss. If the solder melted, or even reached the softening temperature, then the residual stresses in the loop (shown in Figure 3.2-2, page 16 of the MDA report) could allow separation. This hypothetical detachment would also drop the voltage level in the cavity below the value needed to sustain the corona, at least for the present pressure. If this solder connection separation has happened, then there can be no further corona until the pressure decreases enough to move the system far enough along the Paschen curve so that the plasma threshold drops to the now-available voltage level. The predicted time for this change in plasma threshold could be approximated from the measured leak rate and the Paschen curve for N₂.

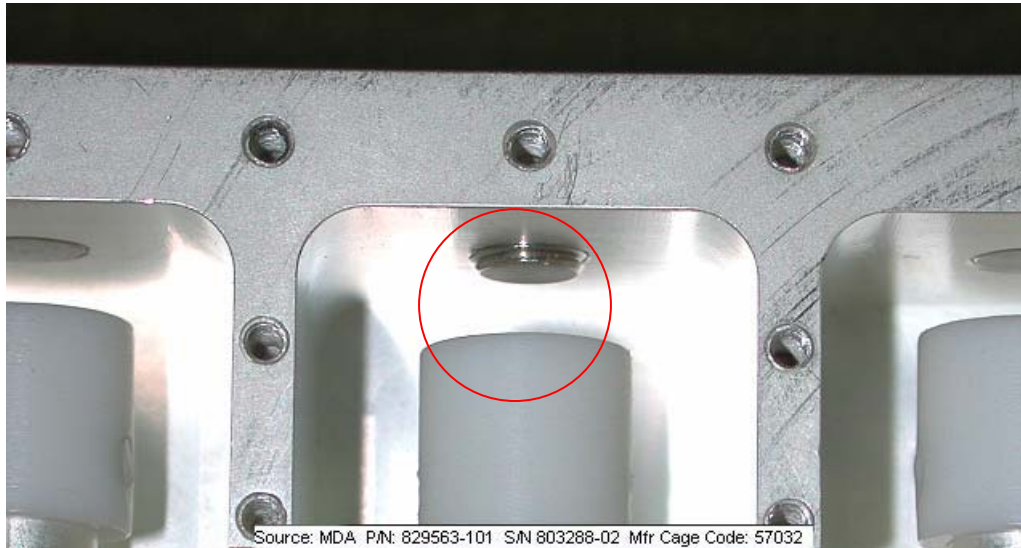
Figure 6.1-4. Bandpass Filter Tuning Screw and Gap (ref. 5)

However, corona was judged unlikely in the initial MDA report because of the observed on-orbit condition of four minutes of normal operation followed by degraded service. The end of Section 3.5 (ref. 1) states: "Corona events tend to be a violent occurrence and with permanent damage. Continued operation would not be sustained." For these reasons, a solder joint at the input to the bandpass filter was initially identified by MDA as the most likely proximate cause of the on-orbit ACRFG anomaly.

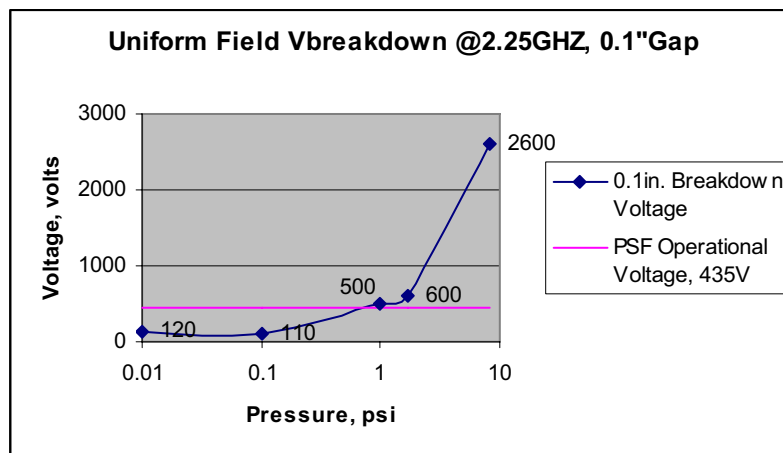
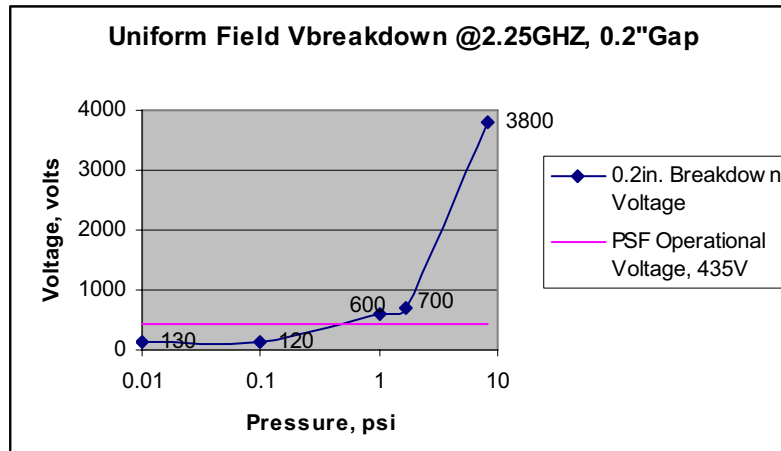
Figure 7.2-1. Breakdown Voltage versus Pressure for Various Gaps (in air) from Woo Curves (ref. 6)

The charts in Figure 7.2-1 show the RF breakdown voltages for a range of pressures in an air environment (refs. 5 and 6). For the purposes of this analysis, N₂ and air are considered

1. At pressures between 0.001 psia and 1 psia, corona is almost certain (>90 percent) for the gap sizes within these assemblies (>90 percent).
2. At pressures of greater than 2 psia, corona at any gap size is unlikely (<10 percent).
3. Between 0.1 and 1 psia, the margin between the operating voltage and corona inception level is essentially non-existent, and the likelihood of corona should be moderate (~70 percent).
4. Below approximately 0.001 psia, multipactor breakdown dominates over ionization breakdown. Corona does not occur in hard vacuum (e.g. <0.00001 psia). However, multipactor breakdown is still possible for small gaps (0.1 inch) in this pressure region, so a breakdown probability of 50 percent would be appropriate.

In the 1 to 2 psia region, the probability of corona is undefined. This is the “knee” of the Paschen curve where the breakdown voltage characteristic changes greatly with small changes in pressure.
