STEREOMICROSCOPE INSPECTION OF POLISHED ALUMINUM COLLECTOR 50684.0. M. C. Rodriguez¹, M. J. Calaway², J. H. Allton³; ¹ Geocontrol Systems- ESCG at NASA/Johnson Space Center, Houston, TX 77058; melissa.rodriguez-1@nasa.gov, ² Jacobs- ESCG at NASA/Johnson Space Center, Houston, TX 77058, ³ NASA/Johnson Space Center, Houston, TX 77058.

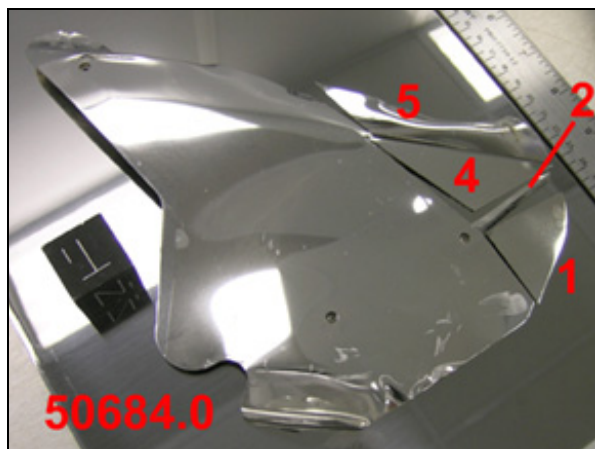
Fig. 1. Polished aluminum collector after subdivision in 2005. Portions 1, 2, 4, and 5 were previously imaged. Imaging of portion 50684.0 is in progress.

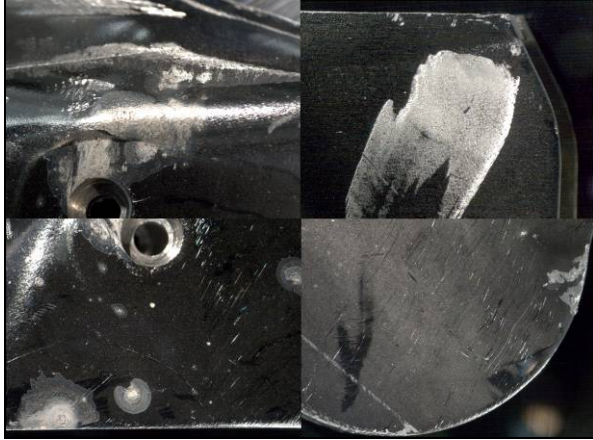
Fig. 3. Four examples of Utahogenic contamination near collector edges at 0.63X.

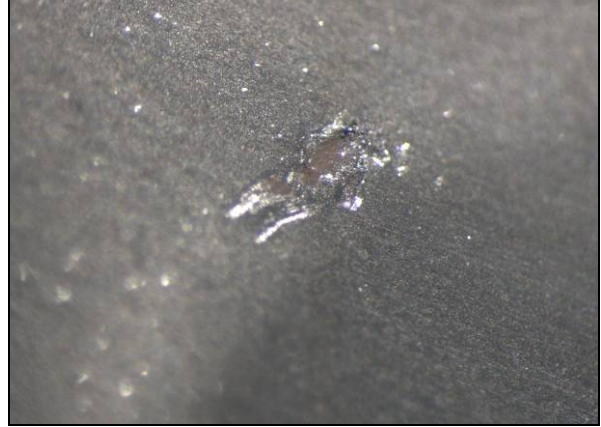
Fig. 6. Irregularly shaped gouge on aluminum kidney surface.

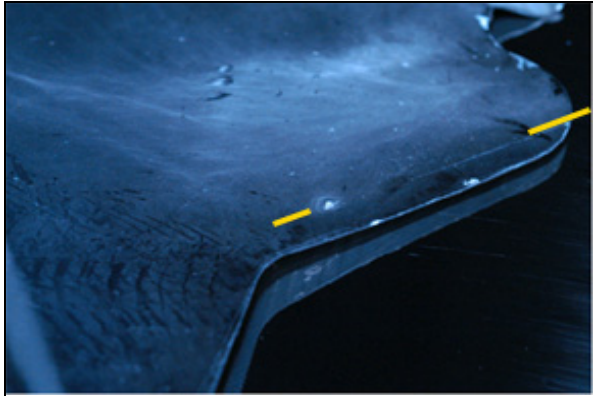
Fig. 4. Patterns in extremely fine material coating the polished surface shows evidence of physical movement of fragments during hard landing.
