Failure of the Trailing Umbilical System Disconnect Actuator on the International Space Station

Abstract

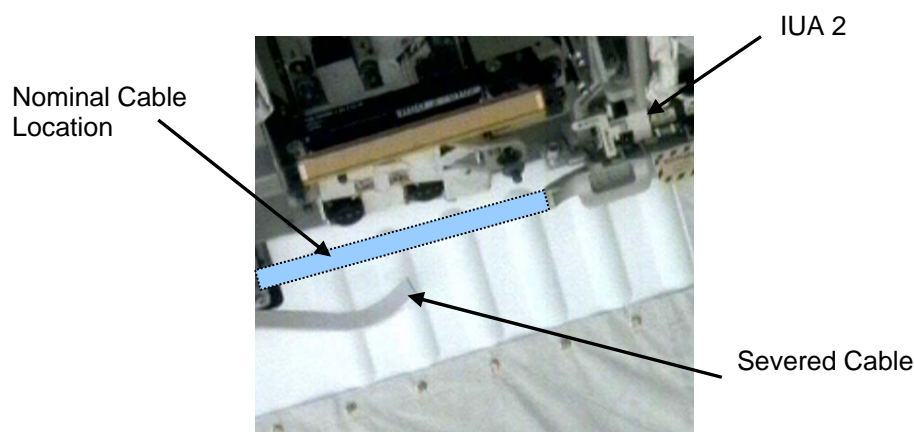
On December 16, 2005, a power switch on the ISS was tripped by a short circuit. Video of the MT and Trailing Umbilical System (TUS) cable revealed the cable routed to Interface Umbilical Assembly (IUA) 2 on the nadir side of the MT had been inadvertently severed (see Figure 1). When the cable was severed the live wire tips contacted metal causing a short, leading to a tripped power switch. Commanded actuation requires three independent power switch closures to the TUS Disconnect Actuator (TDA), and telemetry analysis indicated no possible electrical cause. The only remaining cause of the severed cable was a mechanical failure of the TDA.

Figure 1. Severed TUS Cable on IUA 2

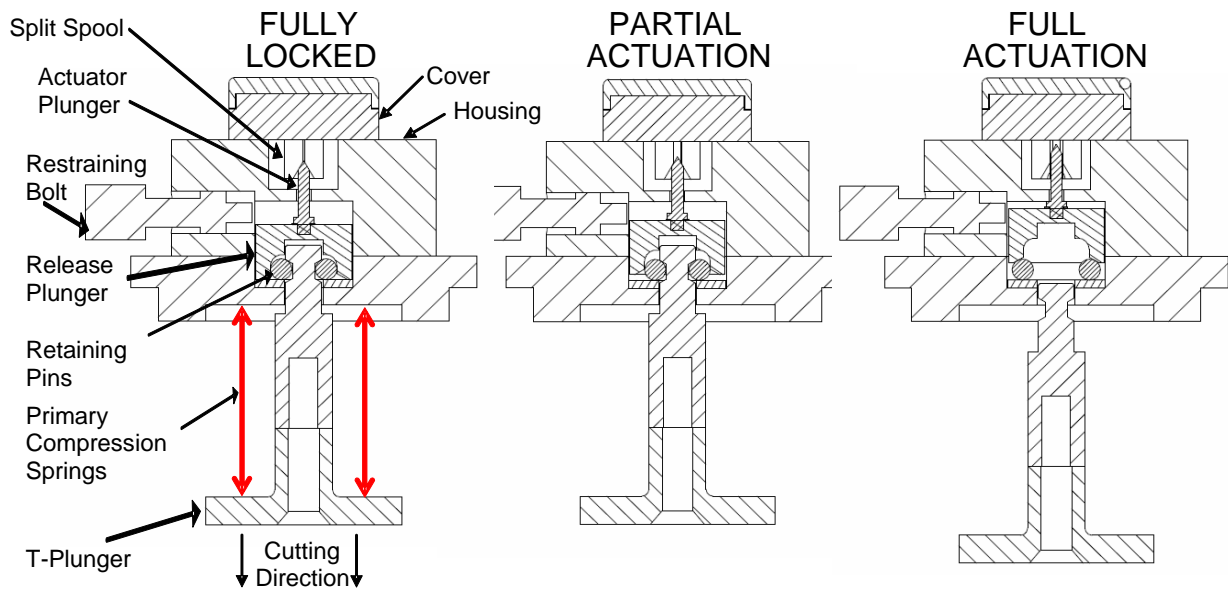
Figure 3. Actuation of the TUS Disconnect Actuator

The Restraining Bolt is used to prevent inadvertent actuation during launch vibration. In Figure 3, the crew interface is on the left side of the Restraining Bolt, and the shaft to the right of the threads blocks the Release Plunger if the TDA is actuated inadvertently. By design, a small gap is intended between the fully engaged Restraining Bolt and the Release Plunger. This ensures that the Split Spool locks the mechanism and the Restraining Bolt is truly a redundant feature. During initial on-orbit activation, the Restraining Bolt is removed, which arms the TDA. The "Fully Locked" view of Figure 3 shows the TDA armed with the Restraining Bolt backed out from the launch position.

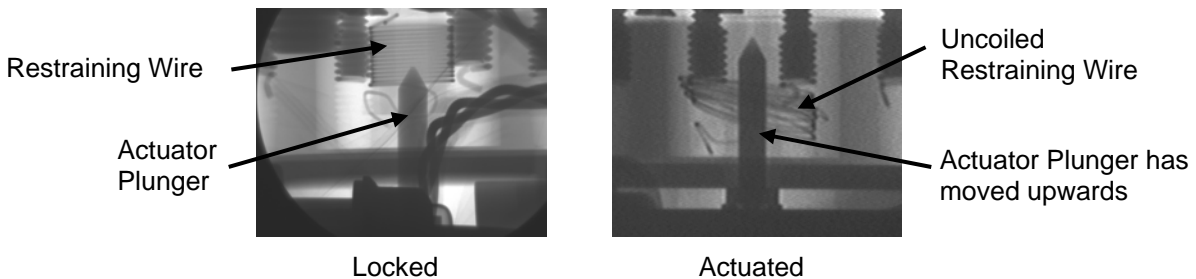
Figure 4. TDA X-Rays

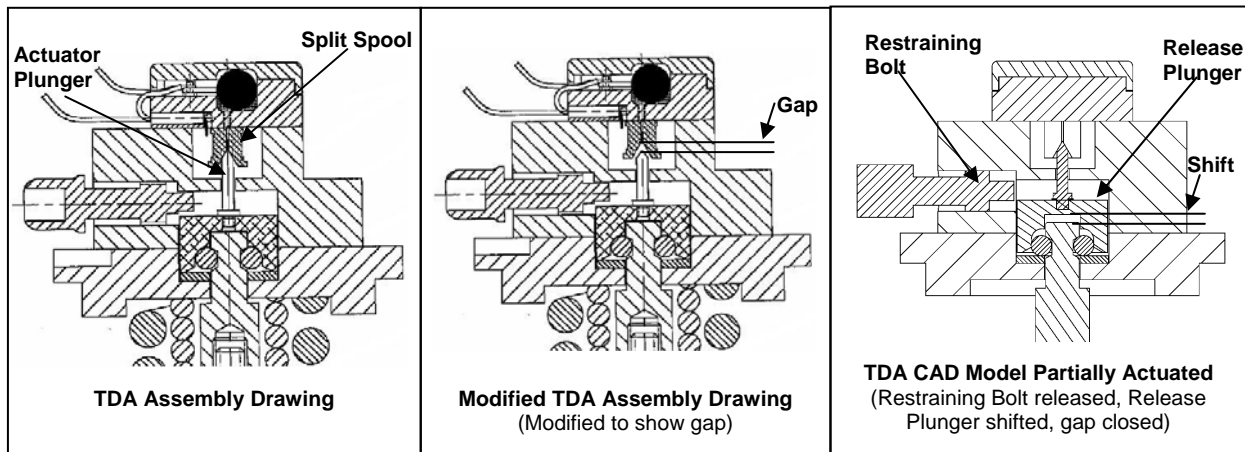
An assessment of the design was performed to determine what effects the as-built hardware could have on the position of the components within the mechanism. The results of the assessment indicated that when the components were built to the nominal drawing dimensions a gap would exist between the Actuator Plunger and Split Spool. If the as-built components were biased to one side this could increase that gap. The TDA assembly drawing omits this gap (see Figure 5).

During assembly of the flight units, the top portion of the T-plunger is installed and the Release Plunger with Retaining Pins is compressed. Next, the Restraining Bolt is engaged to hold the Release Plunger in place and preclude release of the top portion of the T-plunger. The Primary Compression Springs are then mechanically compressed, and the bottom portion of the T-plunger is installed and fastened to the top portion with a single bolt. The final step installs the TDA Cover with Split Spool to the Housing. After reviewing the assembly process it was clear that any gap between the Actuator Plunger and Split Spool would go undetected during final assembly of the flight unit. That gap is maintained by the Restraining Bolt until the unit is activated on-orbit. During on-orbit activation the Restraining Bolt is removed and the Release Plunger would move to close the gap (see Figure 5).

Figure 5. Gap Illustrations

Cross sections of the TDA assembly drawing show a close fit between the Split Spool and the Actuator Plunger and a gap between the Restraining Bolt and Release Plunger. As-built assembly indicated a gap at the Split Spool and a closed gap at the Restraining Bolt to Release Plunger interface, as seen in Figure 5, leaving the TDA partially actuated and changing the load path.

A detailed design study and resting state review considering the impacts of spring forces would point out the possibility of these issues and their impact to loading within the mechanism. Defining critical dimensions for Split Spool and Actuator Plunger height to ensure the Restraining Pins would remain fully seated could prevent a gap and the associated high loading condition.

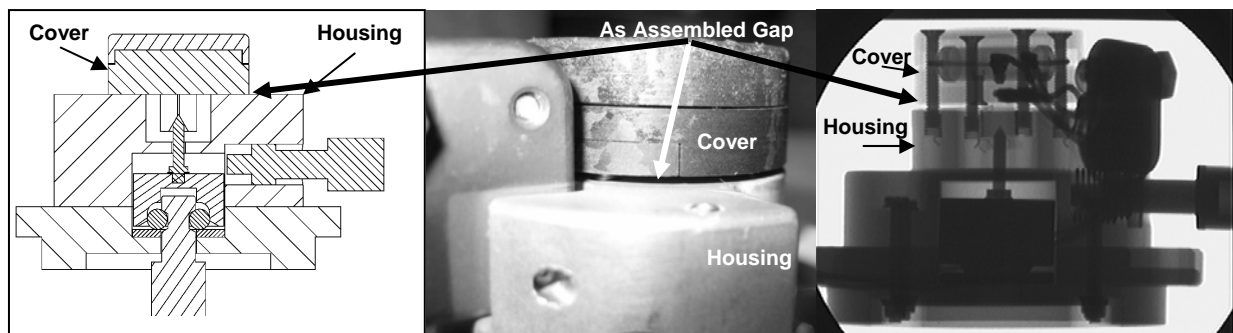
Upon return of the failed TDA, disassembly and non-destructive evaluations were performed. The first was an x-ray of the TDA Housing and internal components to determine whether or not the Restraining Wire and Fuse Wire were still intact. In addition, a detailed survey was performed of the exterior of the TDA Housing and Cover. Since the TDA mechanism was actuated and disassembled from the IUA on-orbit, the T-plunger and spring dimensions and surfaces could also be inspected. The x-ray of the TDA Housing clearly showed the Restraining Wire and Fuse Wire were still intact and did not cause the failure. When the outer covering tape was removed from the top portion of the TDA Cover, a non-uniform gap nearly 1.02 mm (0.04 in) tall was found between the Cover and Housing, indicating an assembly error. This gap was also confirmed by a subsequent review of the x-ray. The markings on the removed tape were consistent with a gap that had been present from initial Cover installation.

Figure 6. Failed TDA External View (tape removed) & X-Ray

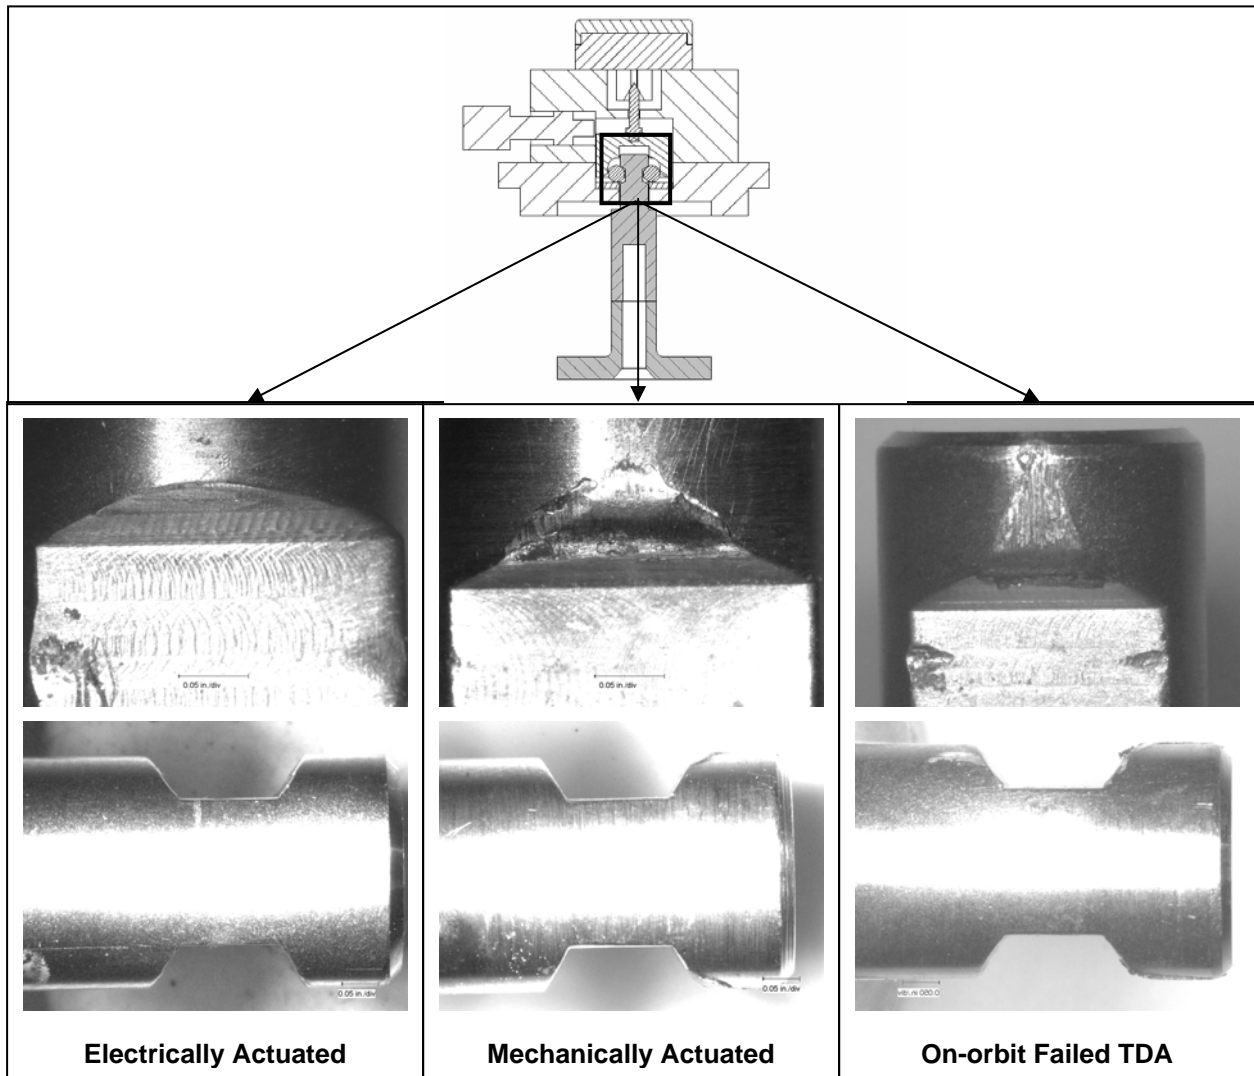
Upon inspection of the T-plunger, yielding was found where it contacted the Retaining Pins. Prior to obtaining the failed TDA, a series of ground tests were performed to support the planned on-orbit repair strategy. These tests included both a slow mechanical release of the Actuator Plunger and a near instantaneous release of the Actuator Plunger. Mechanical actuation was achieved by slowly backing out the fasteners that hold the Cover and Split Spool to the Housing, thus allowing the Release Plunger to shift and release the T-plunger. This test resulted in three findings that were significant to the failure investigation: 1) The T-plunger release required significantly less travel than expected (~0.965 mm (0.038 in) actual vs. ~4.75 mm (0.187 in) expected), 2) The edge of the T-plunger notch was mechanically yielded at the Release Pin interface, 3) The Split Spool was damaged at the Actuator Plunger interface. Post flight inspection of the failed TDA T-plunger indicated similar notch yielding at the Retaining Pin interface. The travel required to mechanically actuate the TDA was similar to the gap that was seen between the Cover and the Housing on the failed TDA. This indicates the TDA was very close to actuating when the Restraining Bolt was first removed on-orbit.

Figure 7. T-Plungers Post Actuation

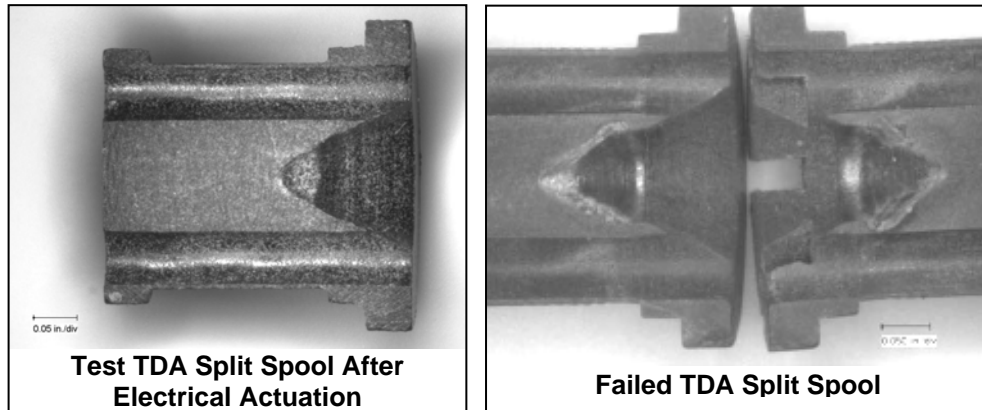
The Split Spool and Restraining Wire were inspected via x-ray and visually after initial disassembly. The Restraining Wire was intact and did not allow the Split Spool to separate. The Split Spool was then separated by removing the Restraining Wire to allow a detailed inspection of the Split Spool halves. The inspection revealed the Release Plunger had compressively yielded the interior of the Split Spool. This finding was consistent with the damage seen during the mechanically actuated ground test. This damage is caused by an increased force transferred to the Actuator Plunger from the Primary Compression Springs during a slow release actuation. As the Release Plunger travels upward the Primary Compression Springs force the Restraining Pins outward. This outward force is then transmitted to the Release Plunger and subsequently to the Split Spool. When the TDA is electrically actuated the Split Spool is free to separate and thus does not compressively yield (see Figure 8).

Figure 8. Split Spool Details

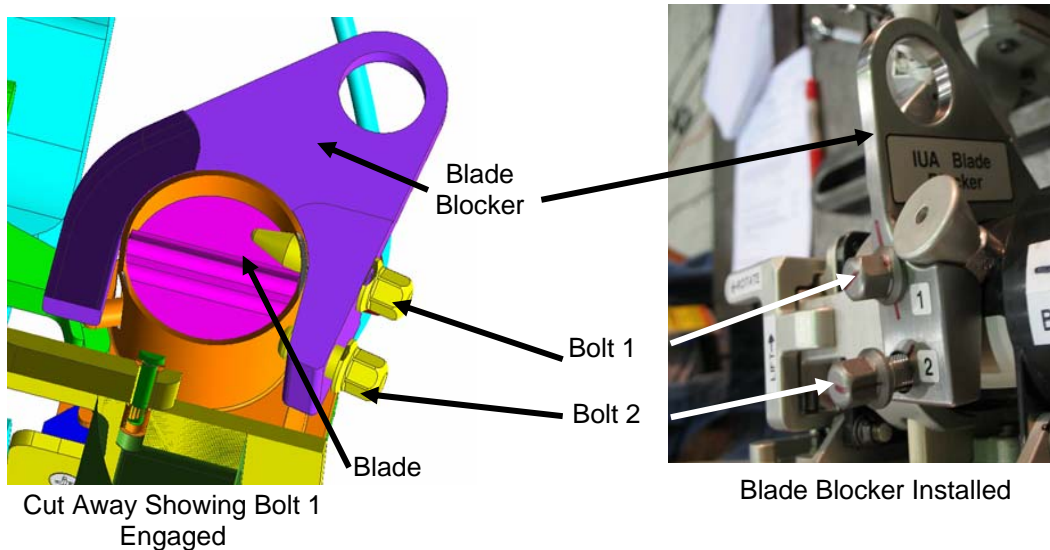
Figure 9. Blade Blocker Details

In the weeks after the TUS 2 cable sever, the team was concerned with the possibility of a second TDA failure on IUA 1 leading to a TUS 1 cable sever. In early February 2006 during Russian Extravehicular Activity (EVA) 15, the TUS 1 cable was routed outside of the TDA to prevent it from being cut until a long term repair could be implemented. The configuration of the MT leading up to the removal of the failed system was the TUS 1 cable was severed (IUA 1 failed) and the TUS 2 cable was routed outside of the TDA. The team prepared a repair to regain full MT redundancy in one Shuttle Flight, STS-121 (ISS Mission ULF1.1), in July of 2006. One requirement was to fly a spare TUS Reel containing a fully intact cable with connectors. In addition, the blade blocker (see Figure 9) was designed and tested on the ground to be installed EVA onto IUA 1 to prevent the TDA from cutting the cable in the case it too mechanically failed. The repair allowed for IUA 1 to be fixed in place in one short EVA task.

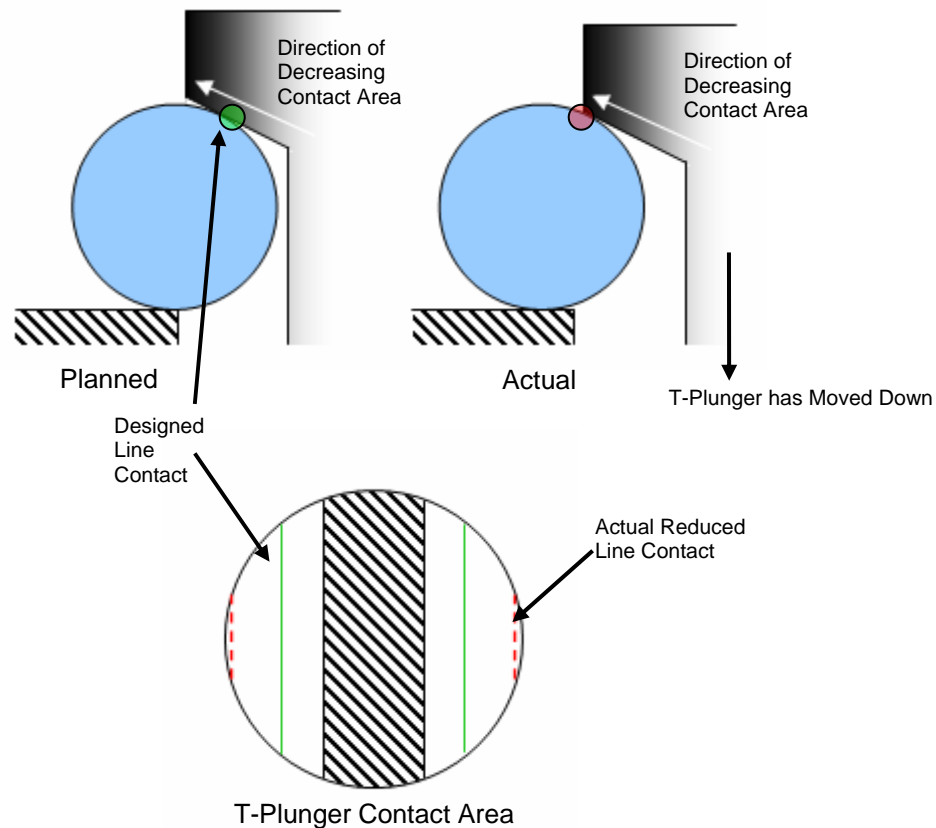
Creating a gap between the Actuator Plunger and the Split Spool allows a partial actuation of the TDA when the Restraining Bolt is removed. The effect of creating that gap is movement of the Retaining Pins along the slope of the T-plunger, as shown in Figure 10. When this loading condition is created, the high force from the Primary Compression Springs is concentrated on a significantly smaller area within the TDA. The designed line contact reduces greatly as it approaches a point contact as shown in Figure 10. Any yielding at that point exacerbates the problem and further actuates the TDA.

Figure 10. Change in Load Condition at Retaining Pin

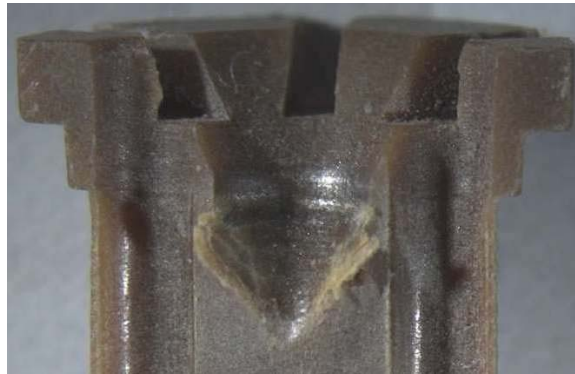
Disassembly of the Cover portion of the TDA assembly revealed deformation and yielding of the Split Spool (see Figure 11). Torlon Split Spools of this type had been used previously in switches for power systems.

Figure 11. Split Spool Deformation

In other applications, Torlon was highly desirable because of its electrical insulating properties. For the TDA, electrical properties were irrelevant. Structure focused requirements for this portion of the TDA would have weighted strength as far more important than electrical resistance. Torlon would not be as robust as steel for this application. Since electrical resistance was irrelevant, a steel Split Spool would be a more desirable choice for a compressively loaded structural member.

Where mechanical and strength properties are the main requirement, they should be weighted more heavily than flight history or other concerns. If the Split Spool was never overloaded, polymer selection would not have been a problem. In this case, other issues led to structural members experiencing loads in excess of design loads and failed by yielding. Caution should be used whenever adapting heritage designs that were developed for other applications.
