STS-118 Radiator Impact Damage

D. LEAR, J. HYDE, E. CHRISTIANSEN, J. HERRIN, F. LYONS

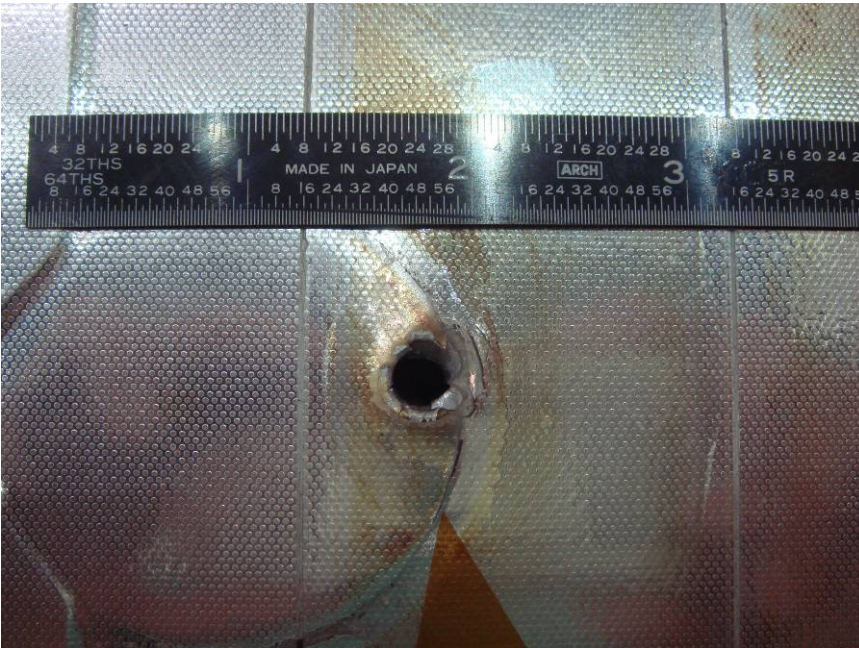
A close-up photograph of the radiator impact entry hole is shown in Figure 1, and the location of the impact on Endeavour's left-side aft-most radiator panel is shown in Figure 2. The aft radiator panel is 0.5-inches thick and consists of 0.011 inch thick aluminum facesheets on the front and back of an aluminum honeycomb core. The front facesheet is additionally covered by a 0.005 inch thick layer of silver-Teflon thermal tape. The entry hole in the silver-Teflon tape measured 8.1 mm by 6.4 mm (0.32 inches by 0.25 inches). The entry hole in the outer facesheet measured 7.4 mm by 5.3 mm (0.29 inches by 0.21 inches) (0.23 inches). The impactor also perforated an existing 0.012 inch doubler that had been bonded over the facesheet to repair previous impact damage (an example that lightning can strike the same place twice, even for MMOD impact). The peeled-back edge around the entry hole, or "lip", is a characteristic of many hypervelocity impacts. High velocity impact with the front facesheet fragmented the impacting particle and caused it to spread out into a "debris cloud." The debris cloud caused considerable damage to the internal honeycomb core with 23 honeycomb cells over a region of 28 mm by 26 mm (1.1 inches by 1.0 inches) having either been completely destroyed or partially damaged. Figure 3 is a view of the exit hole in the rear facesheet, and partially shows the extent of the honeycomb core damage and clearly shows the jagged "petaled" exit hole through the backside facesheet. The rear facesheet exit hole damage including cracks in the facesheet measures 14 mm by 14 mm (0.55 inches by 0.55 inches). The remnants of the impacting particle and radiator panel material blown through the rear facesheet hole also created two penetrations in the TCS blanket 115 mm (4.5 inches) behind the rear facesheet. Figure 4 shows these two impacts, which are located 75 mm (3 inches) apart. Some deposits of material were found on the payload bay door beneath the TCS blanket, but no additional damage occurred to the door.

Figure 1: Entry-hole damage (5.5mm diameter hole) to Endeavour's left-side aft-most radiator panel observed during post-flight inspection.

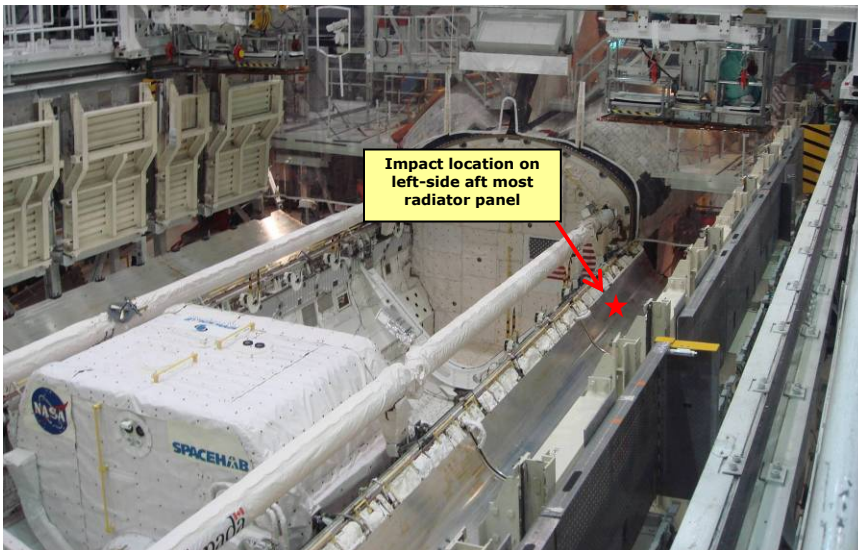
Figure 2: Impact damage location on Endeavour's left-side radiator panel # 4 (LH4)

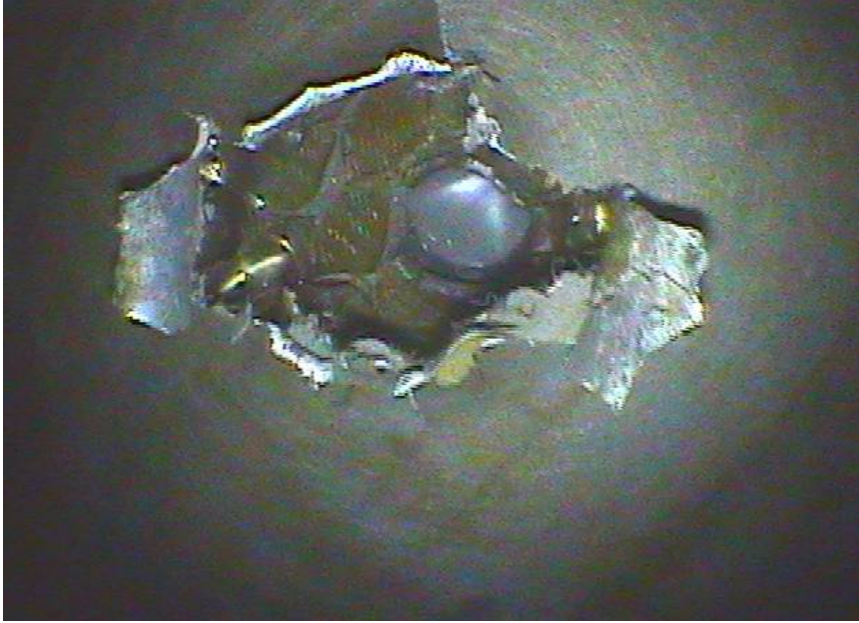
Figure 3: 12mm by 19mm hole in the rear facesheet of the radiator panel

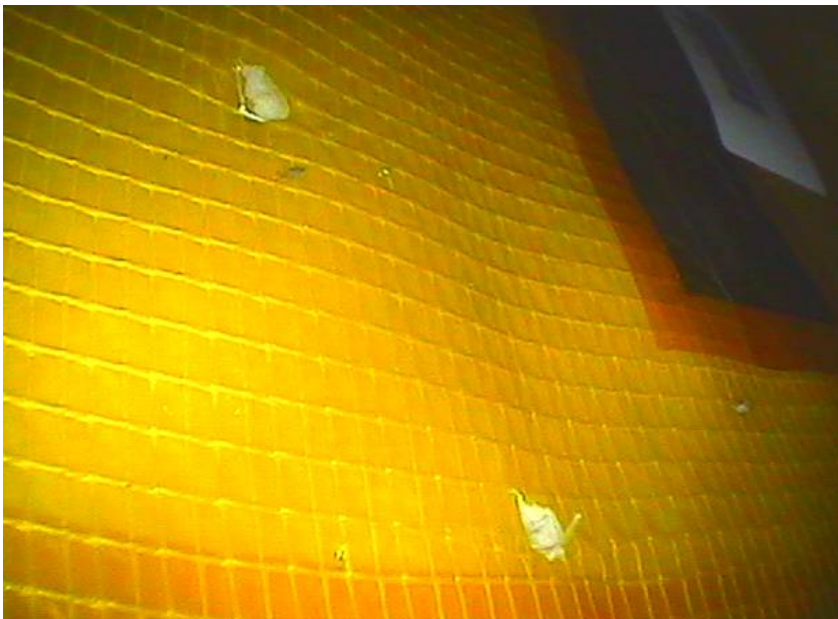
Figure 4: Damage to thermal control system blanket (two impact locations)
