A Comparative Study of Inspection Techniques for Array Packages

Jelila Mohammed
Christopher Green
NASA Electronic Parts and Packaging (NEPP)

April 28, 2008

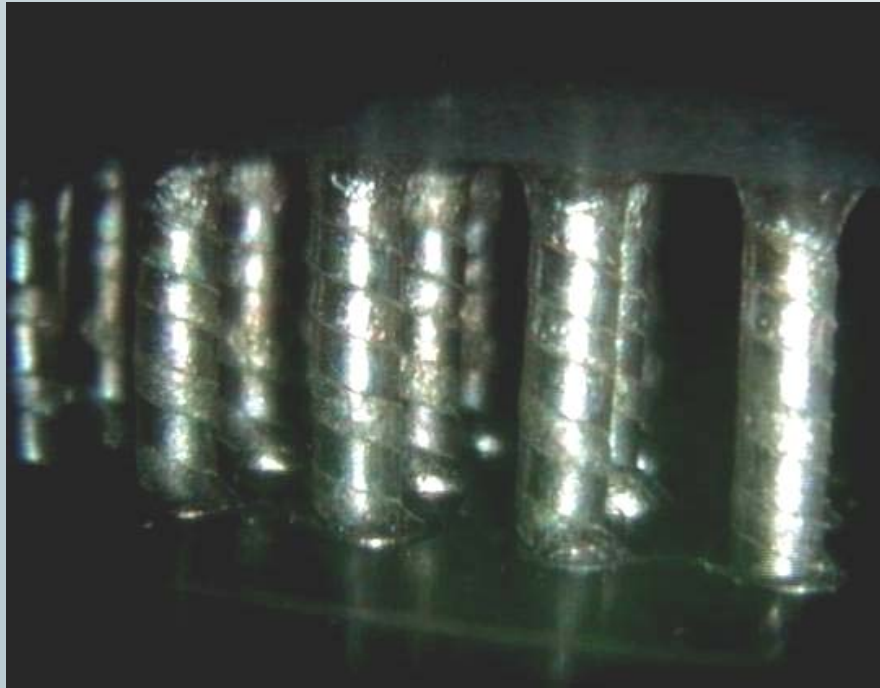
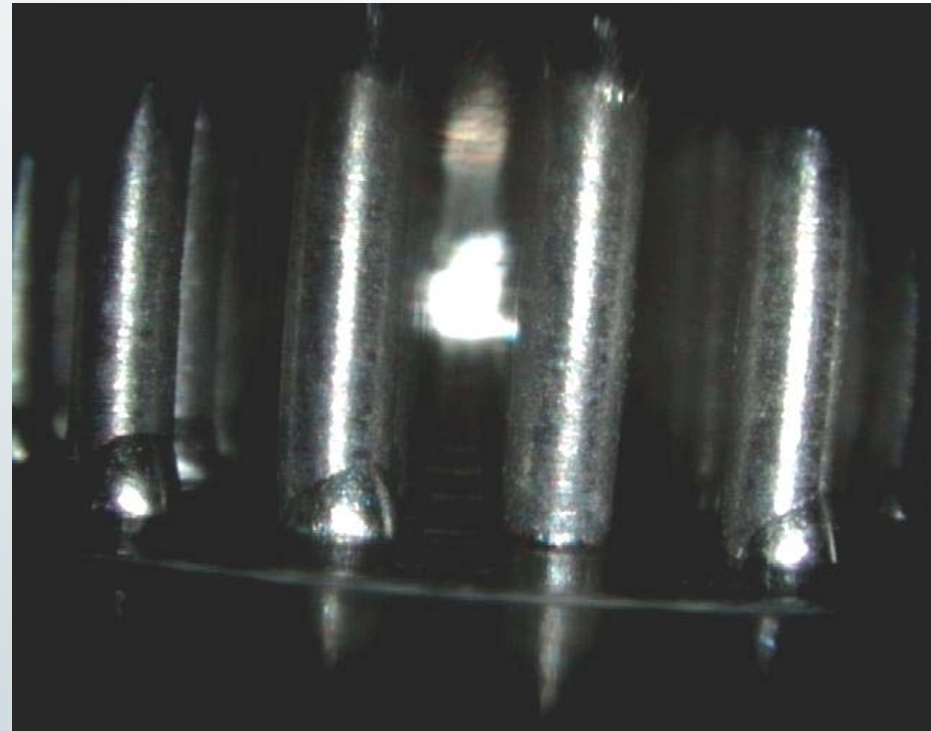
Aids in inspection of
column alignment

True color imaging of columns
and solder joints indicates good
solder quality

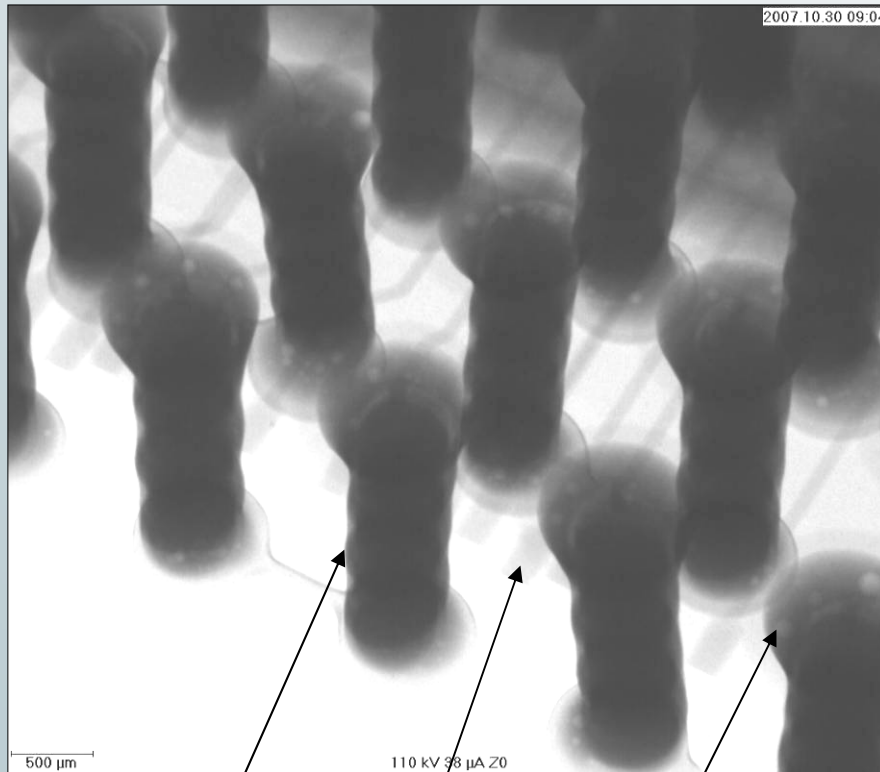
Reinforced column testboard

Cu-wrap

trace

void

- Most of the defects observed were voids in the solder joints
- Other features could be seen
 - Copper reinforcement of the column
 - Metal traces on the board

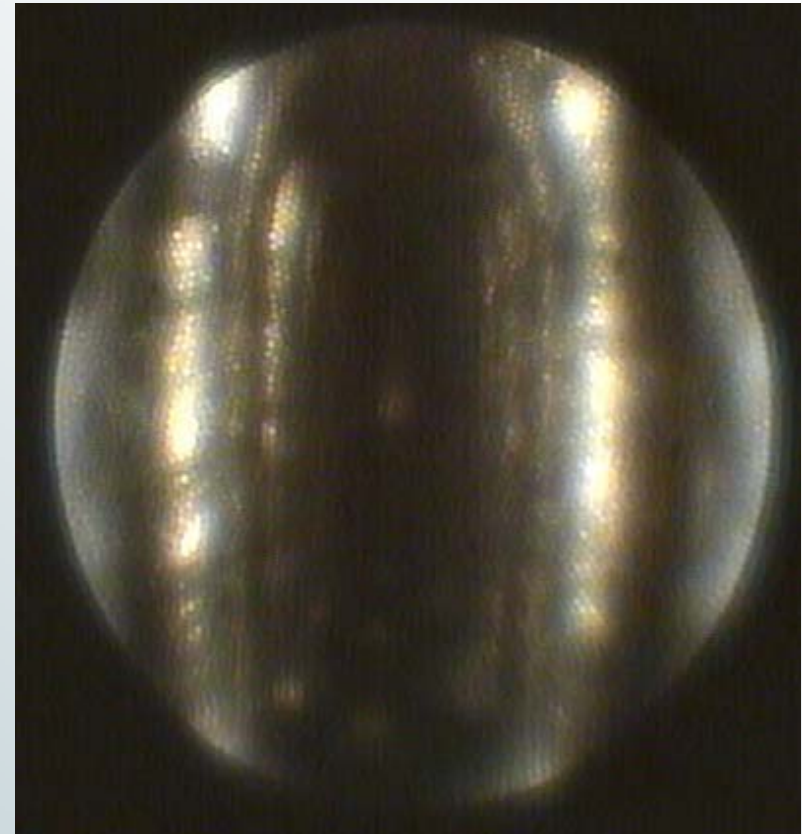
Image of center part of array, showing inner columns

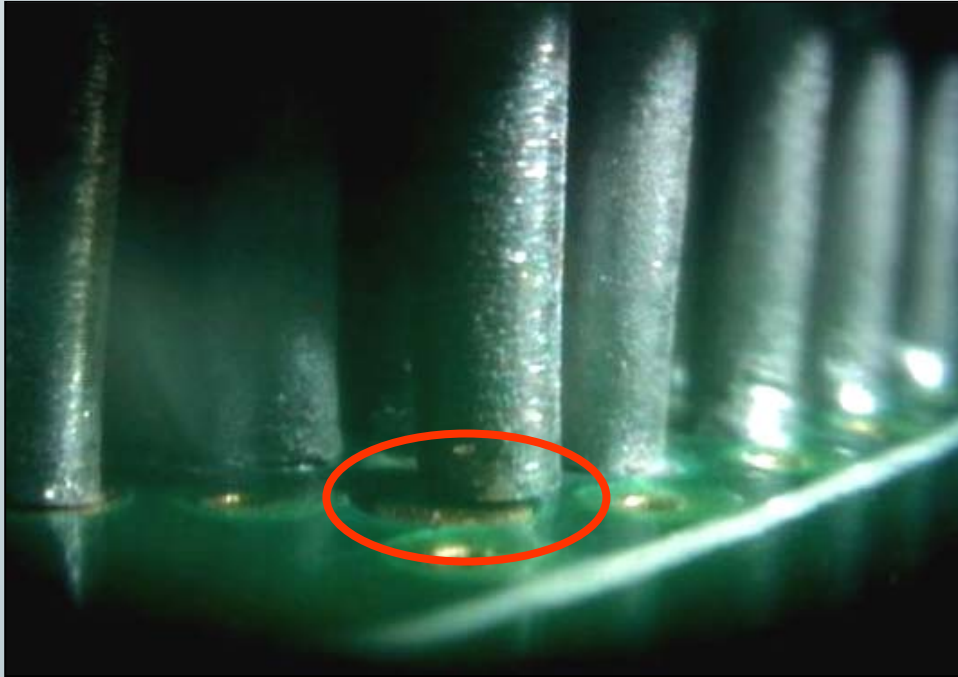
Optical inspection shows column is lifted off pad and has no solder attach at all.

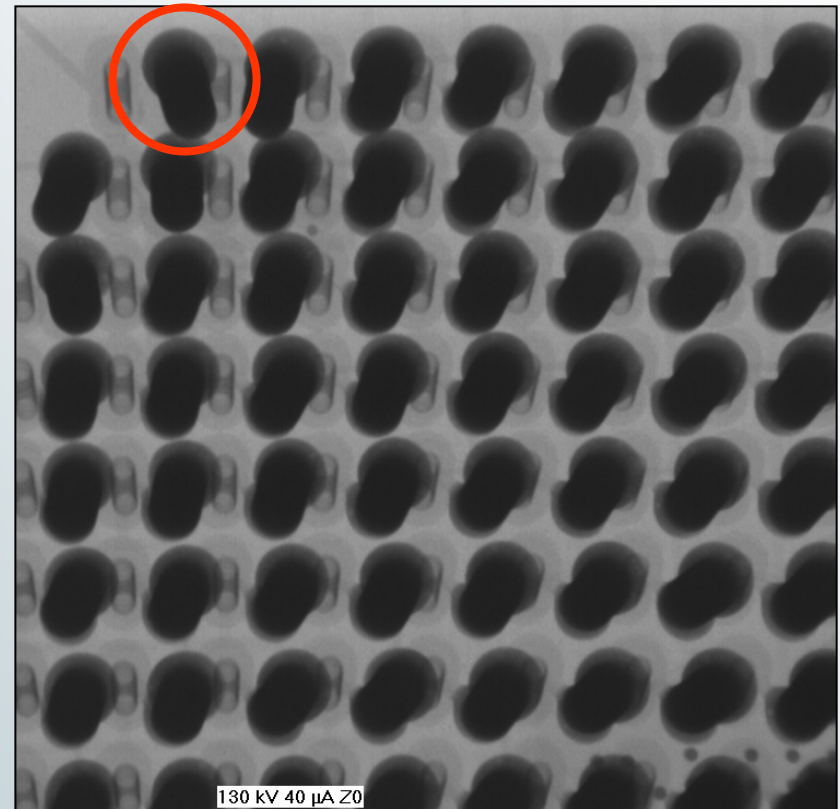
X-Ray inspection does not indicate the column is abnormal.

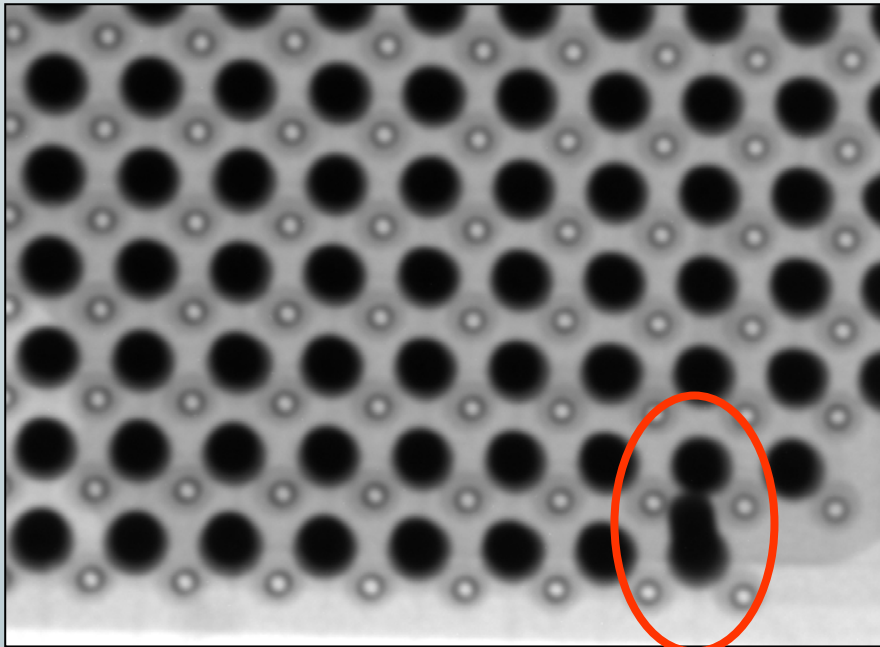
X-ray inspection shows the bent pin, but the short cannot be confirmed

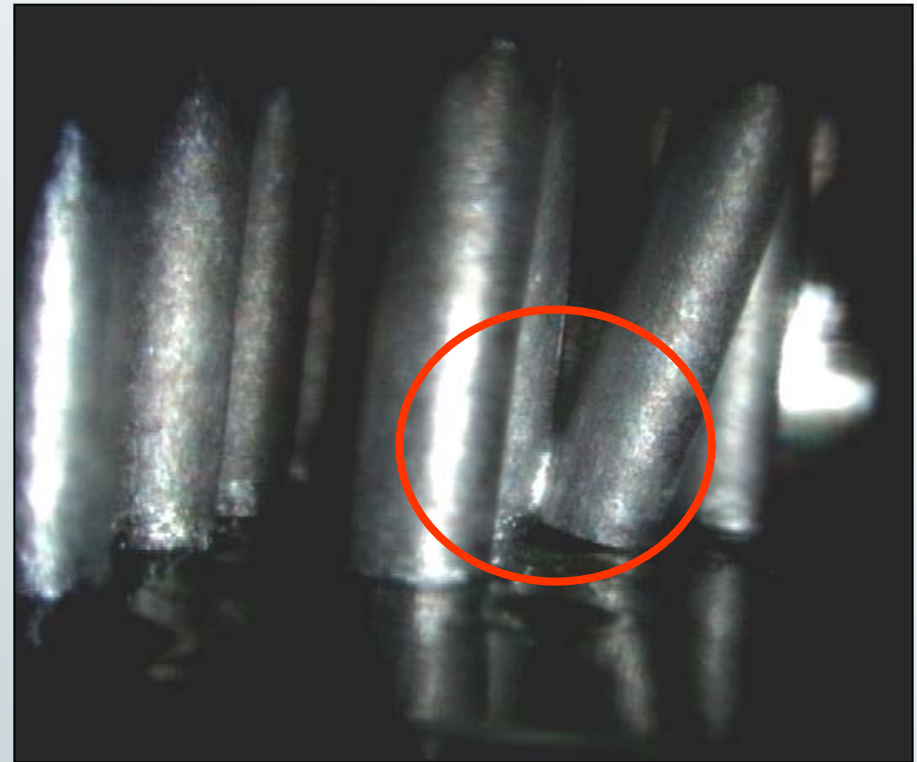
Optical inspection indicates that one pin is shorted to another

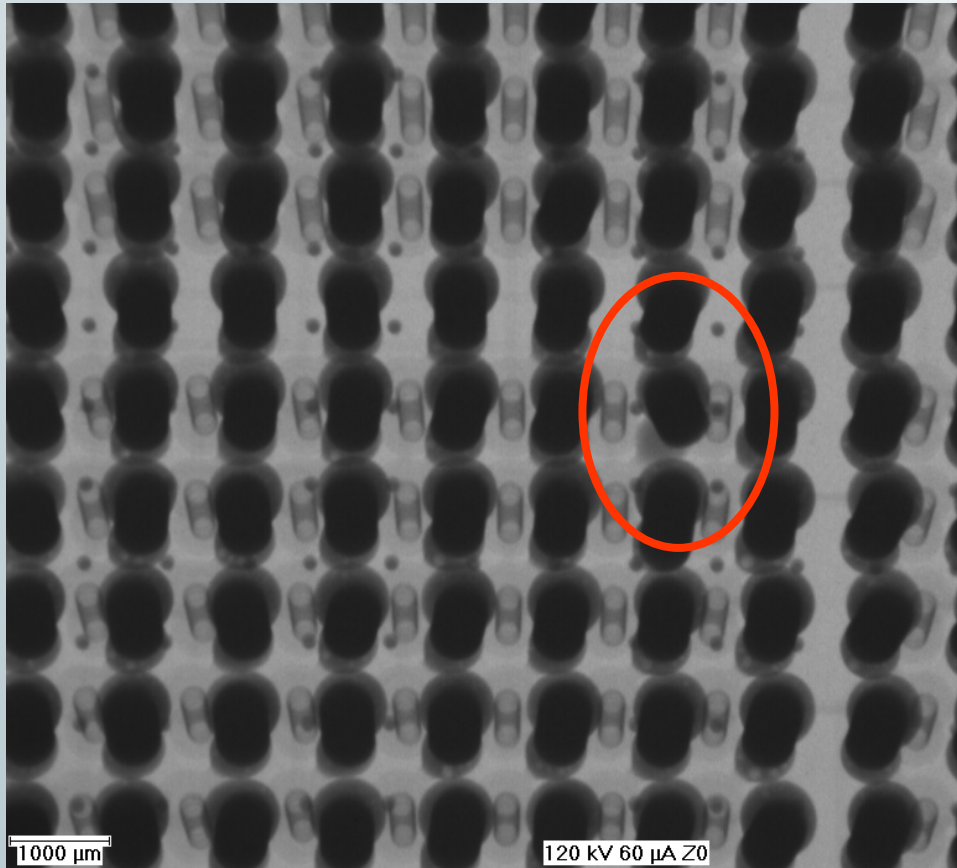
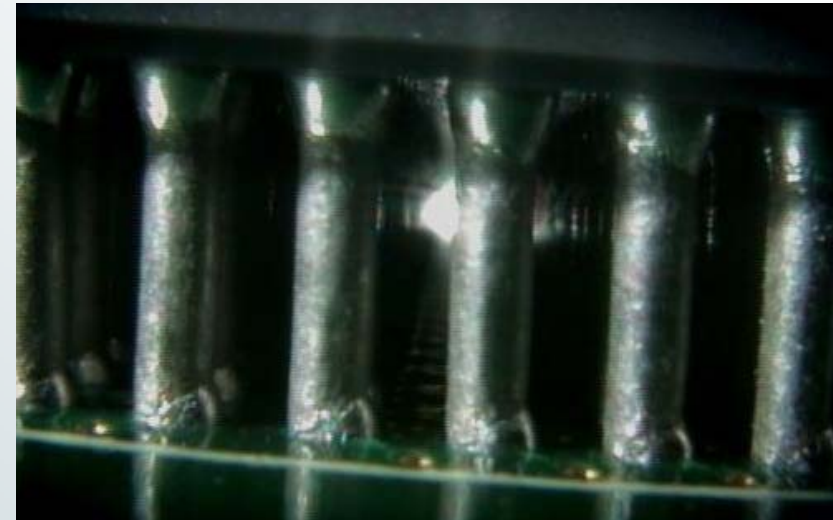
X-ray shows bent column in center of array, but inspection with the optical scope cannot clearly show center part of array.
