## **EXPLOSIVE EVENT IN MON-3 OXIDIZER SYSTEM RESULTING FROM PRESSURE TRANSDUCER FAILURE**

Michael Reynolds and John Anderson  
White Sands Test Facility/Honeywell Technical Solutions Inc.  
Las Cruces, NM

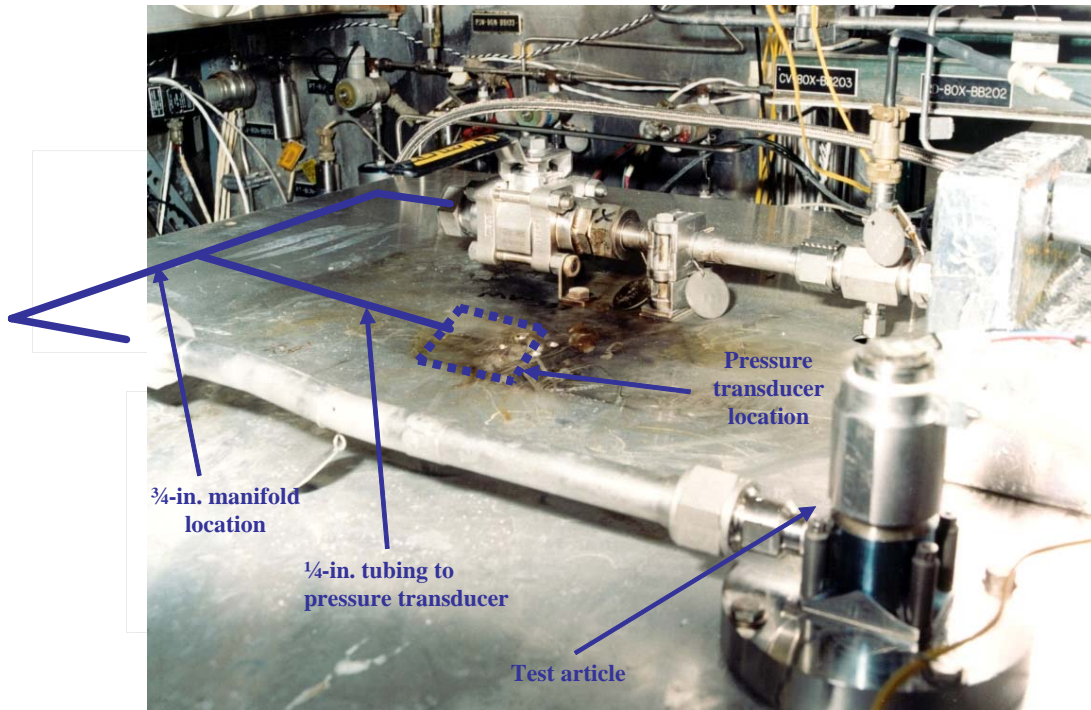
During the inspection, it was immediately obvious a pressure transducer on the test article inlet line failed catastrophically, releasing liquid NTO into the test cell. Figure 1 shows the area of the pressure transducer failure and the approximate previous location of the manifold and pressure transducer. The test team recovered the inlet port and body of the pressure transducer and approximately three-quarters of the diaphragm. The cause of the failure was unknown at this point. An investigation team was assembled to review the situation and determine the cause of the failure and how to avoid similar problems in the future.

**Figure 1: Location of Failed Pressure Transducer**

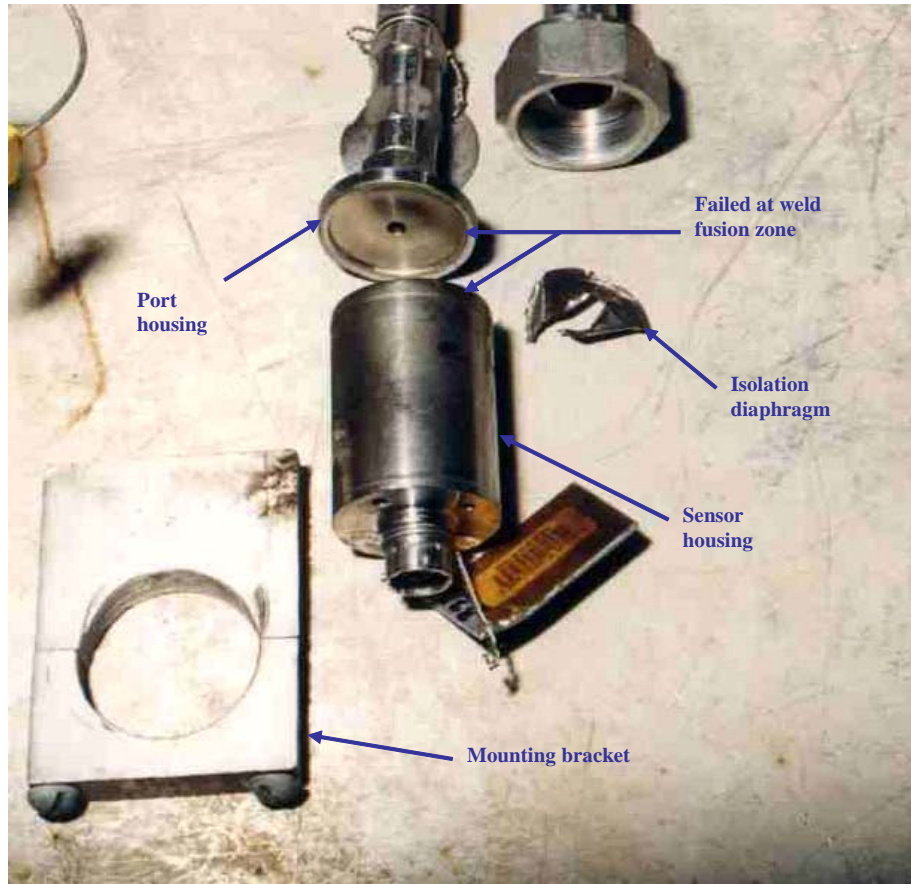
The pressure transducer failed at the welded connection between the transducer body and inlet housing (Figure 2). The weld appears to be an electron beam weld (EBW) butt weld configuration. Failure of this weld is from longitudinal stress in the weld fusion zone. The pressure to fail this welded connection was calculated to be 12,700 psi. The  $\frac{1}{4}$  x 0.035-in. wall 300-series stainless steel tubing connecting the pressure transducer to the  $\frac{3}{4}$  x 0.035-in. wall 300-series stainless steel manifold tubing failed close to the  $\frac{3}{4}$ -in. tubing. Although the  $\frac{1}{4}$ -in. tubing was significantly deformed, the damage primarily appeared to be from thrust generated when the pressure transducer failed. Based on measuring the outside diameter in several locations, the  $\frac{3}{4}$ -in. tubing showed no sign of yielding due to pressure. This indicates the system pressure did not exceed the calculated 3,400 psi required to yield this tubing. A small, central area of the failed diaphragm, which matches the inlet port flow passage diameter, was bulged and ruptured (Figure 3). The calculated pressure to burst the diaphragm when supported at the port diameter is  $\sim$  4,000 psi. Based on these observations, the failure appears to be the result of extremely rapid over-pressurization inside the pressure transducer and behind the isolation diaphragm that first exceeded the  $\sim$  4000-psi diaphragm burst pressure. Flow through the 0.157-in. port flow diameter was inadequate to relieve the over-pressure, thus enabling the pressure to reach the  $\sim$  12,700-psi housing burst pressure. After burst, sufficient thrust was achieved to deform and then fail the  $\frac{1}{4}$ -in. tubing connected to the pressure transducer. The sensor location of the pressure transducer is shown in Figure 4. Note the oily residue seen in this photo.

**Figure 2: Failed Druck® PDCR 130/W/C Pressure Transducer**

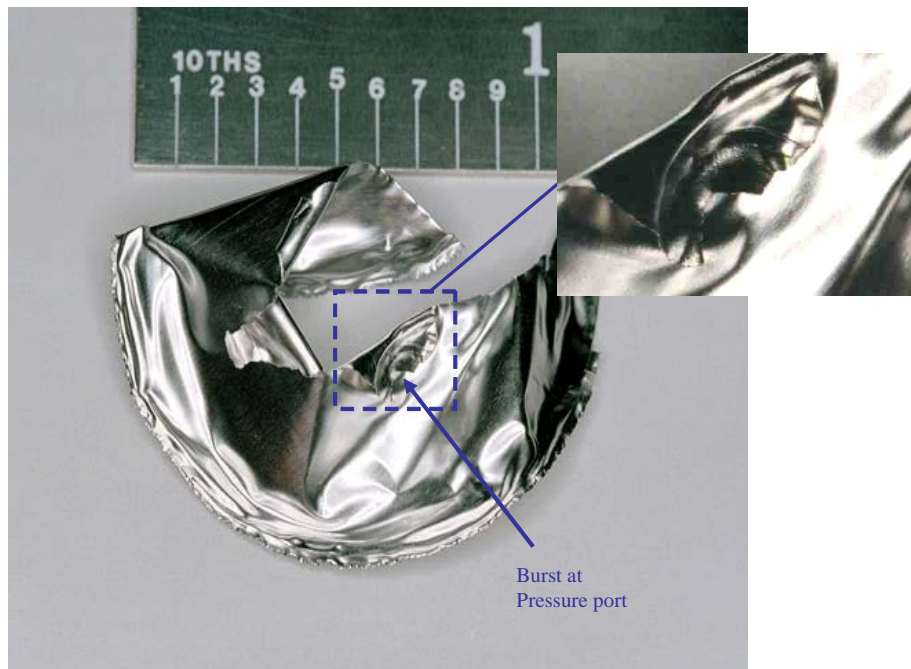
**Figure 3: Failed Isolation Diaphragm**

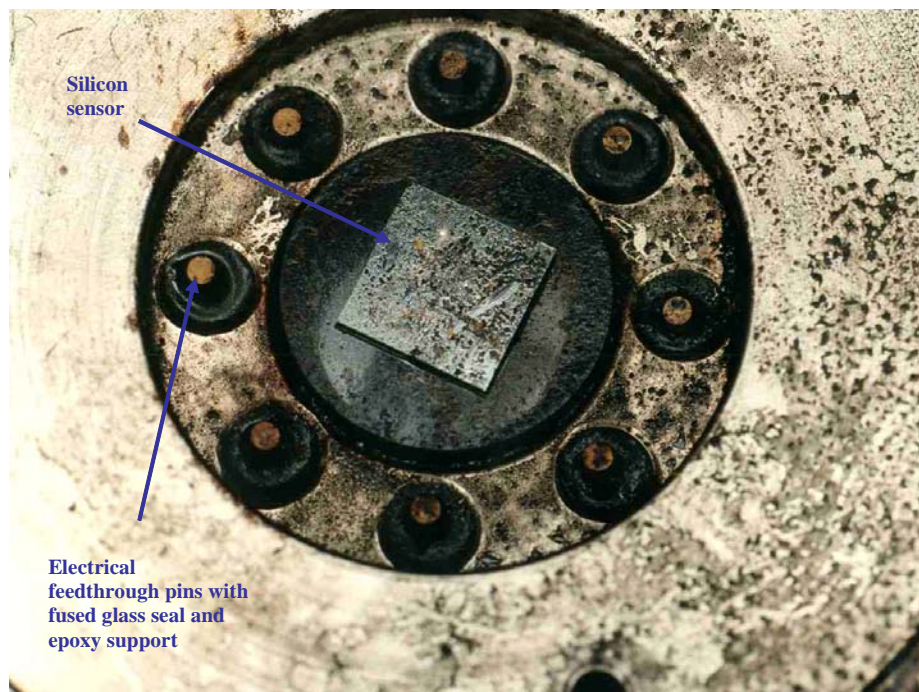
**Figure 4: Failed Pressure Transducer Sensor**

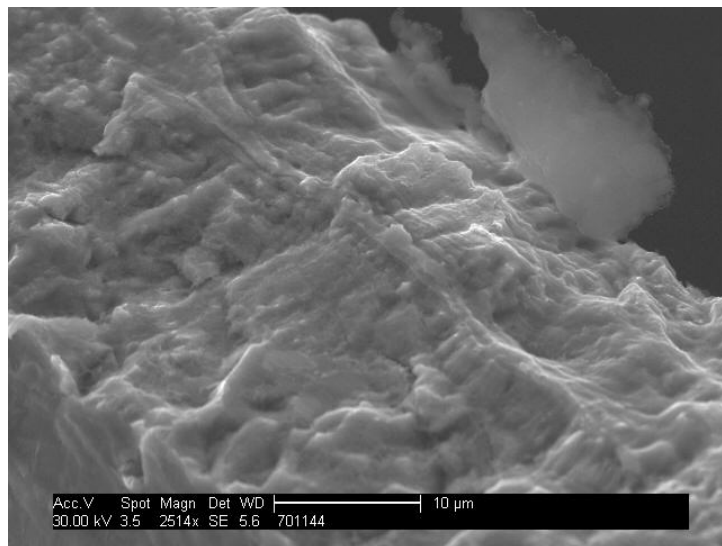
The pressure port housing and the recovered section of the isolation diaphragm were submitted for analysis of the fracture surfaces. The diaphragm exhibited evidence of fatigue fractures, as shown in Figure 5, propagating from multiple initiation sites. Transgranular, partial penetration, secondary fractures were also observed on the diaphragm surface adjacent to and aligned with the through-thickness circumferential fracture, as shown in Figure 6.

**Figure 5. Scanning Electron Photomicrograph of Crack Arrest Marks and Fatigue Striations Observed On Circumferential Diaphragm Fracture**

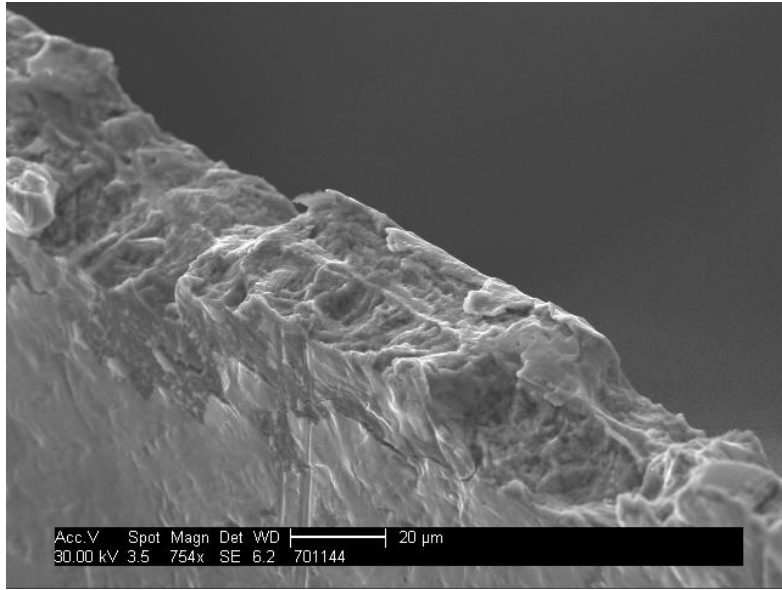
**Figure 6. Scanning Electron Photomicrograph of Crack Arrest Marks Observed On Circumferential Diaphragm Fracture**  
(Note the transgranular, partial penetration, secondary fractures on the diaphragm surface adjacent to and aligned with the through-thickness circumferential fracture.)

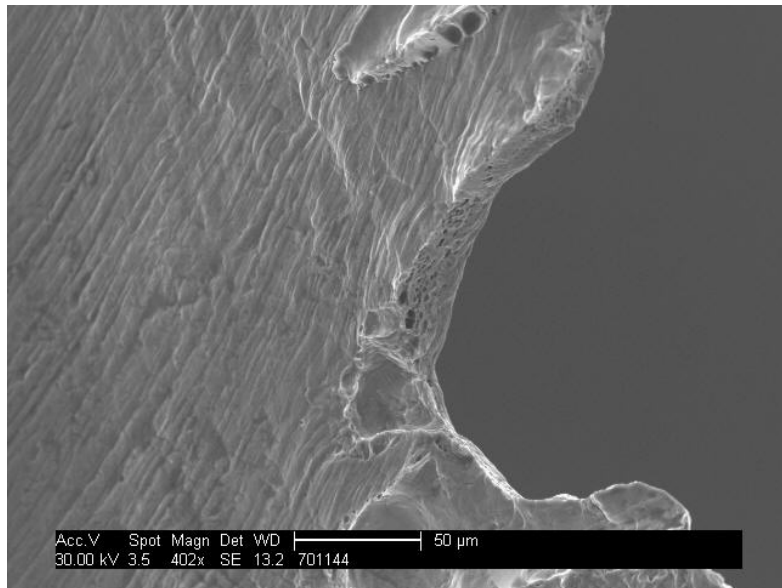
The remainder of the diaphragm fracture surface was described as ductile overload rupture, as shown in Figure 7. No evidence was found that indicated the fatigue fractures were initiated by environmental degradation or a metallurgical discontinuity. X-ray microanalysis indicated the isolation diaphragm alloy was a molybdenum-bearing austenitic stainless steel, consistent with the manufacturer's specification stating 316 stainless steel. The results of microstructural analysis and microhardness testing indicated that the isolation diaphragm material is in the annealed condition.

**Figure 7: Scanning Electron Photomicrograph of Elongated Dimples Observed on Circumferential Diaphragm Fracture at EBW Root, Indicative of Ductile Behavior**

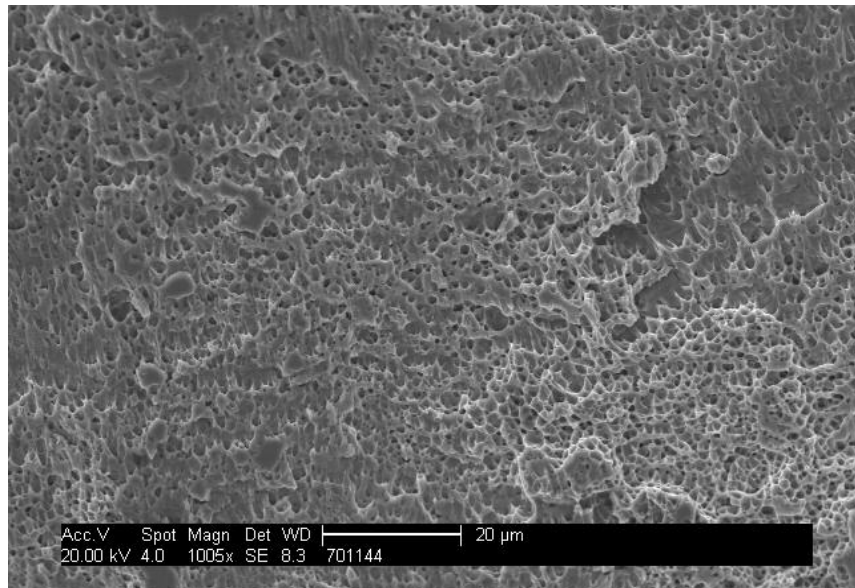
The transducer housing fracture, which occurred at the weld fusion zone, was found to be a ductile overload failure resulting from a single load application, based on analysis of the pressure port end fracture surface, as shown in Figure 8.

**Figure 8: Scanning Electron Photomicrograph Showing Elongated Dimples on Circumferential Pressure Port End Fracture Surface, Indicative of Ductile-Type Overload Rupture**
