# Building a GPS Receiver for Space Lessons Learned

Steve Sirotzky, *Perot Systems*

## ABSTRACT

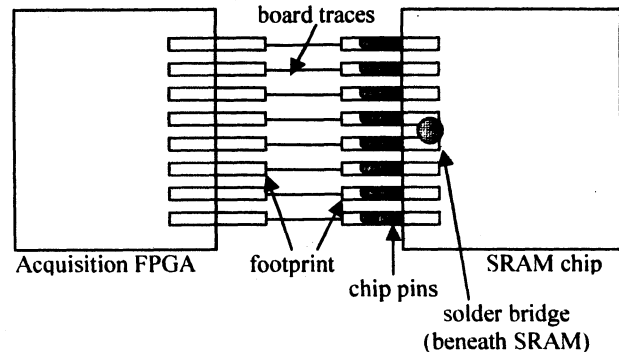
The day that the team performed the initial unit test of the Navigator board, two sets of unrelated pins were failing. Many of the pins were address pins. This was causing data contents to be written in the wrong memory location.

**Figure 4: Location of a solder bridge**

Upon reading the statistics registers, the test engineer knew to look more closely at the pins of the SRAM. It was discovered that solder had splashed under the body of the SRAM and “bridged” (connected) two unrelated pins. This can be seen in Figure 4. Due to the location of the solder bridge, it was difficult to see unless an inspector knew that it was there. Because of the self testing mechanism, the problem was caught quickly and early in the development process.

If the problem had gone undetected, it would have caused erroneous acquisition results. Because the bridge caused two pins to be shorted together, it would likely have reduced the life span of the Acquisition FPGA which was commanding those pins.

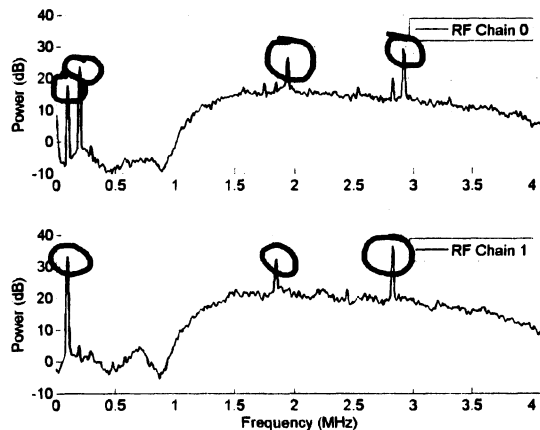
We then ran several tests at 30 dB-Hz and initially were not able to acquire the signals. The first observed symptom was that the forward FFT began overflowing. This made the team think that there was a strong in-band signal that was getting to the ADC.

The RF Daughtercard was reconnected. Digital samples of the I/F signal were taken at the Analog to Digital Converter (ADC) and stored to a file using a digital logic analyzer. When the samples were analyzed, spurs were seen in the power spectral density (PSD) plot. This showed that there was a signal that was getting into the RF or IF chain. Due to the 8.192 MHz sampling, we could only see the aliased frequency of the unwelcome signal.

**Figure 5: Location of unwanted spurs on PSD chart.**

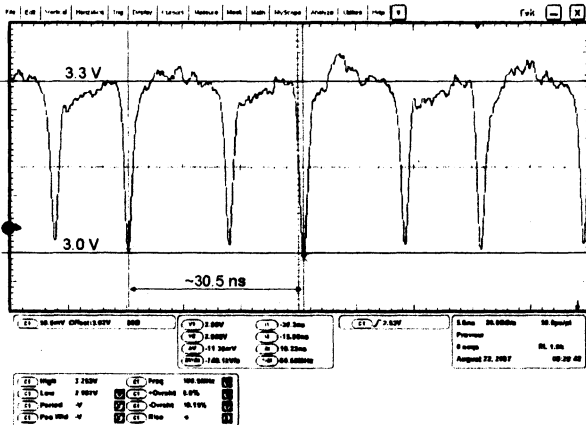
The captured image in Figure 7 shows the voltage on an output pin as a function of time. This signal should be a constant 3.3 volts, however it has recurring spurs that drop down to 2.96 volts. These fast changes create noise.

**Figure 7: Voltage Spurs on the ColdFire scan-out pins.**

The signal displayed in Figure 7 should be constantly high at 3.3 volts. The clock input to the processor is 65.536 MHz, and gets divided by two inside the processor to create a bus clock of 32.768 MHz. It appears that there are two overlapping sets of spurs, which occur at the slower clock frequency. The spurs last only 1-2 nanoseconds from the beginning of their drop to their return to the nominal 3.3 volts. Each spur seen has a magnitude of approximately 0.3 volts.

The peaks were occurring at a frequency of approximately 65.536 MHz. The team observed the harmonics of this frequency on the spectrum analyzer. The 24<sup>th</sup> harmonic of this frequency is 1.57286 GHz, and the L1 C/A code signal is located at 1.57542 GHz. The signals are separated by only 2.56 MHz. While the RF filter's pass band was only 2 MHz wide, the cutoff was not sharp enough to attenuate the emitted harmonic. This harmonic affected each of the amplifiers located before the mixer. Once the incoming signal is mixed down to 35.42 MHz, it is no longer susceptible to the aggressor.

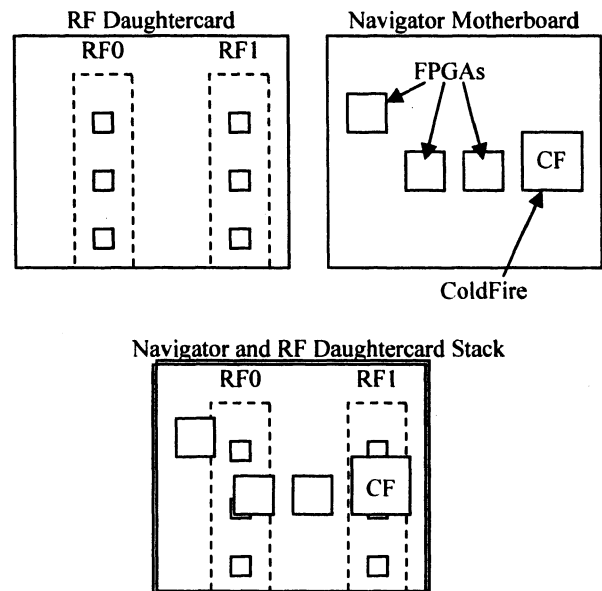
Physical separation also affects the magnitude of interference. As seen Figure 8, only the RF1 chain which was located physically "above" the processor was seriously affected. Even though RF0 was located above several FPGAs, it was only slightly affected by the interference.

**Figure 8: Diagram of relative location of components.**

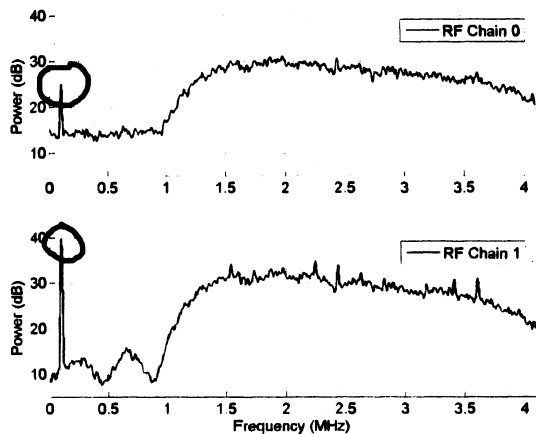
Figure 9: Location of mitigated spurs in PSD chart.

As a result of the mitigation techniques, the LHCP chain (RF Chain 0 - which performs weak signal acquisition) no longer had any spurs above or in the pass band centered at 2.652 MHz. Only one spur was located below the noise floor, but it did not degrade the weak signal acquisition. The RHCP chain (RF Chain 1) still had one spur above the noise floor. Because that chain was only performing fast acquisition, its performance also was not degraded.

Although there was no ready solution to remove the jamming signal, a way had to be found to mitigate the problem. The RF chain had an excess of gain. Each chain had approximately 50 dB of onboard amplification. The rest was off board (located in the antenna's LNA). The gain was needed to implement an Automatic Gain Control (AGC) circuit, which could attenuate any excess gain using digital step attenuators (DSAs). Because each amplifier was allowing the signal to get into the chain, one was removed. This reduced the gain to 37 dB. While

Additionally unshielded passive components on the RF daughtercard were swapped with shielded versions, if available. This improved the magnitude of the jamming frequency, as shown below.

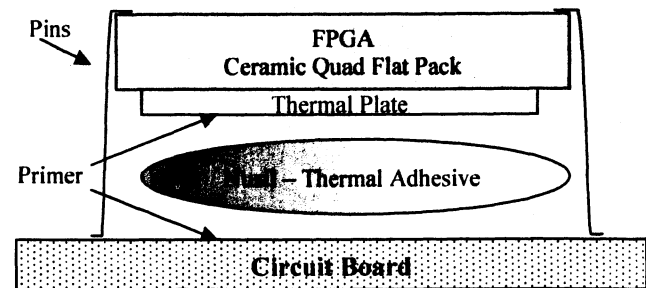
Figure 12: Location of Nusil under FPGA

During post-failure analysis, it was discovered that primer was not placed on the FPGA or the board. Secondly, Nusil only covered 40% of the area under the part. Upon further analysis, it was discovered that there was not enough documentation. A technician who was not familiar with the process of using primer in these situation assembled the board. Finally, due to accelerated schedules, the Board left the lab with only a minor inspection.

There are two requirements to achieve this benefit. The first is to place a primer on the bottom of the chip and on the circuit board. Without the primer, the thermal adhesive is not able to stick to anything. The second, sufficient Nusil must be used to cover 80%-90% of the bottom area of the FPGA.

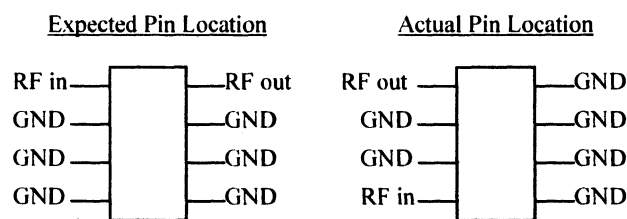
Of the eight pins on the amplifier, the Power (which is also RF-Out), the RF-In and the ground pins were at locations other than what was described in the datasheet.

**Figure 13: Pin locations of the supplied amplifier.**

The RF engineer contacted the company to determine what had happened. In an emailed response, the point of contact acknowledged the company had changed the pin locations without informing him, but he did not know what was the rationale. He offered to replace any damaged parts.

After verifying the correct pin location, the team needed to refabricate the printed circuit board with the correct footprint of the amplifier.
