NASA/TM-2008-215531

Failure Analysis of Electrical Pin Connectors

A failure investigation was initiated to determine the cause of circuit board failure that occurred during vibration qualification testing for the Mars Science Laboratory Entry Descent and Landing Instrumentation (MEDLI) project. MEDLI is an instrumentation suite installed within the heat shield of the Mars Science Laboratory (MSL) Entry Vehicle. The vehicle was designed to collect data about the Martian atmosphere, Thermal Protection System (TPS) performance, and aerodynamic characteristics of the MSL Entry Vehicle during entry and descent, to provide engineering design data for future Mars missions.

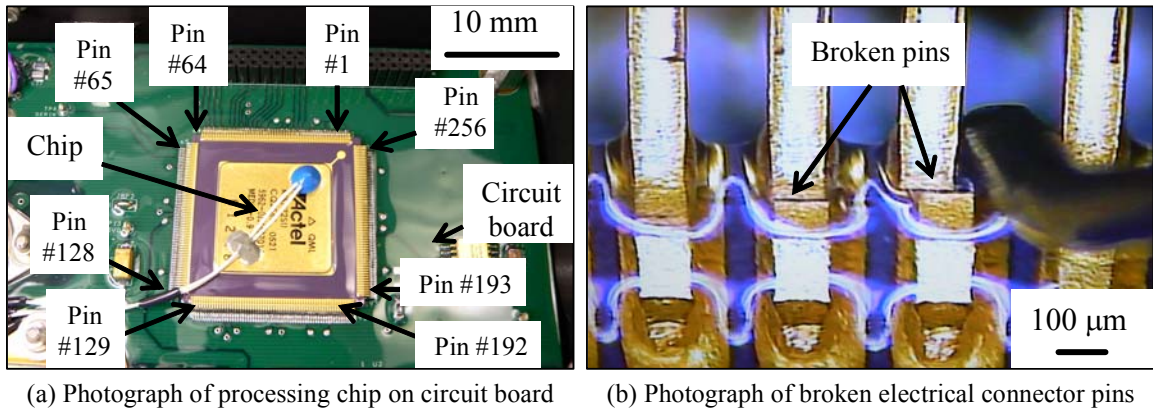
A total of five failed connector pins were analyzed that were selected for analysis due to slight macroscopic differences in the appearance of the pins (some were more severely deformed than others) and to analyze pins at different circuit board locations. The cross-section of these pins was nearly square with sides approximately 100 μm long. The pins consisted of Kovar cores that were coated twice, first with pure nickel, followed by an outer layer of gold. These pins were examined at high magnification in a scanning electron microscope (SEM), and chemical composition of selected failure surface features were determined using Energy-Dispersive X-ray spectroscopy (EDX).

Figure 1. Photographs of failed electrical connector pins.

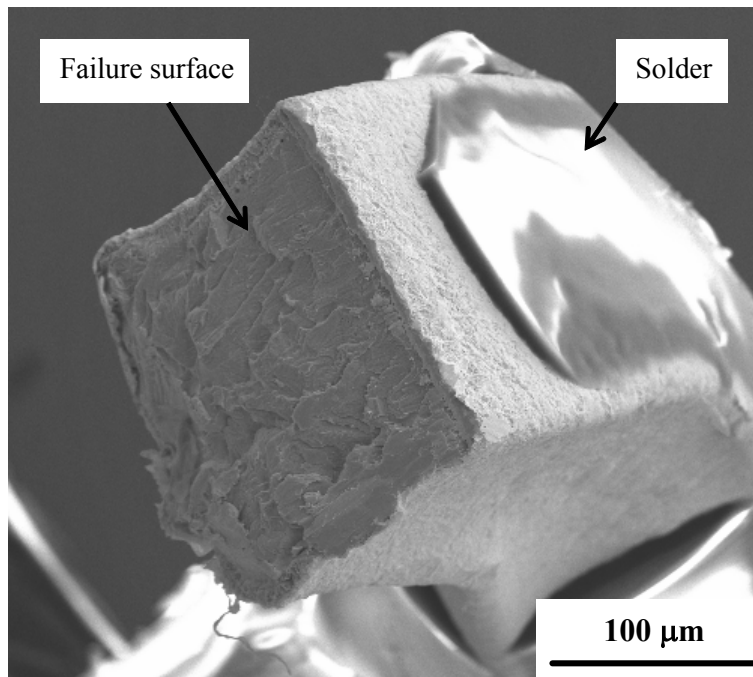
SEM examination revealed that all failure surfaces had very similar microstructural features despite any macroscopic differences observed. A typical SEM image of a pin failure surface (in this case, corresponding to Pin #130) is shown as Figure 2. Here, the pin is shown at an angle of approximately 45° to the failure surface to allow the sides of the pin, and the solder used to connect the pins, to be seen. The lack of obvious ductility (such as, reduction in area at failure) suggests that failure was due to a brittle mechanism such as fatigue crack growth. Detailed examinations of five pin failure surfaces (Pins #63, #64, #129, #130, and #131) have been conducted and results are presented in the following sections.

Figure 2. SEM micrograph of typical electrical pin failure surface (Pin #130).

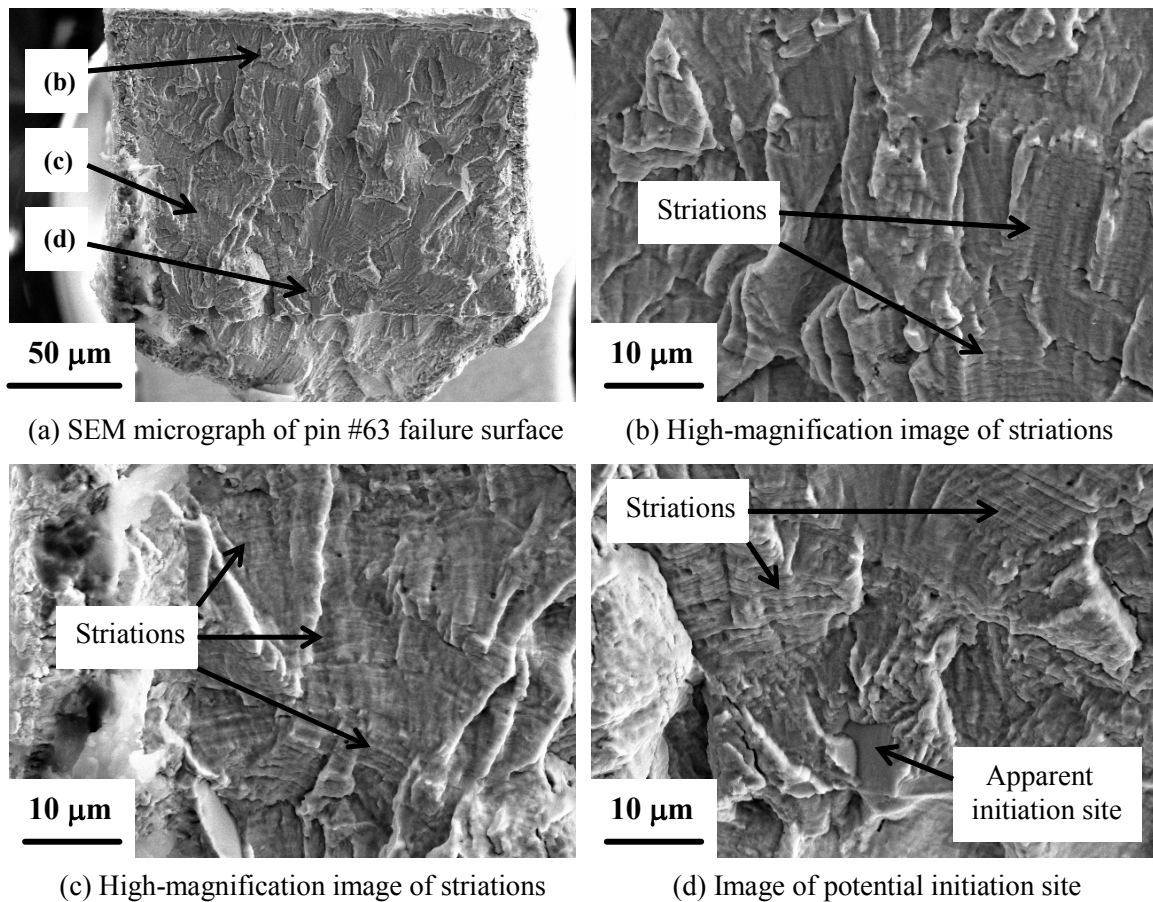
SEM images of the failure surface for Pin #63 are shown in Figure 3. The entire failure surface is shown at relatively low magnification in Figure 3a, along with locations (b, c, d) of regions examined at higher magnification and supplied in Figures 3b, 3c, and 3d, respectively. Fatigue striations are observed in Figures 3b and 3c and are compelling evidence that crack propagation was driven by fatigue loading. By tracing these fatigue striations, which are indications of the crack front location at a given moment in time, back to a starter location, the apparent crack initiation location can be determined. For the failure surface of Pin #63, the apparent crack initiation location is shown in Figure 3d. Here, the apparent crack initiation site appears to have a smooth and faceted morphology relative to the surrounding crack surface.

Figure 3. SEM images of the failure surface for Pin #63.

The difference in crack surface morphology of the apparent crack initiation sites, compared with the surrounding crack surfaces, suggested that a different damage mechanism may have occurred in these regions. The crack initiation sites identified for Pins #63 and #130 were chemically analyzed using Energy Dispersive X-ray (EDX). The results of this chemical analysis are presented in Table 1, along with the nominal composition of Kovar for comparison (ref. 1). Of the main alloying element of Kovar (iron, nickel, and cobalt), these crack initiation sites had very low nickel content relative to the nominal composition of Kovar. The nominal composition of Kovar presented in Table 1 is for the gamma (γ) phase of this alloy, an FCC condition that is widely used in the electronics industry (ref. 1). However, an

undesirable nickel-poor alpha (α) phase can occur, especially as the temperature of this alloy approaches 500°C. The reduction in nickel content is typical of that expected for a gamma-to-alpha phase transformation in Kovar (ref. 2). It is possible the temperatures reached during the soldering process may have triggered an unintended alpha-phase transformation. Based on the crack surface analysis, the presence of this alpha-phase serves as crack initiation sites thereby decreasing the fatigue resistance of the Kovar electrical pin connectors.

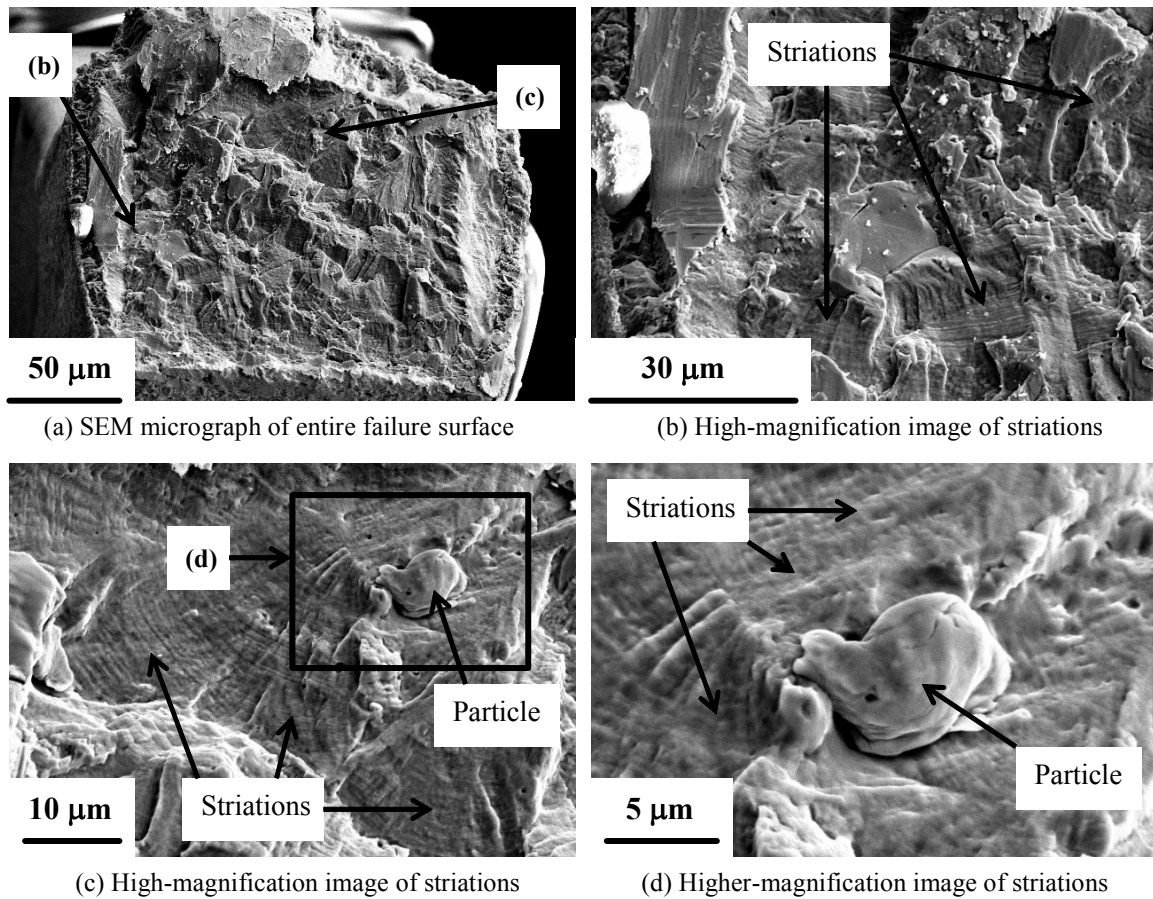
SEM images of the failure surface for Pin #64 are shown in Figure 4. The entire failure surface is shown at relatively low magnification in Figure 4a. Locations shown at higher magnification in Figures 4b and 4c are indicated (shown in Figure 4a as locations (b) and (c), respectively). Fatigue striations are observed in Figures 4b and 4c and are compelling evidence that crack propagation was driven by fatigue loading. An interesting feature observed in Figure 4c (indicated as location (d)) is shown at higher magnification in Figure 4d. This feature appears to be a particle, but the crack surface features do not suggest that this is a crack initiation site. No obvious crack initiation site was found on this crack surface.

Figure 4. SEM images of the failure surface for Pin #64.

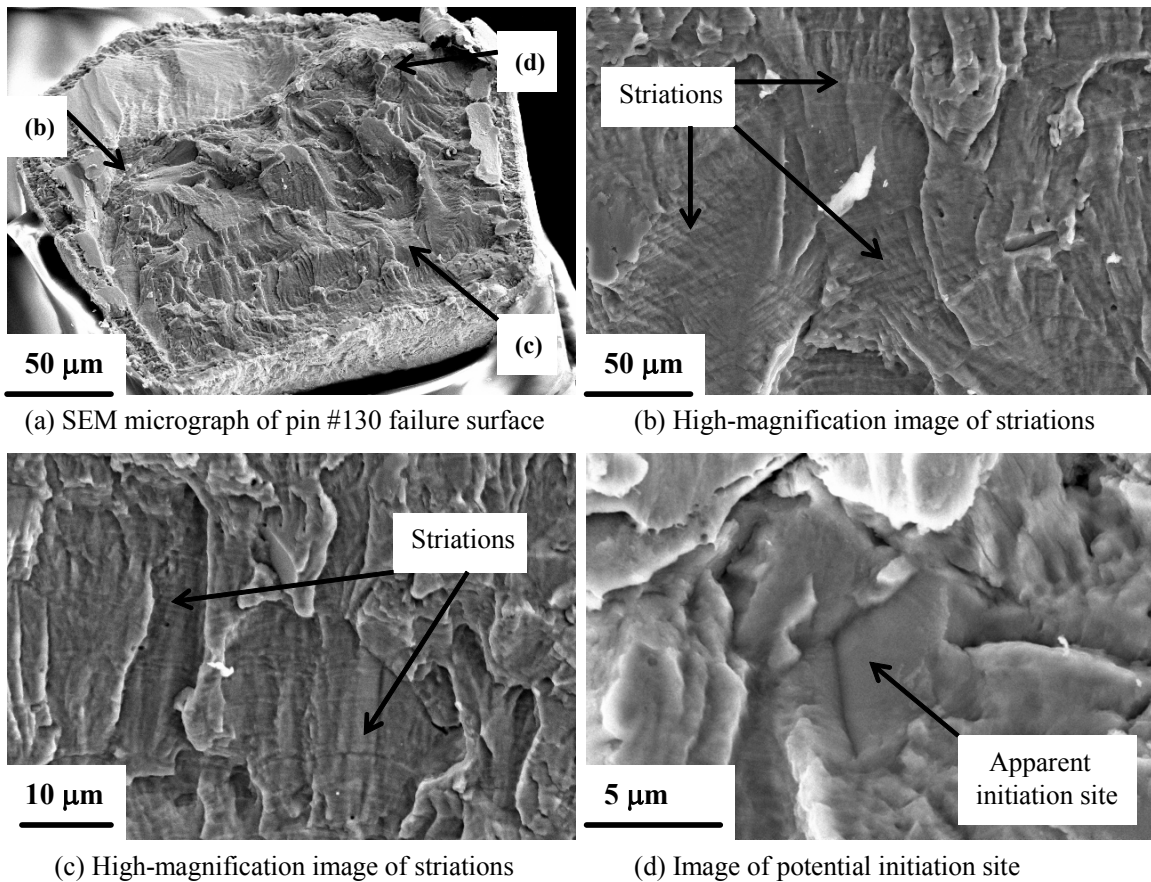
SEM images of the failure surface for Pin #129 are shown in Figure 5. The entire failure surface is shown at relatively low magnification in Figure 5a. Locations indicated in Figure 5a as (b), (c), and (d) are shown at higher magnification in Figures 5b, 5c, and 5d, respectively. Fatigue striations are observed in Figures 5b and 5c and are compelling evidence that crack propagation was driven by fatigue loading. These crack surface features can be used to determine the apparent crack initiation region, which is shown in Figure 5d. Similar to the findings for Pin #63, the apparent crack initiation site appears to have a smooth and faceted morphology relative to the surrounding crack surface.

Figure 5. SEM images of the failure surface for Pin #129.

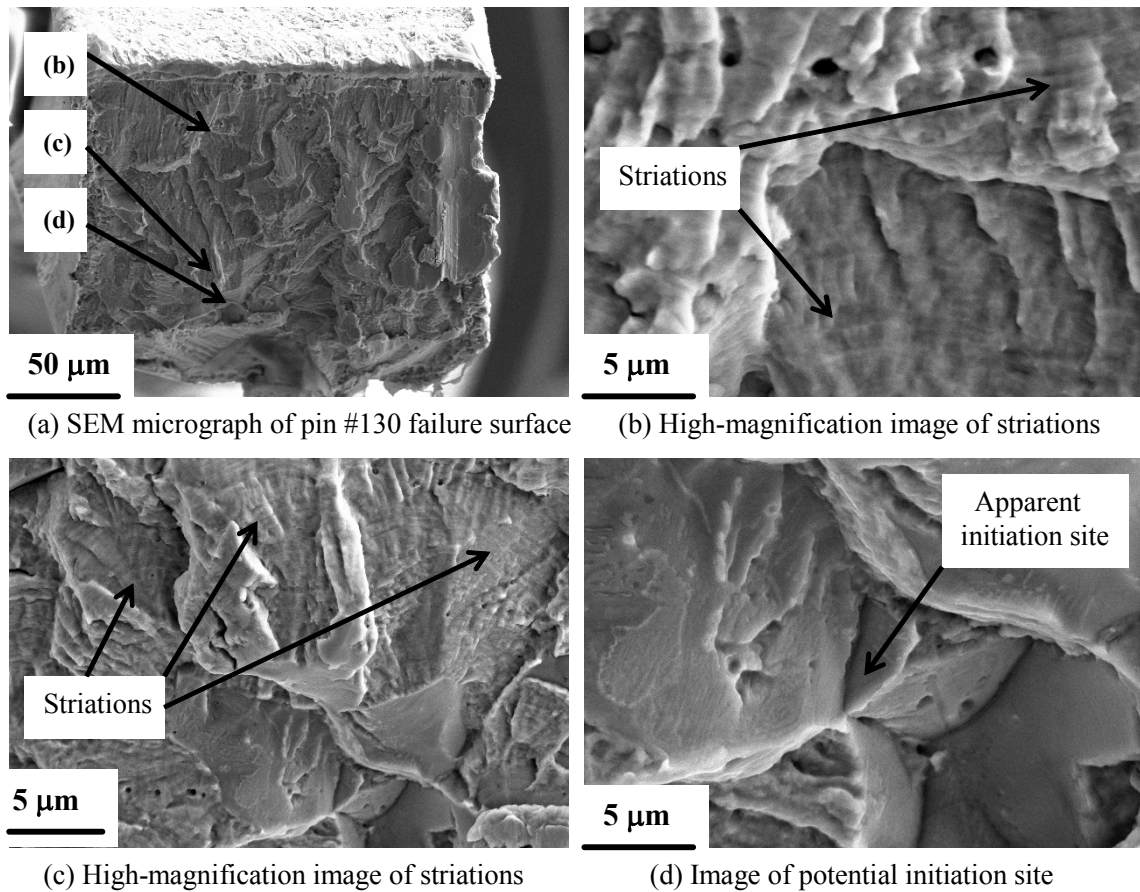
SEM images of the failure surface for Pin #130 are shown in Figure 6. The entire failure surface is shown at relatively low magnification in Figure 6a. Locations indicated in Figure 6a as (b), (c), and (d) are shown at higher magnification in Figures 6b, 6c, and 6d, respectively. Fatigue striations are observed in Figures 6b and 6c and are compelling evidence that crack propagation was driven by fatigue loading. These crack surface features can be used to determine the apparent crack initiation region, which is shown in Figure 6d. Similar to the findings for Pins #63 and #129, the apparent crack initiation site appears to have a smooth and faceted morphology relative to the surrounding crack surface.

Figure 6. SEM images of the failure surface for Pin #130.

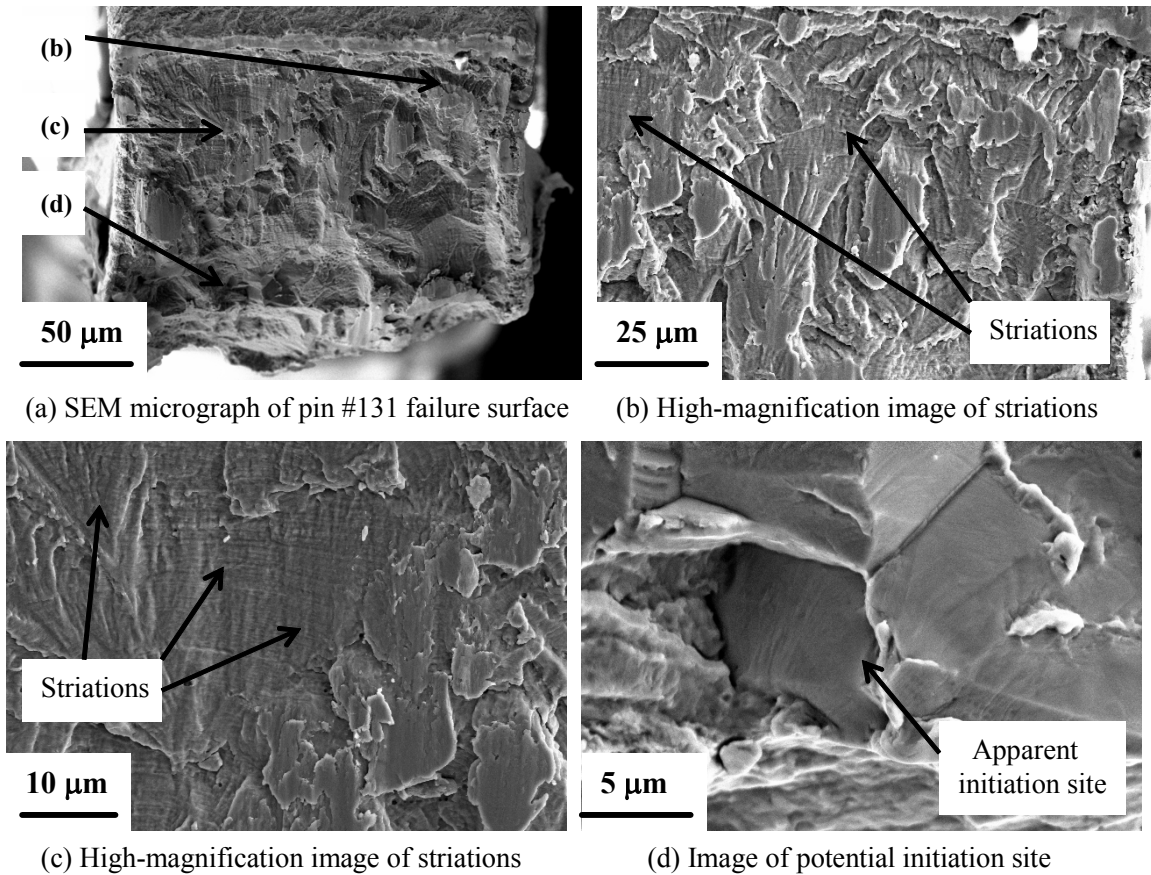
SEM images of the failure surface for Pin #131 are shown in Figure 7. The entire failure surface is shown at relatively low magnification in Figure 7a. Locations indicated in Figure 7a as (b), (c), and (d) are shown at higher magnification in Figures 7b, 7c, and 7d, respectively. Fatigue striations are observed in Figures 7b and 7c and are compelling evidence that crack propagation was driven by fatigue loading. These crack surface features can be used to determine the crack initiation region, which is shown in Figure 7d. Similar to the findings for Pins #63, #129, and #130, the apparent crack initiation site appears to have a smooth and faceted morphology relative to the surrounding crack surface.

Figure 7. SEM images of the failure surface for Pin #131.
