NASA/TM-2008-215525
NESC-RP-06-61/05-036-E

Failure Analysis Study and Long-Term Reliability of Optical Assemblies with End-Face Damage

**Failure Analysis Study and Long-Term Reliability of Optical
Assemblies with End-Face Damage
Technical Assessment Report**

*Phase I: International Space Station (ISS) Termini Root Cause
Analysis Report*

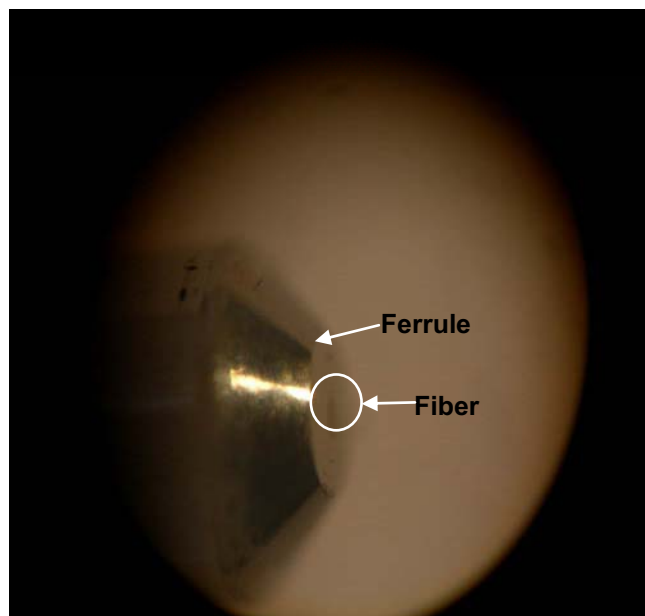
In many applications, a physical contact connection is implemented to mate fiber optic connectors such that the insertion losses are reduced. In the case of this connector, the high vibration levels originally used to “qualify” the connectors for military standard applications showed data indicating that the terminus/connector system should not be of a physical contact type. Therefore, the same processes were specified in this application. For a “concave” polish, it is imperative that the glass end-faces do not come in contact with one another in order to comply with the military standard method and reasoning for non-contact. As stated in OHB’s “Fibre Optic Manufacturing Procedure” Section 4.6: “Inspect the profile of the terminus end-face under 40X magnification. The surface should be slightly concave with the face of the ceramic tip.” This is not an effective method for determining the fiber’s profile. Figure 4.0-1 shows what the profile looks like at 40X magnification. The end-face appears to be flat, and not protruding. This method is non-conclusive for true determination of the end-face profilometry. The profile should be determined using an interferometer or confocal microscopy as illustrated in Figure 4.0-2. The confocal data clearly shows the end-face of the fiber to be convex, which should have failed inspection.

Figure 4.0-1. Visual End-Face Profile @ Magnification of 40X

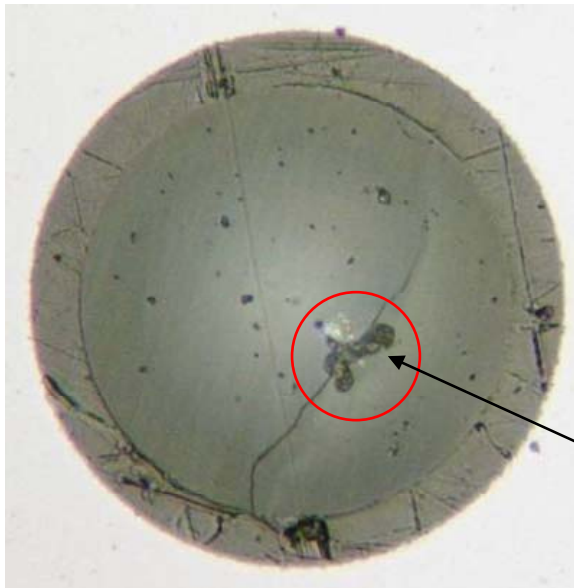
The images in Figures 7.1-1 and 7.1-2 were taken at 200X magnification. The first observations made were: 1) the apparent impact fracture on the end-face, 2) the crack(s) propagating from the fracture, 3) damaged or scarred coating or buffer, and 4) the excessive contamination on the end-face of the fiber.

Impact Fracture/Cracking

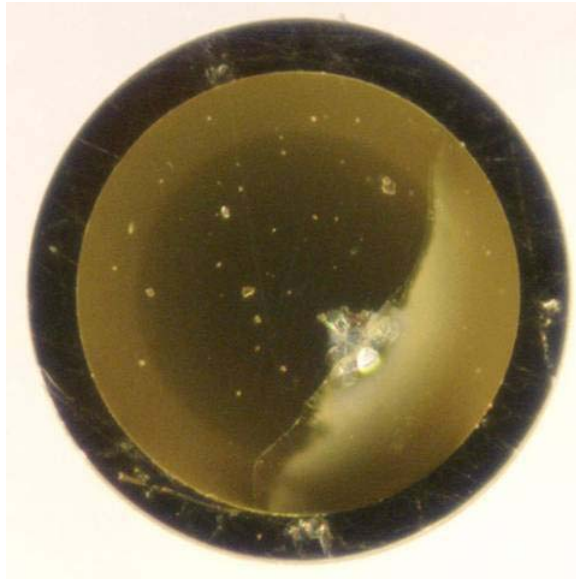
Figure 7.1-2. Dark Field Image

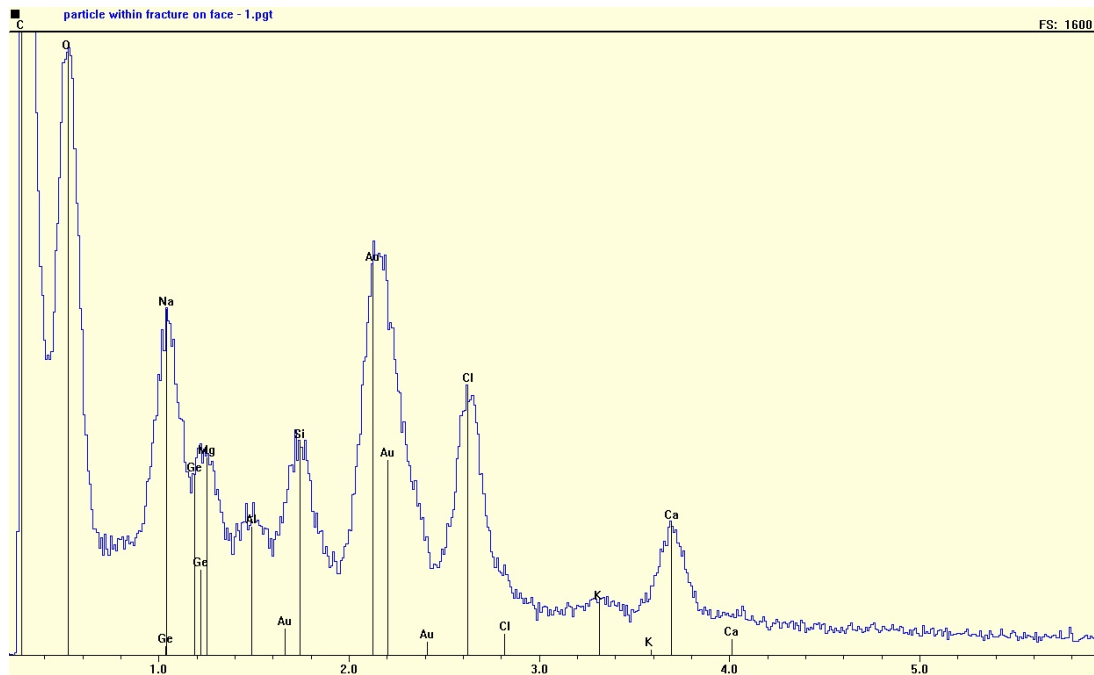
Figure 7.1-5. EDS of Particle inside the Fracture

The discovery of salt crystals in the glass was puzzling. To identify where the salt crystals are located on the end-face, elemental mapping was performed. Elemental mapping was not effective at 500X magnification to locate small traces of certain elements, so to locate Na and Cl, a higher magnification was used. Figure 7.1-6 shows the results when this sample was mapped for Si, Na, and Cl.

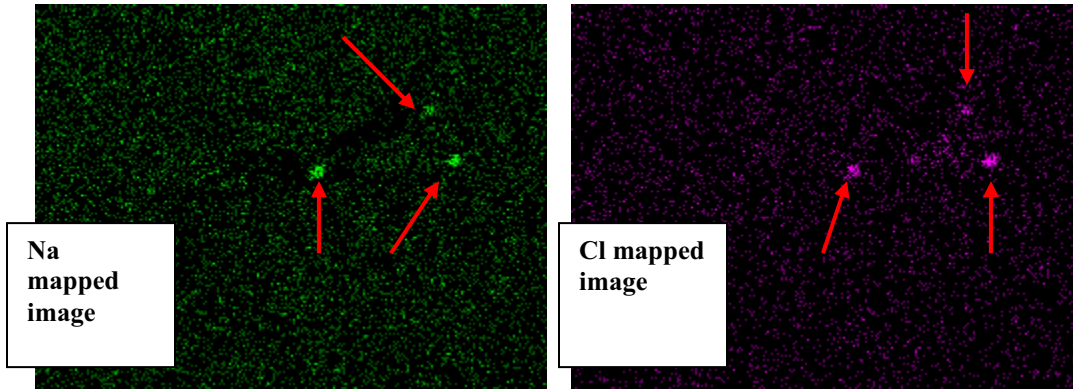
Figure 7.1-6. Elemental Mapping of Si, Na and Cl

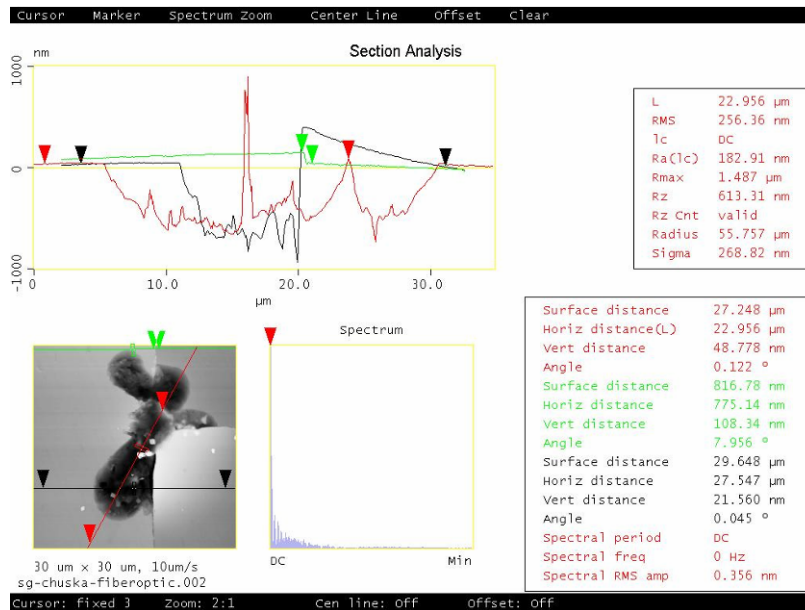
Figure 7.1-11. Impact Fracture AFM Data

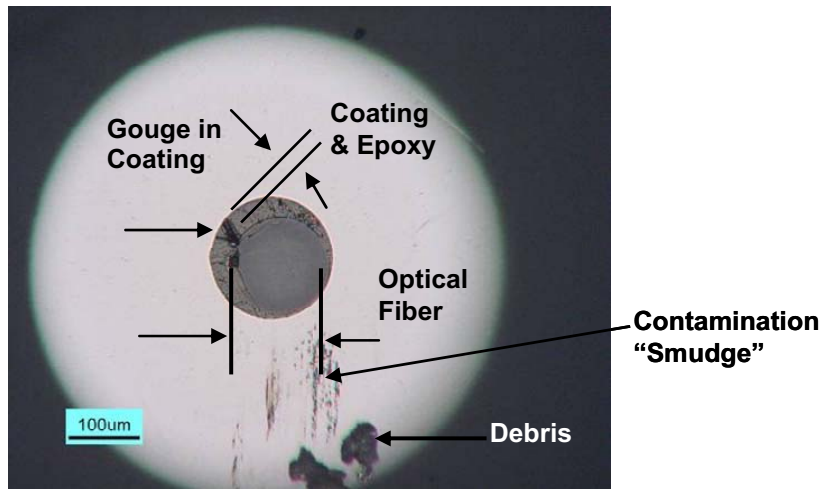
The deep scratches indicate the end-face was “wiped” with something that had an abrasive particle present. It could have been mated with debris present as well.

Figure 7.2-1. Magnification of 100X Optical Image

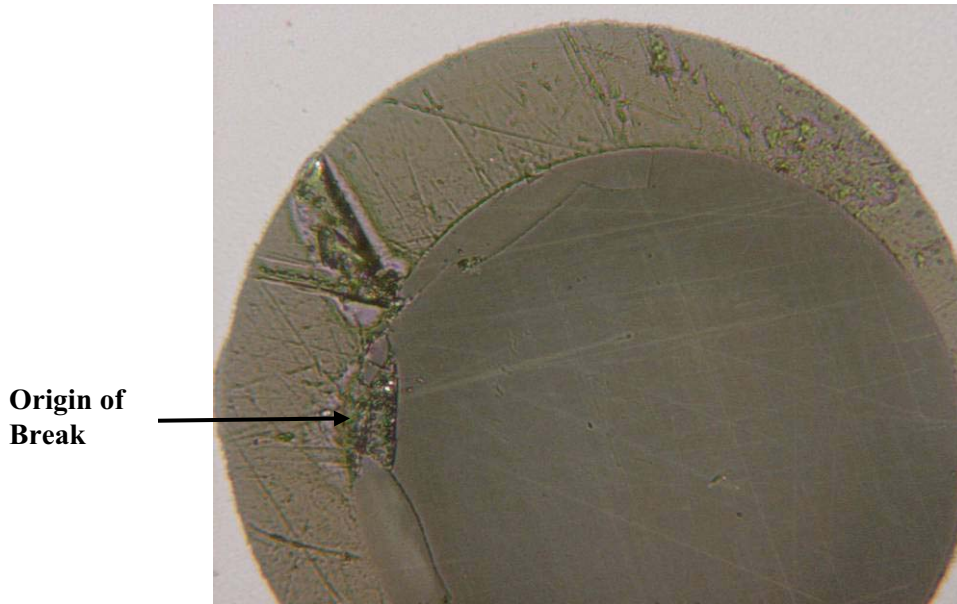
during the epoxy curing procedure. The non-uniform distribution is due to the non-concentric location of the fiber in the coating.

Figure 7.2-3. Deep Gouge in Coating

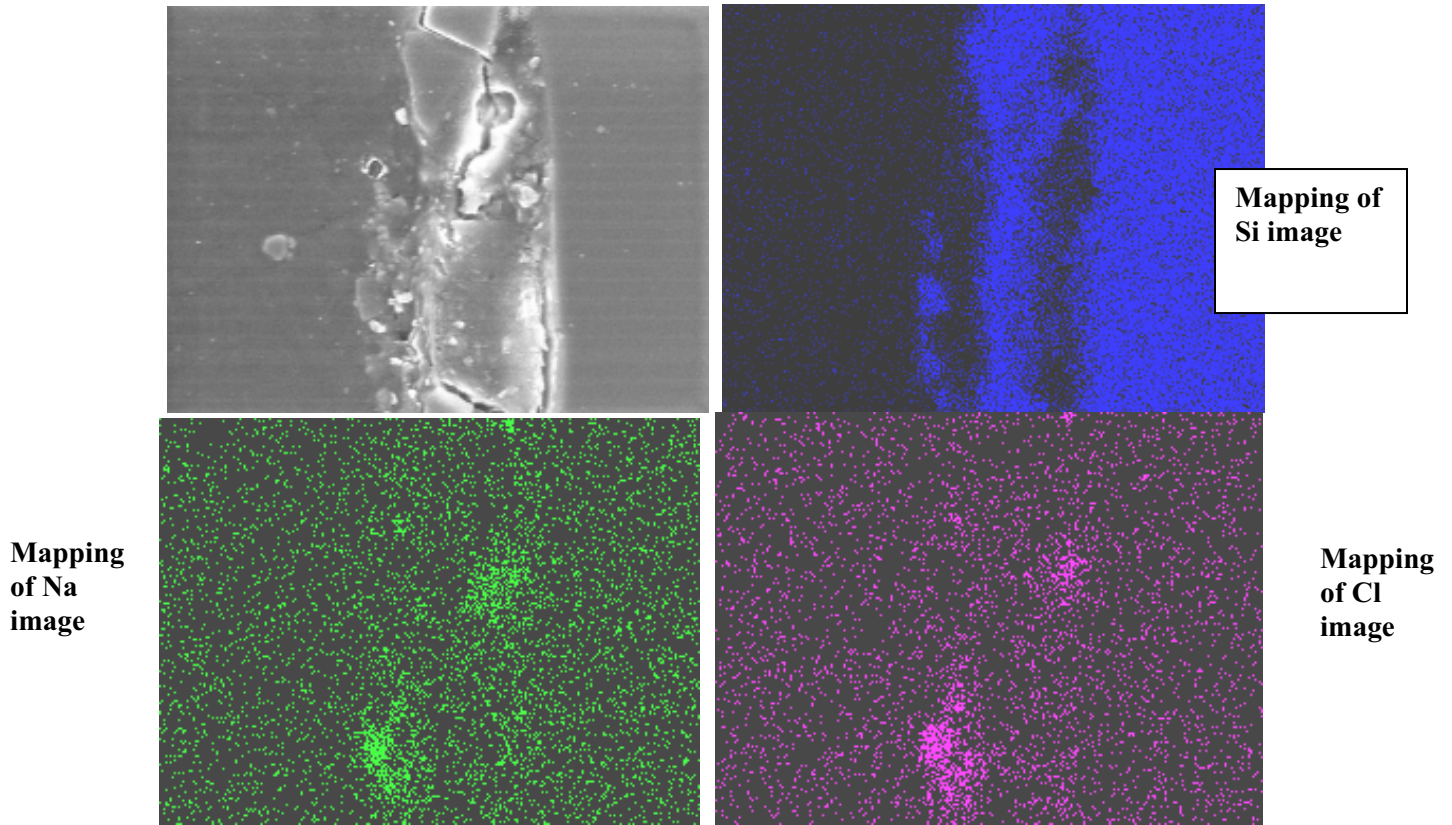
Figure 7.2-7. Elemental Mapping of Corrosion

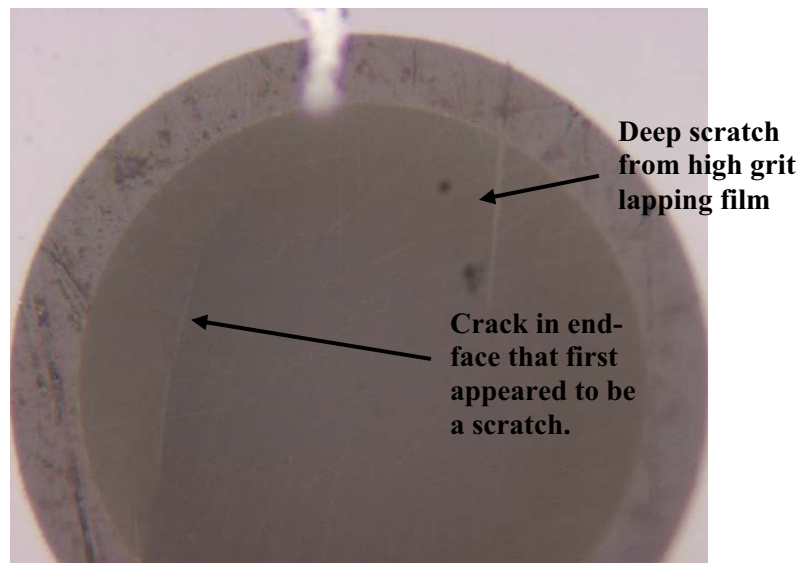
When looking at this fiber at 500X magnification, a deep scratch can be seen. There is also a crack in the fiber that first appeared to be a scratch. This signature of linear scratches is indicative of polishing with high grit lapping film, and not removing the scratches with lesser grit lapping film. Refer to Figure 7.3-1.

Figure 7.3-1. Scratched/Cracked End-Face

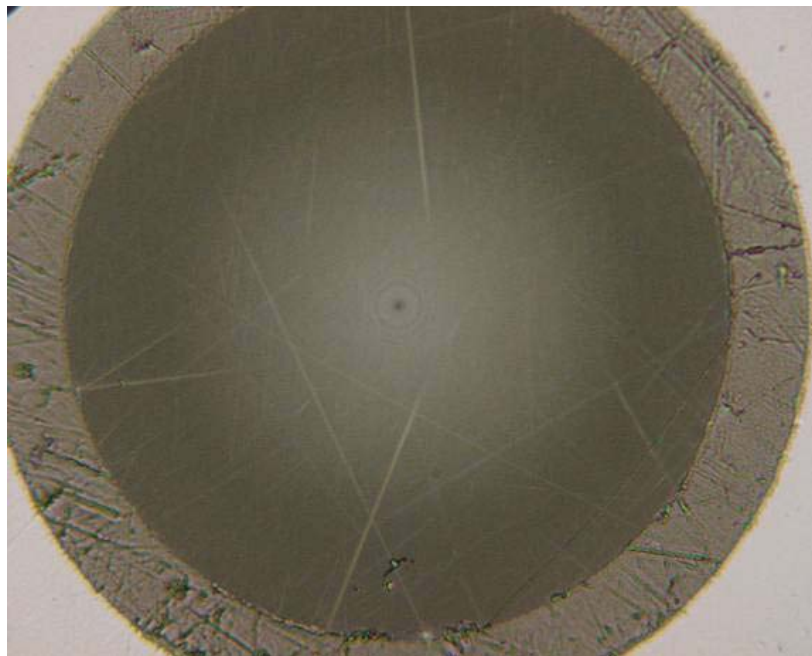
At 500X, some deep scratches on the end-face can be observed (Figure 7.4-1). By changing the illumination field settings, a crack in the fiber can be seen (Figure 7.4-2). ***Light will pass through a crack that is $<1/8\lambda$, and the crack will not be visible.*** Some debris on the end-face can also be observed.

Figure 7.4-1. Bright Field Image Magnification of 500X

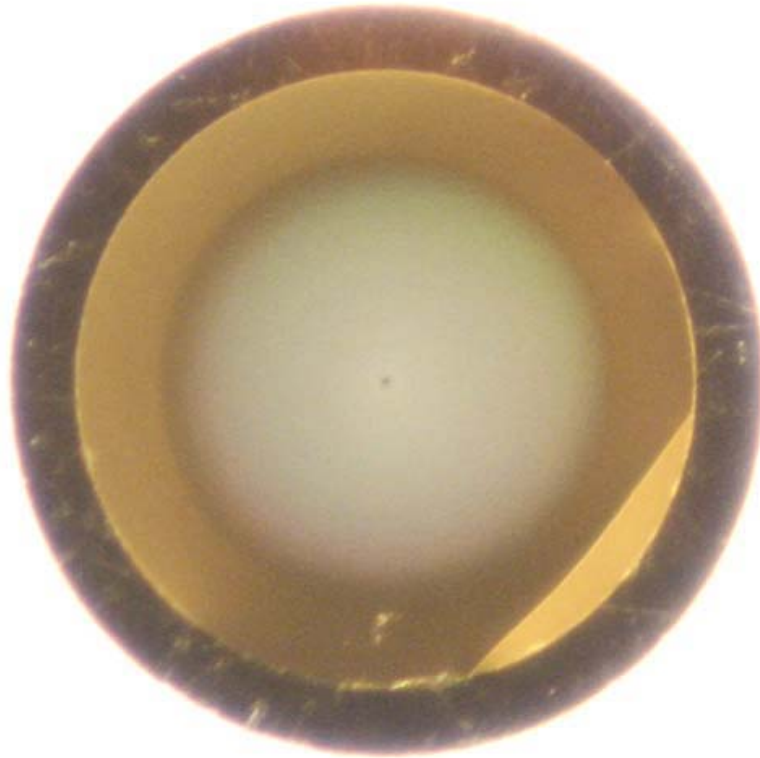
Figure 7.4-2. Dark Field Image at Magnification of 200X

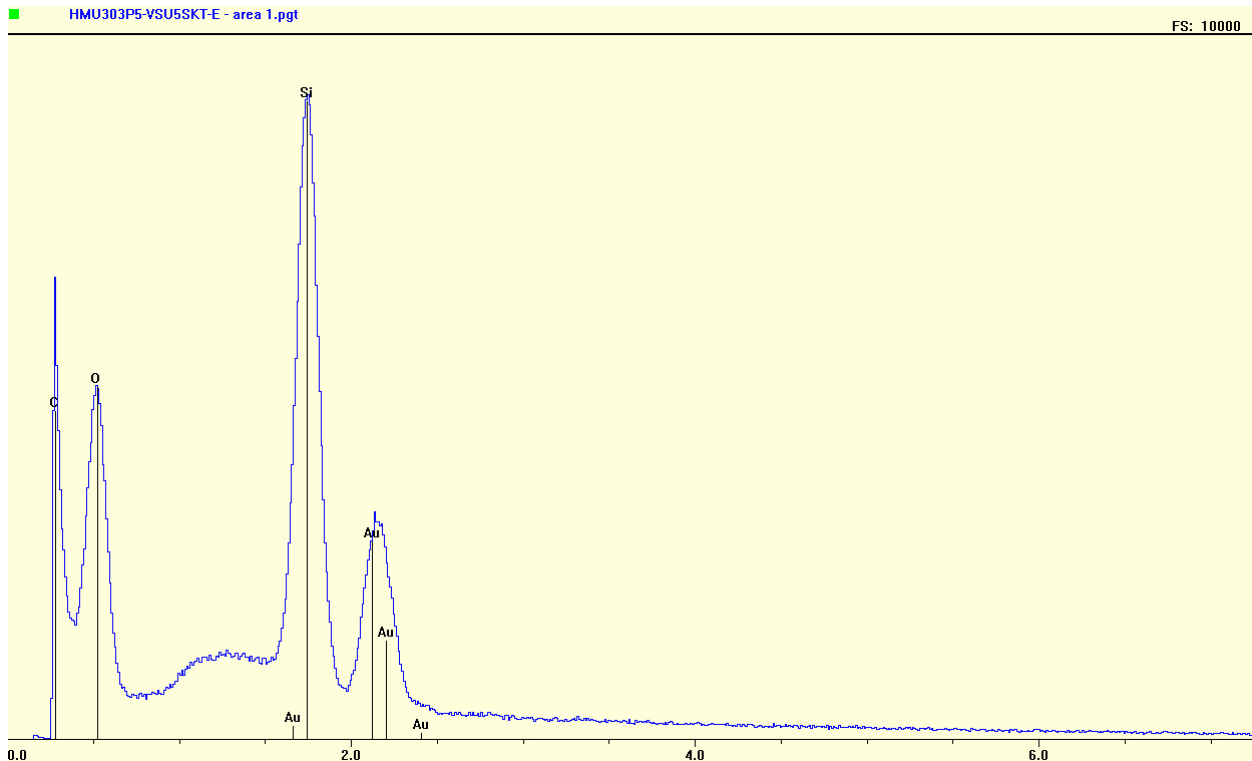
An EDS data analysis was performed (Figure 7.4-5) in the crack region to identify any foreign particles, and a high concentration of carbon, oxygen, and silicon was found. This may suggest the grit of the lapping film was too coarse.

Figure 7.4-5. EDS Data of Crack

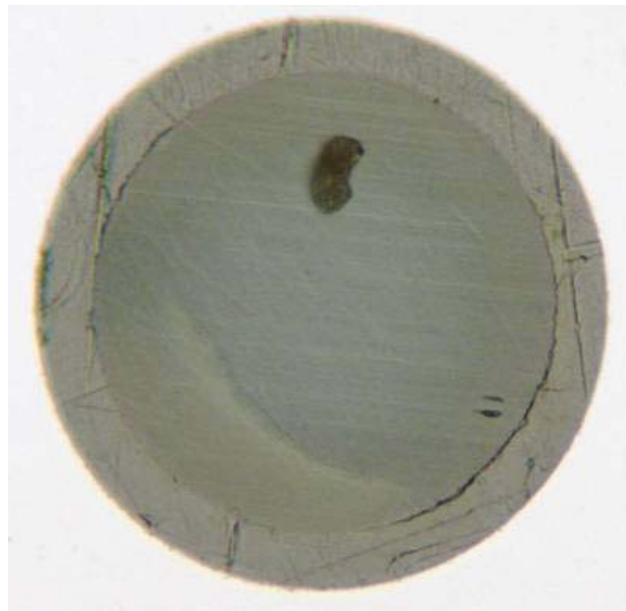
Figure 7.5-3. Scratches

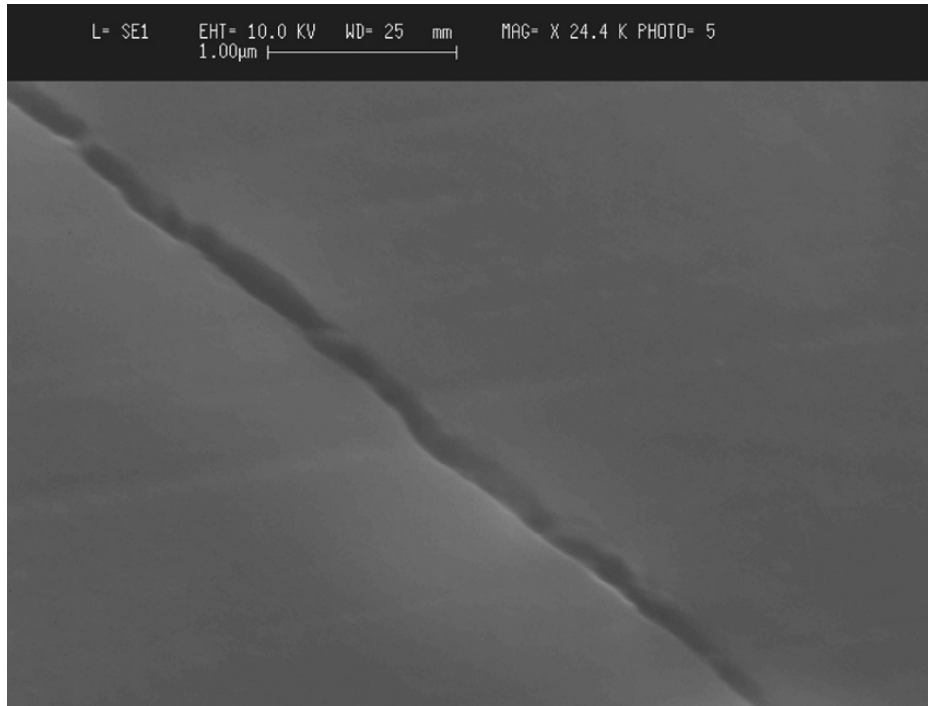
Figure 7.5-5. Magnification of 24,400X SEM Image of Crack

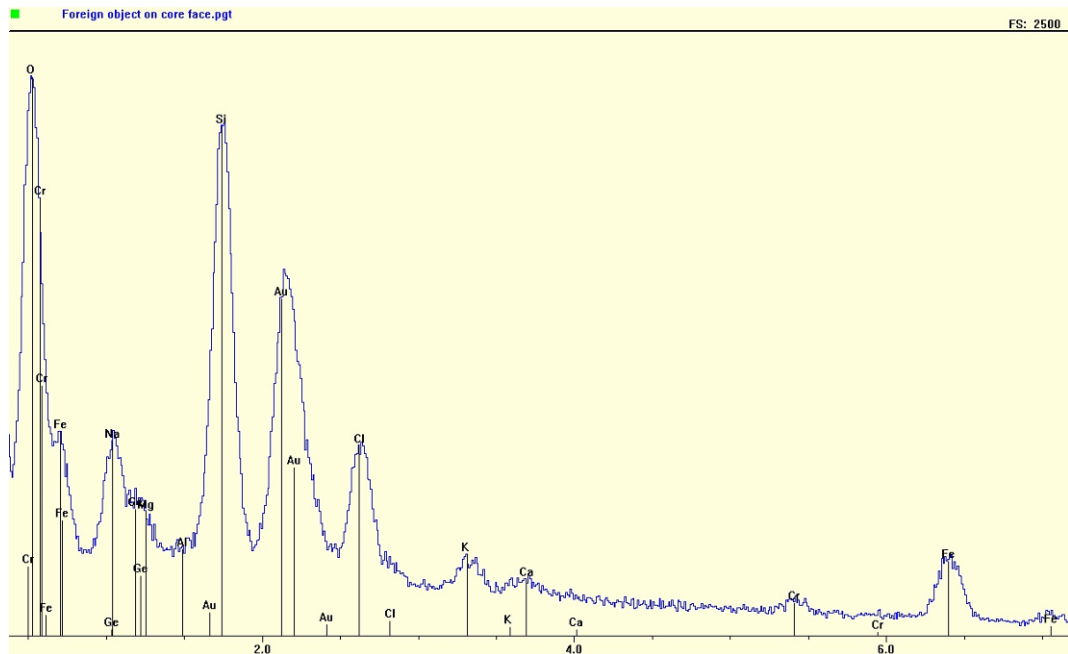
Figure 7.5-8. Foreign Object on Core Face (Figure 7.5-2)

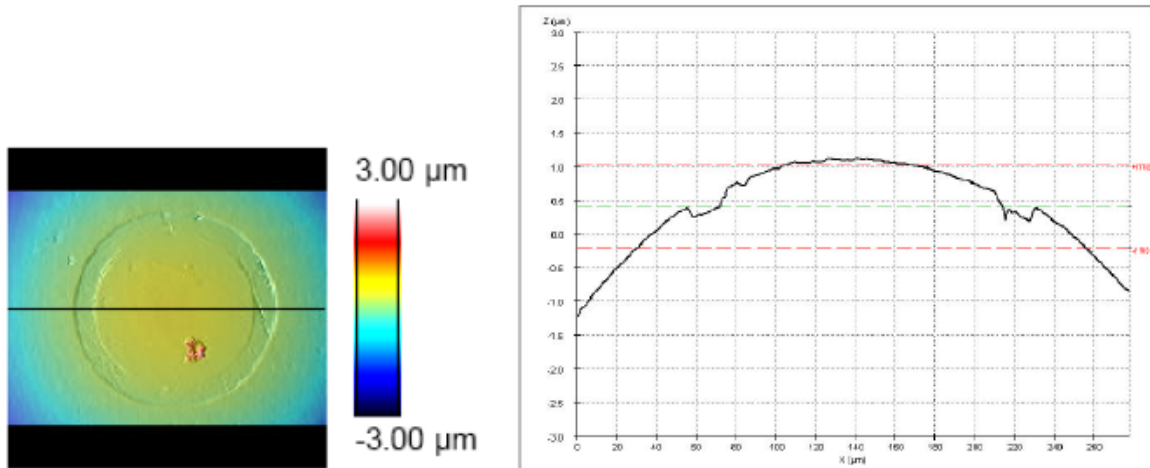
The confocal data (Figure 7.5-10) indicates the fiber is convex which, again, violates the requirements stated in the manufacturing procedure [ref. 3]. The radius of curvature is 4.0 mm.

Figure 7.5-10. Confocal Data

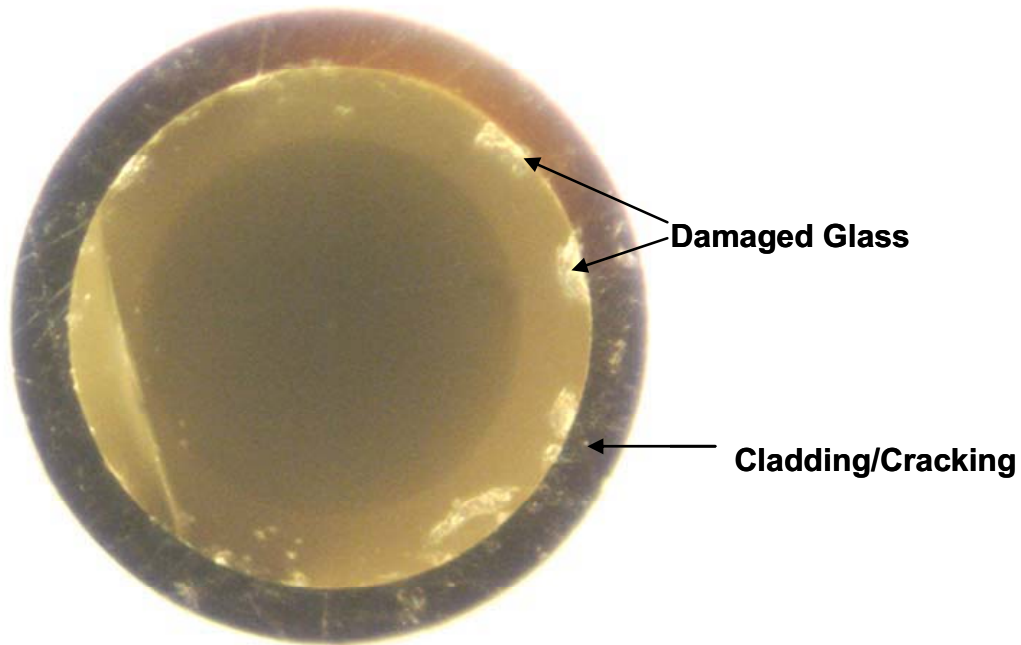
1. There was a crack in the cladding area.
2. There was damage to the glass in several areas around the perimeter of the cladding.

Figure 7.6-1. Magnification of 200X Optical Image

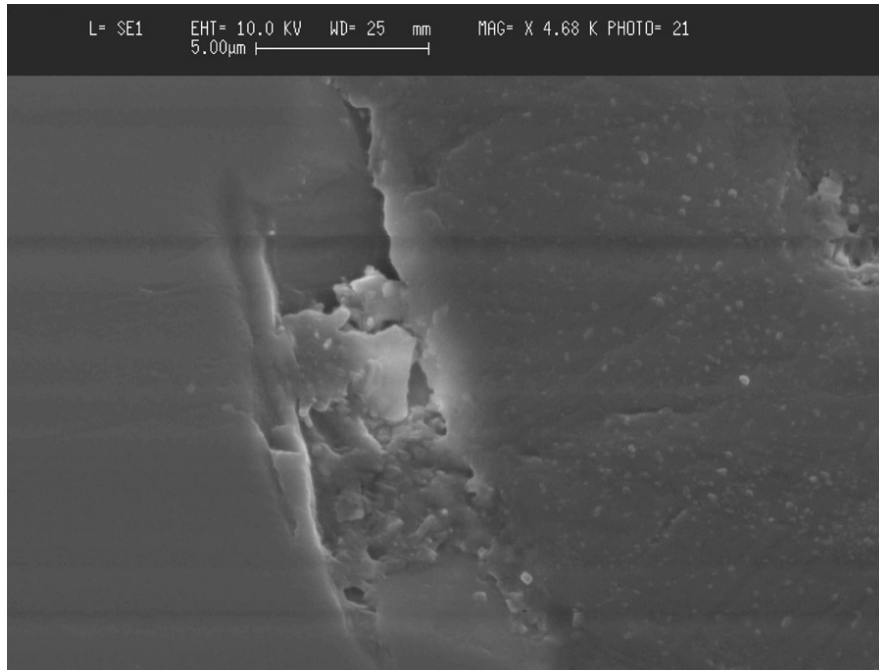
Figure 7.6-3. Magnification of 4,680X SEM Image (Corrosive Attack)

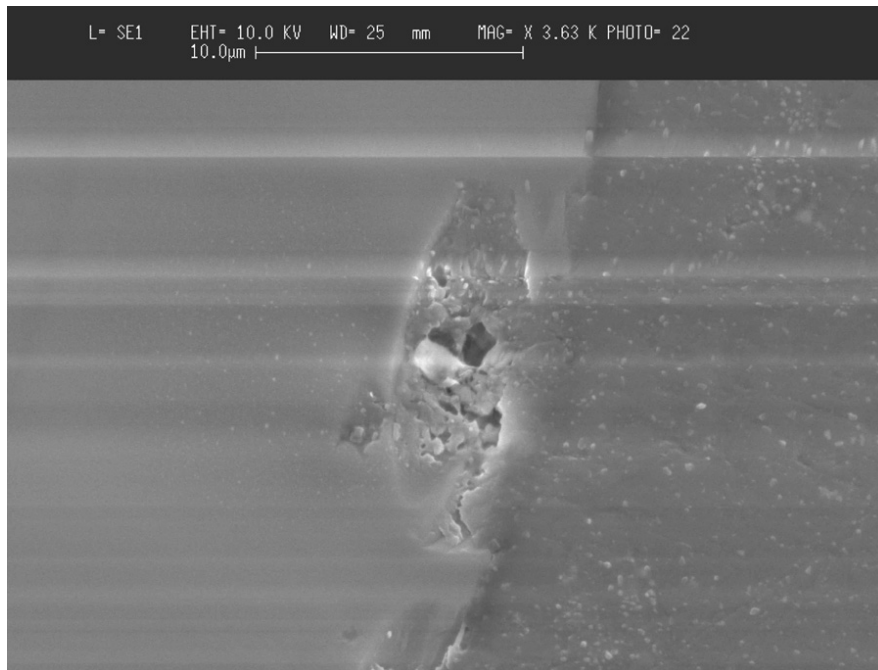
Figure 7.6-4. Magnification of 3,630X SEM Image (Corrosive Attack)

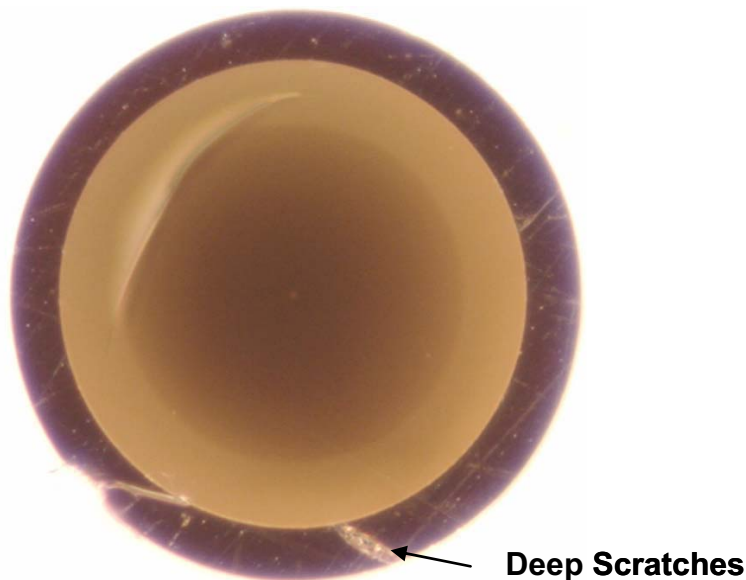
Figure 7.7-1 shows a deep scratch in the end-face of the fiber. This is not a crack that has propagated deep into the fiber. This is evident from how the light is emitted through the crack. When Figures 7.7-1 to Figure 7.10-2 are compared, how the light is affected by a deep crack is observed. There are two areas in the coating with significant damage as well. The damage in the coating is not linear (like the minor visible scratches), thus suggesting it did not occur due to polishing.

Figure 7.7-1. Dark Field Image @ Magnification of 200X

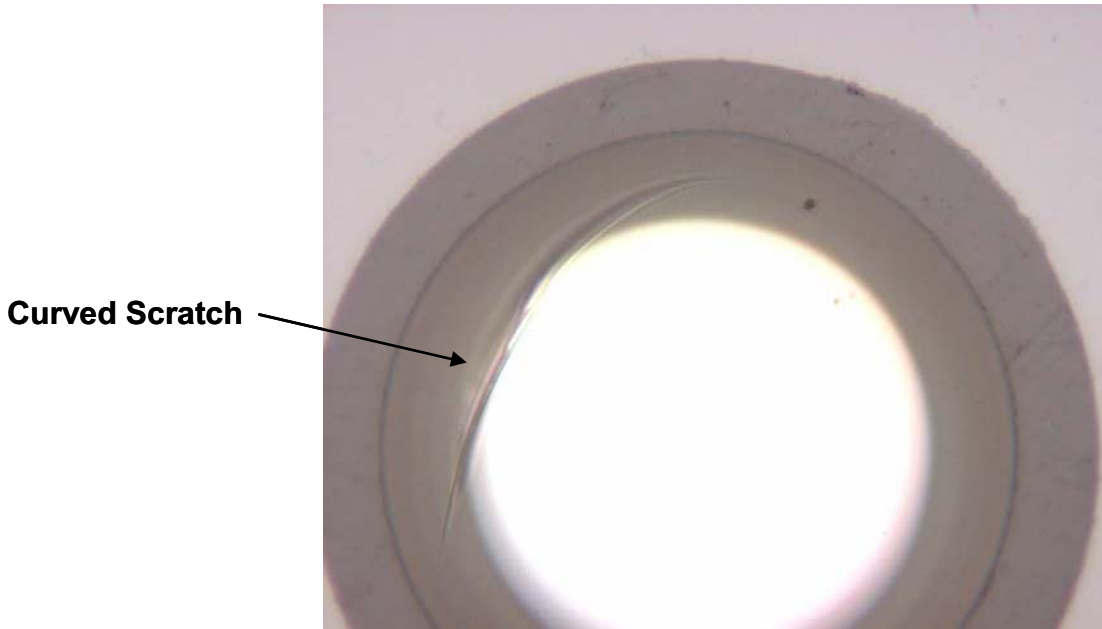
Figure 7.7-3. Curved Scratch in Glass at Magnification of 500X

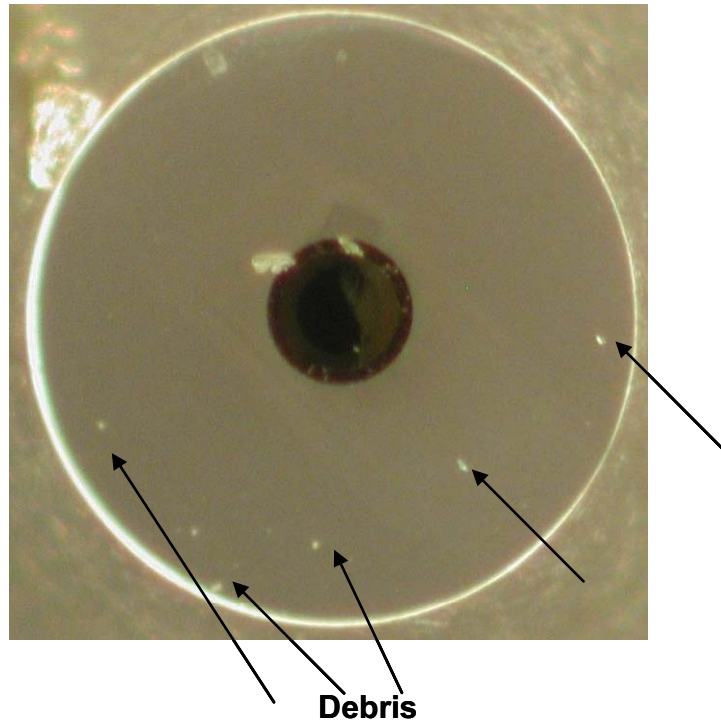
At 40X magnification (Figure 7.8-2), debris can be seen in several areas in and around the fiber. There also appears to be a smudge over the core. When a defect cannot be removed by means of cleaning, it must be observed at higher magnifications.

Figure 7.8-2. Optical Image at Magnification of 40X

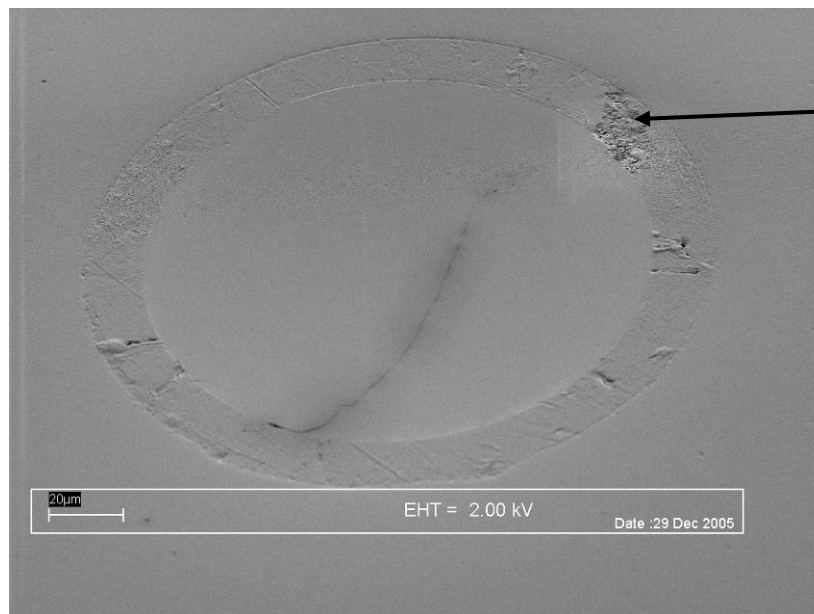
SEM was performed (Figure 7.8-6), which enabled the crack to be clearly observed.

Figure 7.8-6. Clear View of Crack

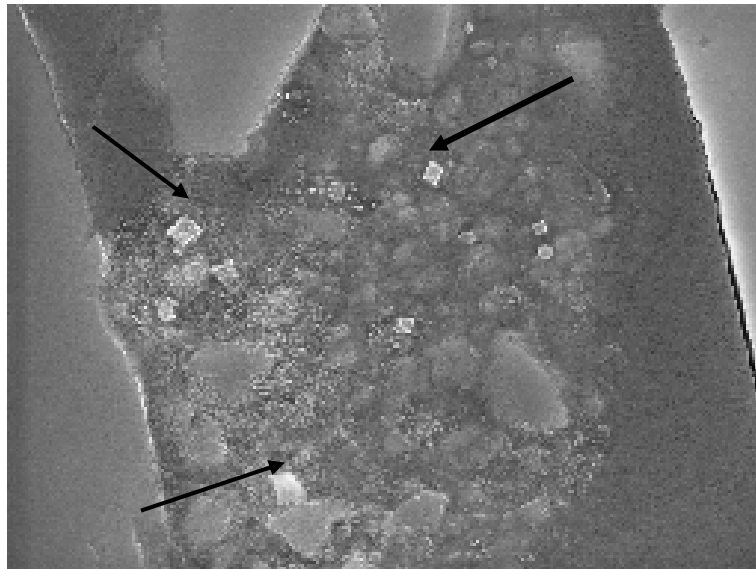
Figure 7.8-7. Visible Crystals in the Polyimide Coating

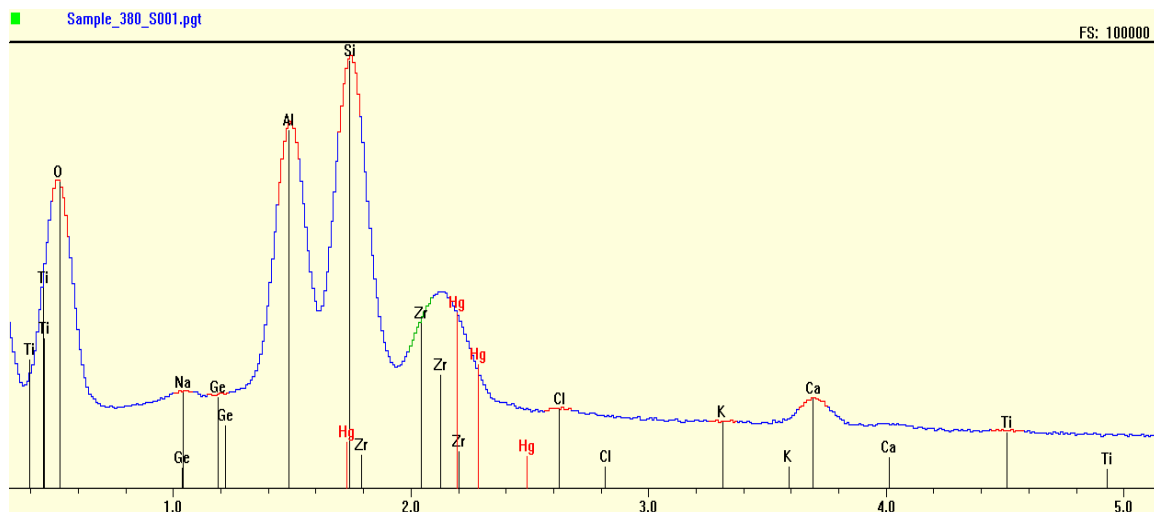
An EDS data analysis (Figure 7.8-8) of the corrosive area indicates the presence of Na and Cl.

Figure 7.8-8. EDS Data

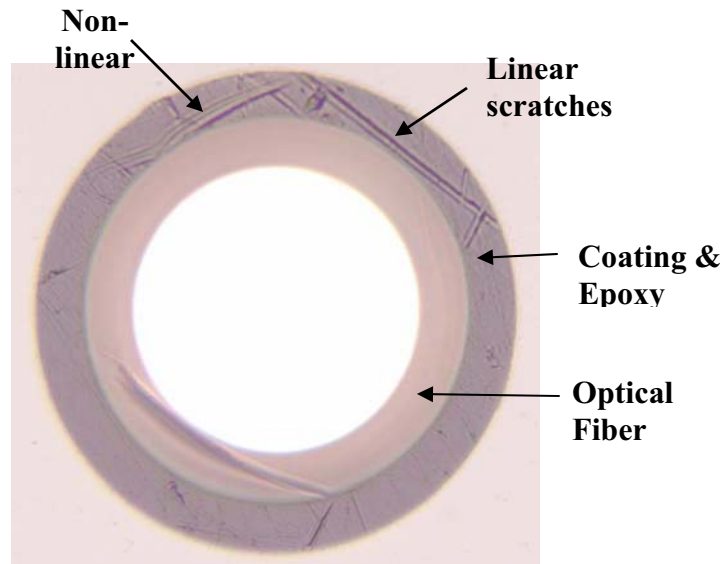
This sample has damage very similar to HMU-303 P3-DAIU SKT C, whereas it appears to have been connected with debris present on the end-face. The scratches in the coating are evidence of a foreign substance being dragged or scraped in a non-linear direction. There is some unidentified debris in the core region that will need to be analyzed with EDS.

Figure 7.9-1. Bright Field Image at Magnification of 200X

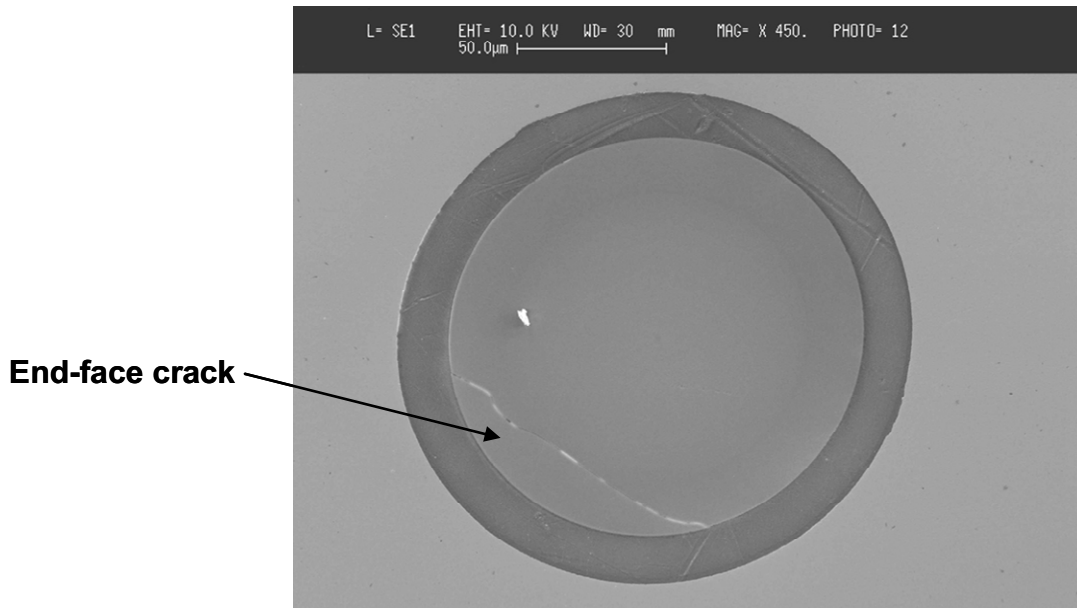
Figure 7.9-3. Crack in the End-Face

SEM shows a clearer picture of the damage (Figure 7.9-3), and what was thought to be a surface scratch becomes a crack in the end-face. There is no obvious origin of the crack. The crack ends at the coating in two locations, and the process of de-lamination occurs (Figure 7.9-4).

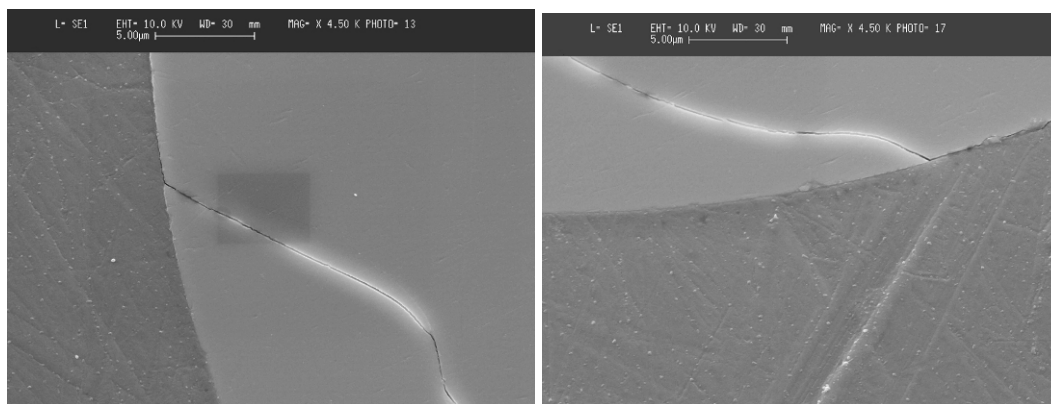
Figure 7.9-4. Crack Ends

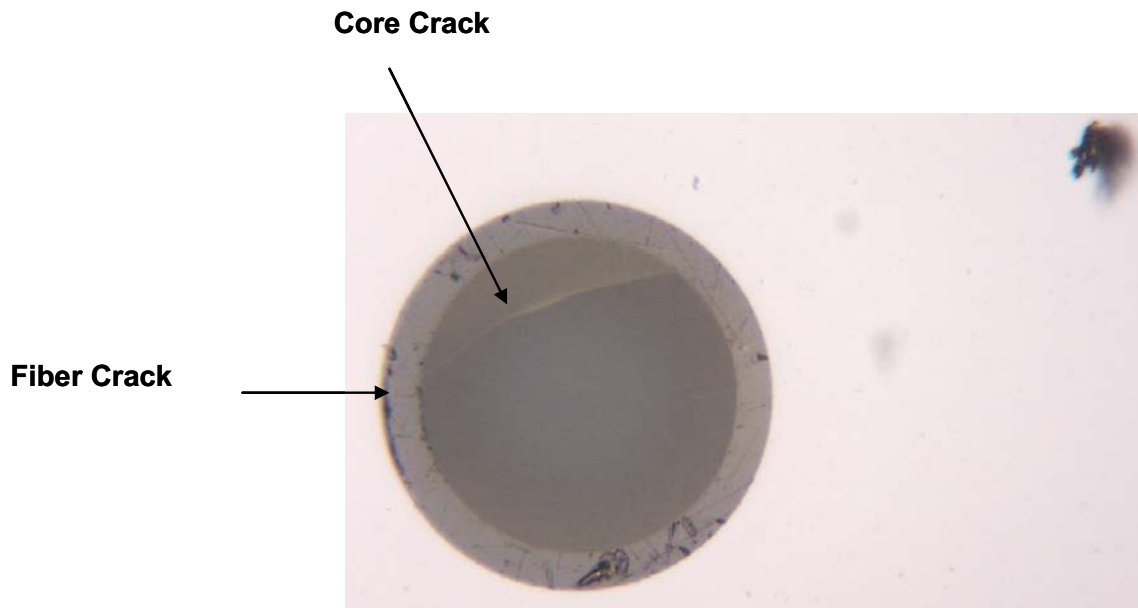
This termination is cracked partially through the core and deep into the fiber (Figure 7.10-1). There is some debris present on the ferrule end, and some damage/debris on the bottom of the coating.

Figure 7.10-1. Bright Field Image

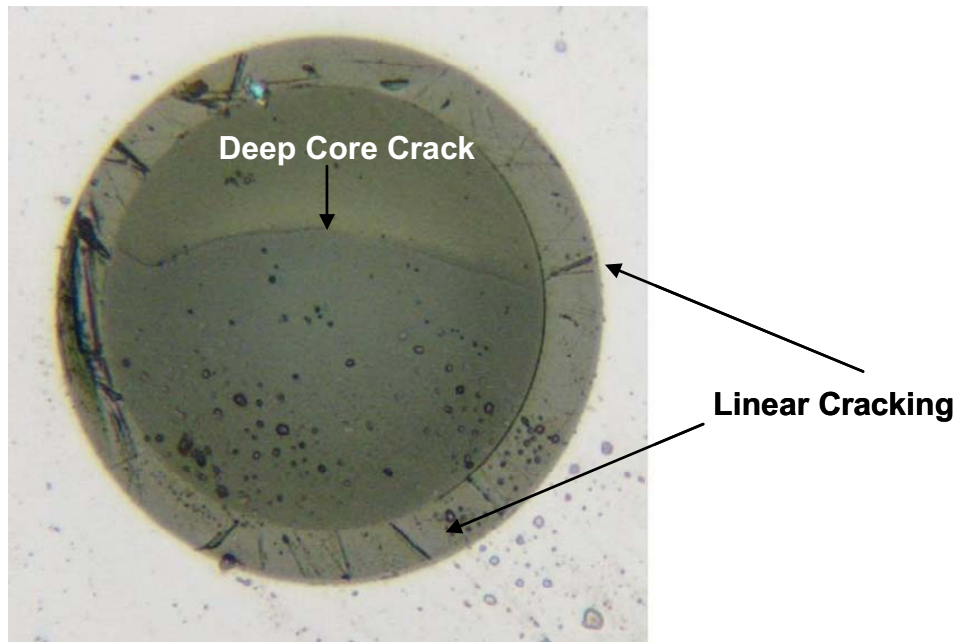
1. There was a deep crack through the core.
2. There were deep scratches in the coating, which appear linear.

Figure 7.11-1. Bright Field at Magnification of 200X

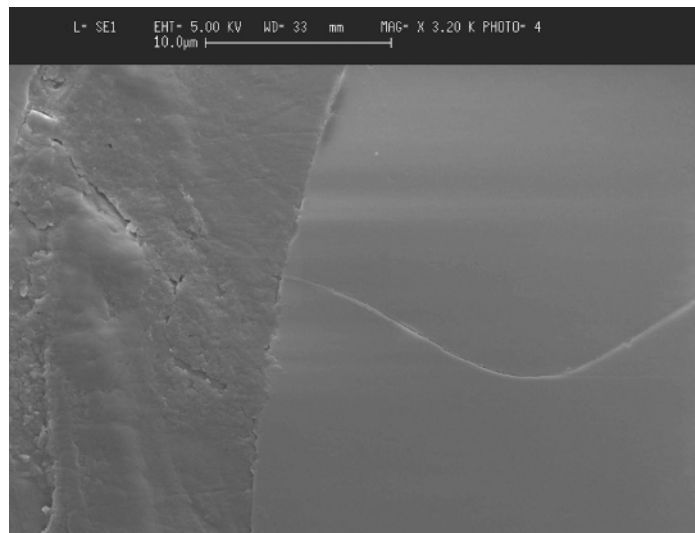
The ends of the crack can be clearly analyzed under 3.2×10^3 and 2.8×10^3 X magnifications (Figure 7.11-3), but no definitive origin was identified.

Figure 7.11-3. Magnification of 3.2 KX

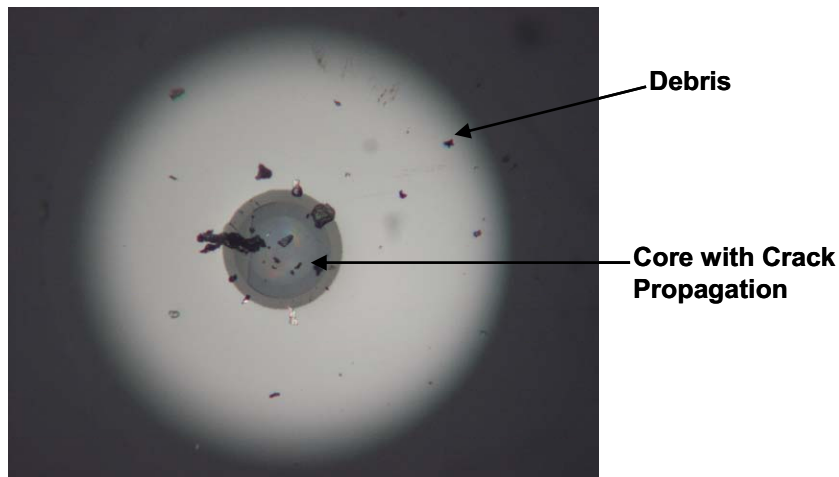
Figure 7.12-1. Connector with Considerable Debris

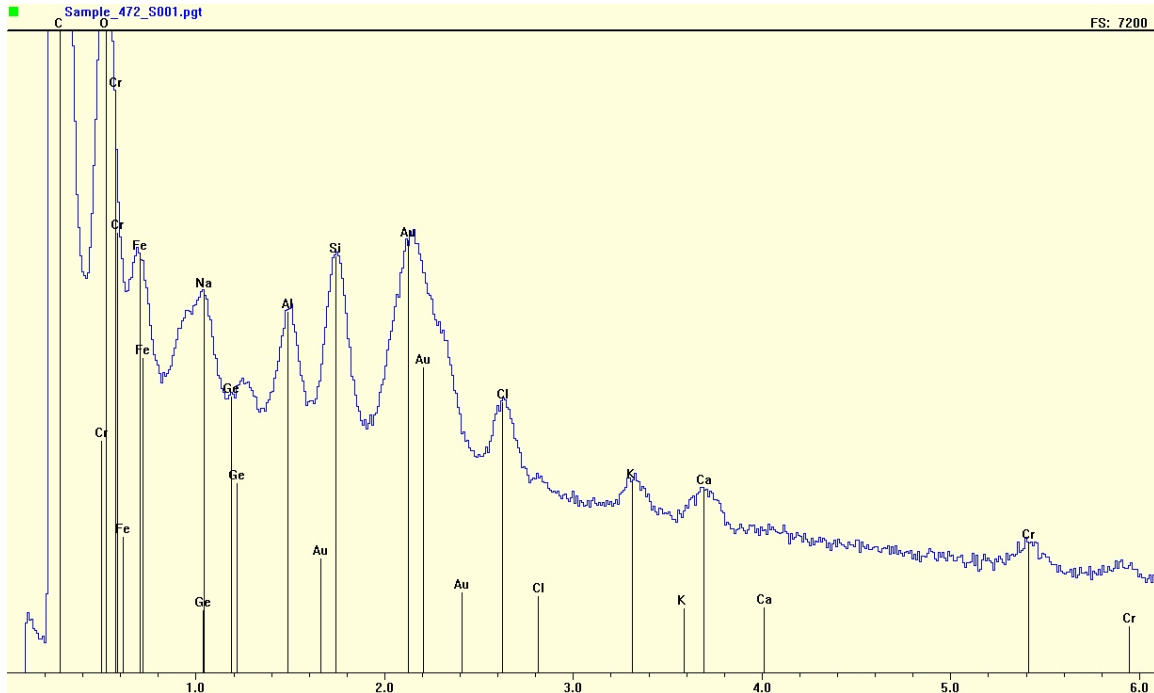
Figure 7.12-3. EDS Data of Debris on End-Face

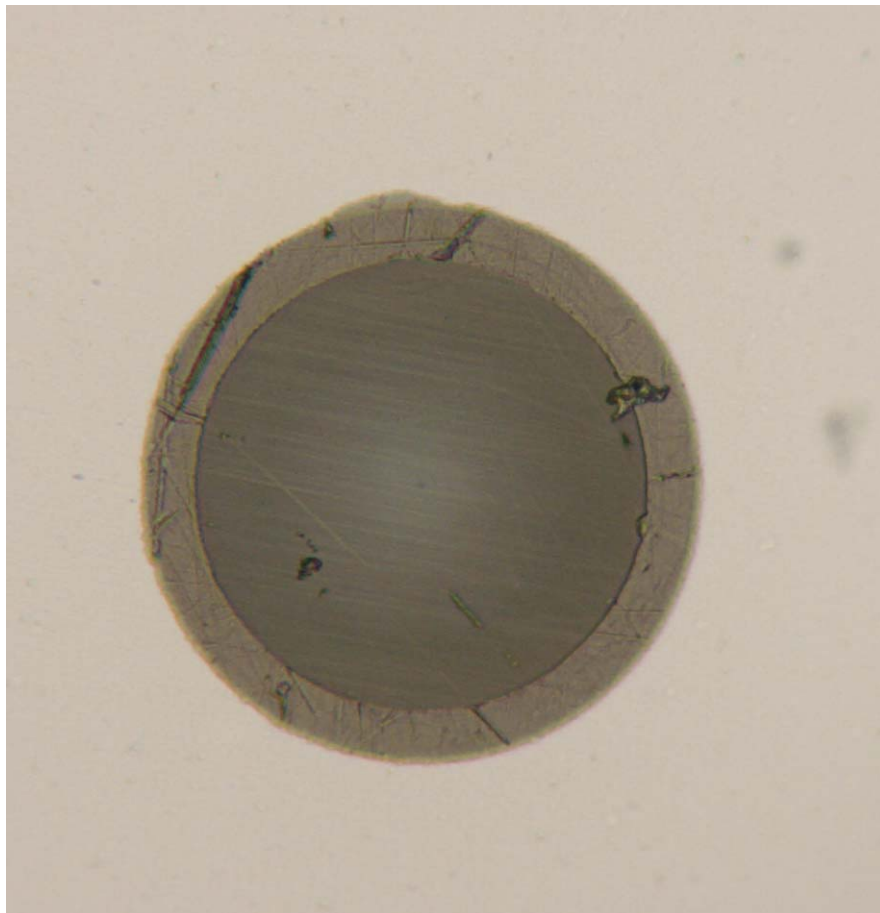
Figure 7.13-1. Deep Scratches from Polishing Process
