IAC-08-A6.3.1

MICROMETEOROID AND ORBITAL DEBRIS THREAT MITIGATION TECHNIQUES FOR THE SPACE SHUTTLE ORBITER

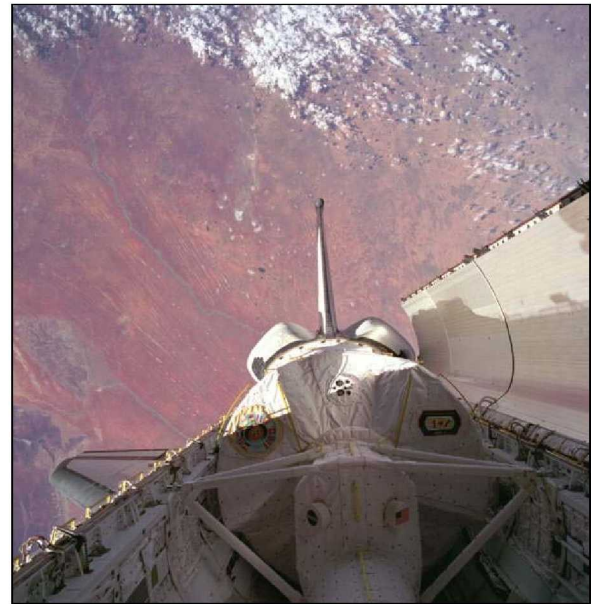
The 16 day STS-73 mission in 1995 carried a United States Microgravity Module (USML) Spacelab module and an EDO cryogenics pallet in the payload bay. The vehicle was oriented with its port wing into the velocity vector for 13 days of the mission, so the port payload door was kept partially closed in order to protect the USML and EDO payloads from MMOD impacts. Post flight inspections revealed a crater in the outside surface of the port payload bay door that was 17 mm in diameter and 6 mm deep. A 1.2 mm long intact fragment of a circuit board was found in the crater [6]. If this orbital debris projectile had impacted a different region of the orbiter, such as the EDO pallet or a wing leading edge RCC panel, it could have caused the loss of the vehicle and crew.

Figure 1. Payload bay of shuttle Columbia on STS-73

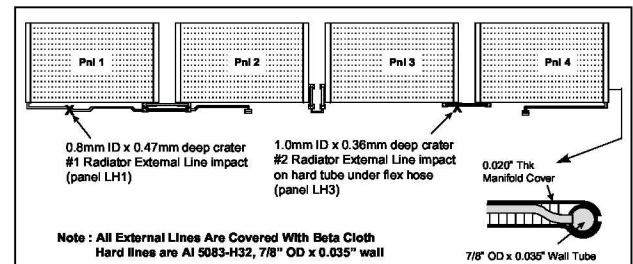
After the STS-86 mission in 1997, several significant MMOD impacts were observed on the left hand radiator interconnect lines (Fig. 2). The aluminum tubes carry Freon coolant between the thermal control system radiator panels.

Figure 2. Impacts on STS-86 LH radiator interconnect lines.

micrometeoroid particle. After this mission, an additional layer of beta cloth was added to the external radiator lines on all orbiters [6].

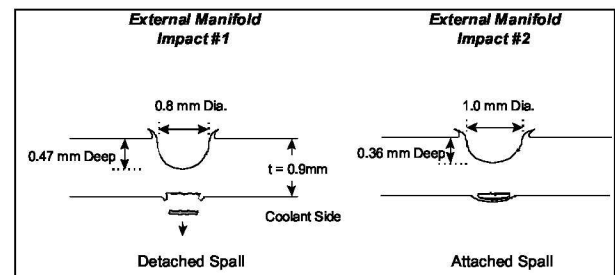
Figure 3. Impacts on STS-86 radiator interconnect lines.

The largest impact, on the external line at panel #1, penetrated just over halfway through the 0.9 mm wall thick coolant tube wall [6]. Post flight inspections determined that the site experienced detached spall on the inside surface of the tube wall, close to a tube perforation (Fig. 3). A tube leak would likely have resulted in a mission abort and possible loss of mission objectives. Post flight analysis indicated that impact #1 was caused by an orbital debris particle of stainless steel, while impact #2 was produced by a

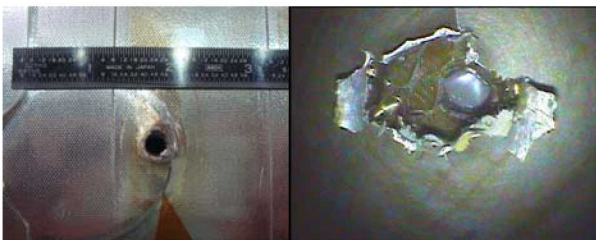
The STS-118 mission in 2007 experienced a large MMOD impact on the left hand #4 radiator. The impact produced a 5.5 mm diameter entry hole in the thermal tape and outer face sheet of the aluminum sandwich panel (Fig. 4). Subsequent inspections revealed a 12 mm x 19 mm exit hole in the inner face sheet of the radiator panel, with two small down stream damage sites on a thermal control system (TCS) blanket under the radiator. The payload bay door under the TCS blanket was not damaged by the impact. Analysis showed that this impact was caused by an orbital debris particle that was rich in Titanium, Zinc and Antimony.

Figure 4. MMOD impacts on STS-118 LH4 radiator.
